APPENDIX F

Phase 1 Archaeological and Heritage Impact Assessment on the farm
Hondekraal 234 JS, in respect of proposed wetland rehabilitation
activities in the Loskop Dam Nature Reserve, Mpumalanga Province.

8 December, 2017

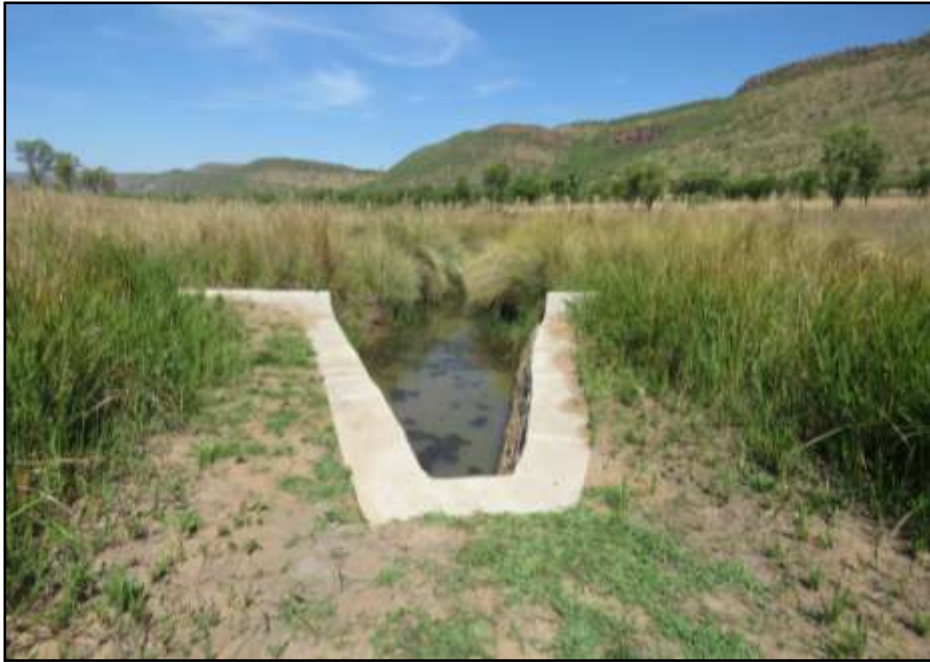
Fig. 1. An example of a typical hard engineering intervention known as a stone masonry weir which may be used at Hondekraal.

At the Hondekraal erosion dongas the soft interventions such as re-vegetation and silt fences are currently desirable as they will be the most effective long term measure in reducing and halting the erosion. Some hard interventions like small stone masonry weirs may also be necessary. Also see Appendix C for maps illustrating possible interventions.

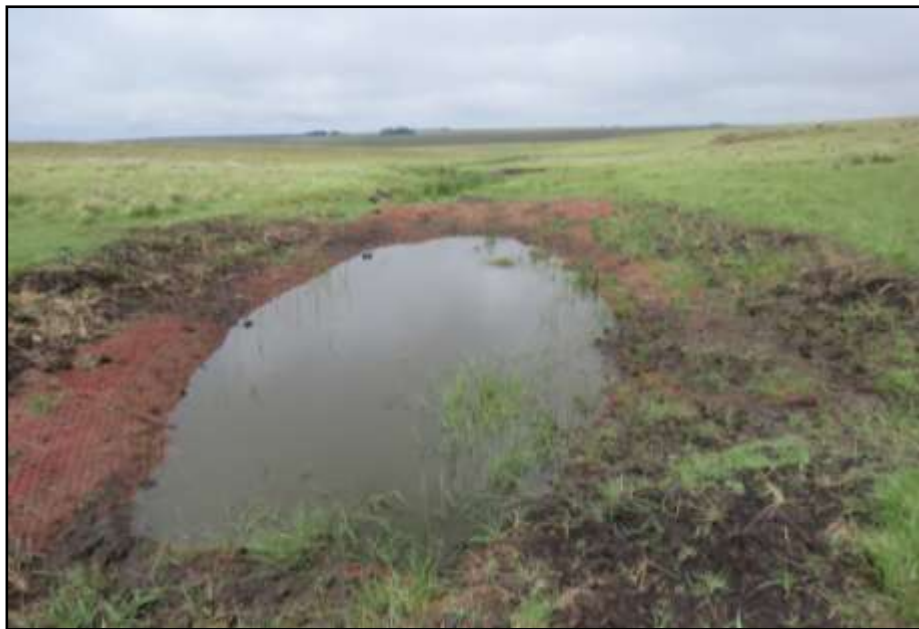
Fig. 2. A typical soft intervention (geomat) for erosion control where the outcome is to trap sediment and thereby promote the re-establishment of vegetation which halts further erosion. This will be used at Hondekraal.

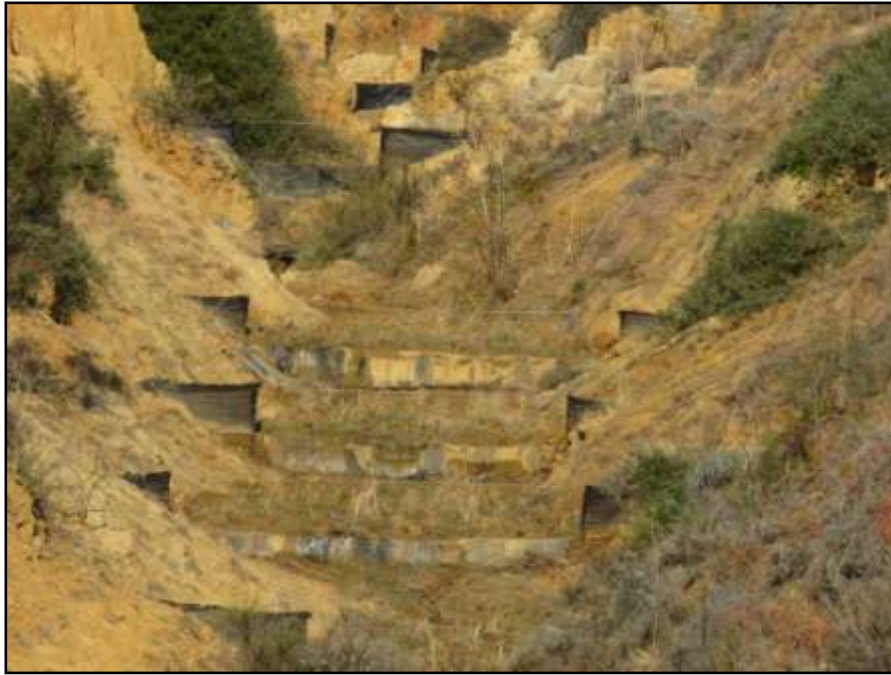
Fig. 3. Another example of soft intervention is a silt fence which reduces and stops erosion in dongas with small catchment areas by means of cheap and easily constructed structure. This is a photo shortly after construction.

- Silt fences. These reduce and stops erosion in dongas with small catchment areas by means of cheap and easily constructed structure. The structure requires vertical iron stays to be knocked into the ground, followed by shade netting being draped across and tied firmly to the stays. The structures can also be made with natural materials which are biodegradable.

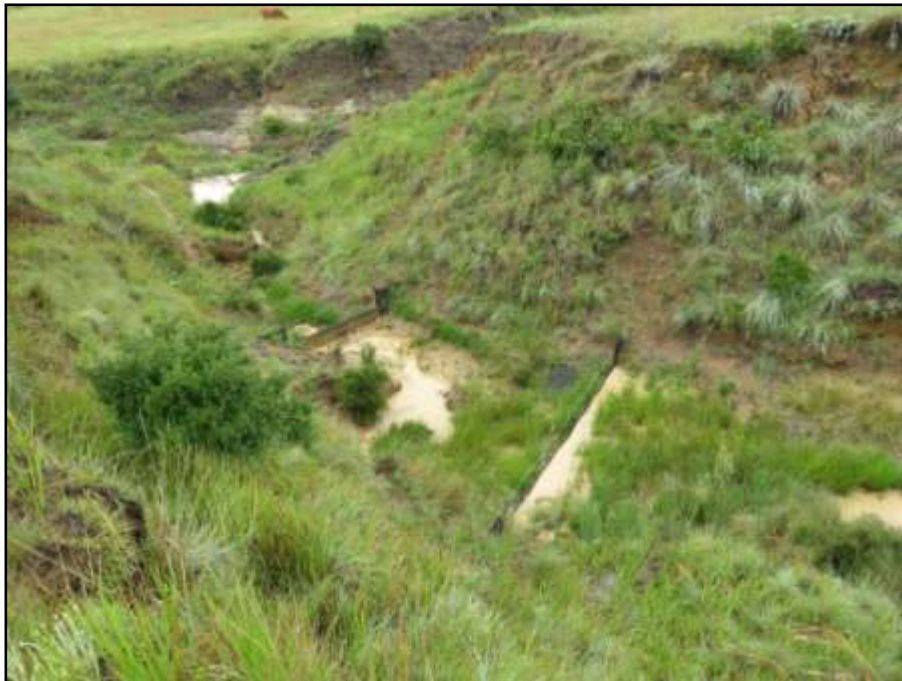
Fig.4. Silt fences after it has been implemented in an erosion donga resulted in halting the erosion and re-established plant growth.

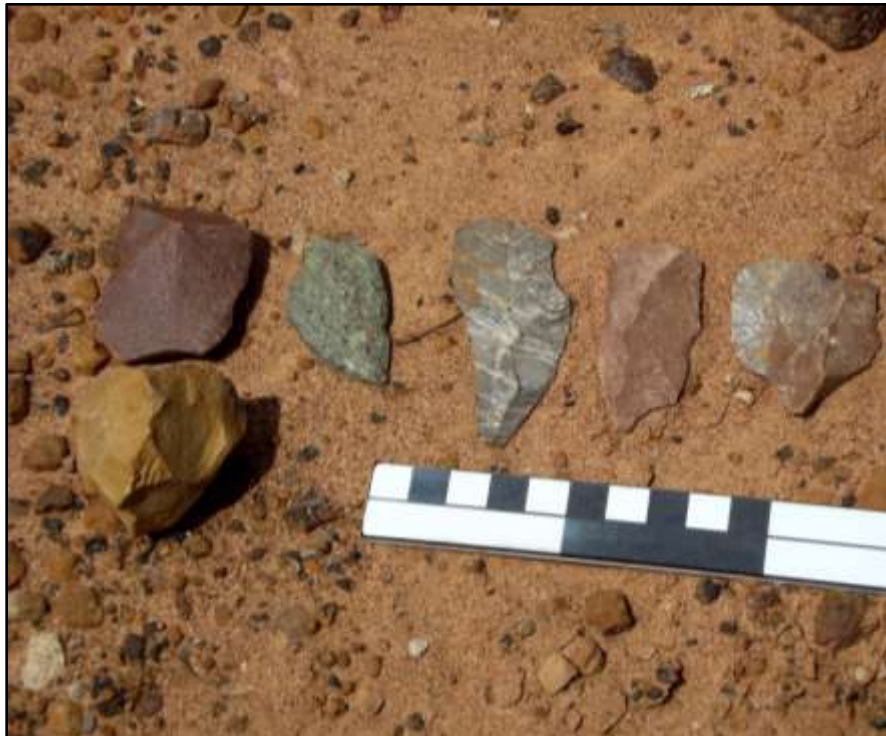
Fig. 4. Site F. (l-r) Cores and flakes on the surface of the erosion donga at site F. Larger tools has blunt edges appearing rounded and weathered, possibly as a consequence of continuing sheet erosion.

Soil erosion can be considered as a post-depositional process which together with substantial water flow, resulted in a rounded and weathered appearance on the stone tools at Hondekraal 234 JS. Post-depositional processes as an influence on archaeological material have been discussed by some authors (Wright et al. 2016). Natural and anthropogenic processes that have occurred after the deposition of archaeological material might have transformed them into their present state. Understanding of post-depositional processes is vital to assess the possible biases they might have caused in the archaeological record. Some of the best examples of this include erosion and agricultural activities such as ploughing. Given the fact that soil erosion has had a negative effect on the archaeological deposit in this area, which was intervened by site recording and archaeological excavation since 1997 through 2005, and that the sheet erosion has continued since 2005 (12 years) it is my opinion that the proposed interventions by the Working for Wetlands programme to stop further erosion will also halt ongoing degradation of the archaeological deposit and will therefore be a positive impact. The proposed activities will not impact on in-situ archaeological material or sites (i.e. knapping sites, Pelser & Teichert, 2001, 2002, 2005). Therefore the proposed interventions are supported.

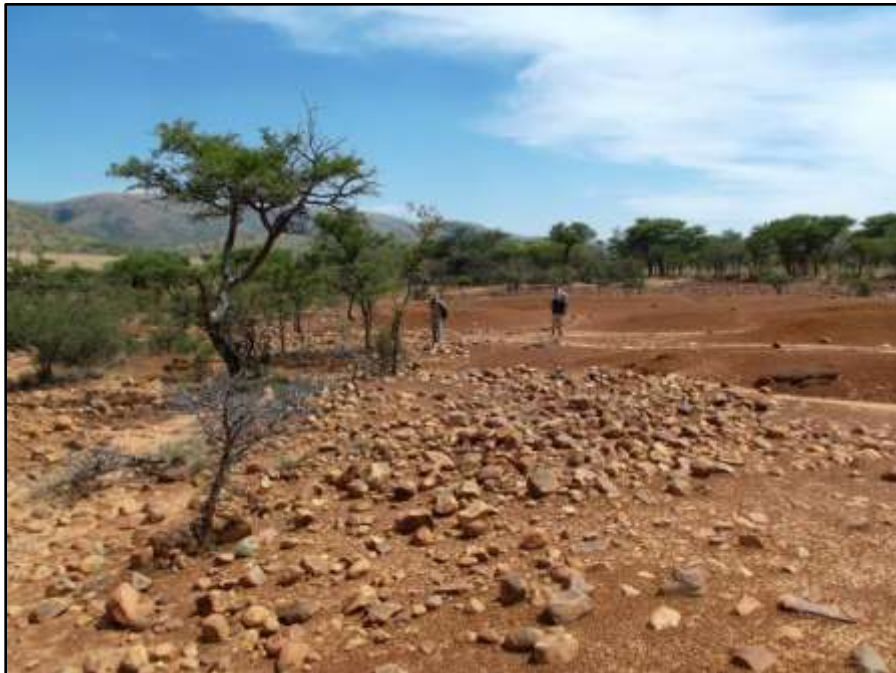
Fig. 6. Site F. Photo taken north. Note that some plants have resettled in some areas of the erosion donga which helps to lessen the effect of the erosion.

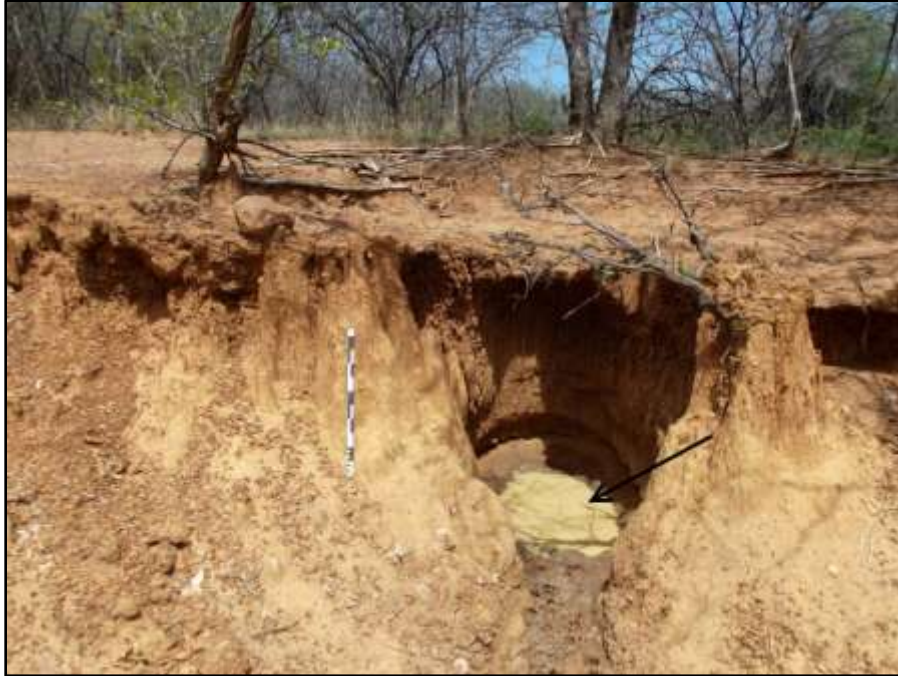
Fig. 9. Site F1. An example of the typical effect of soil erosion. The arrow indicates a puddle of fresh water which is indicative of continuing soil erosion. Scale is 50cm. Photo taken in a southern direction.

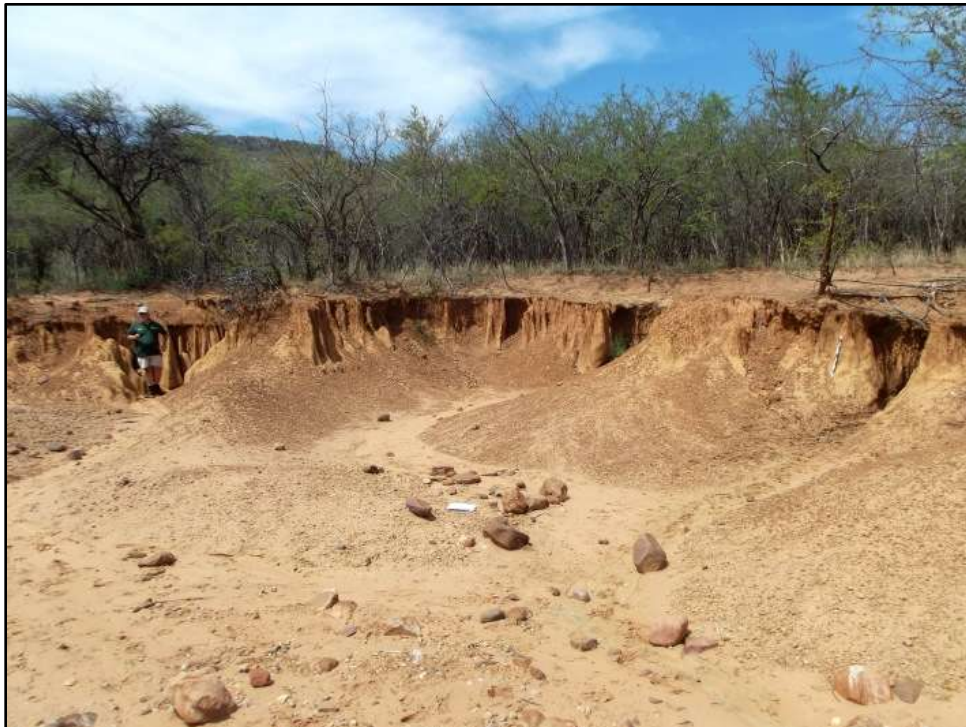
Description: A location inside the erosion donga (site F) where the effects of erosion is clearly visible (see photos in Appendix D fig. 9, 10).

Fig. 10. Site F1. Photo taken in a eastern direction.

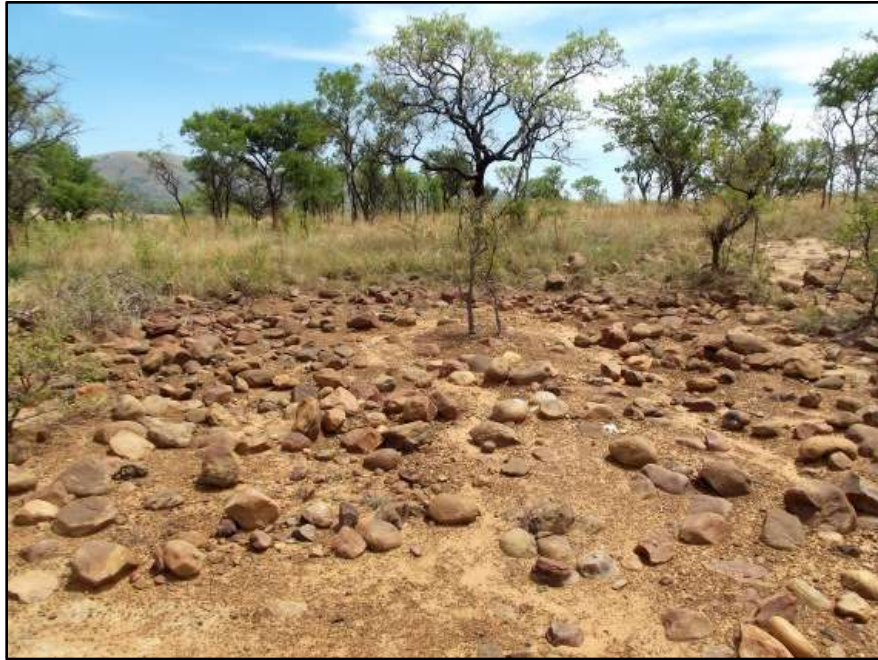
Fig. 11. Site F2. A possible stone circle site previously documented by Pelser and Teichert 2001, 2002. Photo taken in a north western direction.

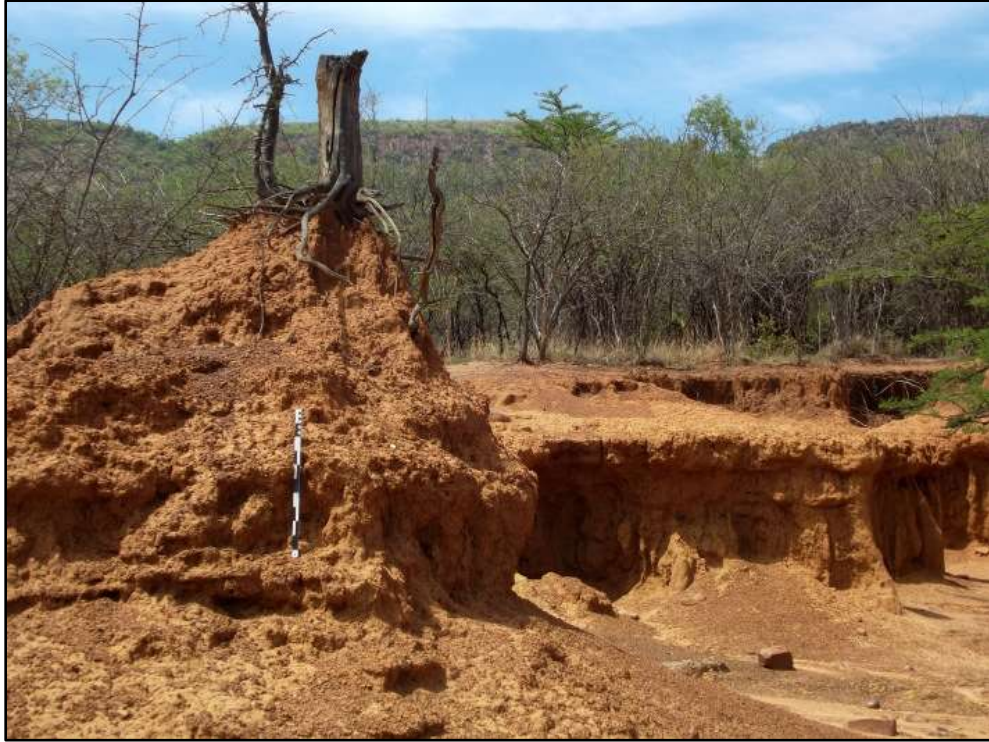
Fig. 13. Site F3. Photo taken in an eastern direction. The dead tree on top of the soil is evidence of the rapid nature of the erosion process. Scale is 50cm.

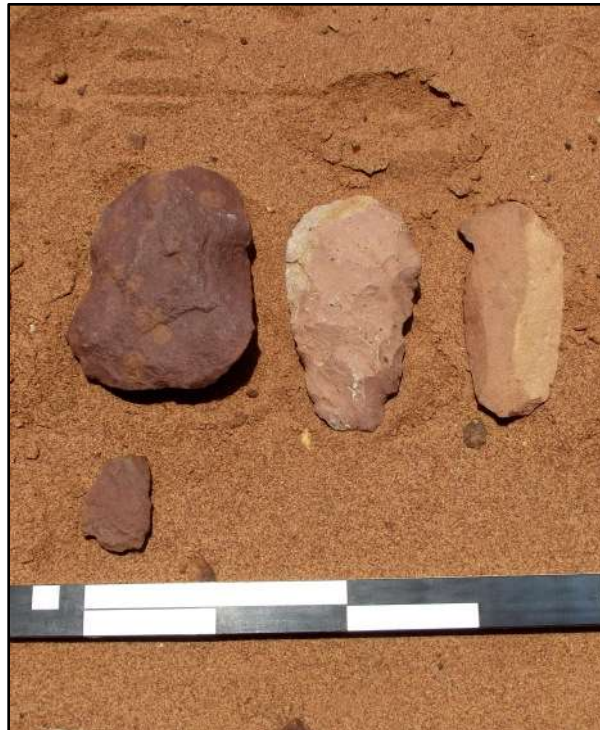
Fig. 16. Site D. Some handaxes and flakes collected from the surface. Most tools have blunt edges appearing rounded and weathered, possibly as a consequence of continuing sheet erosion.

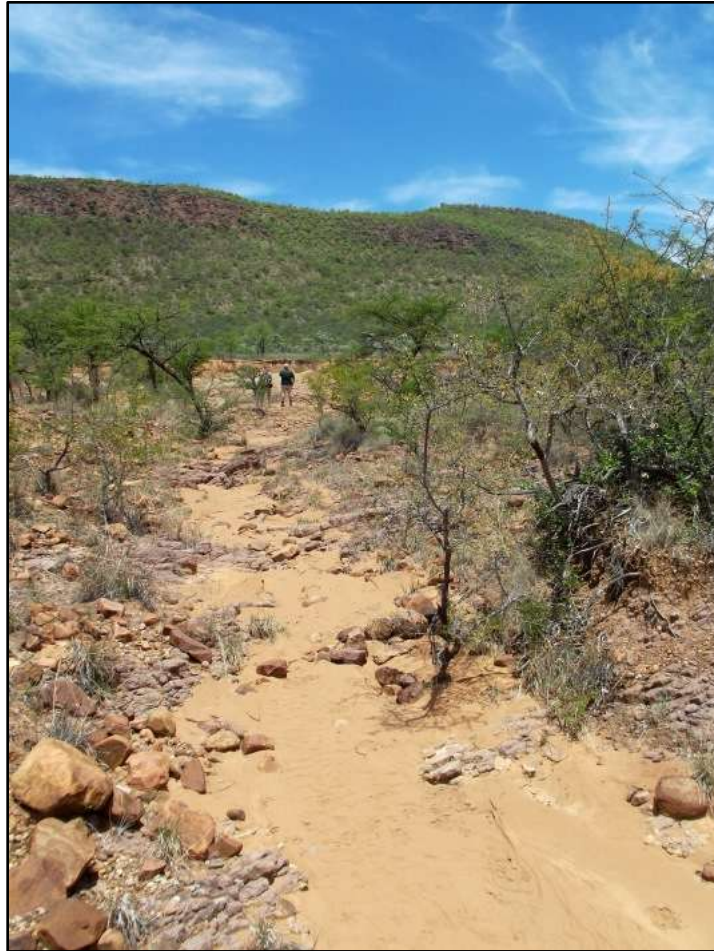
Fig. 17. Site D. Approximately 100m north of site D where the silting is obvious. This is potentially a place where a “hard intervention” structure can be placed.

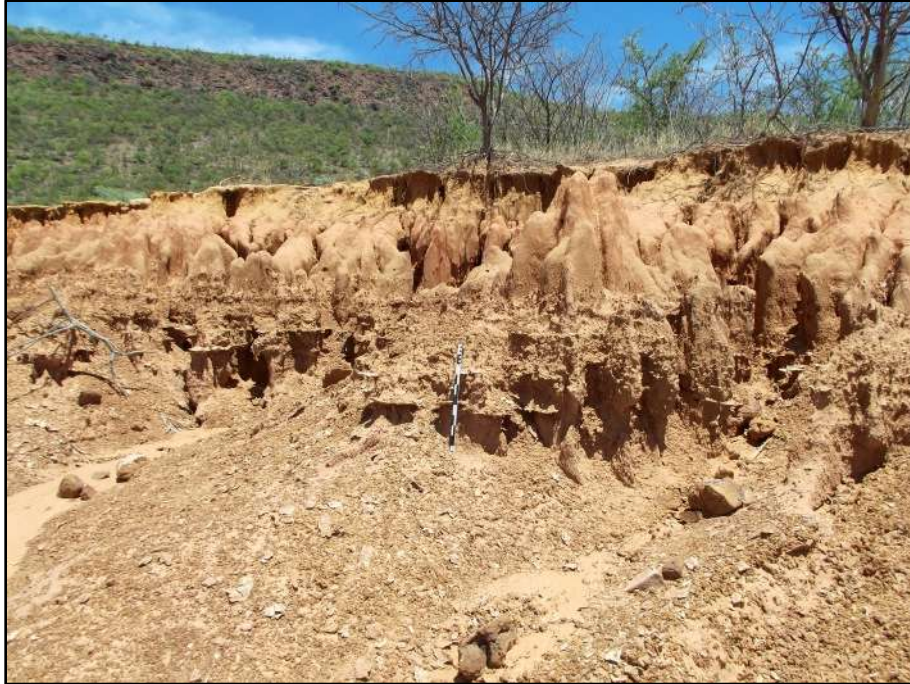
Fig. 18. Site D1. Photo taken in a southern direction. Scale is 50cm. The soil colour and texture is uniform.

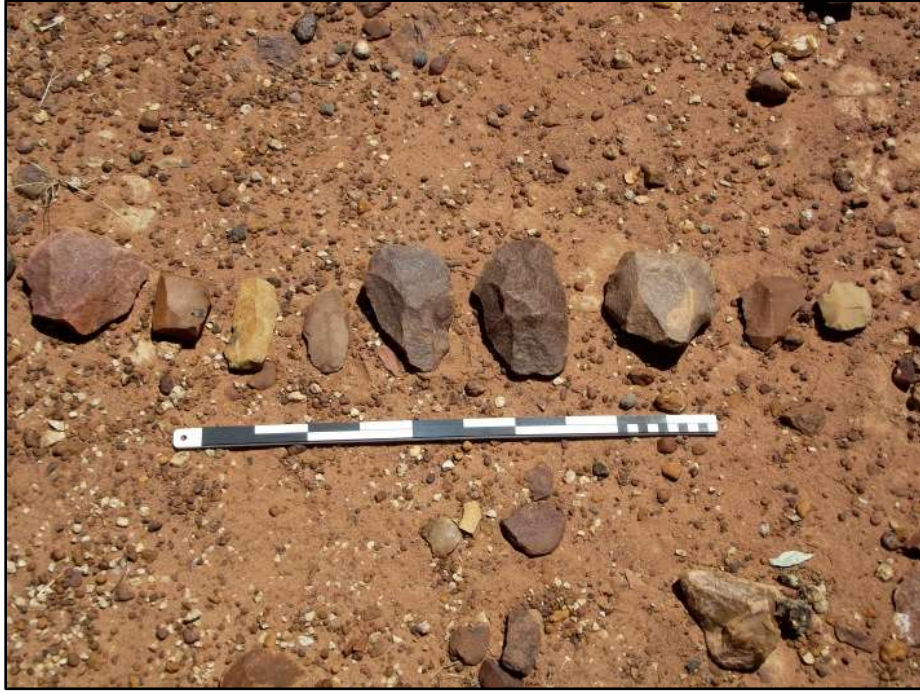
Fig. 20. Surface scatter in the proximity of Site D1. Some handaxes and flakes collected in this area on the surface. The tools are often rounded with weathered edges probably as a result of continued sheet erosion.

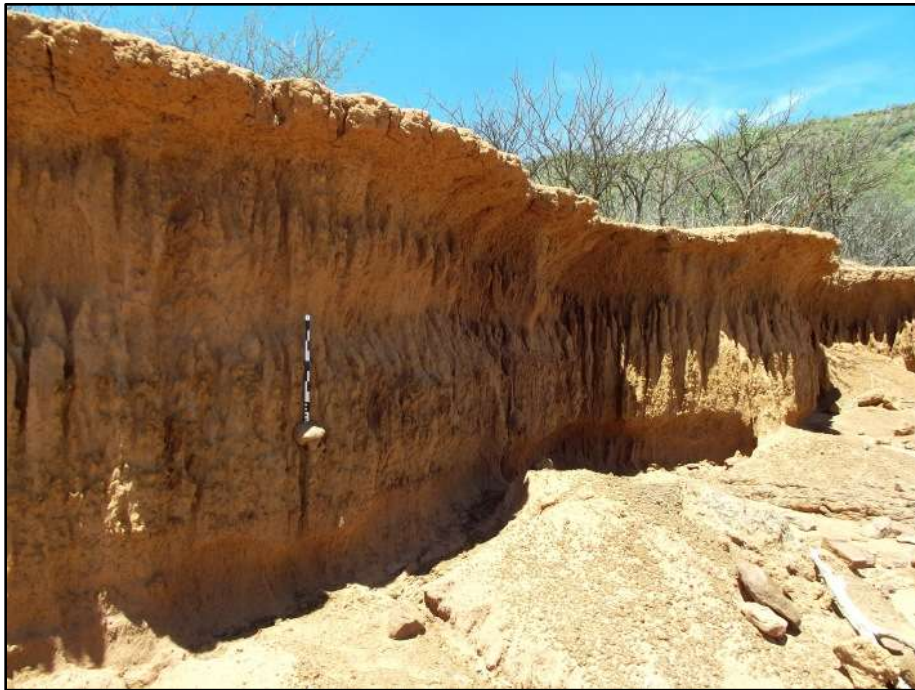
Fig. 21. Site D2. Photo taken in a north eastern direction. Scale is 50cm. The soil colour and texture is uniform.

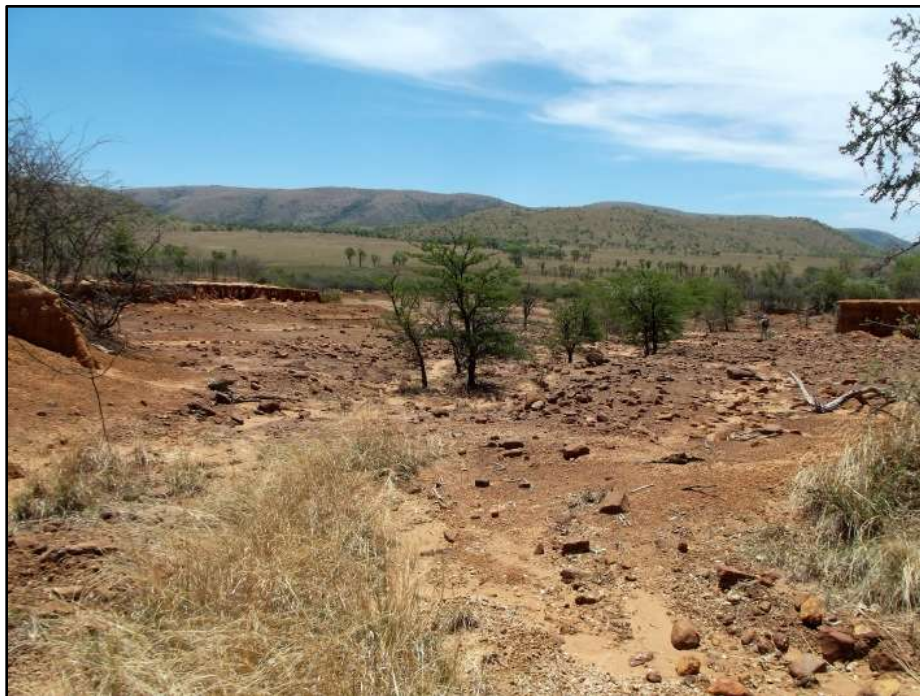
Fig. 23. Site D3. Photo taken in a northern direction. This is the southern edge of the erosion donga. Note the silting which indicates the direction of water flow north.

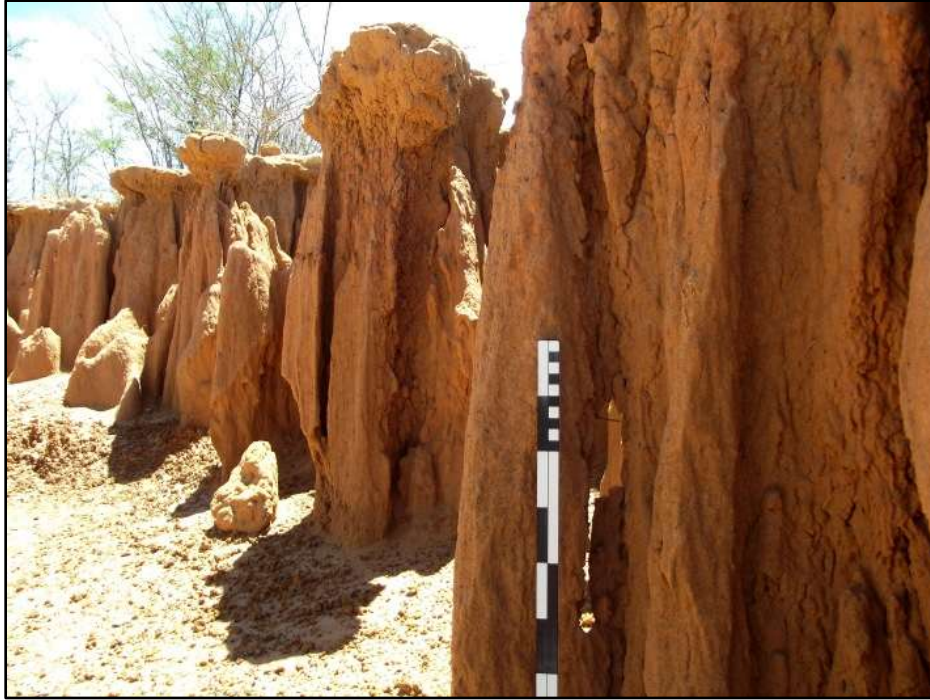
Fig. 24. Site D4. Photo taken in a southern direction. This is a location on the south western edge of the erosion donga. Scale is 50cm.

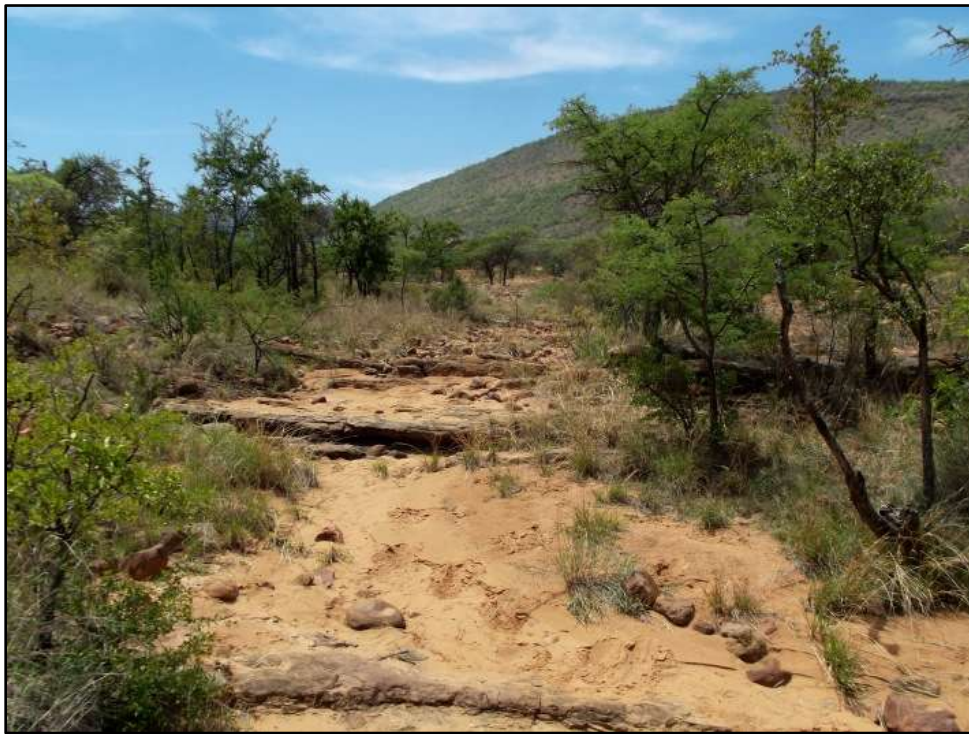
Fig. 25. Site SO1. Photo taken in an eastern direction. Silting of the eroded soil is clearly visible.

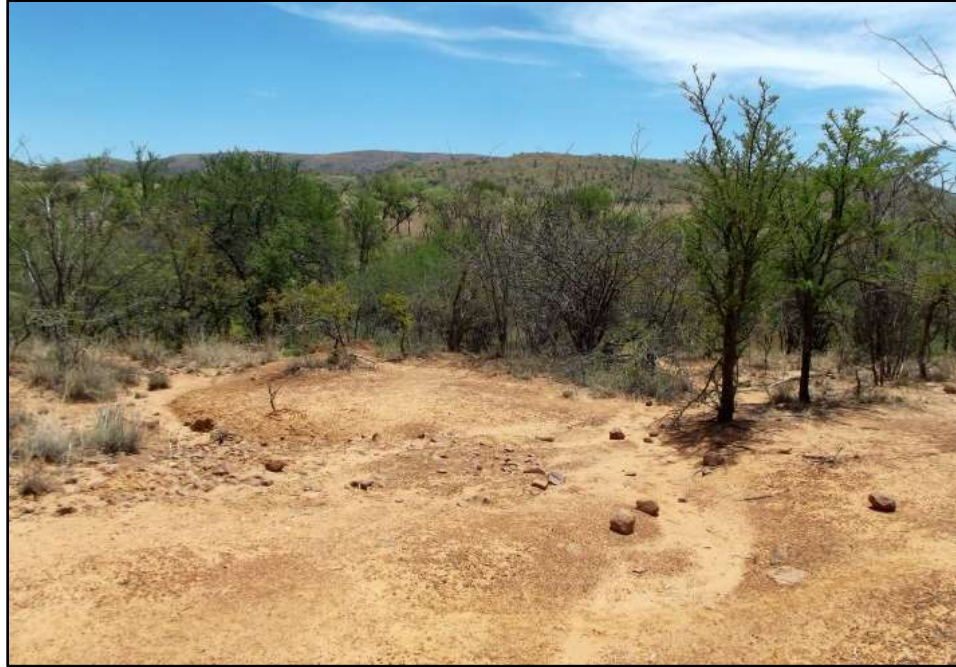
Fig. 31. Site SO4. Photo taken in a north western direction. The effects of erosion and silting is visible.

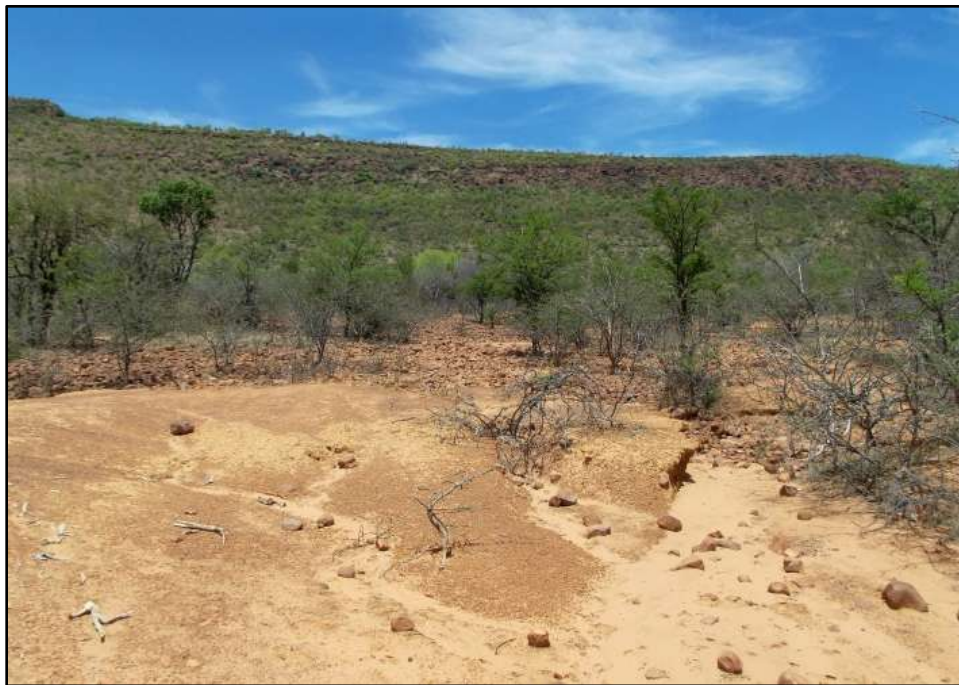
Fig. 32. Site SO4. Photo taken in a south western direction. The effects of erosion and silting is visible.

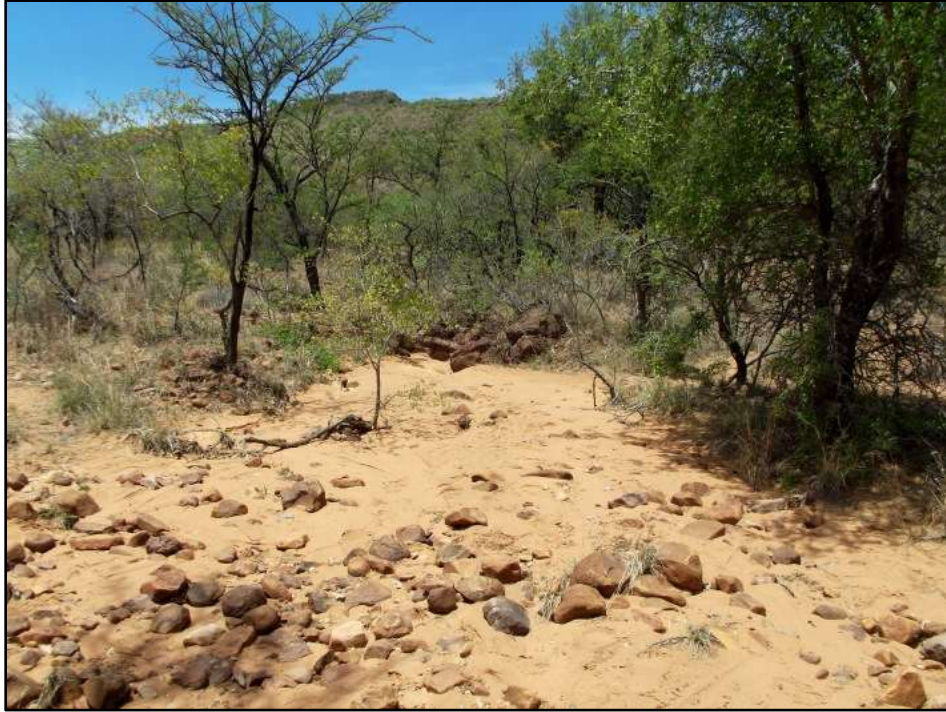
Fig. 33. Site SO 5. Photo taken in an eastern direction. The silting is visible in the foreground of the photo. A few metres south this reaches the wetland.

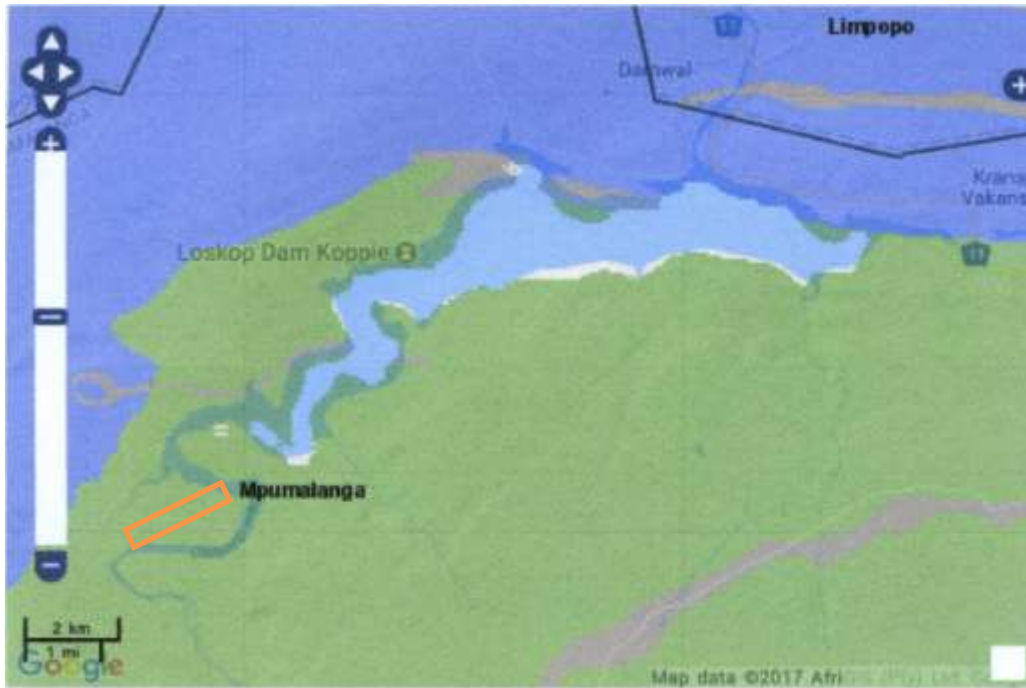
According to the geological map (Fig 2) the farm Hondekraal 234, at the south western part of the dam where the Oliphants River enters the dam, lies in the Loskop Formation with other ancient rocks surrounding the dam and wetlands. This region however is recorded as “green” in the SAHRIS palaeosensitivity map (Fig 1).

Figure 1: SAHRIS Palaeosensitivity map for the area around Loskop Dam, north of Middelburg and close to the Limpopo-Mpumalanga boundary. Colours indicate the following degrees of sensitivity: red = very highly sensitive; orange/yellow = high; green = moderate; blue = low; grey = insignificant/zero.

The volcanic rocks do not contain fossils but the Wilge and Loskop Formations contain shale and sandstones. They are, however, too old to contain body fossils. Microorganisms, such as bacteria and algae, had evolved by this time and could be preserved in tidal pools and the like, but none has yet been reported from the fan delta lobes in this area. Although the SAHRIS palaeosensitivity map, Fig 1, indicates that the area around the dam is green, from the geology there is no indication of any fossils being preserved.

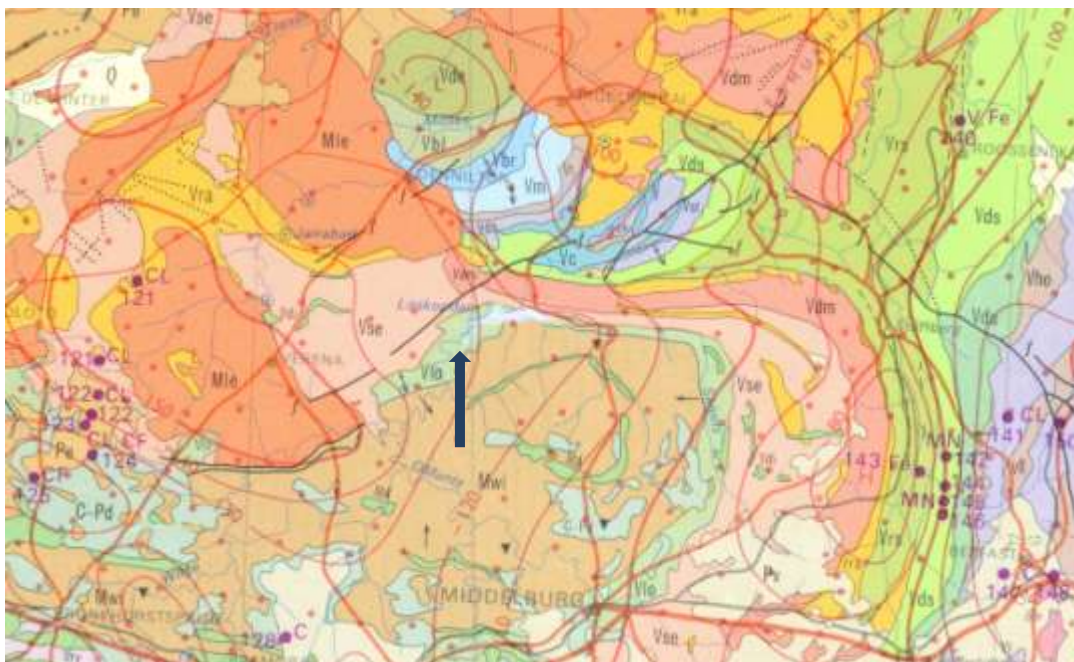
Figure 2: Geological map of the area around Loskop Dam Nature Reserve north of Middelburg on the farm Hondekraal 234, Mpumalanga. The approximate location of the proposed project is indicated with the arrow. Abbreviations of the rock types are explained in Table 2. Map enlarged from the Geological Survey 1: 1 000 000 map 1984.
