HERITAGE IMPACT ASSESSMENT FOR THE PROPOSED SOL INVICTUS 3 PV FACILITY, NAMAKWALAND MAGISTERIAL DISTRICT, NORTHERN CAPE

Required under Section 38 (8) of the National Heritage Resources Act (No. 25 of 1999).

First draft: 08 April 2016

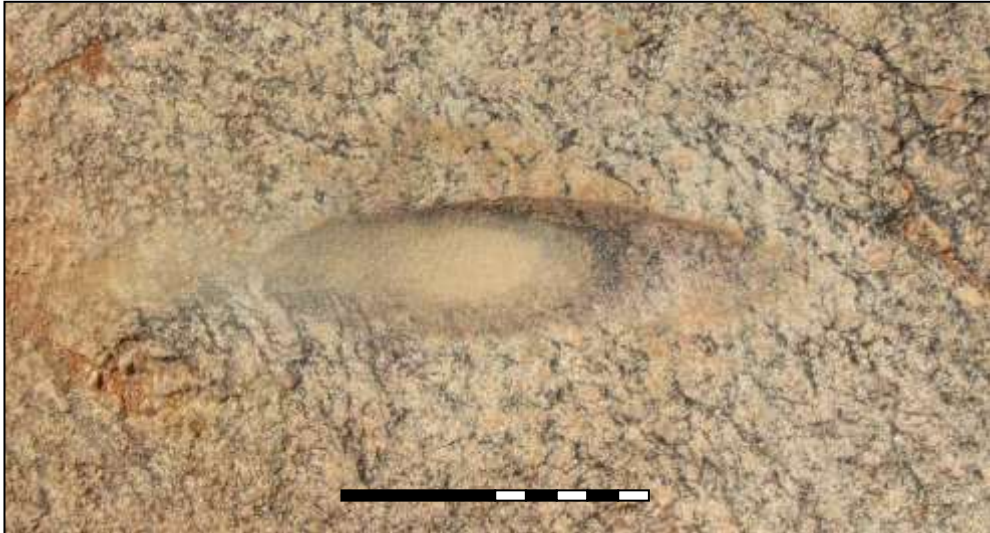
Figure 17: A very prominent grinding groove located at waypoint 050. The scale bar is 10 cm long.

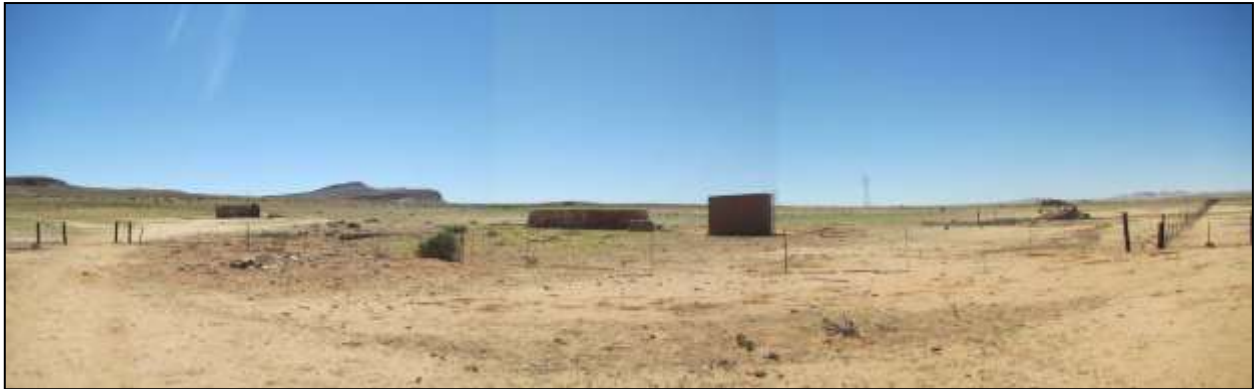
A small ruined farm complex was found along Alternative 1 transmission corridor at waypoint 008. The structures are in a state of disuse. Historical aerial photography shows it to have been present in 1962/63. The structures are widely dispersed with those furthest apart being 180 m from one another (Figures 27 & 28). They are not old, probably dating to the mid-20th century, and one of them appears to have been a cottage with an external hearth which may have housed farm labourers (Figure 29). There are three structures, a circular cement reservoir and a livestock loading ramp.

Figure 27: View towards the east showing the widely dispersed farm complex at waypoint 008.
