Phase 1 Palaeontological Impact Assessment of the Boundary PV solar facility on farm Karreeboom 1716, Boshof District, FS Province.

- At the request of Savannah Environmental Consultants, a Phase 1 Palaeontological Assessment was carried out at the proposed new 75MW Boundary Photovoltaic (PV) facility located on farm Karreeboom 1716 in the Boshof district in the western Free State Province.
- The field assessment indicates that construction will primarily impact on Quaternary-age surface deposits.
- The likelihood of palaeontological impact on **superficial Quaternary sediments** resulting from the construction of the photovoltaic panels and associated infrastructure at farm Karreeboom 1716 is considered extremely **low**.
- The terrain is not considered palaeontologically vulnerable and there are no major palaeontological grounds to suspend the proposed development.

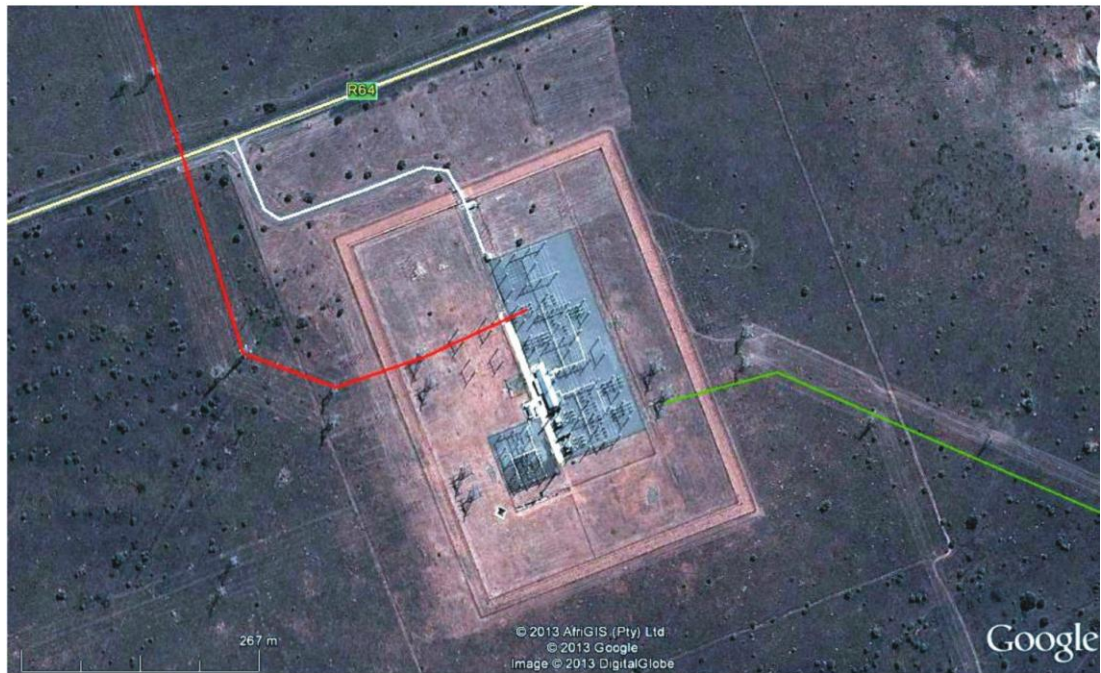
At the request of Savannah Environmental Consultants, a Palaeontological Desktop Assessment was carried out at the proposed new 75MW Boundary Photovoltaic (PV) facility located in the Boshof district in the western Free State Province (**Fig.1**). The development involves the construction of a photovoltaic solar facility and associated infrastructure that will connect to the ESKOM grid via the Boundary Substation that is situated on-site (**Fig 2**).

Figure 2. Aerial view of the affected area and substation.

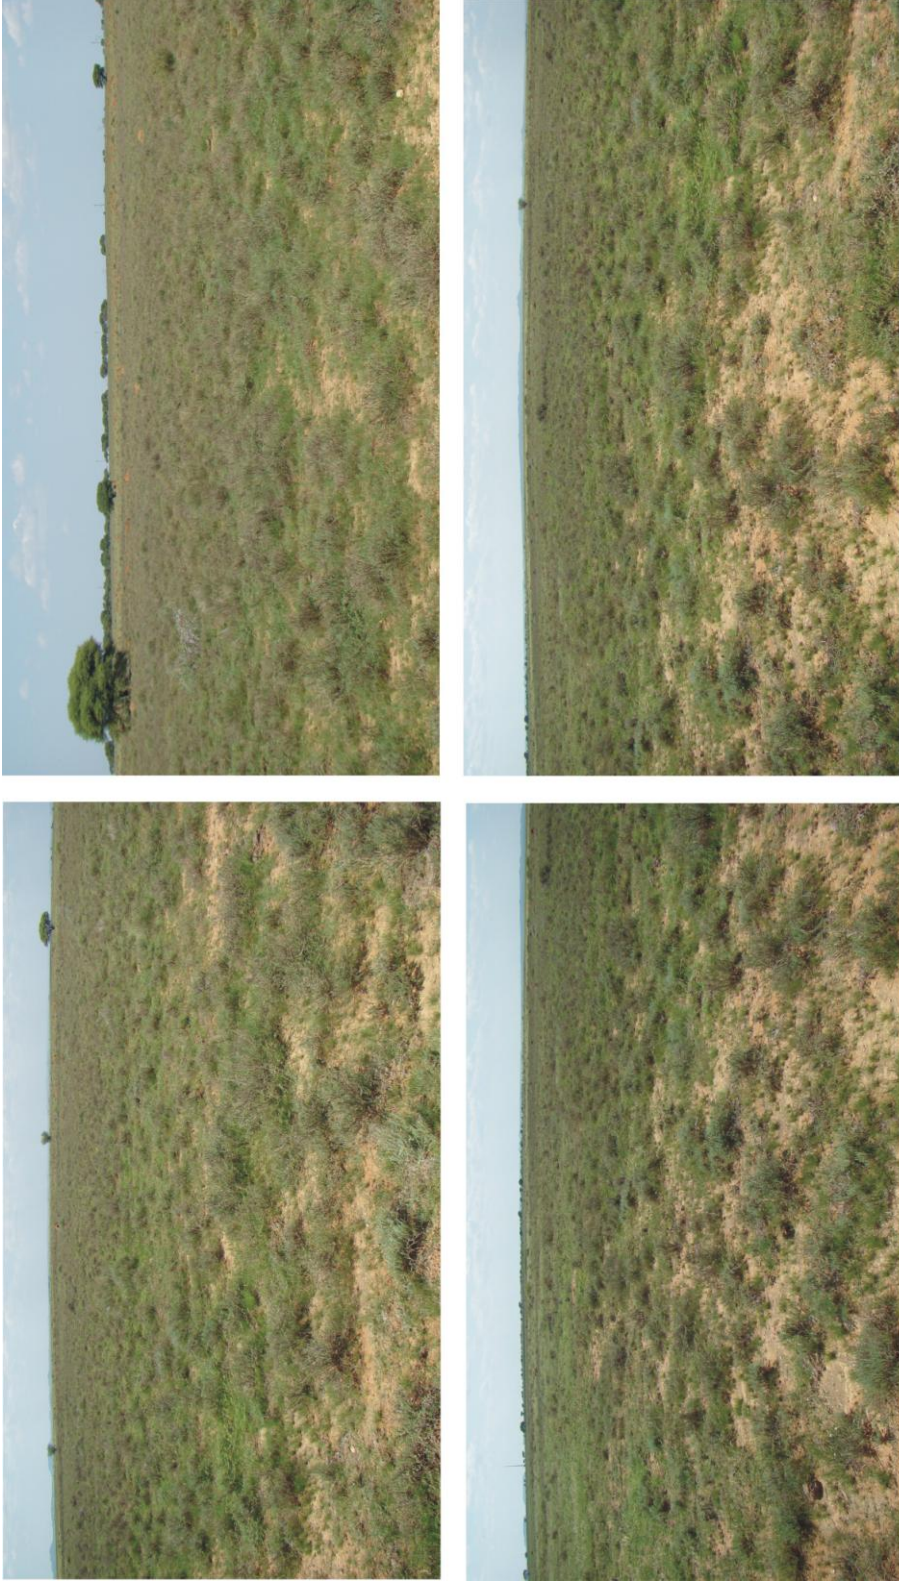
The affected terrain is made up of flat, open veld with no visible outcrop. There are no springs or alluvium within the confines of the area where the photovoltaic solar facility and associated infrastructure will be constructed; however there is a pan present next to where the layout is proposed. In the absence of some of the above erosional features, common intrusive features like springhare hollows and aardvark dugouts were investigated for tell-tale signs of excavated palaeontological material (**Fig. 6**). Pedestrian survey indicates that the photovoltaic panels, associated buildings and access roads will be constructed on Quaternary-aged residual soils largely represented by calcrete-rich aeolian sand (red-brown Kalahari sands, *Qs*) (**Fig. 7**). There is no indication for the accumulation and preservation of intact fossil material within the Quaternary sediments (unconsolidated topsoils). Impact on Quaternary sediments within the footprint will be extensive, but impact on potential *in situ* Quaternary fossils, within the confines of the affected area is considered unlikely.

Figure 4. The affected terrain is made up of flat, open veld with no visible outcrop, looking north, east, south and west.

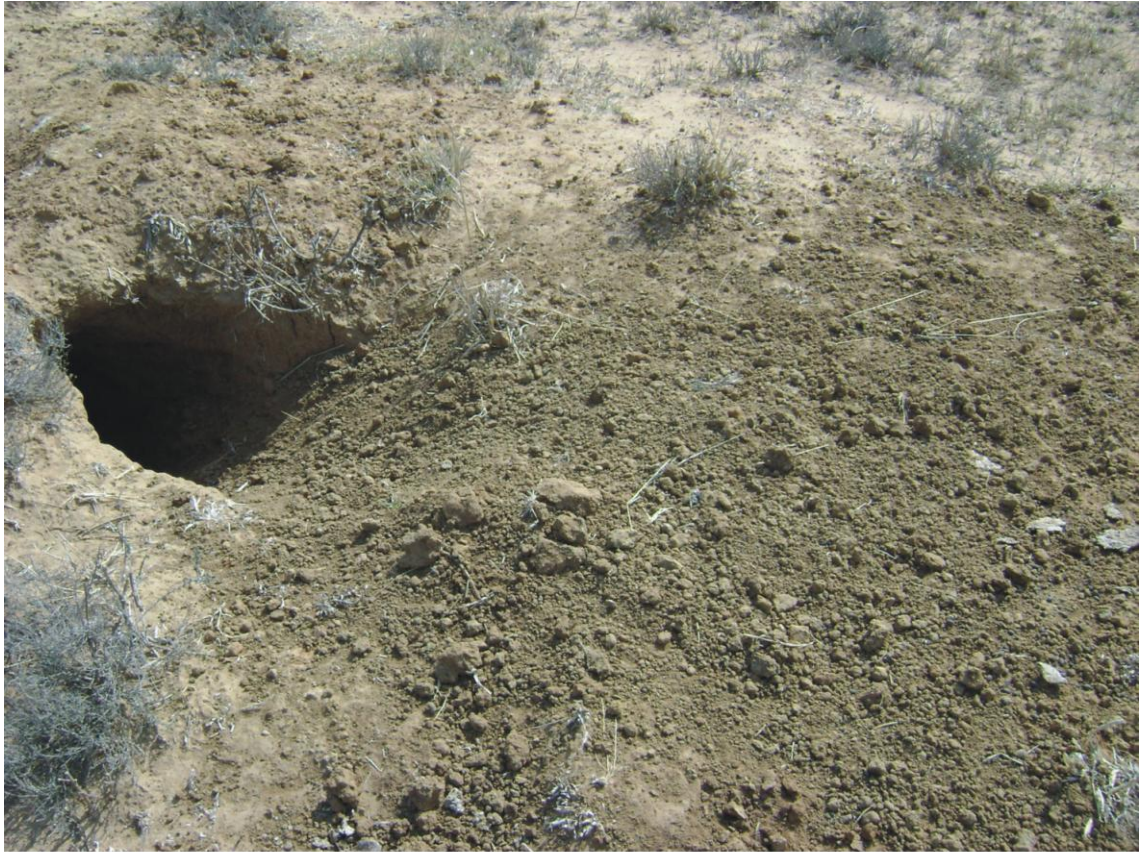
Figure 6. When found, intrusive features like springhare hollows and aardvark dugouts were investigated for tell-tale signs of excavated palaeontological material.
