**HERITAGE IMPACT ASSESSMENT REPORT:  
PROPOSED BELFAST MINING PROJECT LOCATED  
ON PORTIONS OF THE FARMS LEEUWBANK 427 JS,  
BLIJVOORUITZICHT 383 JT, ZOEKOP 426 JS, SOUTH  
OF WONDERFONTEIN AND BELFAST, MPUMALANGA**

**Charles Linström  
Exxaro Resources Limited Head Office**

**DATE: 31 December 2009**

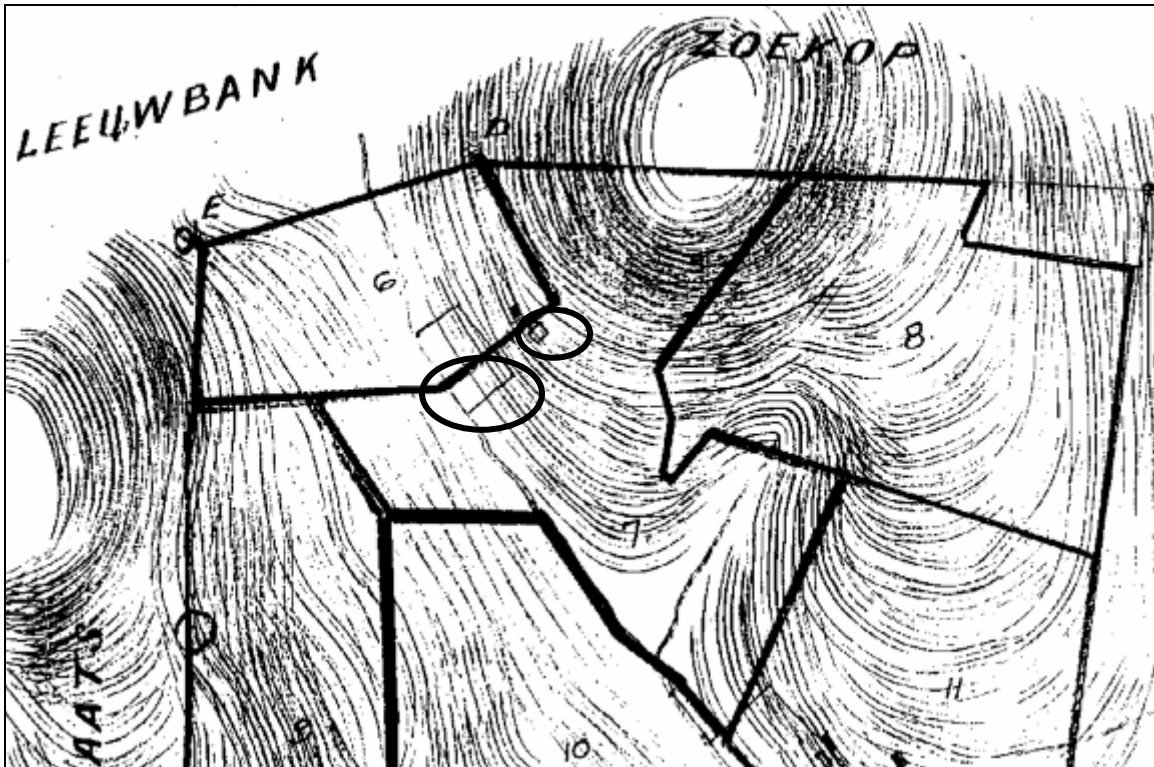
Portion of survey diagram of Blijvooruitzicht Portion 2 indicating two unknown structures on Portion 7 (have disappeared)

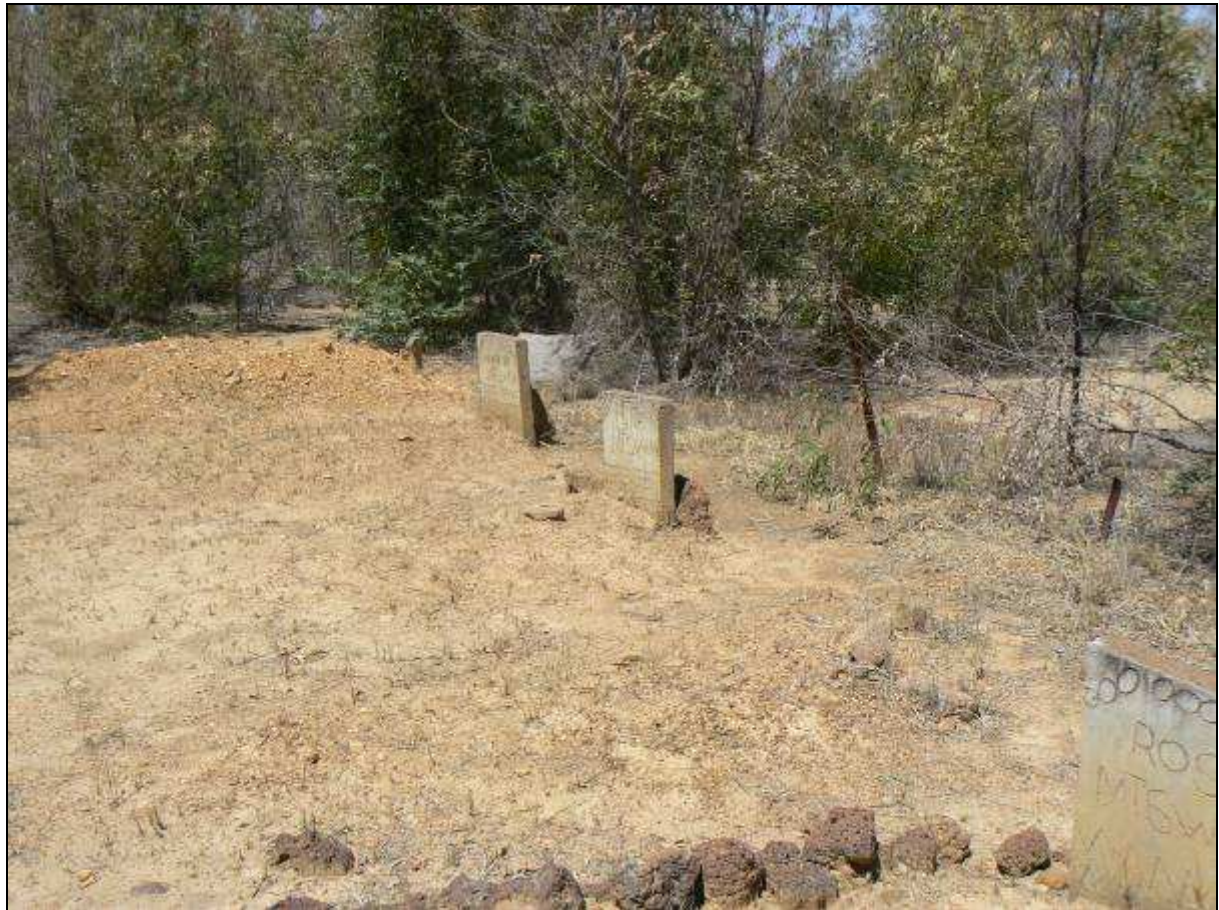
<b>BV8F FARMSTEAD</b>	
Feature name: Farmstead	
Type of feature: Building/structure	
Location/Area	Blijvooruitzicht 8
GPS coordinates	25°48'34.91"S 29°59'33.82"E
References	None
NHRA protection status	None
Description: Modern farmstead	
Significance status (1)	1
Condition status and value (2)	3
Sensitivity assessment (1 x 2 = range = level)	3
Predicted impact	Adverse (inside mining area)
Recommended management interventions to preserve feature or mitigate impact: Document before any demolition. There are no compelling reasons for preservation.	
Photo

<b>BV8G MTSWENI GRAVEYARD</b>		
Feature name: Mtsweni graveyard		
Type of feature: Burial site		
Location/Area	Blijvooruitzicht 8 inside dense copse of trees	
GPS coordinates	25°48'53.23"S 29°59'38.78"E	
References	None	
NHRA protection status	Section 36	
Description: 5 graves with new headstones of members of Mtsweni family		
Significance status (1)		3
Condition status and value (2)		3
Sensitivity assessment (1 x 2 = range = level)		9
Predicted impact	Adverse (inside mining area)	
Recommended management interventions to preserve feature or mitigate impact: Avoid if possible, restore, protect and interpret, otherwise relocate. The graves are possibly linked to a land claim.

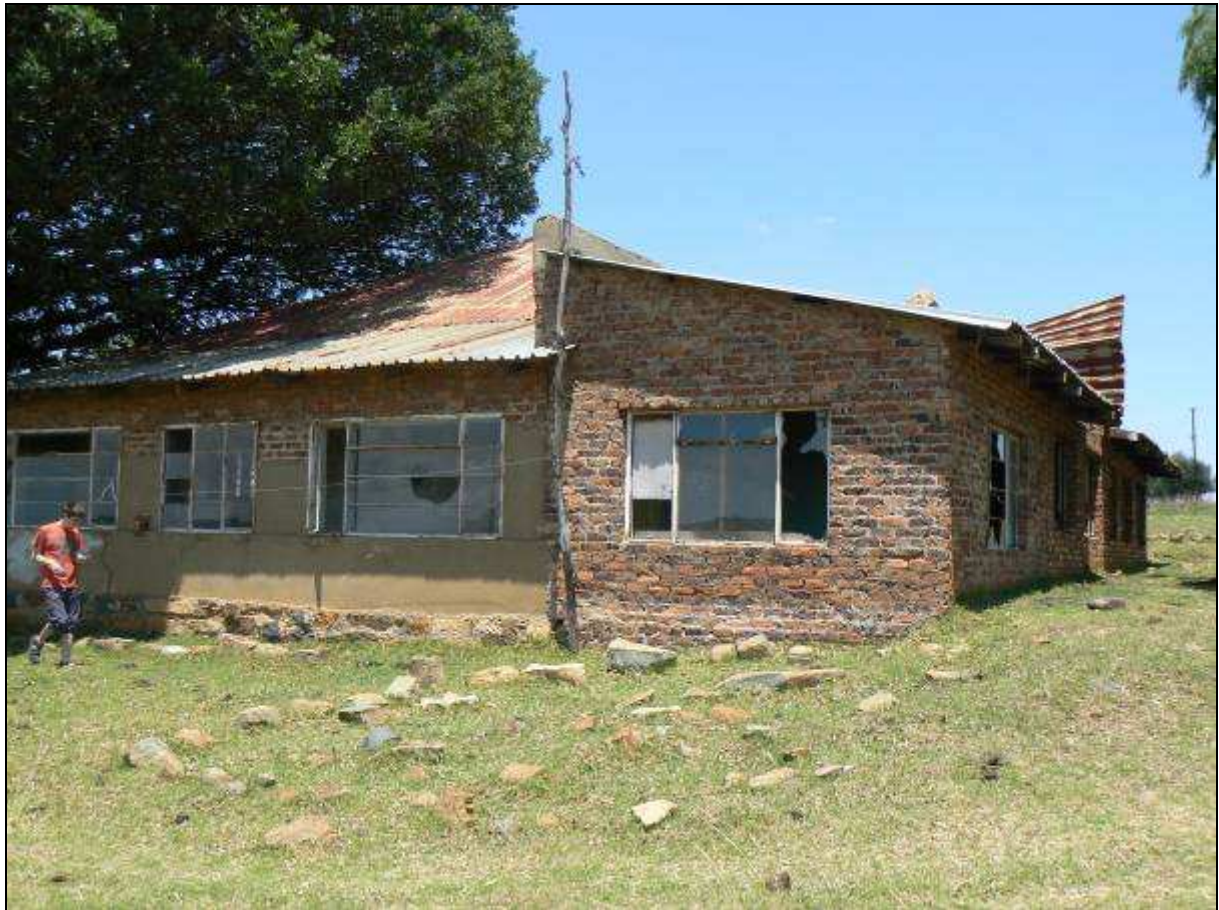
<b>BV18F FARMSTEAD</b>	
Feature name: Farmstead	
Type of feature: Building/structure	
Location/Area	Blijvooruitzicht 18 near road
GPS coordinates	25°48'9.80"S 30°0'14.70"E
References	None
NHRA protection status	Section 34
Description: Dwelling (much altered) and ruins of stone rondavel and outbuildings, unoccupied. Portion 18 is farmed by the Coetzers and they live in a new dwelling further to the north.	
Significance status (1)	1
Condition status and value (2)	2
Sensitivity assessment (1 x 2 = range = level)	2
Predicted impact	Unknown (just outside mining area)
Recommended management interventions to preserve feature or mitigate impact: Avoid, otherwise document before demolition. There are no compelling reasons for preservation.

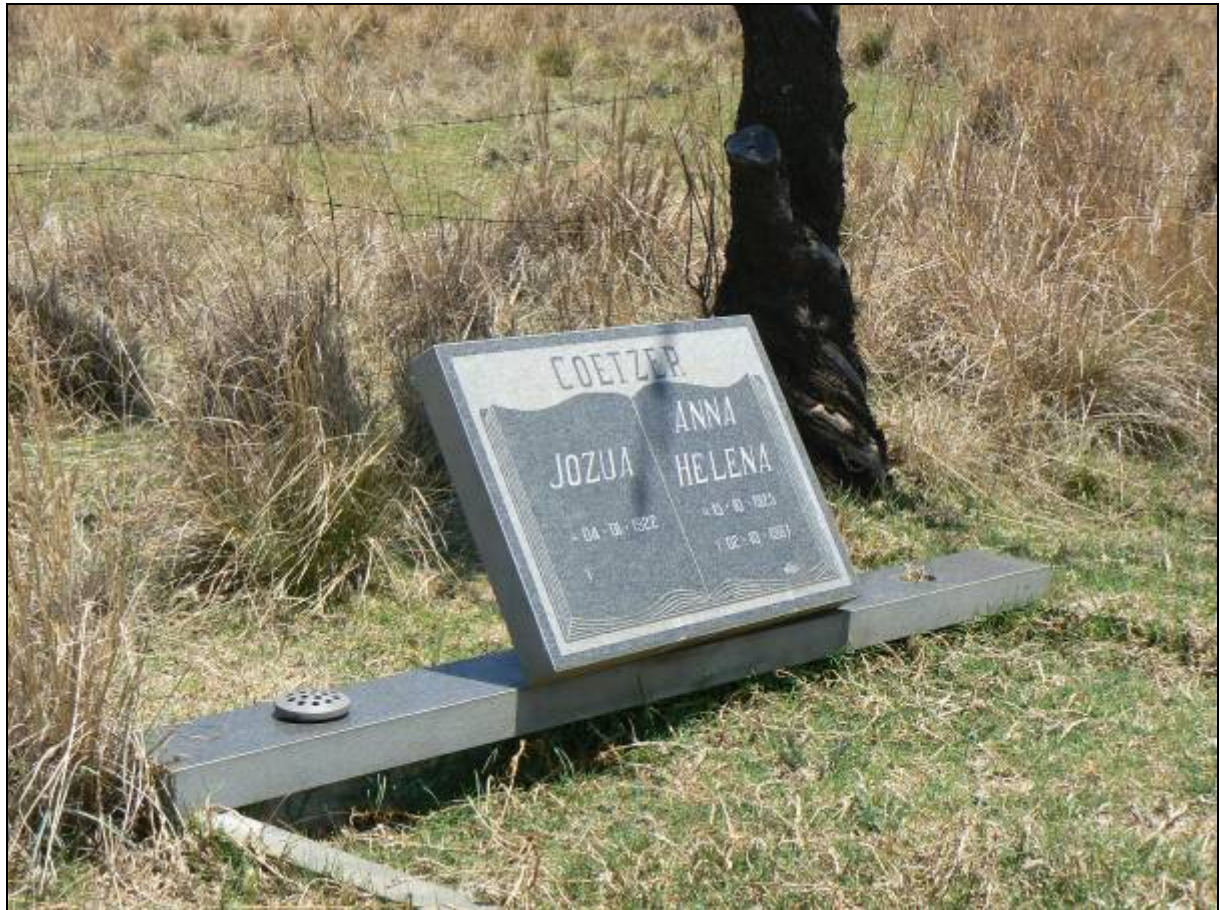
<b>BV18G GRAVES</b>	
Feature name: Coetzer graves	
Type of feature: Burial site	
Location/Area	Blijvooruitzicht 18 near farmstead and large tree
GPS coordinates	25°48'9.10"S 30°0'15.50"E
References	None
NHRA protection status	Section 36
Description: Graves of Coetzer and his wife	
Significance status (1)	3
Condition status and value (2)	2
Sensitivity assessment (1 x 2 = range = level)	6
Predicted impact	Unknown (just outside mining area)
Recommended management interventions to preserve feature or mitigate impact: Avoid if possible, restore, protect and interpret, otherwise relocate

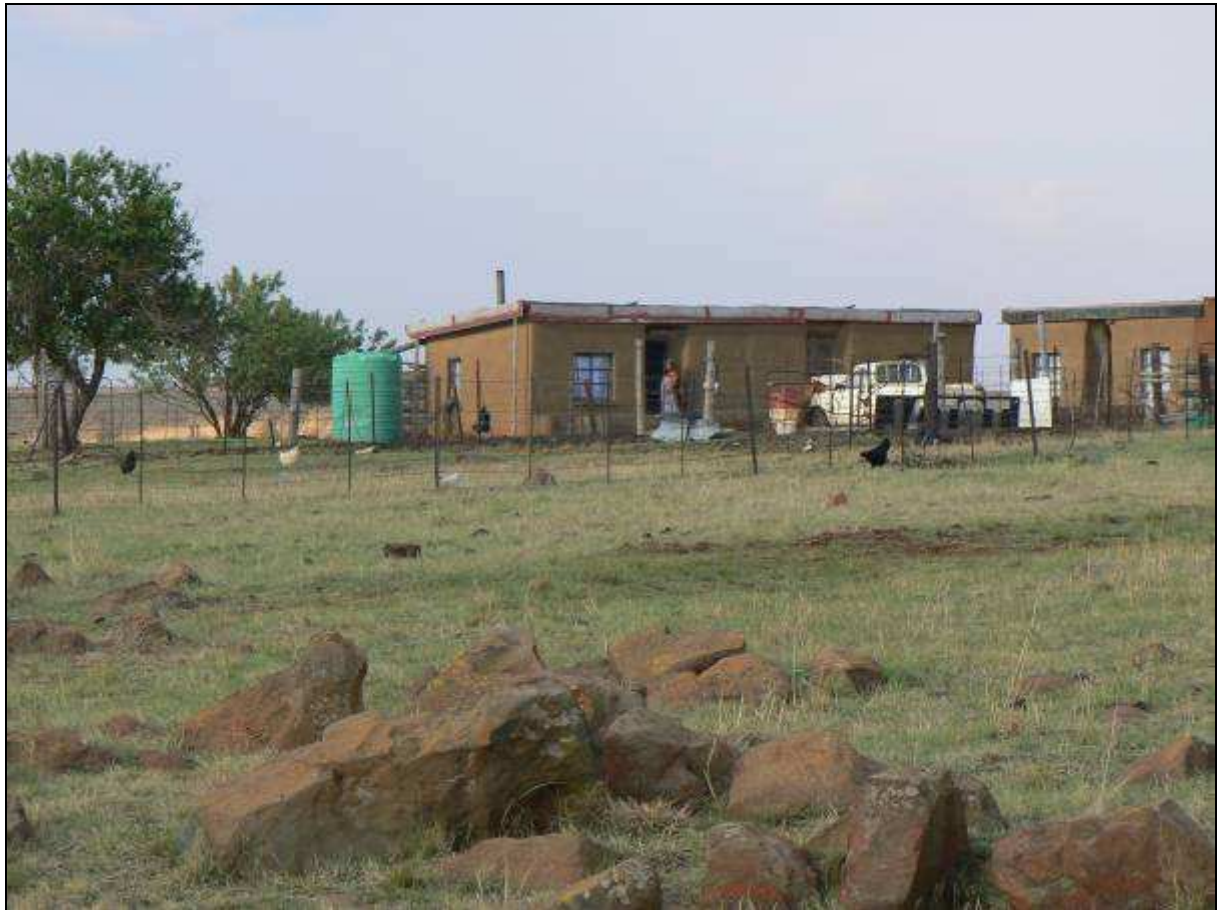
Photo

<b>L3H HOMESTEAD</b>	
Feature name: Mtsweni homestead	
Type of feature: Building/structure	
Location/Area	Leeuwbank 3 near road
GPS coordinates	25°50'13.36"S 29°56'7.83"E
References	None
NHRA protection status	None
Description: Typical homestead of workers belonging mainly to the Mtsweni family	
Significance status (1)	1
Condition status and value (2)	2
Sensitivity assessment (1 x 2 = range = level)	2
Predicted impact	Adverse (inside mining area)
Recommended management interventions to preserve feature or mitigate impact: Avoid, otherwise document before demolition. There are no compelling reasons for preservation.

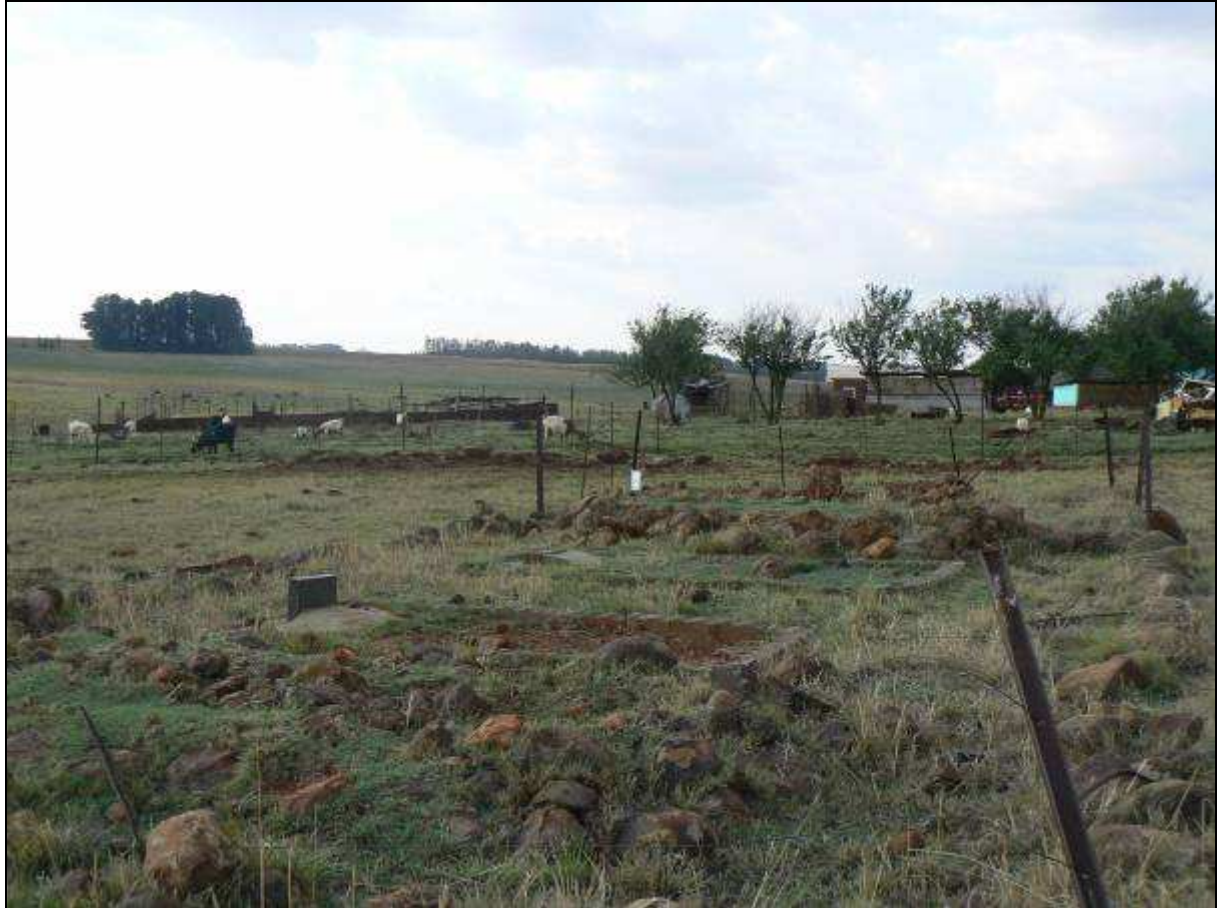
<b>L3G GRAVEYARD</b>	
Feature name: Farm workers' graveyard	
Type of feature: Burial site	
Location/Area	Leeuwbank 3 at homestead
GPS coordinates	25°50'15.80"S 29°56'6.40"E
References	None
NHRA protection status	Section 36
Description: Graveyard with about 20 graves, some with headstones	
Significance status (1)	3
Condition status and value (2)	2
Sensitivity assessment (1 x 2 = range = level)	6
Predicted impact	Adverse (inside mining area)
Recommended management interventions to preserve feature or mitigate impact: Avoid if possible, restore, protect and interpret, otherwise relocate

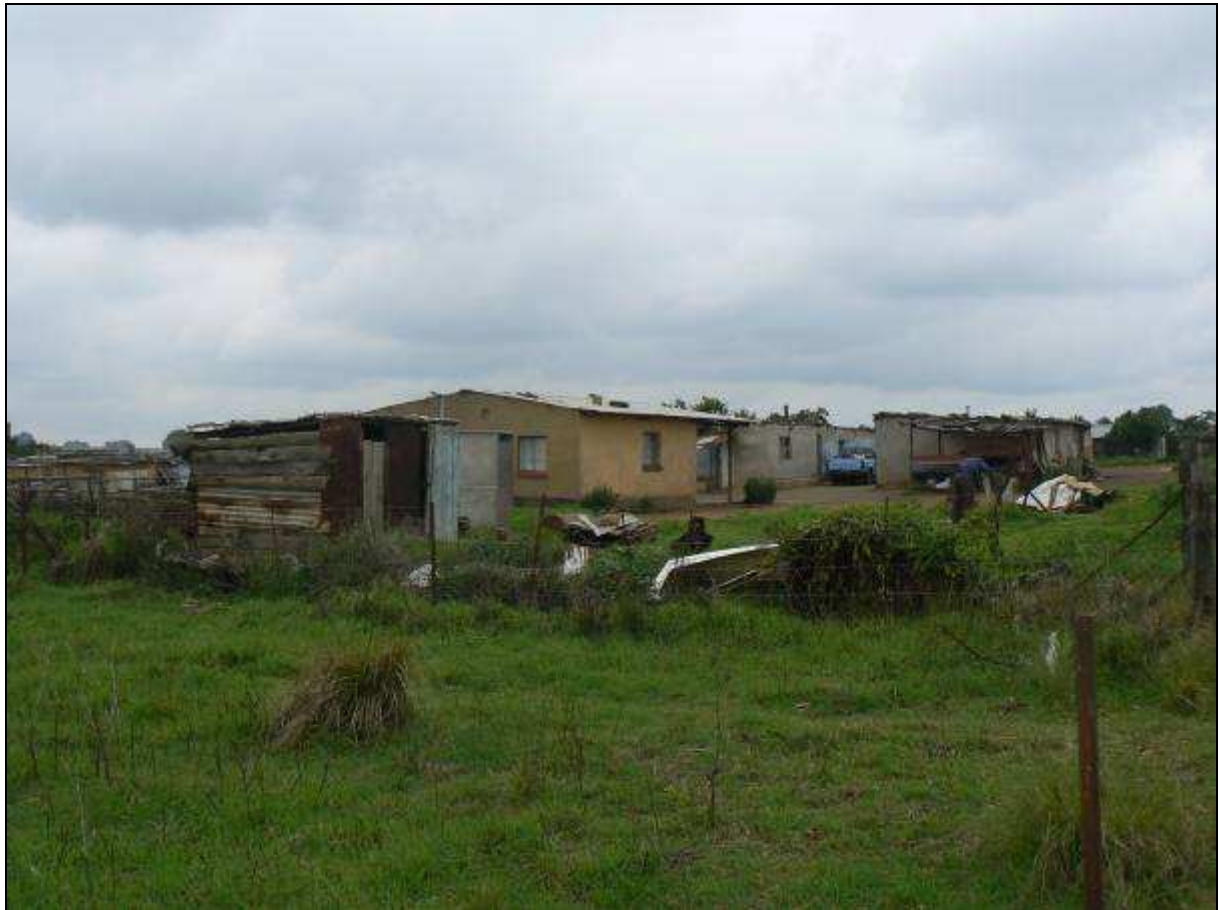
<b>L5H HOMESTEADS</b>	
Feature name: Homesteads of farm workers on Leeuwbank	
Type of feature: Buildings	
Location/Area	Leeuwbank farm Portion 5 near gravel road
GPS coordinates	25°46'56.78"S 29°57'8.80"E
References	None
NHRA protection status	None
Description: Village inhabited by farm workers	
Significance status (1)	1
Condition status and value (2)	2
Sensitivity assessment (1 x 2 = range = level)	2
Predicted impact	Just inside mining area
Recommended management interventions to preserve feature or mitigate impact: Avoid if possible, otherwise photo documentation before destruction

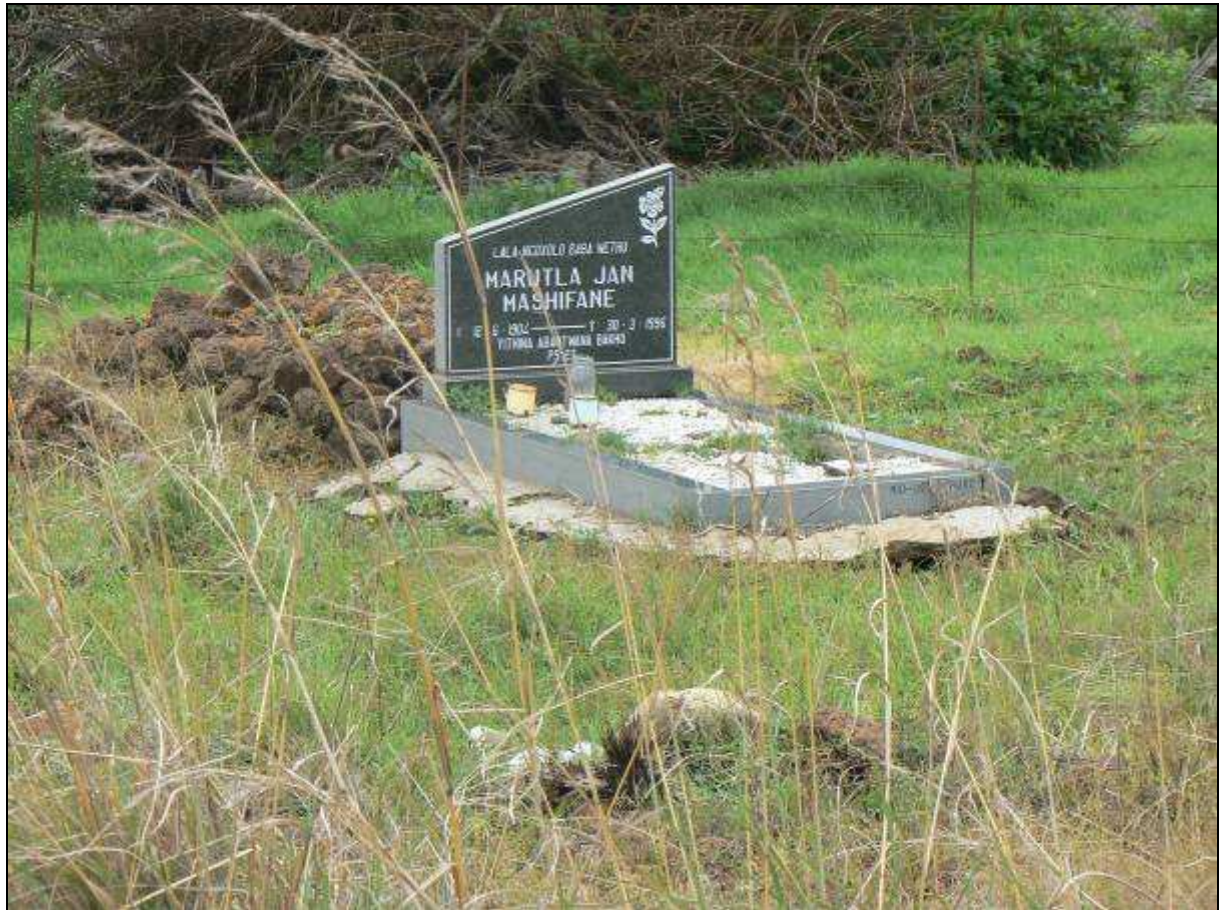
<b>L5G GRAVES</b>	
Feature name: Leeuwbank graves	
Type of feature: Burial site	
Location/Area	Near gravel road
GPS coordinates	25°47'0.90"S 29°57'10.80"E
References	None
NHRA protection status	Section 36
Description: Graves of farm workers (ca 22)	
Significance status (1)	3
Condition status and value (2)	2
Sensitivity assessment (1 x 2 = range = level)	6
Predicted impact	Adverse (just inside mining area)
Recommended management interventions to preserve feature or mitigate impact: Avoid if possible, restore, protect and interpret, otherwise relocate

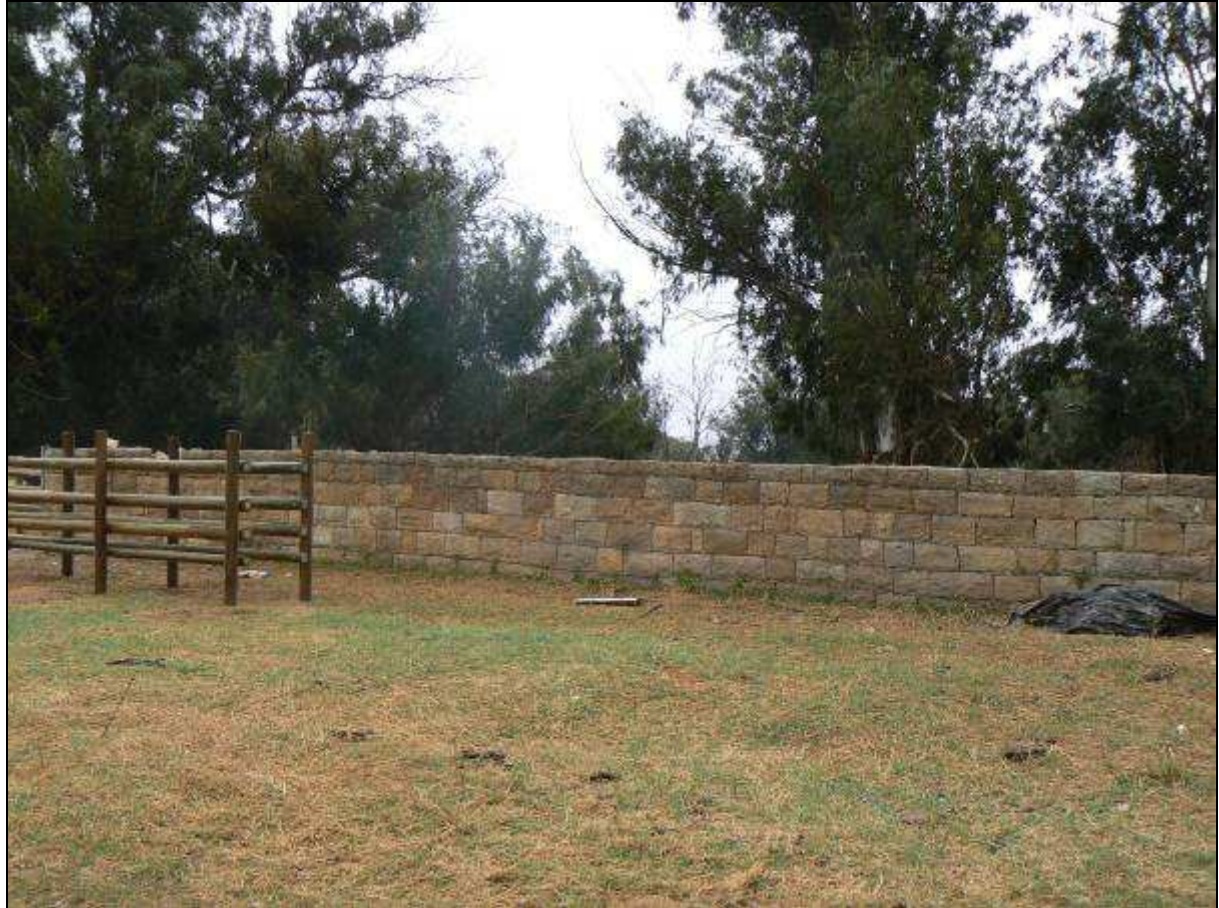
Photo

<b>L7F FARMSTEAD</b>	
Feature name: Farmstead	
Type of feature: Building/structure	
Location/Area	Leeuwbank 7 near gravel road
GPS coordinates	25°48'24.11"S 29°57'10.67"E
References	None
NHRA protection status	Some buildings protected via Section 34
Description: Modern farmstead with established trees and some sandstone walls, kraals and buildings	
Significance status (1)	1
Condition status and value (2)	3
Sensitivity assessment (1 x 2 = range = level)	3
Predicted impact	Adverse (inside mining area and close to proposed plant)
Recommended management interventions to preserve feature or mitigate impact: Avoid, otherwise document before any demolitions. There are no compelling reasons for preservation.

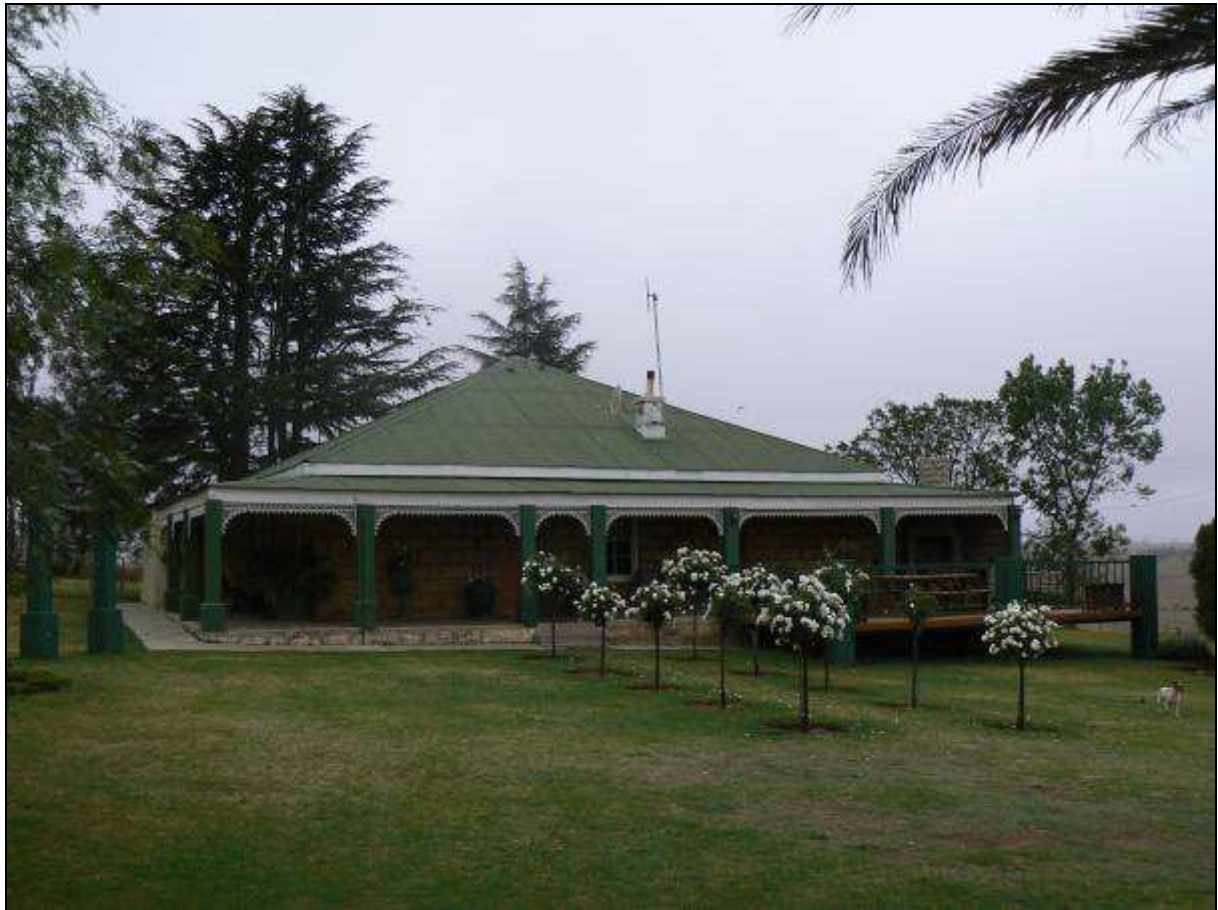
Photo

<b>L10F FARMSTEAD</b>		
Feature name: Farmstead		
Type of feature: Building/structure		
Location/Area	Leeuwbank 10	
GPS coordinates	25°48'42.80"S 29°58'39.40"	
References	None	
NHRA protection status	Section 34	
Description: Well-preserved farmstead comprising sheds, kraals, sandstone main house, sandstone barn, 1950s house etc		
Significance status (1)		3
Condition status and value (2)		3
Sensitivity assessment (1 x 2 = range = level)		9
Predicted impact	Adverse (inside mining area)	
Recommended management interventions to preserve feature or mitigate impact: Avoid and preserve if possible. This farmstead is one of the best preserved in the study area. If this is not possible the farmstead should be fully documented before demolition.

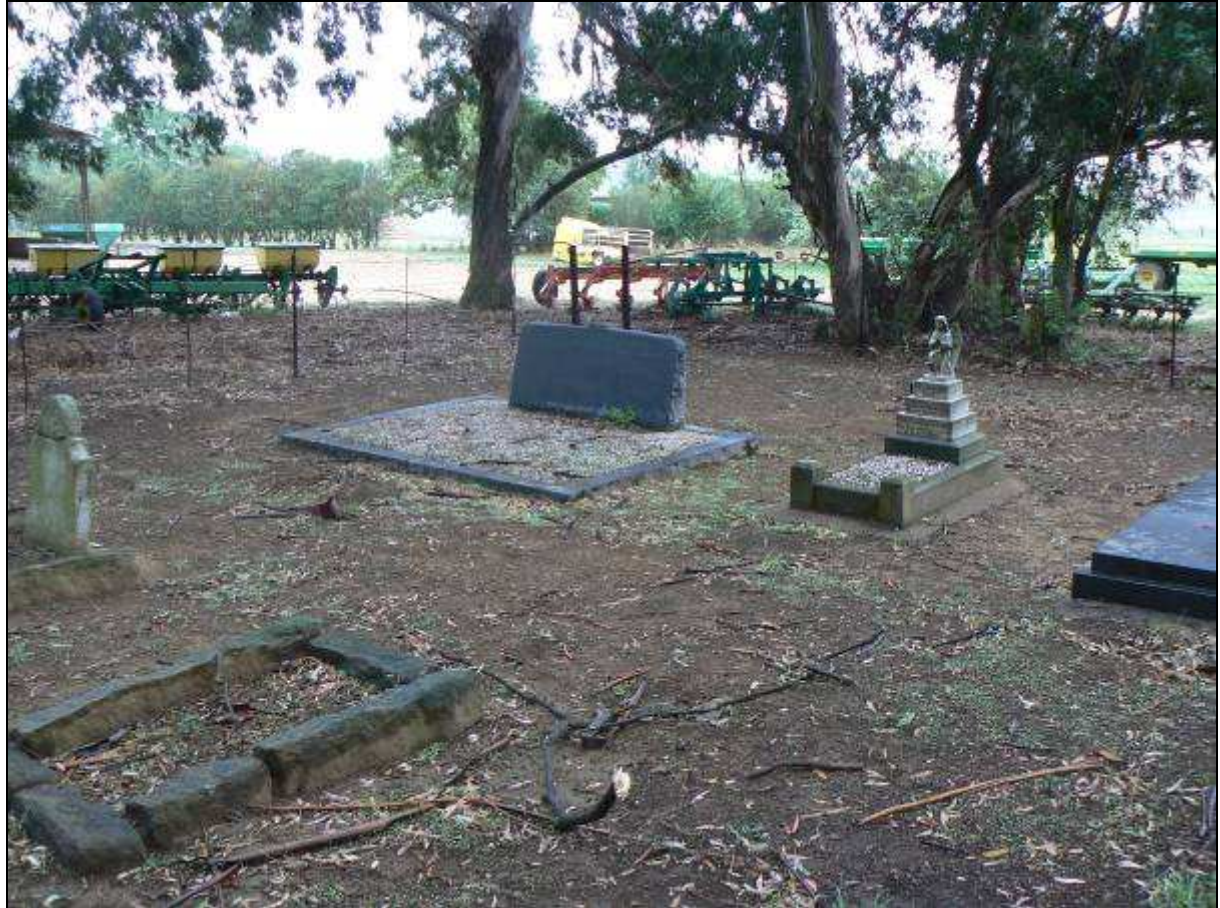
<b>L10G 1 GRAVEYARD</b>	
Feature name: Graveyard	
Type of feature: Burial site	
Location/Area	Leeuwbank 10 near farmstead
GPS coordinates	25°48'39.55"S 29°57'16.78"E
References	None
NHRA protection status	Section 36
Description: Fenced-in graveyard with graves of Swart and Senekal families. One grave (unmarked) is outside the fence.	
Significance status (1)	3
Condition status and value (2)	2
Sensitivity assessment (1 x 2 = range = level)	6
Predicted impact	Adverse (inside mining area)
Recommended management interventions to preserve feature or mitigate impact: Avoid if possible, restore, protect and interpret, otherwise relocate

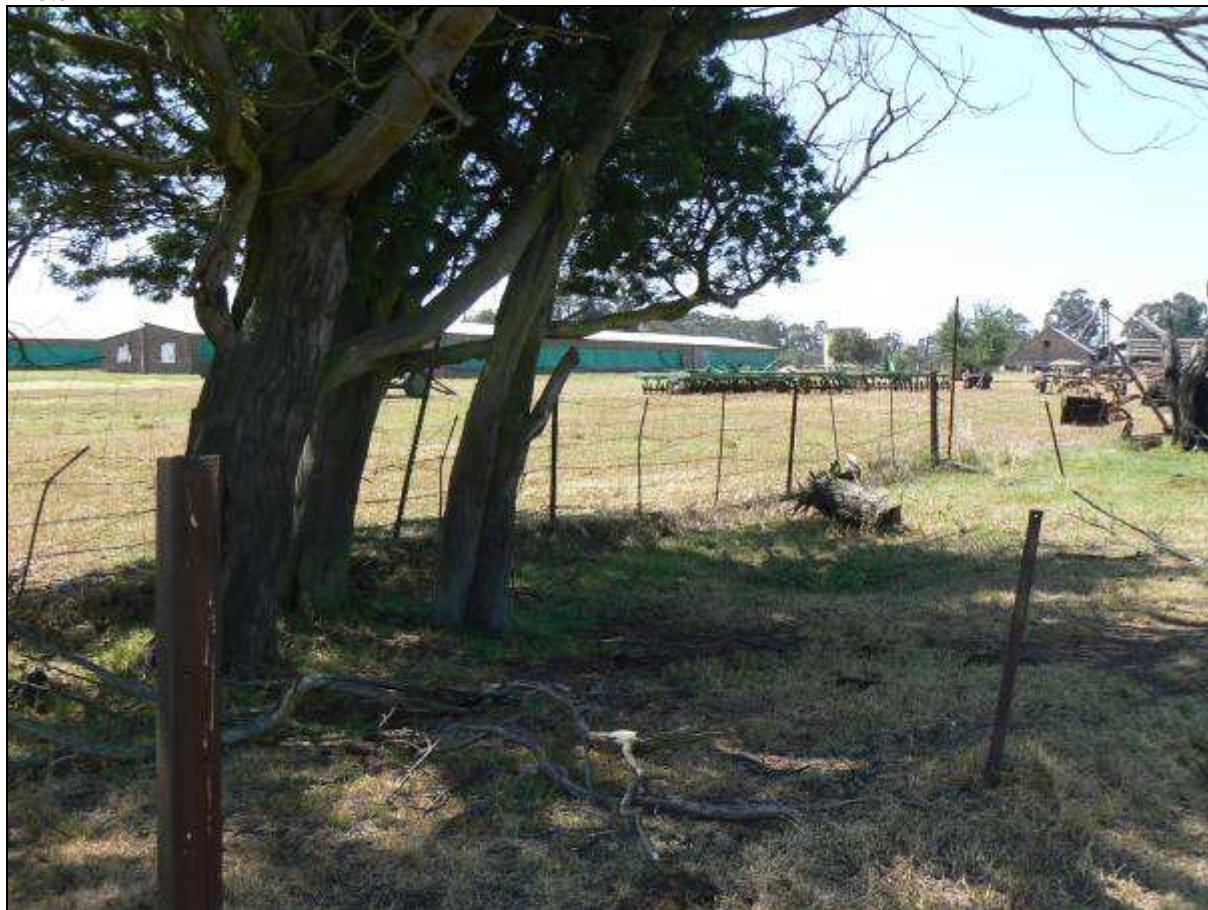
Photo

<b>Z1G1 GRAVEYARD</b>	
Feature name: Graveyard	
Type of feature: Burial site	
Location/Area	North of farmstead
GPS coordinates	25°48'22.10"S 29°58'53.50"E
References	None
NHRA protection status	Section 36
Description: Small graveyard of farm workers, hardly recognisable, identifiable by broken fence poles and mounds of rocks	
Significance status (1)	3
Condition status and value (2)	1
Sensitivity assessment (1 x 2 = range = level)	3
Predicted impact	Adverse (inside mining area)
Recommended management interventions to preserve feature or mitigate impact: Avoid if possible, restore, protect and interpret, otherwise relocate

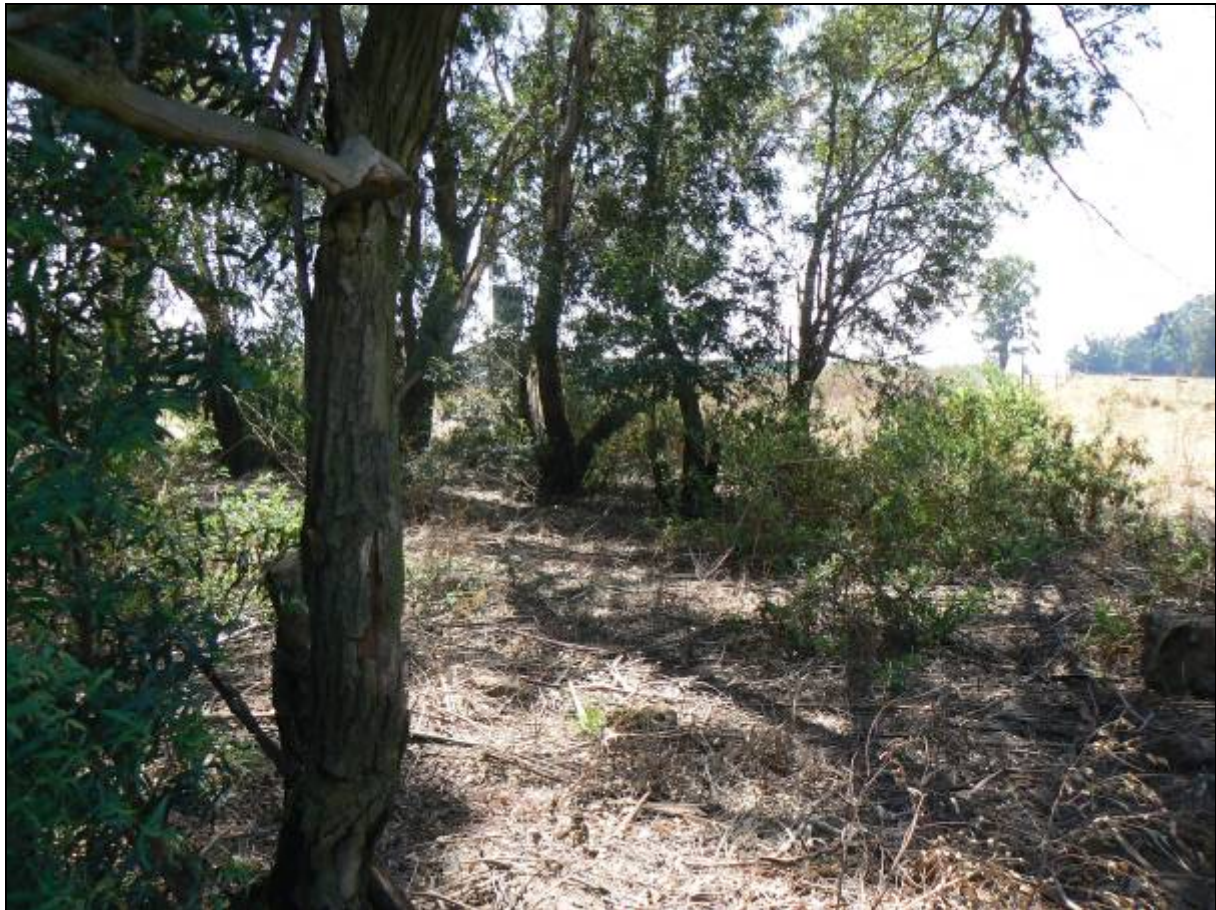
<b>Z1G2 GRAVEYARD</b>	
Feature name: Graveyard	
Type of feature: Burial site	
Location/Area	South of farmstead under trees
GPS coordinates	25°48'27.44"S 29°59'8.81"E
References	None
NHRA protection status	Section 36
Description: Farm workers' graveyard under trees, recognisable by mounds of rocks, hardly visible	
Significance status (1)	3
Condition status and value (2)	1
Sensitivity assessment (1 x 2 = range = level)	3
Predicted impact	Adverse (inside mining area)
Recommended management interventions to preserve feature or mitigate impact: Avoid if possible, restore, protect and interpret, otherwise relocate

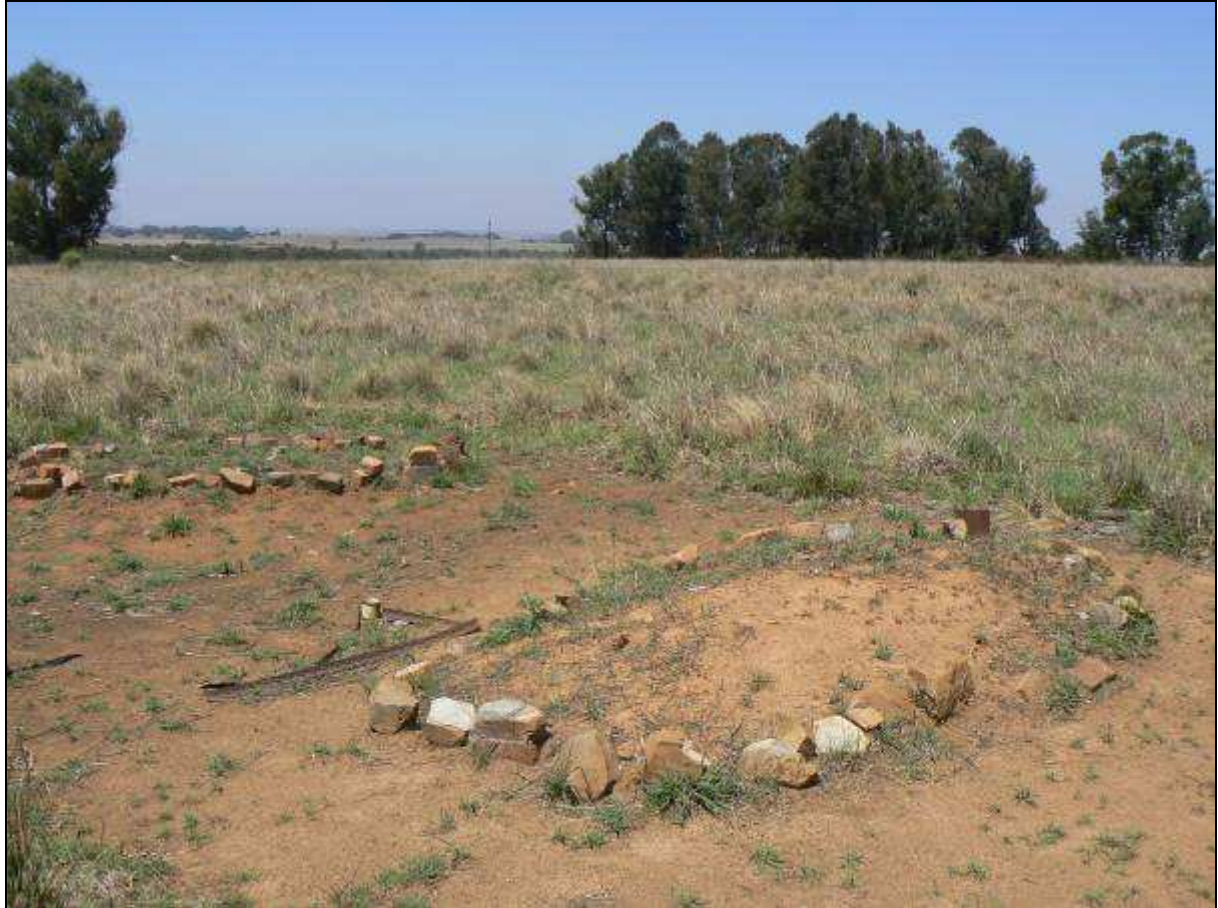
<b>Z1G3 GRAVEYARD</b>	
Feature name: Graveyard	
Type of feature: Burial site	
Location/Area	East of farmstead in open land
GPS coordinates	25°48'26.83"S 29°59'13.61"E
References	None
NHRA protection status	Section 36
Description: Small graveyard of about 5 graves of farm workers	
Significance status (1)	3
Condition status and value (2)	2
Sensitivity assessment (1 x 2 = range = level)	6
Predicted impact	Adverse (inside mining area)
Recommended management interventions to preserve feature or mitigate impact: Avoid if possible, restore, protect and interpret, otherwise relocate

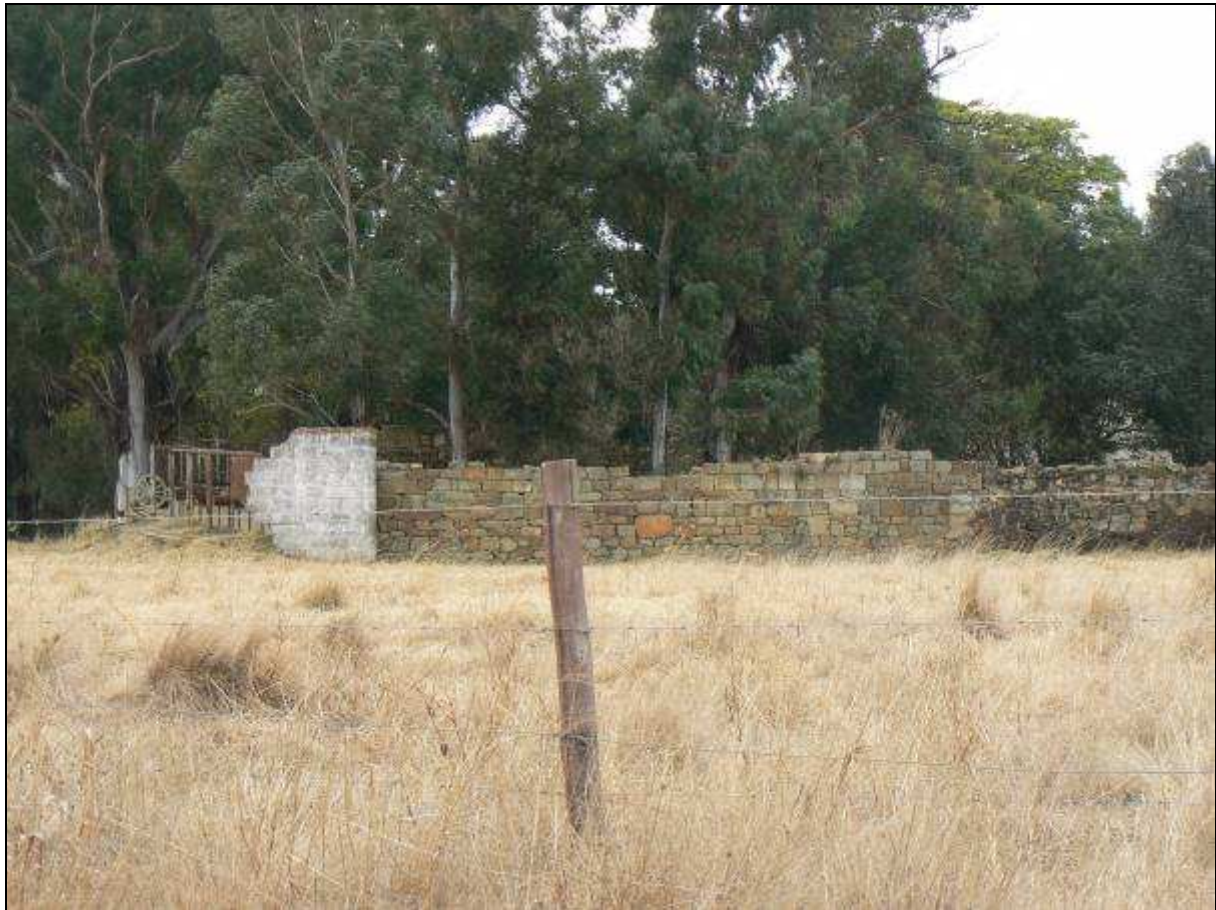
Photo

<b>Z2F FARMSTEAD</b>		
Feature name: Farmstead		
Type of feature: Building/structure		
Location/Area	Zoekop 2 near gravel road	
GPS coordinates	25°47'42.57"S 29°59'59.36"E	
References	None	
NHRA protection status	Section 34	
Description: Old farmstead comprising dilapidated dwellings and ruins of sandstone outbuildings and kraals		
Significance status (1)		1
Condition status and value (2)		1
Sensitivity assessment (1 x 2 = range = level)		1
Predicted impact	Adverse (inside mining area)	
Recommended management interventions to preserve feature or mitigate impact: Avoid, otherwise document before any demolition. There are no compelling reasons for preservation.

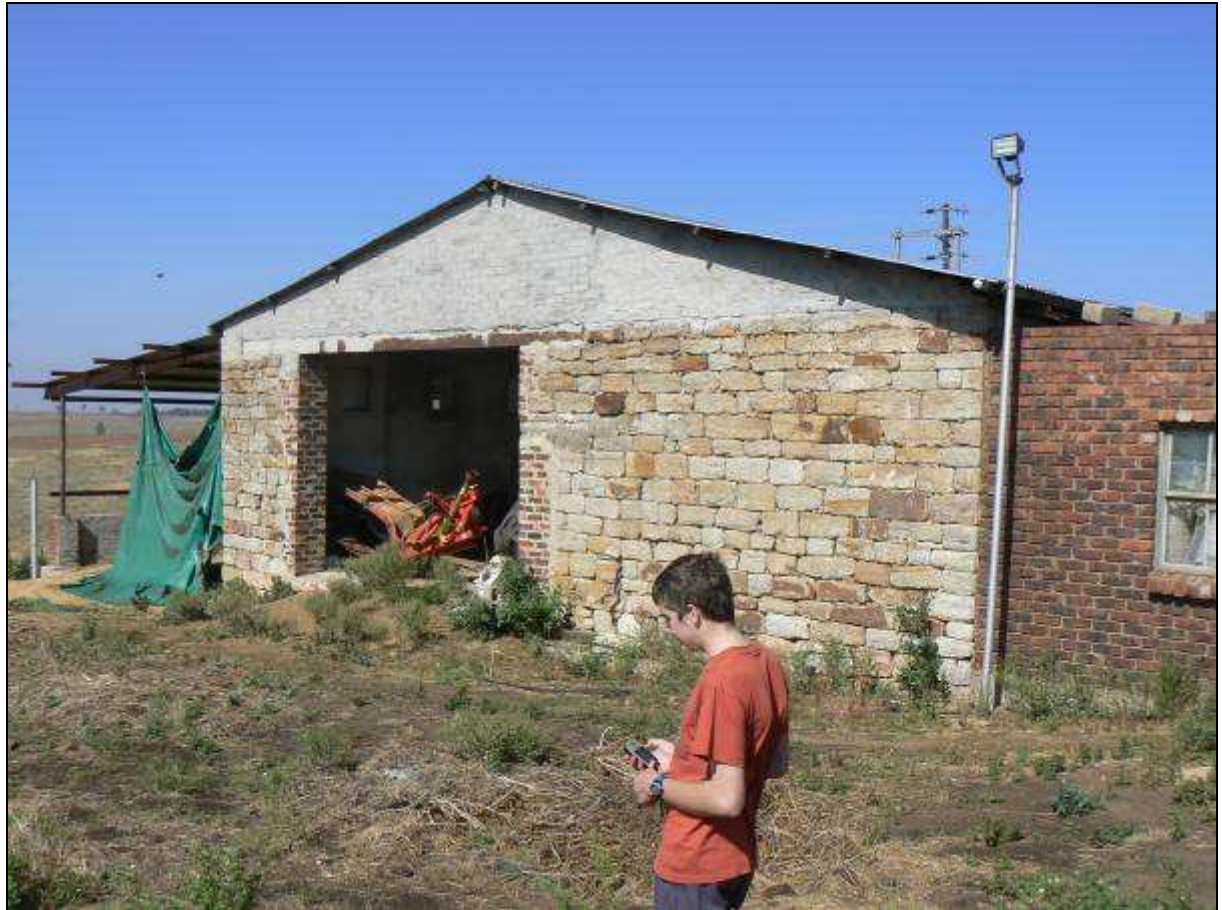
Photo

<b>Z4F FARMSTEAD</b>	
Feature name: Farmstead	
Type of feature: Building/structure	
Location/Area	Northern corner of Portion 4
GPS coordinates	25°45'34.70"S 29°59'56.60"E
References	None
NHRA protection status	Section 34 (some buildings)
Description: Modern farmstead with one sandstone outbuilding, much altered	
Significance status (1)	1
Condition status and value (2)	2
Sensitivity assessment (1 x 2 = range = level)	2
Predicted impact	Adverse (inside mining area)
Recommended management interventions to preserve feature or mitigate impact: Avoid, otherwise document before demolition. There are no compelling reasons for preservation.

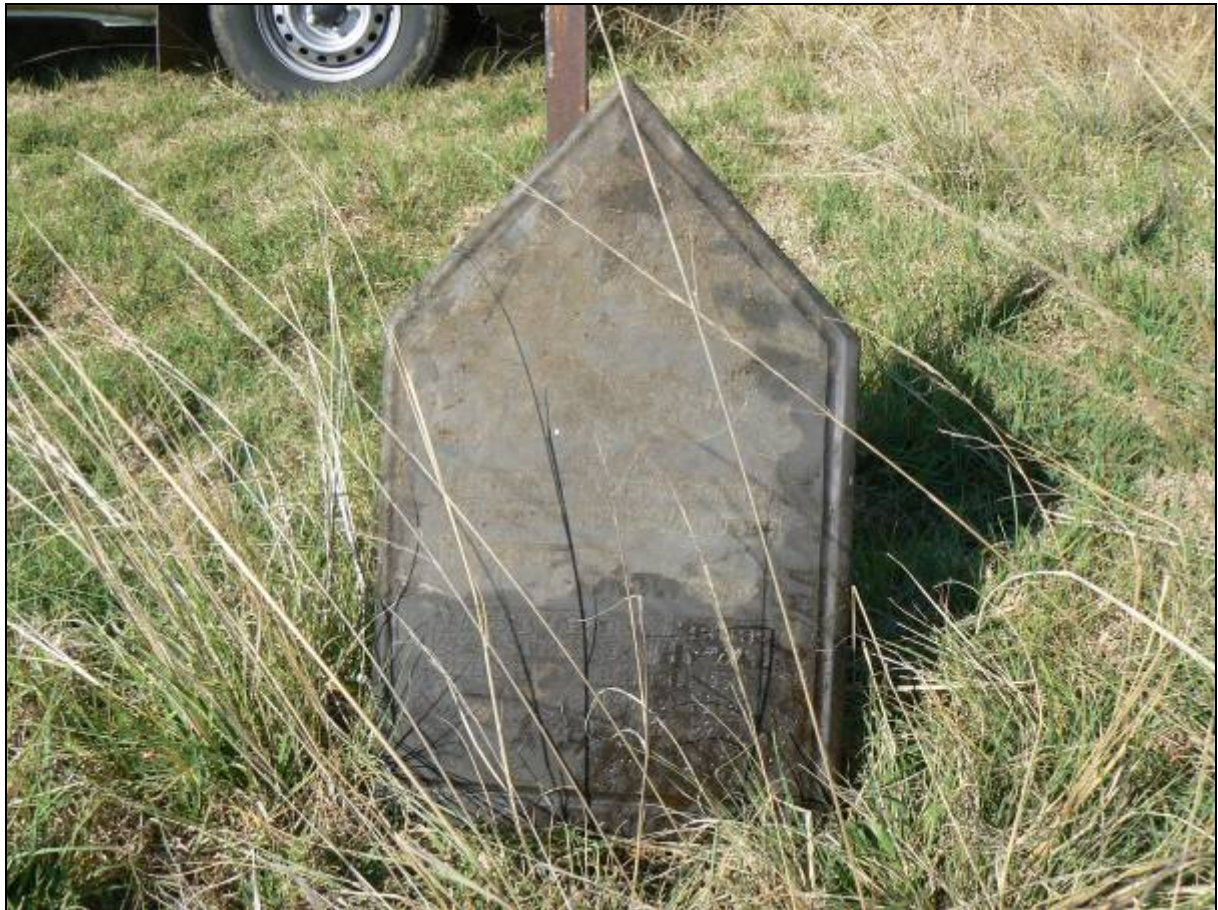
<b>Z4G1 GRAVE</b>	
Feature name: Van Deventer grave	
Type of feature: Burial site	
Location/Area	North of farmstead near edge of field
GPS coordinates	25°45'29.10"S 30°0'4.20"E
References	None
NHRA protection status	Section 36
Description: Single grave of Van Deventer, broken headstone	
Significance status (1)	3
Condition status and value (2)	1
Sensitivity assessment (1 x 2 = range = level)	3
Predicted impact	Adverse (inside mining area)
Recommended management interventions to preserve feature or mitigate impact: Avoid if possible, restore, protect and interpret, otherwise relocate

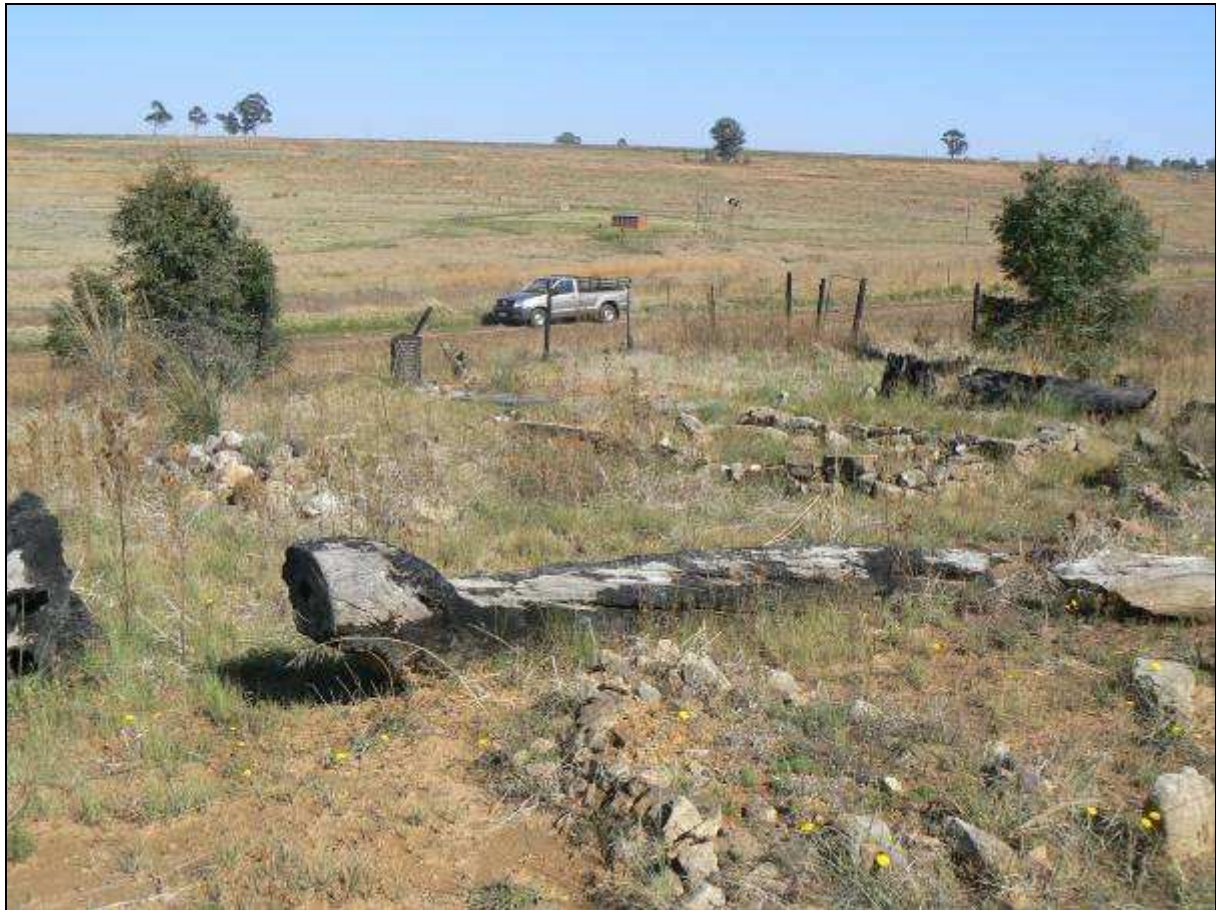
<b>Z4G2 GRAVEYARD</b>	
Feature name: Graveyard	
Type of feature: Burial site	
Location/Area	South of farmstead near boundary with Portion 16
GPS coordinates	25°45'59.90"S 30°0'4.30"E
References	None
NHRA protection status	Section 36
Description: Graveyard with some 20 graves of farm workers, some with headstones	
Significance status (1)	3
Condition status and value (2)	2
Sensitivity assessment (1 x 2 = range = level)	6
Predicted impact	Adverse (inside mining area)
Recommended management interventions to preserve feature or mitigate impact: Avoid if possible, restore, protect and interpret, otherwise relocate
