**HERITAGE IMPACT ASSESSMENT REPORT:  
PROPOSED BELFAST MINING PROJECT LOCATED  
ON PORTIONS OF THE FARMS LEEUWBANK 427 JS,  
BLIJVOORUITZICHT 383 JT, ZOEKOP 426 JS, SOUTH  
OF WONDERFONTEIN AND BELFAST, MPUMALANGA**

**Charles Linström  
Exxaro Resources Limited Head Office**

**DATE: 31 December 2009**

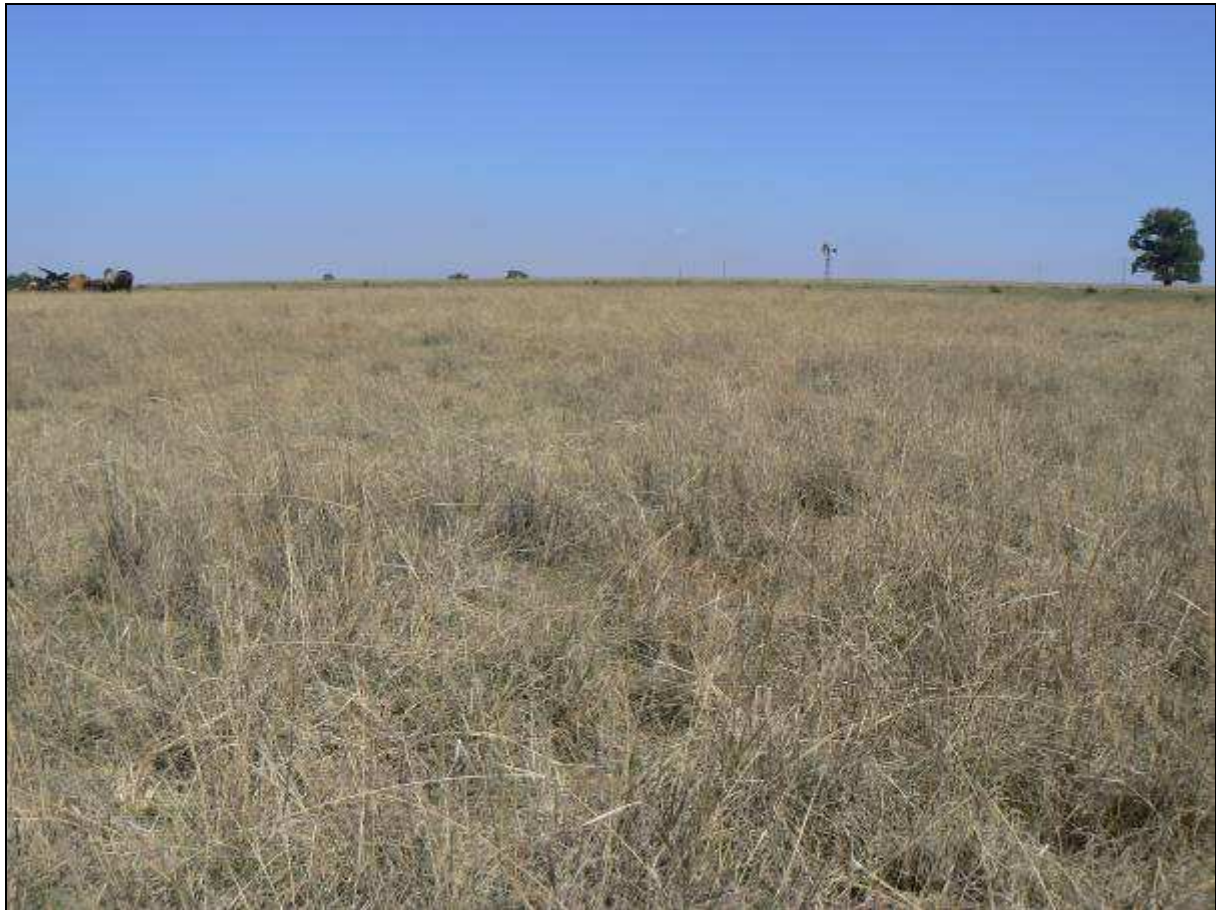
Photo

<b>Z8G GRAVEYARD</b>	
Feature name: Graveyard	
Type of feature: Burial site	
Location/Area	West of gravel road
GPS coordinates	25°47'11.70"S 29°59'27.80"E
References	None
NHRA protection status	Section 36
Description: According to JH Gerrits children of farm workers are buried here. There are about four graves, hardly visible.	
Significance status (1)	3
Condition status and value (2)	1
Sensitivity assessment (1 x 2 = range = level)	3
Predicted impact	Adverse (inside mining area)
Recommended management interventions to preserve feature or mitigate impact: Avoid if possible, restore, protect and interpret, otherwise relocate

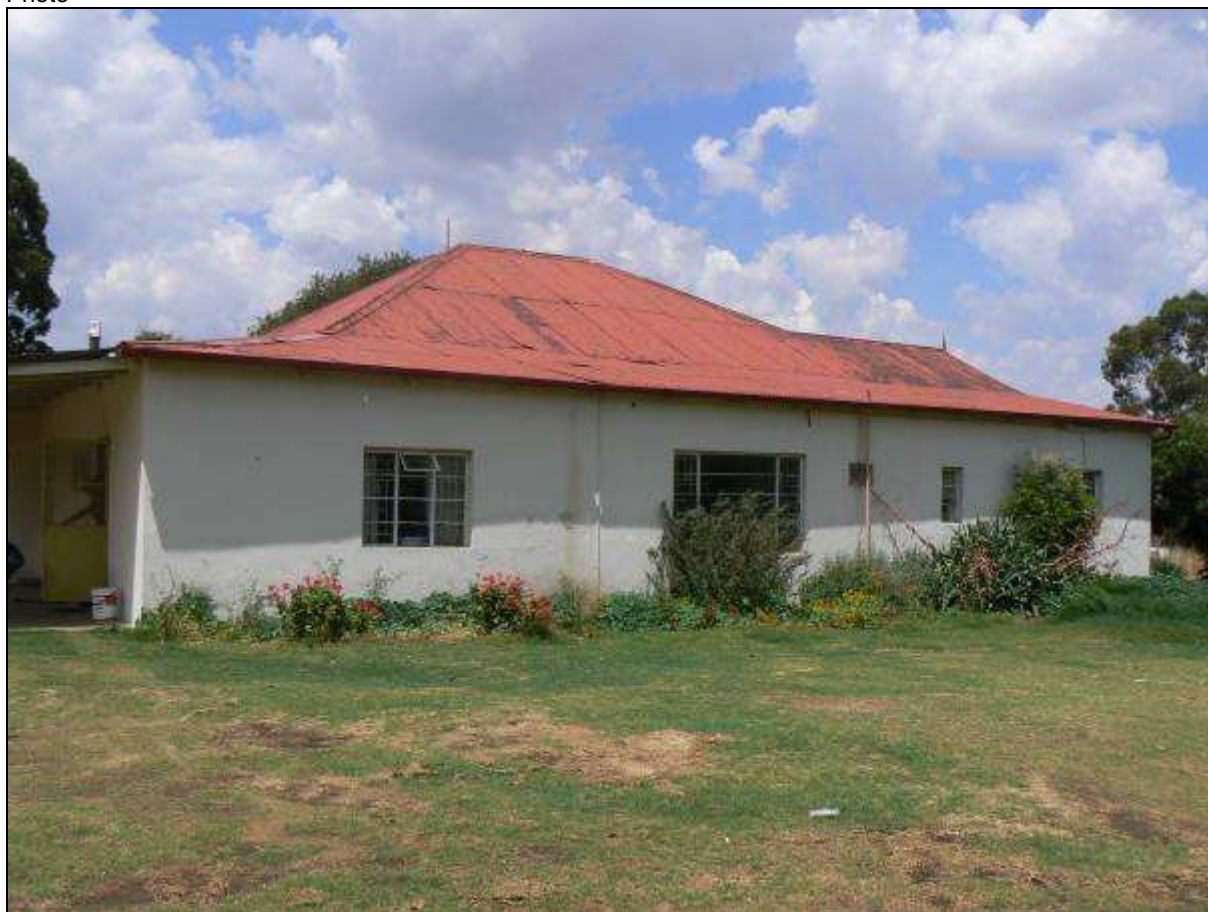
Photo

<b>Z11F FARMSTEAD</b>	
Feature name: Farmstead	
Type of feature: Building/structure	
Location/Area	Near N 4
GPS coordinates	25°45'4.40"S 29°59'53.10"E
References	None
NHRA protection status	Section 34
Description: Sandstone farm house with outbuildings, visible from the N 4	
Significance status (1)	3
Condition status and value (2)	2
Sensitivity assessment (1 x 2 = range = level)	<b>6</b>
Predicted impact	Outside mining area
Recommended management interventions to preserve feature or mitigate impact: Avoid (local landmark). Compelling reasons for preservation.

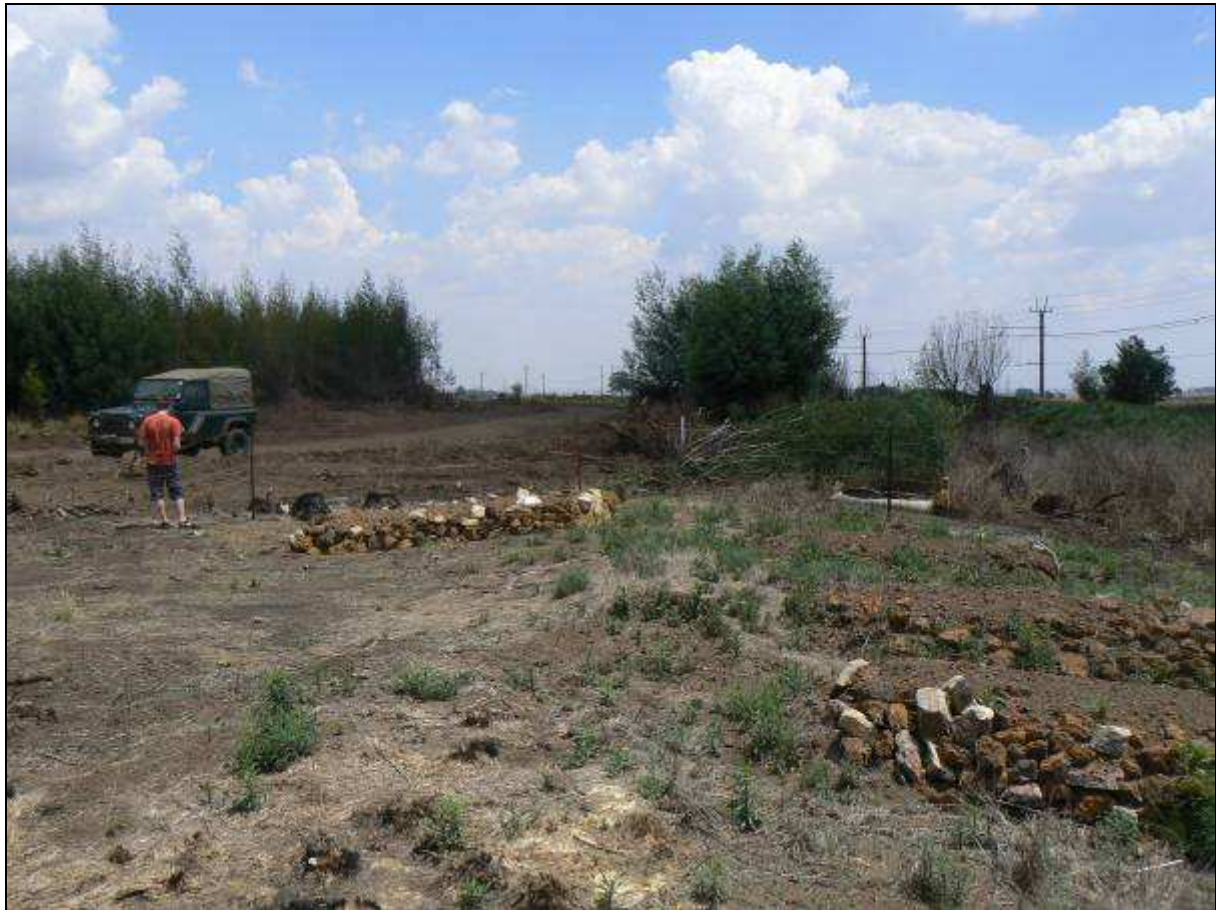
<b>Z11G GRAVEYARD</b>		
Feature name: Graveyard		
Type of feature: Burial site		
Location/Area	Next to railway line	
GPS coordinates	25°45'0.60"S 29°59'44.10"E	
References	None	
NHRA protection status	Section 36	
Description: Graves of farm workers (about 5), fairly recent		
Significance status (1)	3	
Condition status and value (2)	2	
Sensitivity assessment (1 x 2 = range = level)	6	
Predicted impact	Outside mining area	
Recommended management interventions to preserve feature or mitigate impact: Avoid

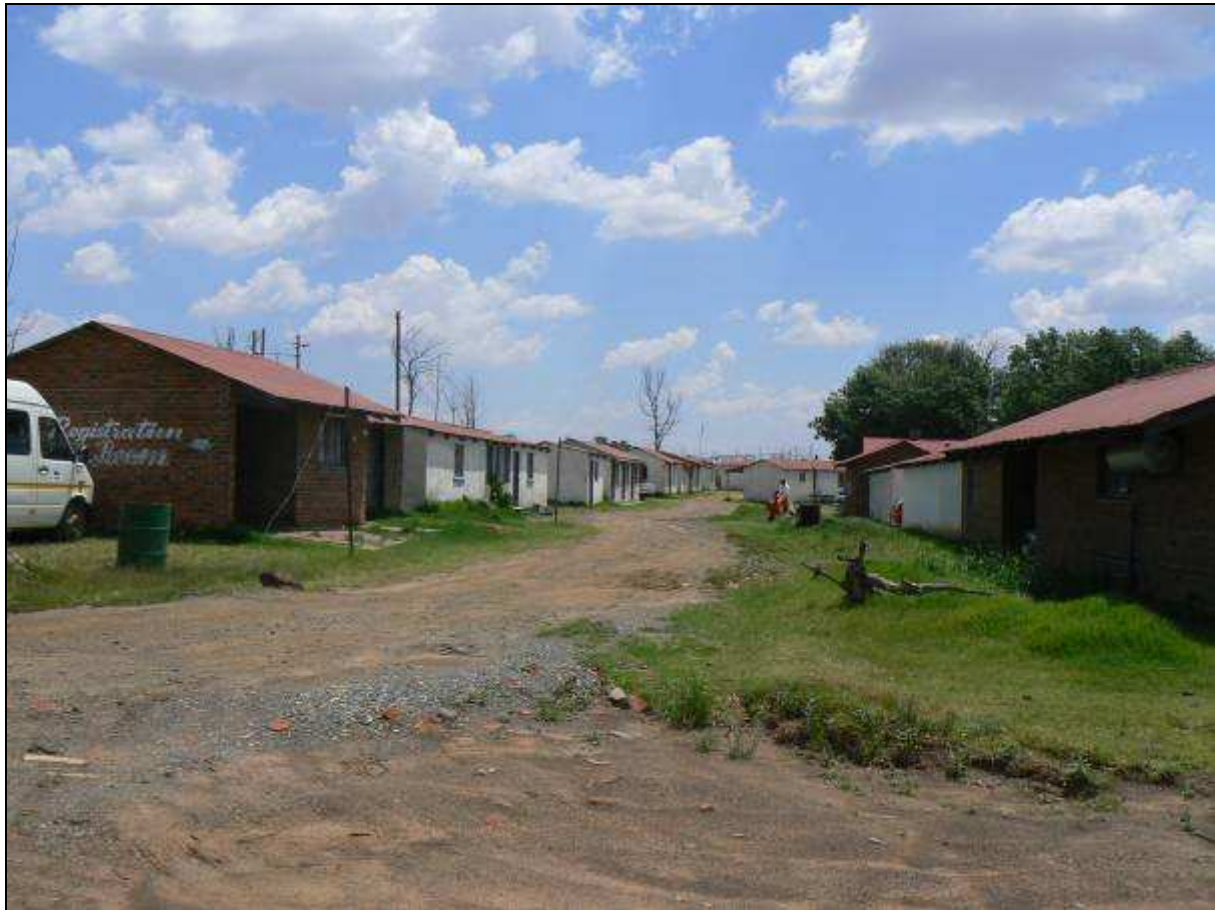
Photo

<b>Z14B VICTORY FELLOWSHIP</b>	
Feature name: Mission station	
Type of feature: Building/structure	
Location/Area	Between N 4 and railway line
GPS coordinates	-
References	None
NHRA protection status	None
Description: Collection of modern buildings comprising hall, sheds, garages, kitchens, dormitories and dwellings	
Significance status (1)	2
Condition status and value (2)	2
Sensitivity assessment (1 x 2 = range = level)	4
Predicted impact	Outside mining area
Recommended management interventions to preserve feature or mitigate impact: Avoid

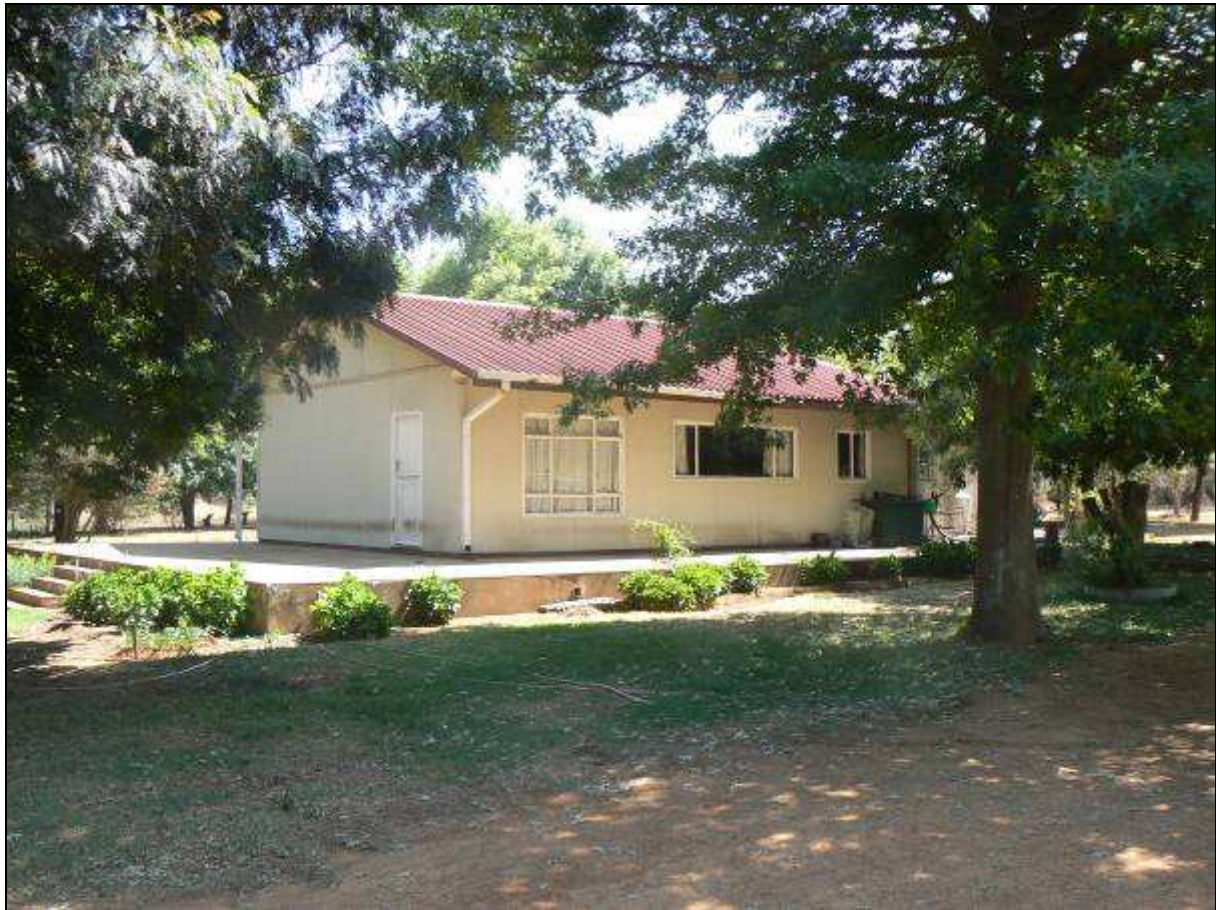
Photo

<b>Z15F FARMSTEAD</b>	
Feature name: Farmstead	
Type of feature: Building/structure	
Location/Area	Zoekop 15
GPS coordinates	25°47'14.60"S 29°58'46.90"E
References	None
NHRA protection status	None
Description: Modern farmstead	
Significance status (1)	1
Condition status and value (2)	2
Sensitivity assessment (1 x 2 = range = level)	2
Predicted impact	Adverse (Inside mining area)
Recommended management interventions to preserve feature or mitigate impact: Document before demolition. There are no compelling reasons to preserve this feature.
