**Architectural Impact Assessment for the buildings on portion
252 on the property Everton 864, eThekweni Metropolitan
Council, Outer West.**

**Prepared for: Afzelia Environmental Consultants
Lower Hilton Quarry Centre
October 2008**

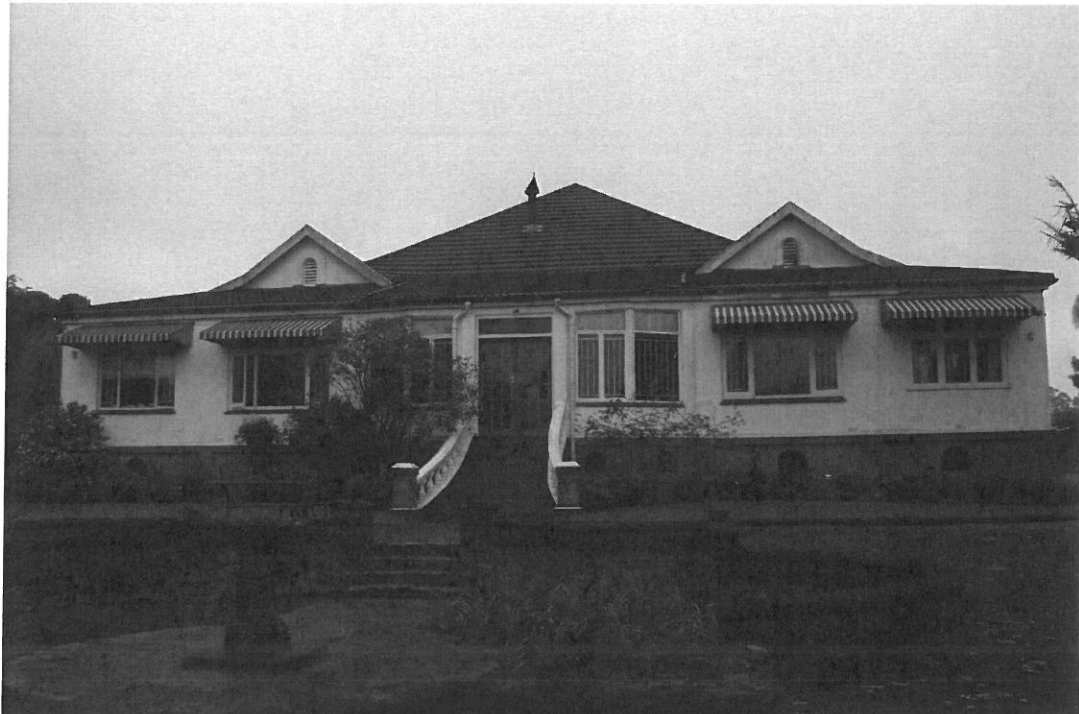
Southern Elevation: Emberton House (Photo: Author: 6 October 2008)

Emberton House is currently inhabited by the Halstead family and is in good repair. Although it has been much changed, it still has a sense of the original scale and proportions, and elevational siting. The house also had strong connections with the established garden in the past, and it is strongly recommended that this relationship could be revived and enhanced in the development of the site.

Its condition, scale and proportion and its prominent siting, contribute to its forming part of a recently disappeared historic landscape of the area. It is strongly recommended that the house remain, and should any alterations, internal, external be intended, appropriate application be made to Amafa aKwaZulu-Natali in this regard. The fact that the building is much altered does not in any way diminish its value, nor its status as a heritage site.

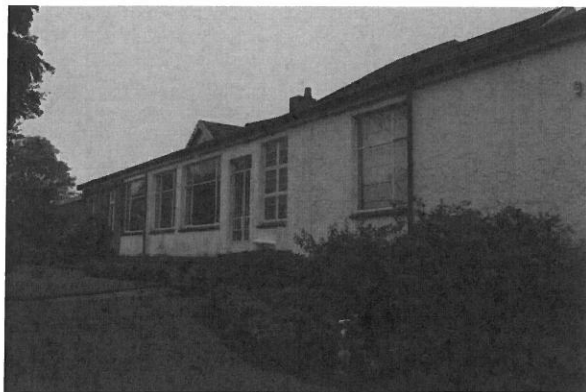
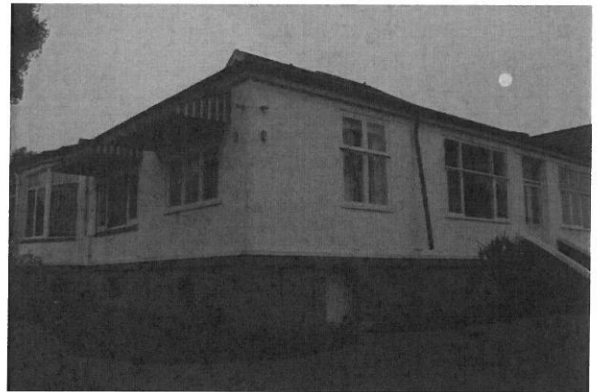
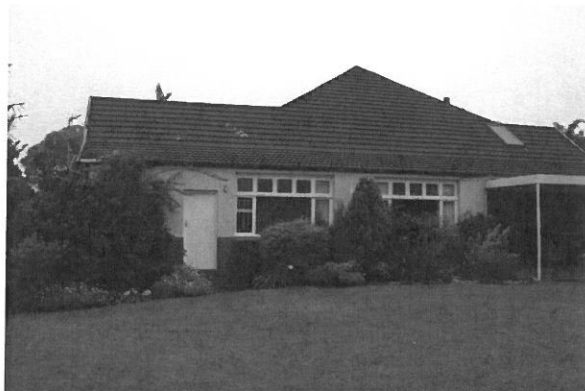
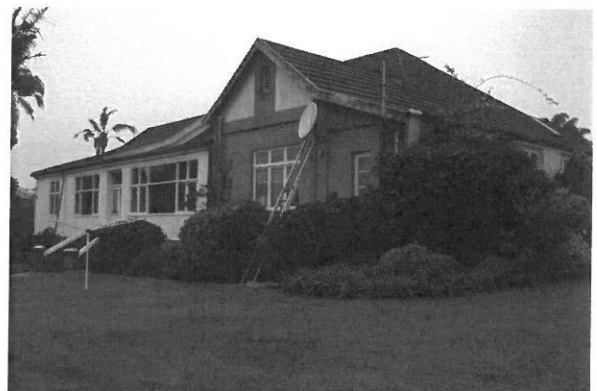
The current Emberton House is of mixed construction under Holley-Harveytile. It has been much altered over the years, with the original core being constructed of red face-brick. A strong dado of the same brick runs along much of the base of the structure. It appears that a large part of the 'extensive alteration' is from the closing in of a large veranda which ran around most of the structure. It was constructed in the early 1920's. Windows consist of a mixture of steel, louver and timber. Large sections of the veranda infill have been stucco plastered.

Fig 2: showing house from south west

Fig 3: showing House from south east

Fig 4: Showing house from North

Fig 5: showing house from north east

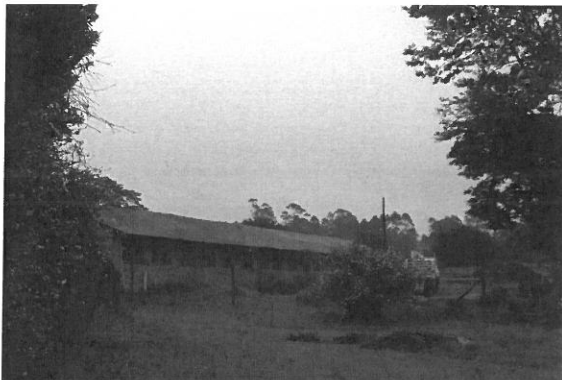
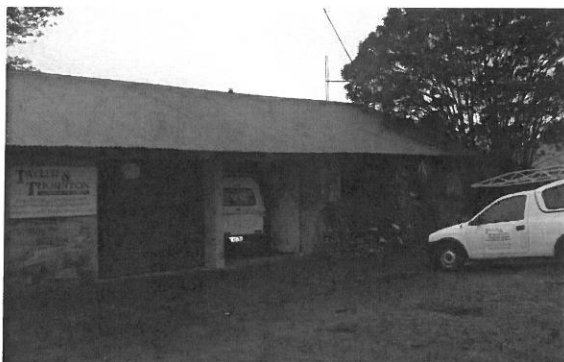
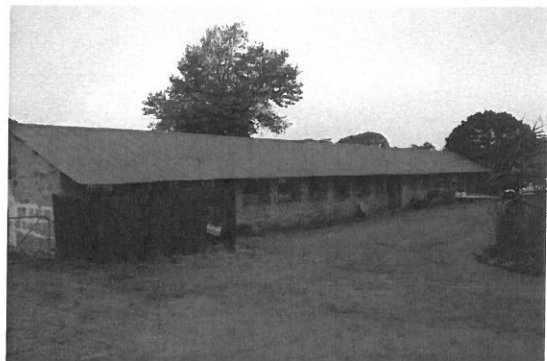
This is an extremely long structure which is conspicuous on the 1937 photograph, which dates it to pre-World War II. It is constructed of random stonework with cement mortar, under corrugated sheeting. There is a strong history of dairying on the property. Currently, the major section of it is used as a storeroom, and a portion of it is currently used as an office for a business, as well as a lock up garage.

Fig 6: old dairy from south east

Fig 7: Internal view of old dairy

Fig 8: south end of dairy

Fig 9: dairy from north

Records reflect the efficacy of the farm being used for dairying, supplying the Model Dairies in Durban (O'Keefe: 1988:79) It is a building which is more pastorally picturesque invoking nostalgia than one which can practically be reused. The structure is likely to have been constructed out of stone retrieved from the old Emberton Wall. However, despite this, there is not much to recommend it architecturally, technically, historically nor scientifically and demolition, should it be requested, is an option. Since the stone is possibly already recycled, recycling the stone again is an option to be explored.

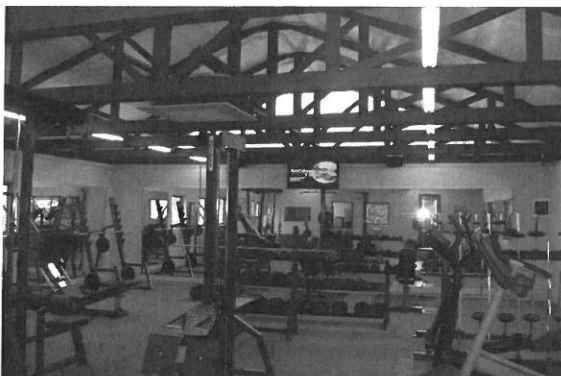
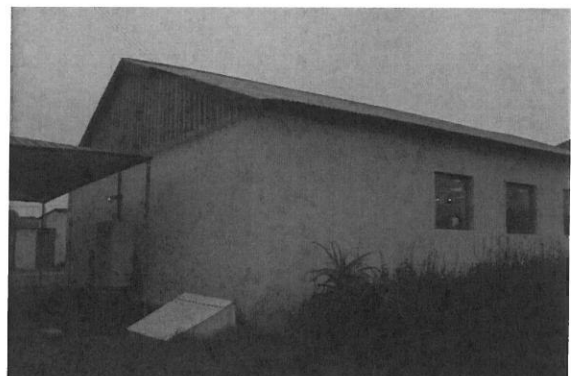
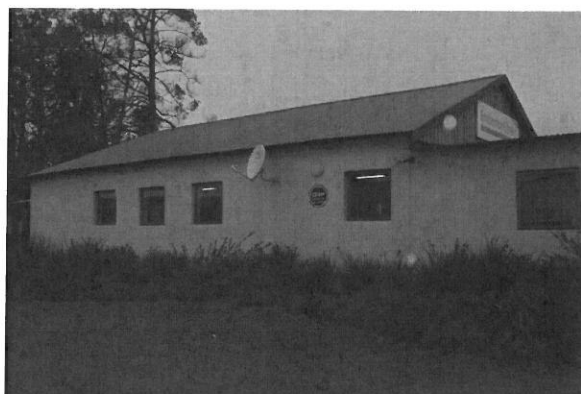
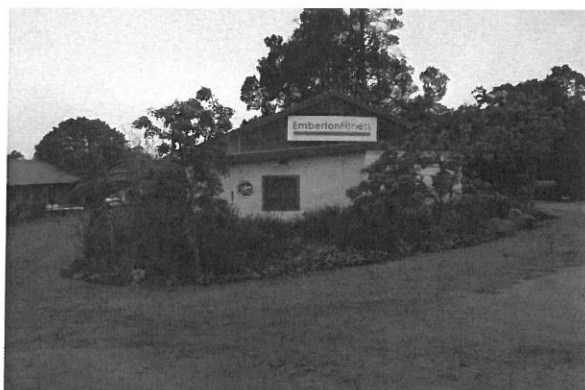
The 'Fitness Centre' is plastered and painted conventional construction under corrugated sheeting. It has been much altered, particularly the windows which have assumed a post-modern format, and the 'Modek' sheeting to the gable ends. Russell Halstead asserts that the structural timber in the roof dates back to the original building.

Fig 10: internal view of 'Fitness centre'

Fig 11: View-'Fitness Centre' South East

Fig 12: Fitness Centre in foreground, dairy in rear

Fig 13: view from north east

Fig 14: view on approach from north

This structure, whilst much altered and reinterpreted, has the 'invisible' core of an historic structure. However, despite this, there is not much to recommend it architecturally, technically, socially nor scientifically and demolition, should it be requested, is an option. Reuse of the structural roof timbers is an option though would be expeditious and a-contextual.

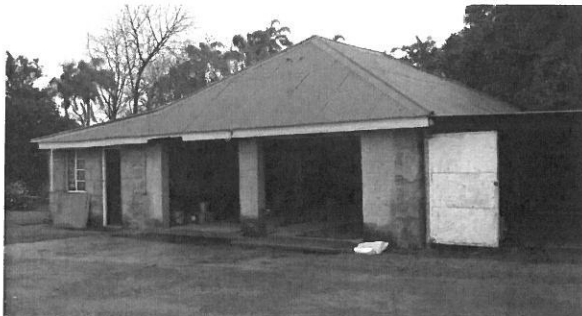
This is currently used as a garage and store room by Emberton House. It is a neat building of coursed but undressed stonework under a hipped corrugated roof with 'afdaks' to both sides. It has been extended and steel windows inserted. It appears in good condition and a good example of stone vernacular architecture.

Fig 15: Outbuilding 1 from gate

These buildings are all of basic vernacular construction and used as purely functional structures. The author sees little merit in their retention, except in a contrivedly pastoral landscape, and demolition is thus an option. The author is also of the opinion that the stone came from parts of the old Emberton Wall (see section 5) and suggests that the possibility of similar recycling be considered and even interpreted as such, ensuring a small amount of historical continuity.

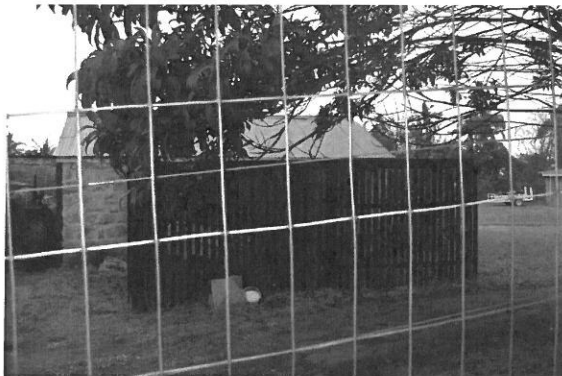
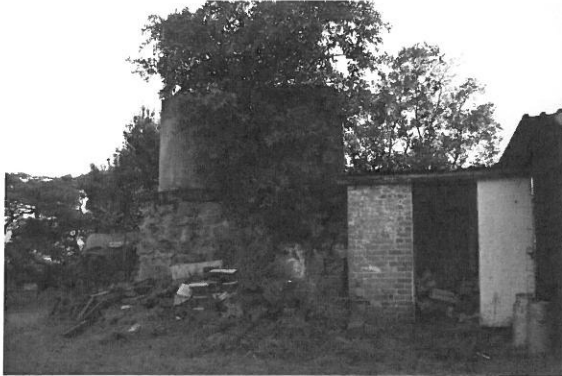
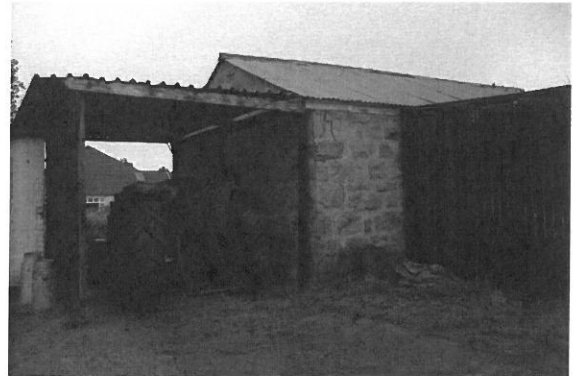
This is a building of very mixed construction, with stone, brick and plaster and painted surfaces under corrugated sheeting, both IBR and corrugated. Some of the brickwork is garden wall bond, indicating pre-World War II construction. There is a large concrete reservoir to the east situated on a random rubble stonework base. These spaces act as sheds and storerooms. There is little merit in this structure apart from possibly being waterproof.

Fig 16: OB 2 through fence from Dairy

Fig 17: OB 2 from east (downhill)

Fig 18: OB 2 showing water tank/reservoir

Fig 19: OB 2- area adjoining water tank

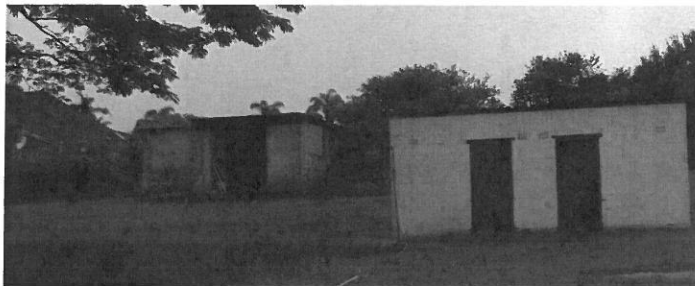
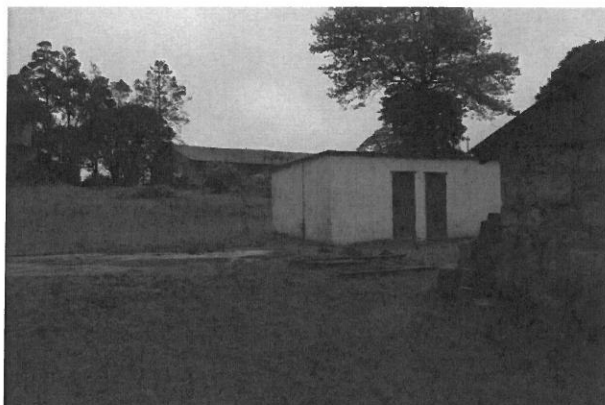
Outbuilding 3 is a plastered and painted structure of little merit or significance. Because of indications from materials used, it is doubted whether this structure is 60 years old, but this has been included as it features within a random group of others that are. It is possibly accommodation.

Fig 20: showing house at extreme left, OB 5 to the left, and OB 3 in the front

Fig 21: OB 4 in the foreground, OB 3 in the middle ground and the dairy in the distance

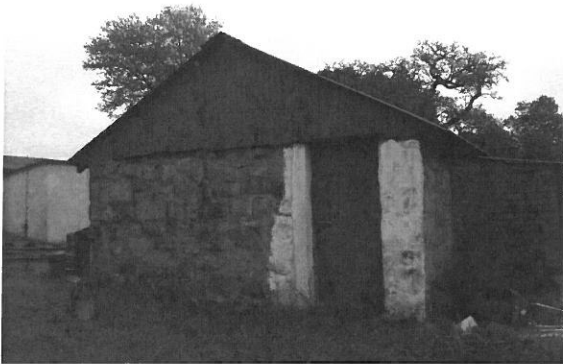
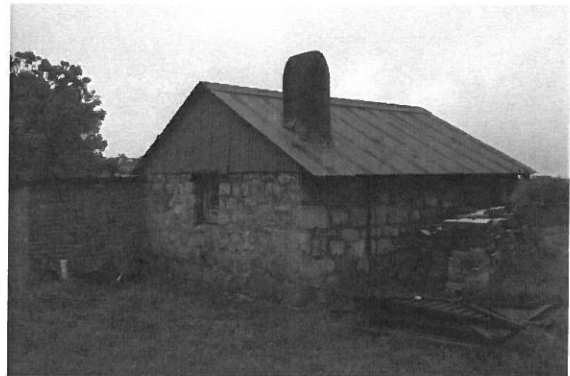
This is a neat uncoursed stone building, again possibly constructed from portions of the Emberton Wall. It has corrugated sheeting and a dominant chimney. The brickwork to the addition is post War, but the building itself, gauging from the windows is older than 60 years. It appears indistinct on the 1937 aerial photographs.

Fig 22: OB 4 Cottage with OB 3 behind

Fig 23: Cottage showing chimney

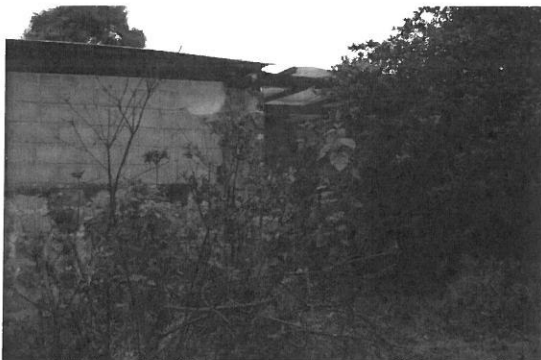
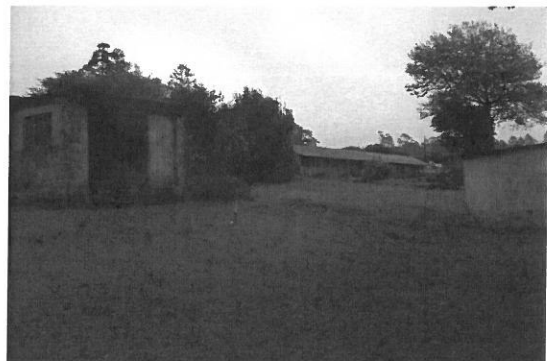
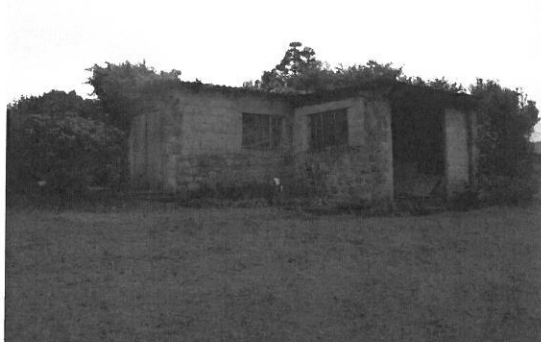
This is a part stone, part brick part block series of accretions which has little merit on any level apart from shelter. Again, the stone may have originated from the demolition of parts of the old wall, and may have formed the basis of a much earlier structure.

Fig 24: OB 5 from below

Fig 25: OB 5 (left) showing dairy at rear

Fig 26: OB 5 from east

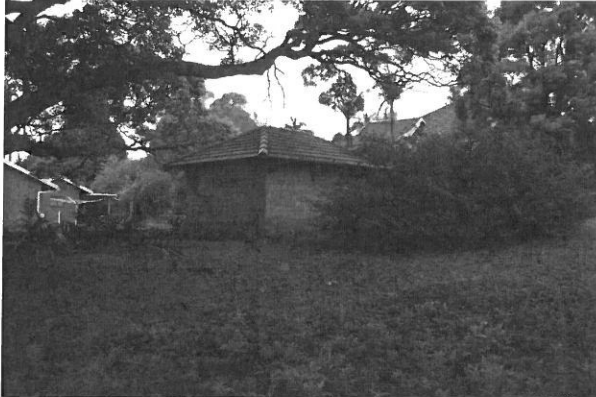
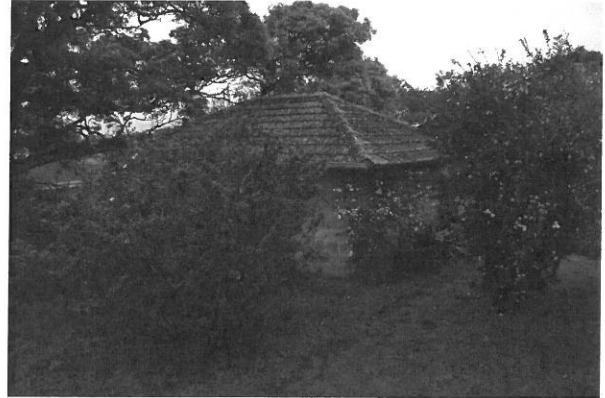
Possibly the most meritorious of the outbuildings, this is a simple and neat almost square stone building with a hipped Marseille tile roof. It has been altered on the one façade using large steel windows. It is associated with the new face-brick house as seen in the left of figure 27.

Fig 27: Showing OB 6 from north east

Fig 28: OB 6 from north
