**Architectural Impact Assessment for the buildings on
lots 224, 245, 248, 247, 258, 476 and 502 Rem of
Townlands of Pietermaritzburg, currently forming part of
the Midlands Townhill Hospital Complex**

**For: Osmond Lange Architects and Planners
P O Box 1450
KLOOF
3640**

Architectural Impact Assessment for the buildings on lots 224, 245, 248, 247, 258, 476 and 502 Rem of Townlands of Pietermaritzburg, currently forming part of the Midlands-Townhill Hospital Complex

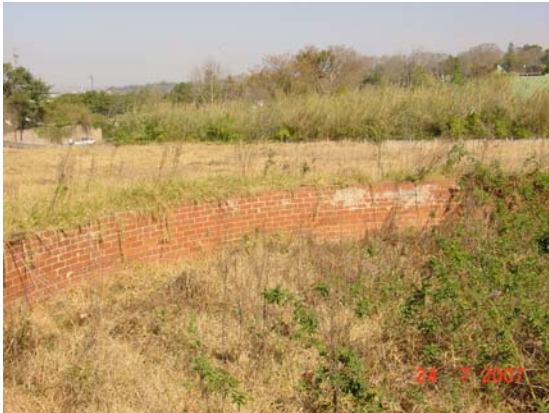
Fig 2: showing disused reservoir

The only structure on this portion is a disused reservoir which would appear to date back to the days when the site was a working farm. In 1910, this formed part of the property of the late William Leathern, a notorious transport rider who owned three adjoining lots. The plot was originally surveyed in 1874.

Recommendation: If demolition is required, there is little to recommend the retention of this structure.

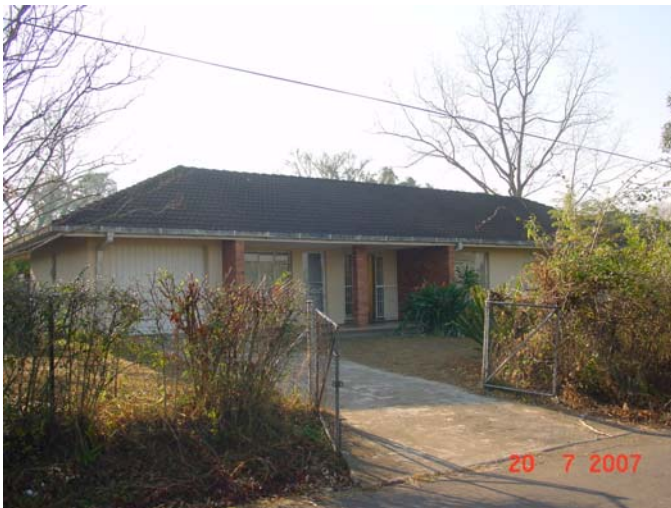
Fig 3: Showing house of recent construction

The buildings on this portion are of recent construction, do not fall under the Heritage Act no 10 of 1997, nor do they have many redeeming qualities. The main building is a dwelling with an outbuilding complex consisting of a service room. The construction is brick and mortar, plastered, with steel framed windows and a Marseille tiled roof. In 1910, the site was owned together with Lot 258, forming a piece of land named 'Dulwich'. It is currently occupied by hospital staff.

Recommendation: should demolition be required there is little to recommend retention of this building.

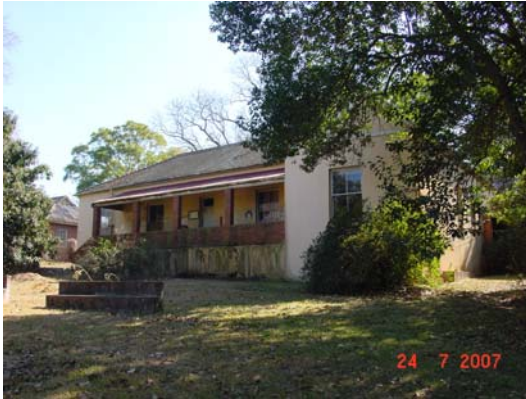
Fig 15: the original part of Ward 3

By all accounts, Wild Bill Leathern was a colourful character, in 1902 applying for rights to open a brick yard on Government ground (SG1242/1902). He also made application to the Natal Government Asylum to pipe water from the stream on their lands to his property (PWD 2/10 1296/1895). It is suspected that the part of Ward 3 marked with the asterisk above, which has a date of 1880 on it, predates the rest of the building. This conclusion is drawn partly from the brick-worked corners being present on the north and eastern faces and not on the gabled building itself. Also, the initial part has 4/4 sash windows, and the latter 12/12.

In addition, it is known that this site was occupied by the Leathern family in 1898, and that in 1910 it was still part of their land (see appendix). The site of the house as mentioned above is not evident on Lot 224, and if it was on Lot 248, then it was most probably where the platform of land that houses the stables and administration block are, given the large plane tree in the paddock close to them. However, it is felt that the 1880 part of the building, as seen in Fig 15, could possibly be this house known as Sandringham.

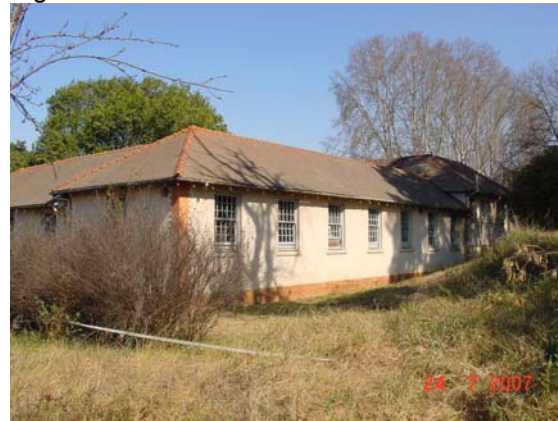
Fig 18: Building from North

The main building is institutional and serviceable in nature, with plastered walls, 12/12 sash windows and a round-nosed brosely-tiled roof. It has an unusual detail in that the edges of the north and eastern faces of the extension to the main building are quoined in the salmon brick that characterizes Pietermaritzburg. The gable facing Hyslop Road announces that it was built in 1880. It is situated within a clump of very established trees, with an approach down a plane tree avenue to rival that of the Botanic Gardens, which were planted in 1908. The building is not particularly visible from either Hyslop nor Chatterton/Town Bush Roads.

The external condition is reasonable, with some tiles missing from the roof, and many of the windows broken or boarded up. People working at the Police Unit say that there were workers from the Department of Health living in the building, and that many of the suspended timber floors had been removed and that all the copper piping had been stolen. This I could not immediately see when peering through the windows. It is a disconsolate building.

Recommendation: the possibility of retaining all or part of this building should be explored, given that it was an early part of the history of this area, as well as the connections of the site, at least, with a renegade character of the city's history.

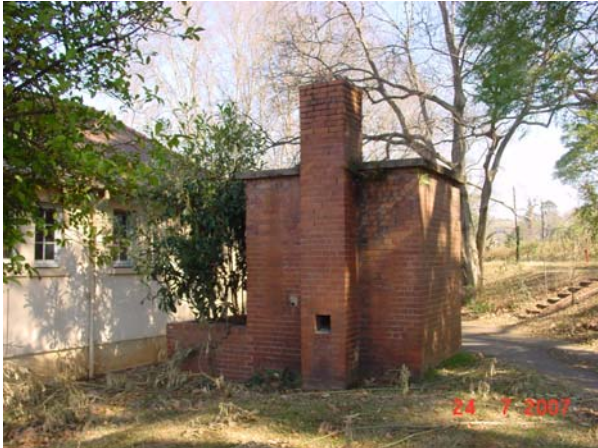
Fig 19: showing structure adjacent to Ward 3

This is a brick structure with a concrete slab roof probably used as a boiler for hot water. It is not particularly significant.

Recommendation: should demolition be required there is little to recommend retention of this building.

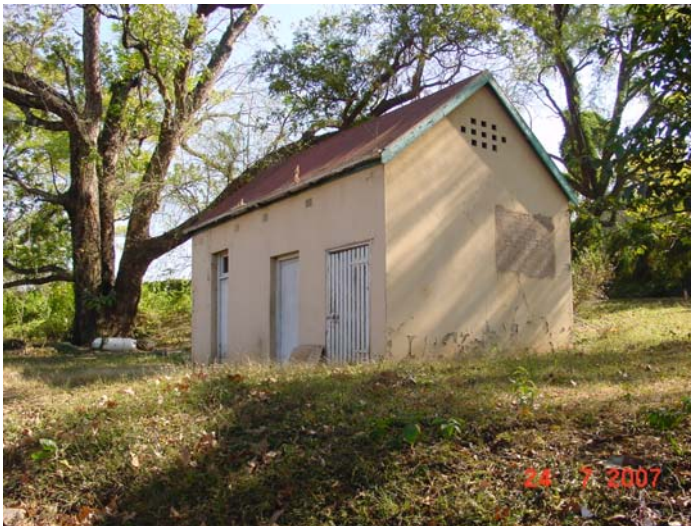
Fig 20: showing the shed above and adjacent to Ward 3

A small plastered building above the level of the main complex that has a corrugated sheeting roof. It is in good condition.

Recommendation: should demolition be required this building is representative of a common service type and is not unique.

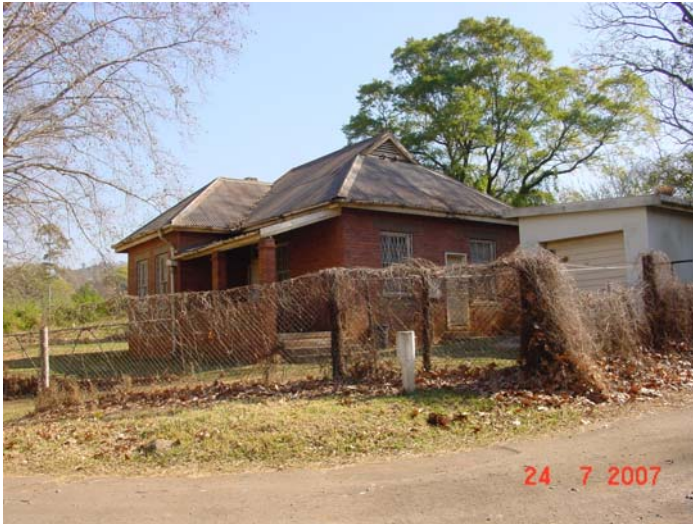
Fig 20: showing house and garage/carport

This is a building constructed more than 60 years ago out of dark red brick. It has corrugated sheeting roofs, 6/6 sash windows, and an unhappily resolved veranda addition. It is a good, through not particularly unique example of Public Works domestic architecture. The garage is plastered brick and corrugated sheeting and not subject to the conditions of the KwaZulu-Natal Heritage Act.

Recommendation: should demolition be required this building is representative of a common service type and is not unique.

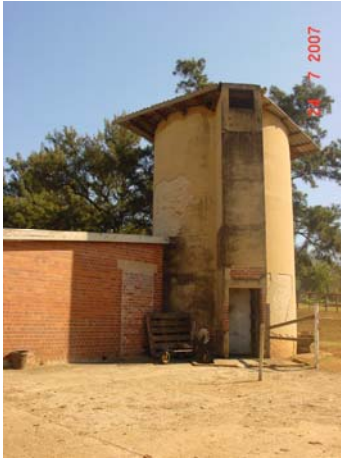
Fig 4: showing the silo

This building forms an enigmatic statement in the landscape moving up Town Bush road, and has embodied nostalgia of the agricultural nature of the site. It is strongly recommended that the vertical form be reinterpreted in any new building, as a link between past and present. It is constructed of plastered brick and a corrugated sheeting roof.

Recommendation: Should demolition be required, it is suggested that this is acceptable, but that the vertical form be replicated in the new construction

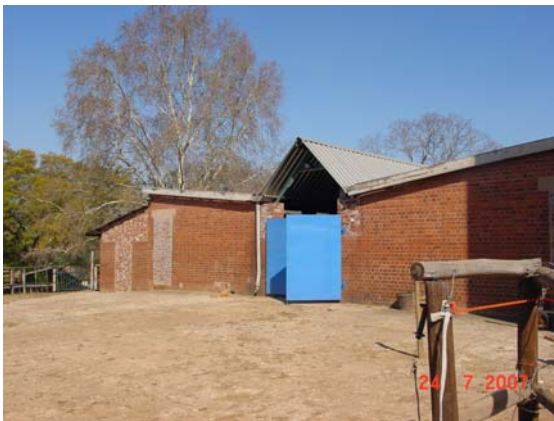
Fig 5: Showing stable block

This is a well built and commodious brick stable building, with two main stable areas and a central gangway with a steeply pitched corrugated sheeting roof. There have been a few alterations as seen in the photograph, with spaces being filled with new brickwork.

Recommendation: should demolition be required there is little to recommend retention of this building.

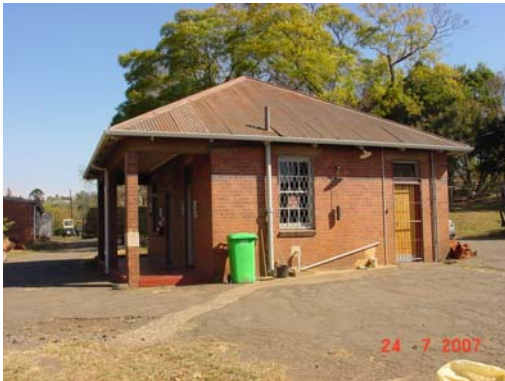
Fig 6: Showing Administration block

This is currently used as the Administration for the Mounted Police Unit. It is a well constructed brick building, with a corrugated sheeting roof and timber sash windows. It is in good condition. It is an example of a common building type.

Recommendation: should demolition be required there is little to recommend retention of his building.

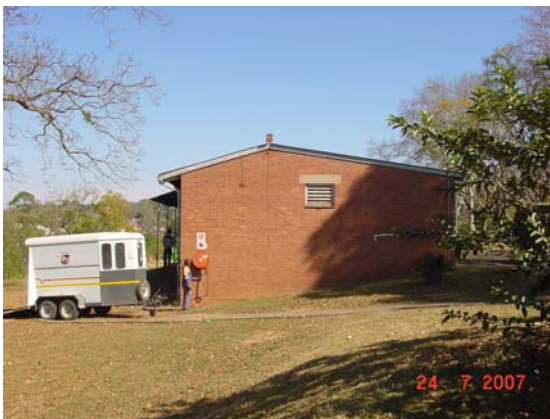
Fig 7: Showing workshop from the north

This is currently used as a workshop and a farrier's yard. It has had alterations in recent years which have been carried out in a haphazard and sloppy fashion. The building is well constructed out of brick and corrugated sheeting. Mr Pillay mentioned an aviary, and this could have been the place that the birds were kept.

Recommendation: should demolition be required there is little to recommend retention of this building.

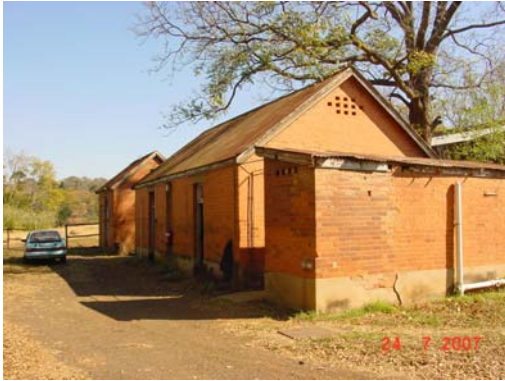
Fig 9: the central building is the 'recreational block'

These three buildings are used by the Police, as washrooms and a recreational block. They are salmon brick under corrugated sheeting, and as a group are not in very good condition. The 'Rec' room is more of a dumping ground than a space that people spend time in.

It should be mentioned that behind these buildings (behind the paddock fence in Fig 9) is evidence of some structure that has been demolished. Mr Pillay, the informant who has worked on the site for 40 years, cannot remember any structures that were demolished in this area.

Recommendation: should demolition be required there is little to recommend retention of this complex of buildings. However, if excavations occur in the area noted above, they should proceed with due caution and the relevant authorities contacted should industrial or archaeological artifacts be unearthed (see Chapter 5 - Historical Archaeology).

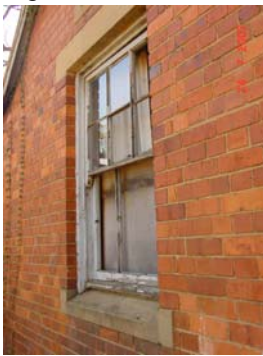
Fig 10: sash window boarded up and rotting: from the south side of the single roomed cottage

The washrooms in the foreground are not meritorious, and the small cottage, which is inhabited at the rear, is also suffering from lack of maintenance (see fig 10)

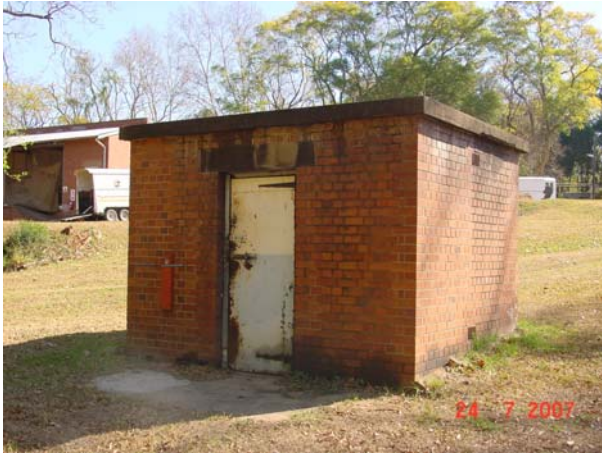
Fig 12: showing the substation

This building sits to the north of the Recreation Complex. It is of brick and concrete construction. It does not fall under the 60 year clause as stipulated in the KwaZulu-Natal Heritage Act.

Recommendation: should demolition be required there is little to recommend retention of this building.

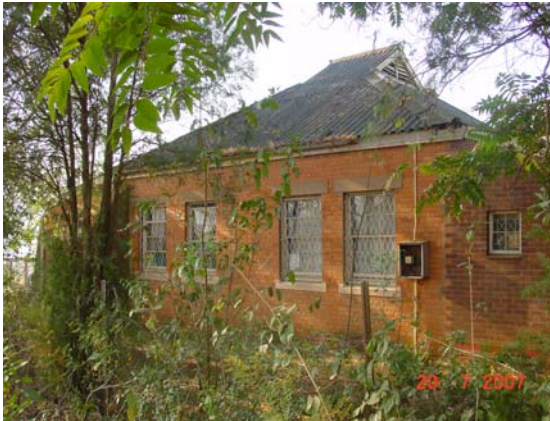
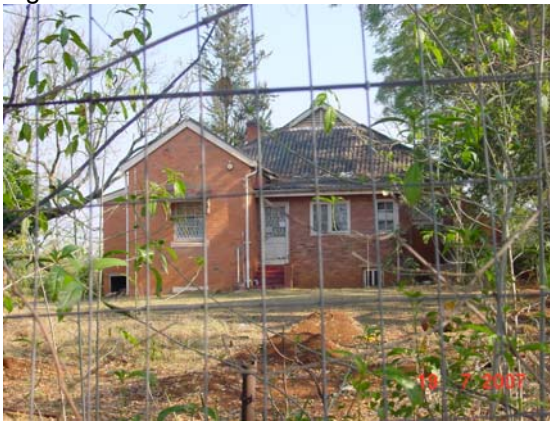
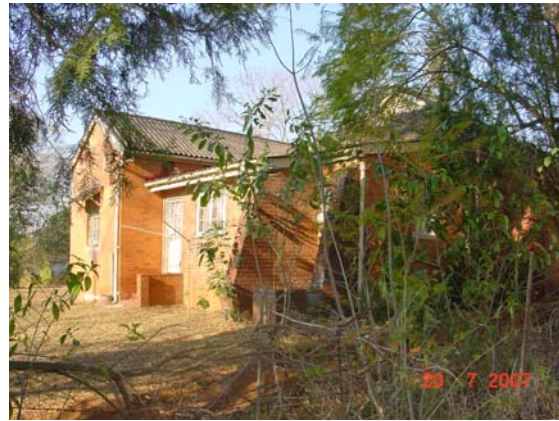
The house is constructed of salmon brick and has an asbestos sheeting roof. It has simple sash windows, some timber casements and is in good condition, though has been subject to a number of alterations.

Recommendation: should demolition be required this building is representative of a common type and is not unique.

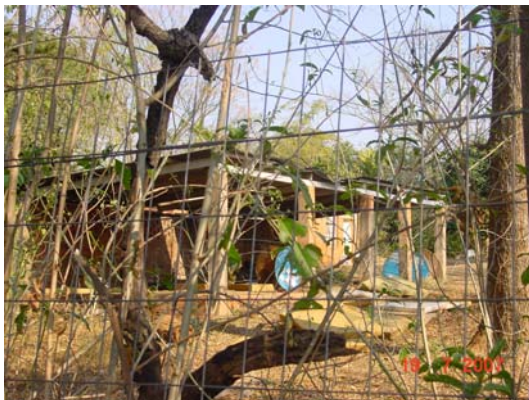
Fig 24: Carport from the north

A brick and sheeting structure situated to the north of the house. It is of no particular value.

Recommendation: should demolition be required there is little to recommend retention of this building.

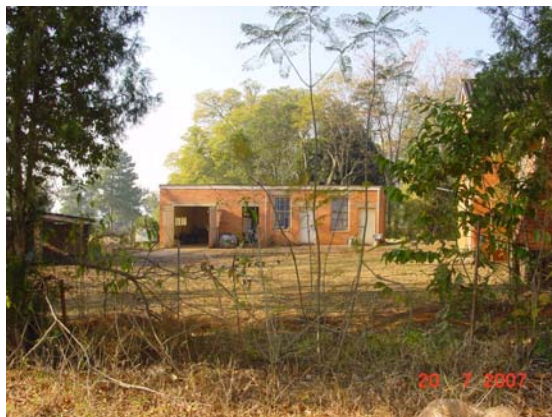
Fig 25: Outbuilding

This is a simple salmon brick structure common to many properties in Pietermaritzburg. It is most probably contemporary with the house.

Recommendation: should demolition be required this building is representative of a common service type and is not unique.

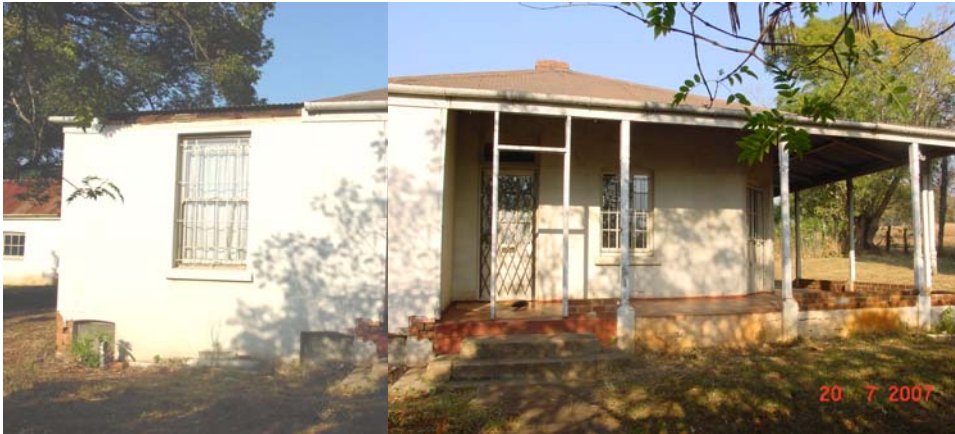
Fig 26: Composite photograph of north elevation

This is a very solid building, plastered with corrugated sheeting and timber suspended floors. The interior is simple, there is some termite damage, and there is the ubiquitous crack (see Fig 28). It is not certain how old the building is, though it does predate the turn of the twentieth century. There is a corner entrance to the lounge area from the veranda, which has timber posts. The rear has a row of windows with basket arches.

Recommendations: that as this (1) form(s/ed) part of a streetscape, (2) still does address the Townbush Valley road, (3) is on the periphery of the site, it can be retained as part of the development. The possibility to highlight the modest domesticity of this building in a sophisticated and elegant manner is great.

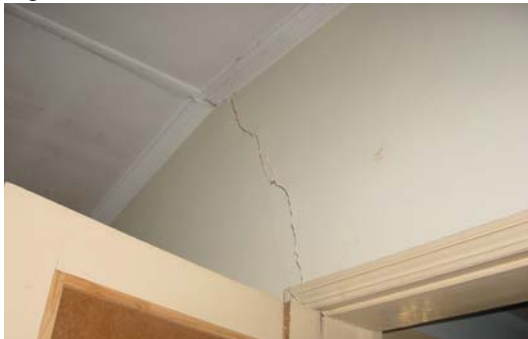
Fig 28: showing the 'Wembley' crack.

It needs a reasonable amount of repair work.

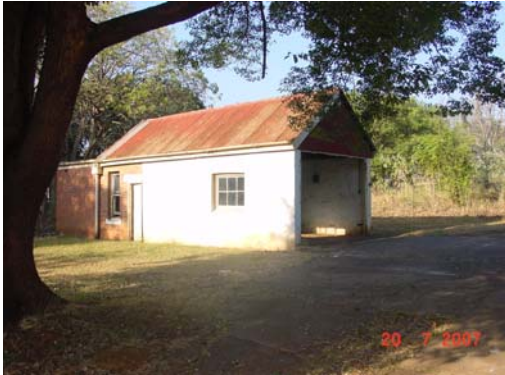
Fig 29: showing the carriage house

This is a simple carriage house that is constructed of plastered brick and corrugated sheeting. It needs some repair work.

Recommendation: should demolition be required this building is representative of a common service type and is not unique.

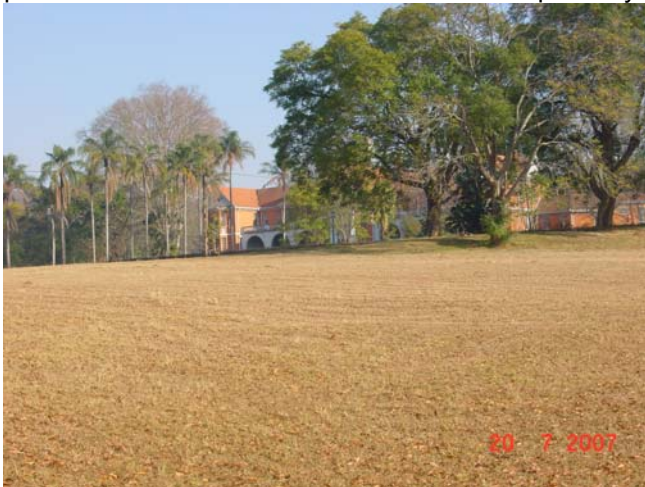
Initially, it was thought that the very strong palm avenue which leads down the hill could be a point of departure for the design of the rear part of any new construction. However, the tenuousness is recognized, given the scale of the site and the interruption of the slope over the distance from North Park Block to Hylsop Road/ Chatterton Road circle. However, it is urged that the context of this building, which has a very elegant command of its site, be recognized by the architects, and that deference to it be made in some manner.

Fig 30: showing North Park Block and avenue

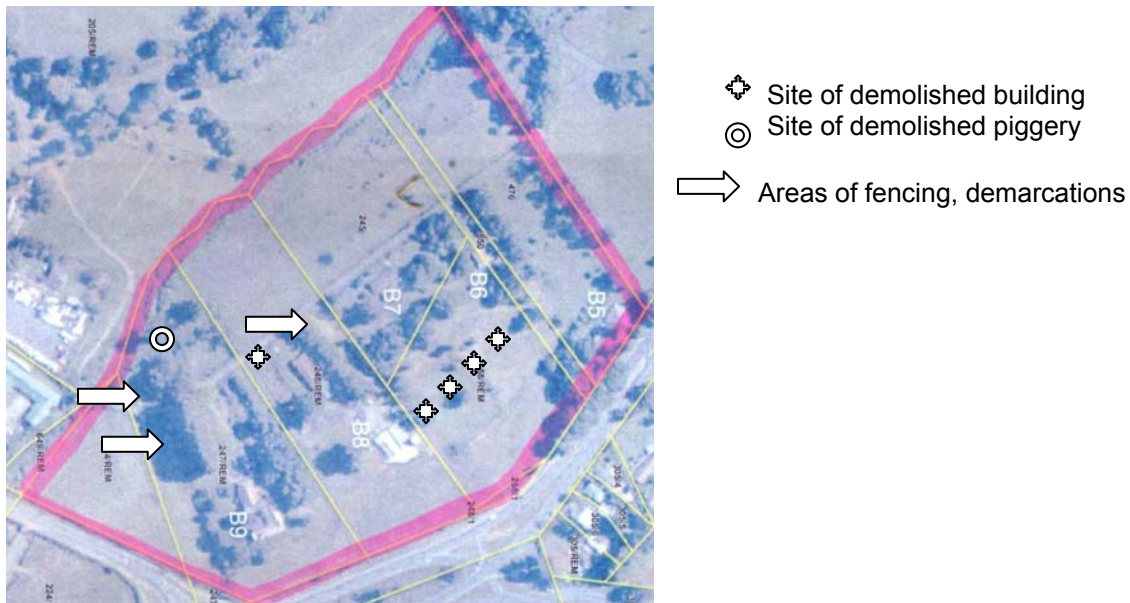
Fig 31: showing sensitive areas during excavation

A number of places have been identified as sensitive, where old structures have been removed. This is in addition to places where fencing and demarcations existed, such as along the plane tree avenue on the Hyslop Road edge. There are also large pieces of field stone and some material identifiable as the raw material of the brickyards, which is plausible given their proximity and the zeal with which Leathern wanted to manufacture bricks! These sites are identified on the map below, and it is recommended that the appropriate authorities at Amafa aKwaZulu-Natali be contacted if needed during the excavation process.
