Proposed Mitigation of Unmarked Grave

The '53 Pipeline is an Umgeni Water (UW) prestressed concrete pipeline. This pipeline forms part of Umgeni Water's bulk conveyance pipelines and is an integral part of the system for supply to eThekweni, especially the newly constructed Western Aqueduct which conveys water to various terminal end reservoirs in the eThekweni region. This pipeline is currently in the road reserve and needs to be relocated to allow for major upgrades to the N3 in the vicinity of Ashburton.

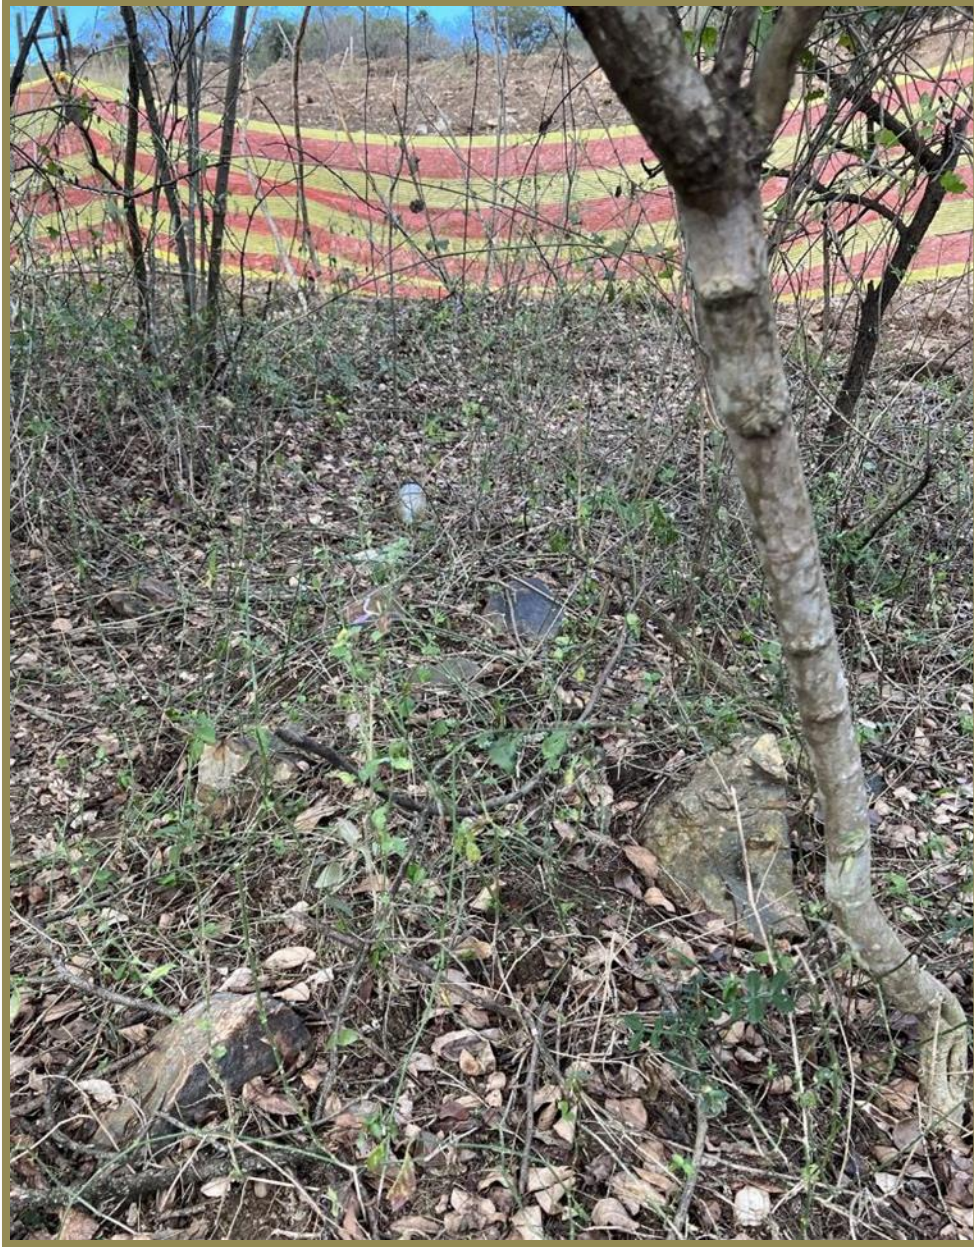
I confirmed that their initial assessment was correct and that a single unmarked grave had been identified. The contractors had immediately barricaded the grave site with netting on its discovery.

The grave site is located within the UW 10m-wide registered servitude. The most pressing concern was the possibility of a work stoppage and delays to pipe excavation operations as this will have a knock-on effect to the SANRAL National Route 3 (N3) upgrades. We then assessed the grave's location in relation to the surveyed edge of the servitude and confirmed that, from the central axis of the grave to the edge of the servitude, the pipeline can be re-aligned 3m away from grave without any disturbance to the heritage feature.

Figure 1 Unmarked grave as revealed during bush clearing activities located at 29° 39' 14.73" S, 30° 27' 09.62" E.
(See kml loaded to SAHRIS Case File)

1. That the grave site be fenced (2m x 3m) by means of 1.2m high Y-bar fencing standards strung with 4 strands of barbed wire. Ski-netting should be attached to the fence to enhance visibility during construction activities.
2. On completion of construction activities and during servitude rehabilitation the grave site should have a sign attached indicating a grave. This for visibility in the event of future maintenance activities along the servitude. A schematic of the pipeline re-alignment is attached (see Appendix 2 and image as loaded to the SAHRIS Case File).
3. The DEO shall communicate to the workers the findings of this report and safe working procedures within this sensitive area.
4. I have requested that the fence be erected immediately, prior to a response from the AMAFA Heritage and Research Institute, in order to ensure the sanctity of the grave site.
