## archaic consulting

### Short assessment of the remains of structures on the government grounds, Ndwedwe on the site of the proposed Vehicle Testing Station for JLB Consulting, December 2016

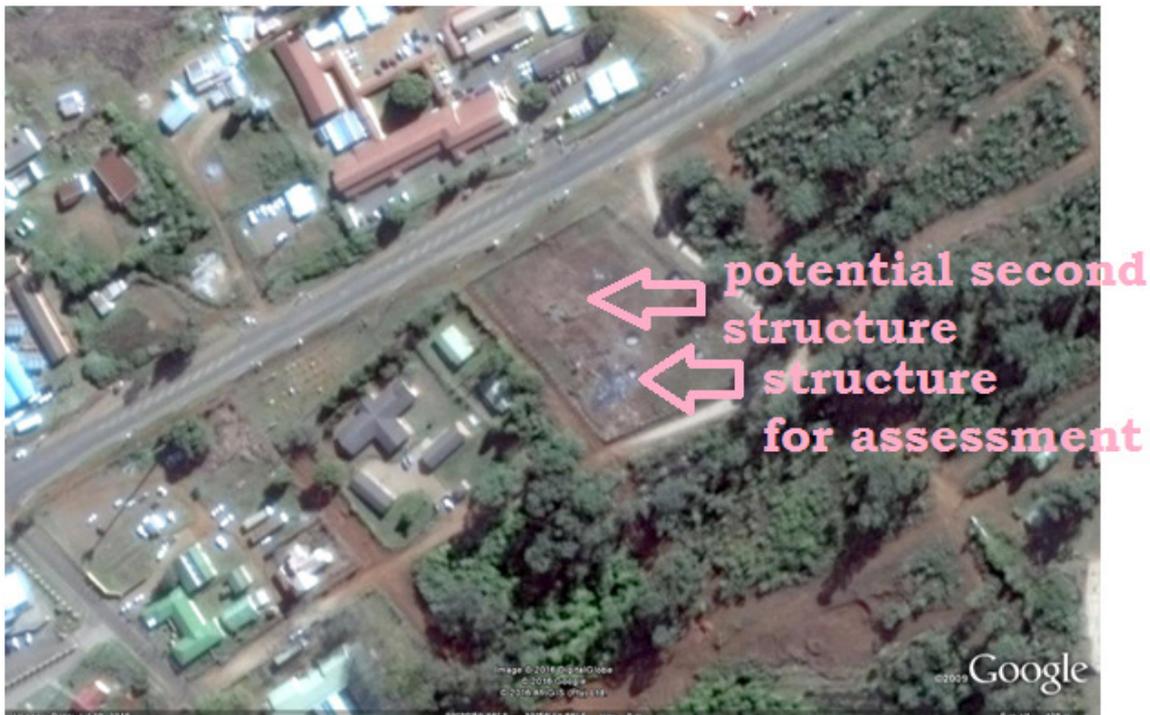
**Fig 1: Google Earth image of cleared land showing areas for assessment**

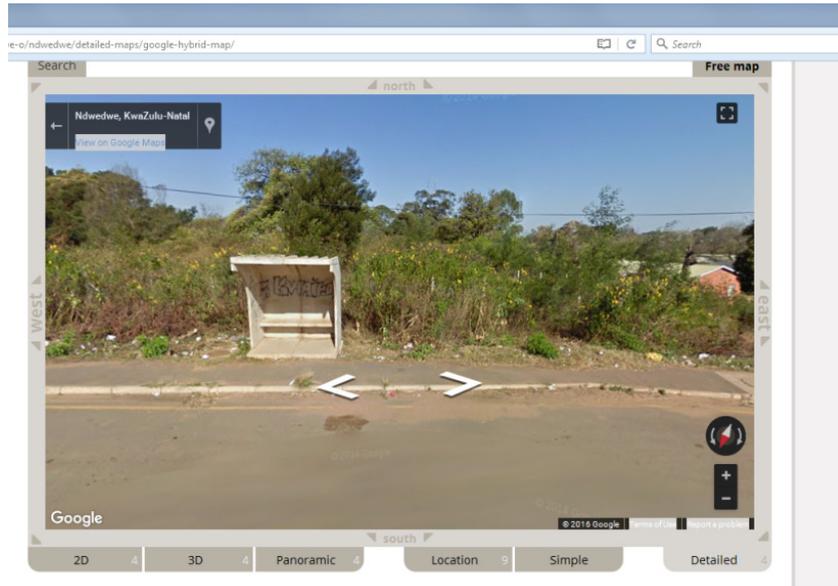
**Fig 2: Google Street View picture of bush in which the ruins of the building are located**

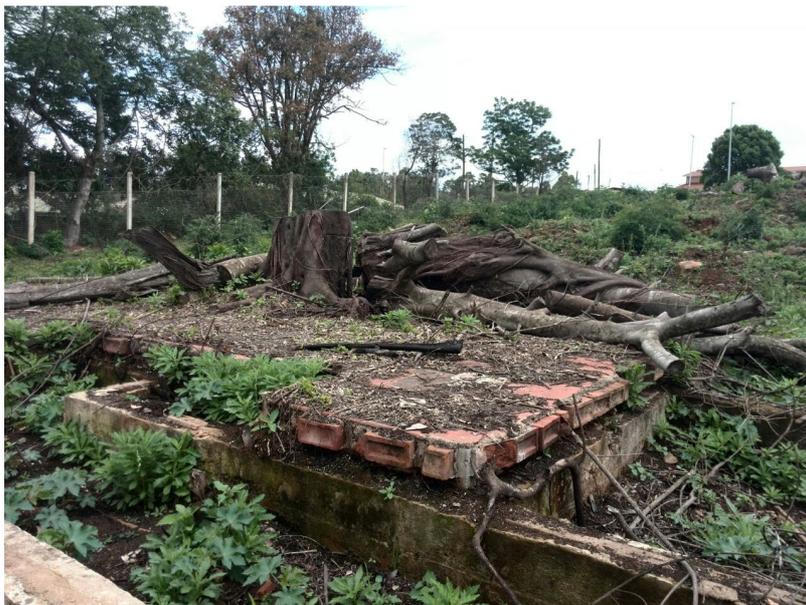
It would appear from the ruins, that this was a simple, orthogonal domestic scale building with a central passage, a paved patio to the north which was edged by a large fig tree, the remains of which lie across it, and a plastered and painted rear *stoep* to the south. The fireplace and chimney supposes a cooking hearth, given its situation on the south and perhaps in the corner of what may have been the kitchen.

**Fig 3: Ruins showing raised and paved possible north stoep with tree stump (Beater 2016)**

***It is recommended that the ruins of this structure can be removed, given their potential hazard to people and animals, and that the Government Department responsible for maintaining and developing the property engage in a greater investigation into the official precinct that formed the Magistracy of Ndwedwe, since many of these areas have significant histories, which are completely ignored given their previous context as tribal Trust lands.***

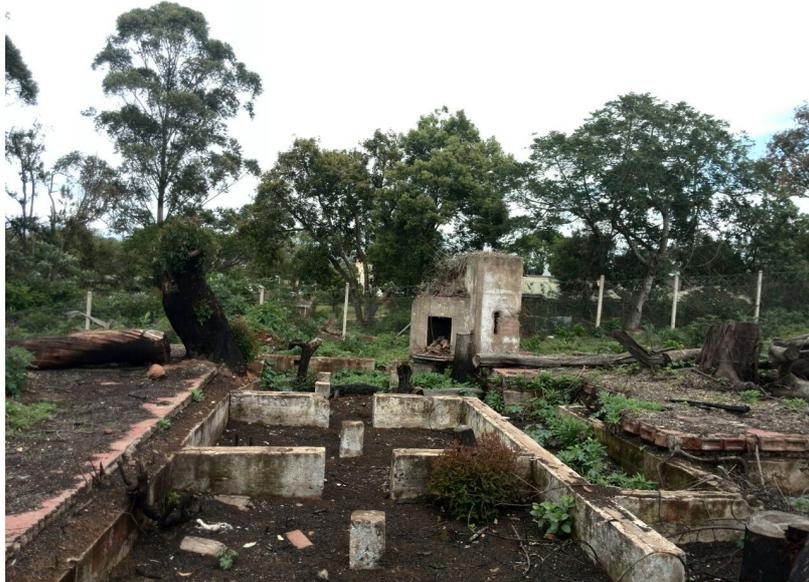
**Fig 4: Ruins looking west at hearth and chimney (Beater 2016)**

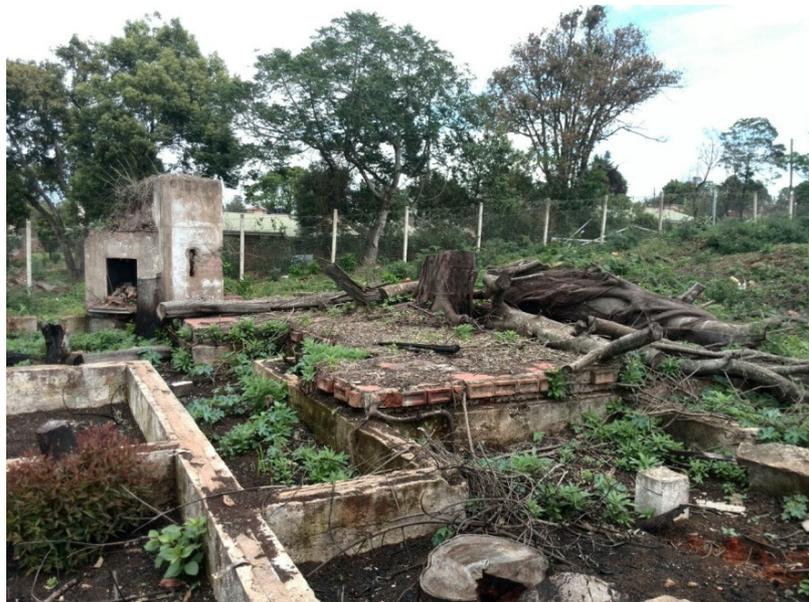
**Fig 5: Ruins showing raised stoep and fireplace (Beater 2016)**

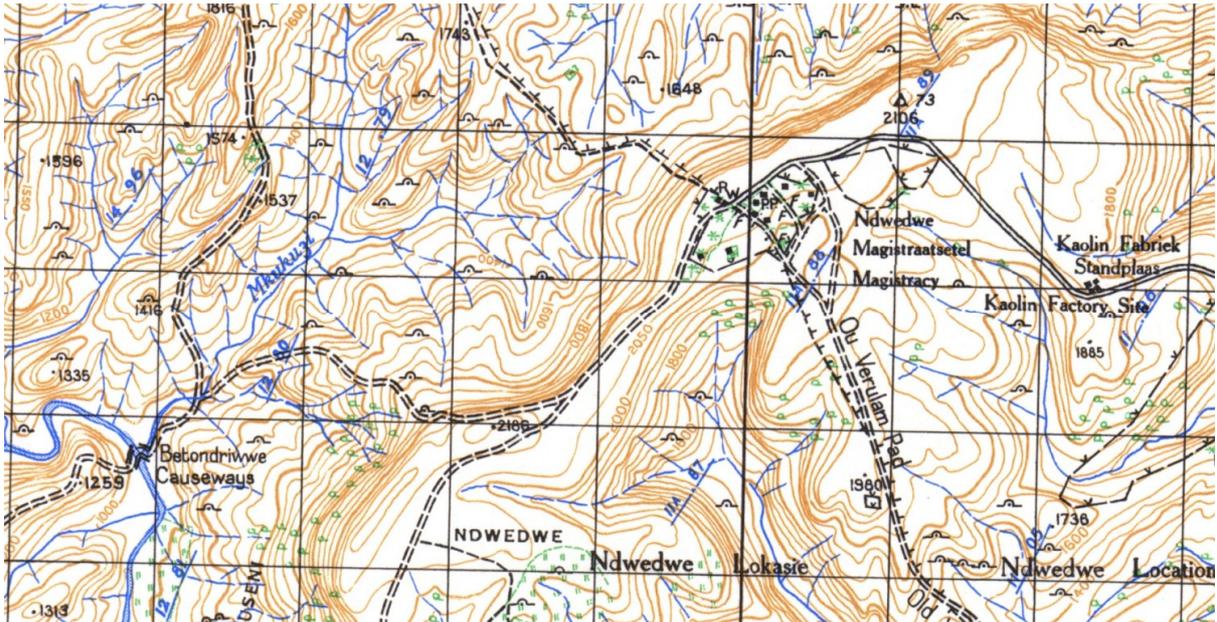
In order to establish its possible provenance, empirical sources were consulted. The topocadastral 2930DB 1942 (Figure 6) shows a number of structures around the site, situated along what was known as the Old Verulam Road. Whilst the topocadastral is a little inscrutable suggesting that buildings on the site could have been water towers or reservoirs (F), Police Post (PP) it does not mention the old Goal which was essentially established by 1937 as this was present on the 1937 aerials. In addition, the general area, perhaps, is annotated Ndwedwe Magistracy.

**Fig 6: Topocadastral Map 1942**

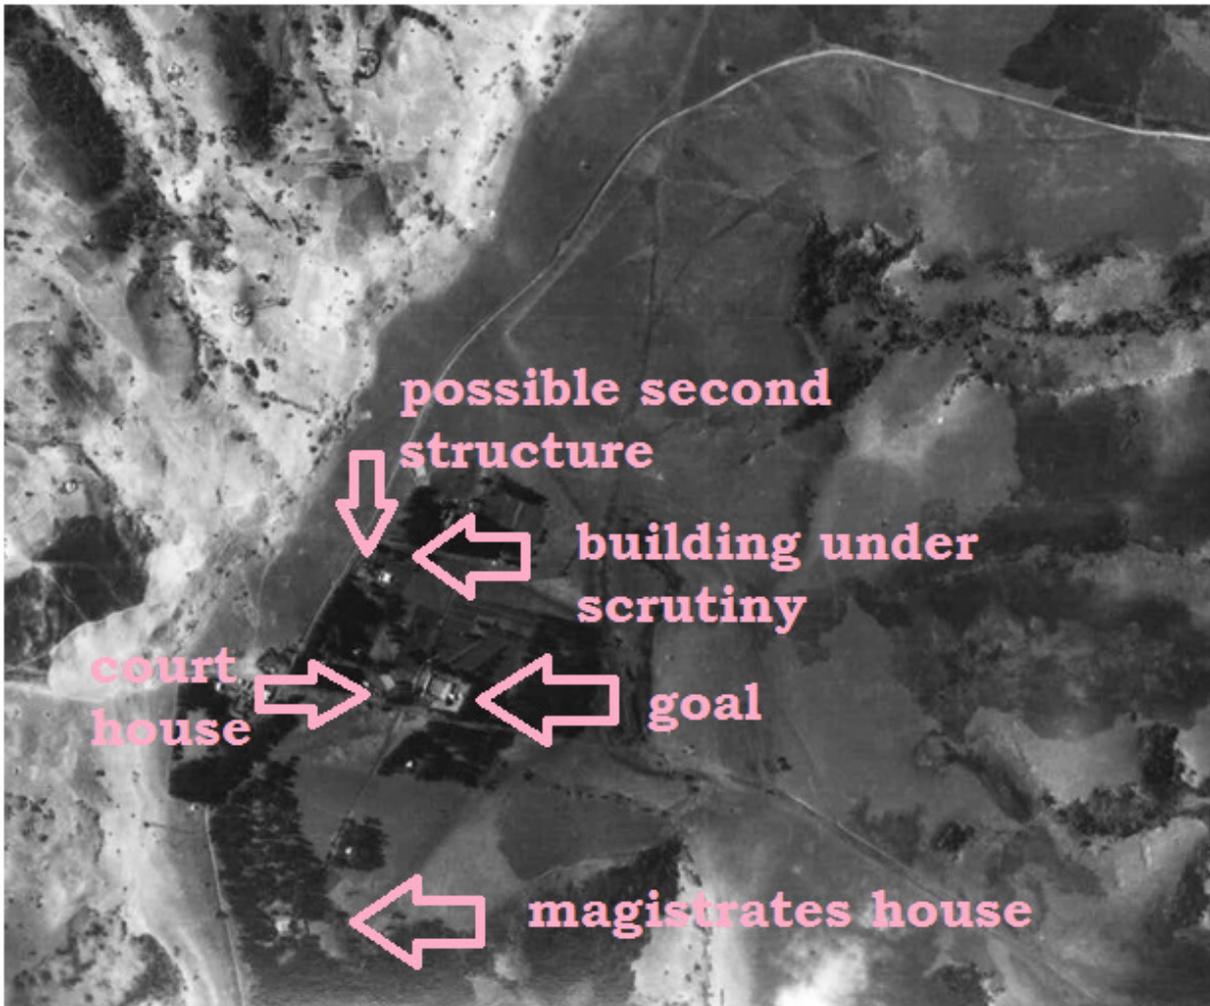
**Fig 7: 1937 aerial photographs showing structure on site as well as a possible structure in front of it**

The second structure appears to have been subsumed by dense planting, or else have been demolished by the time of the aerial photographic series in 1959.

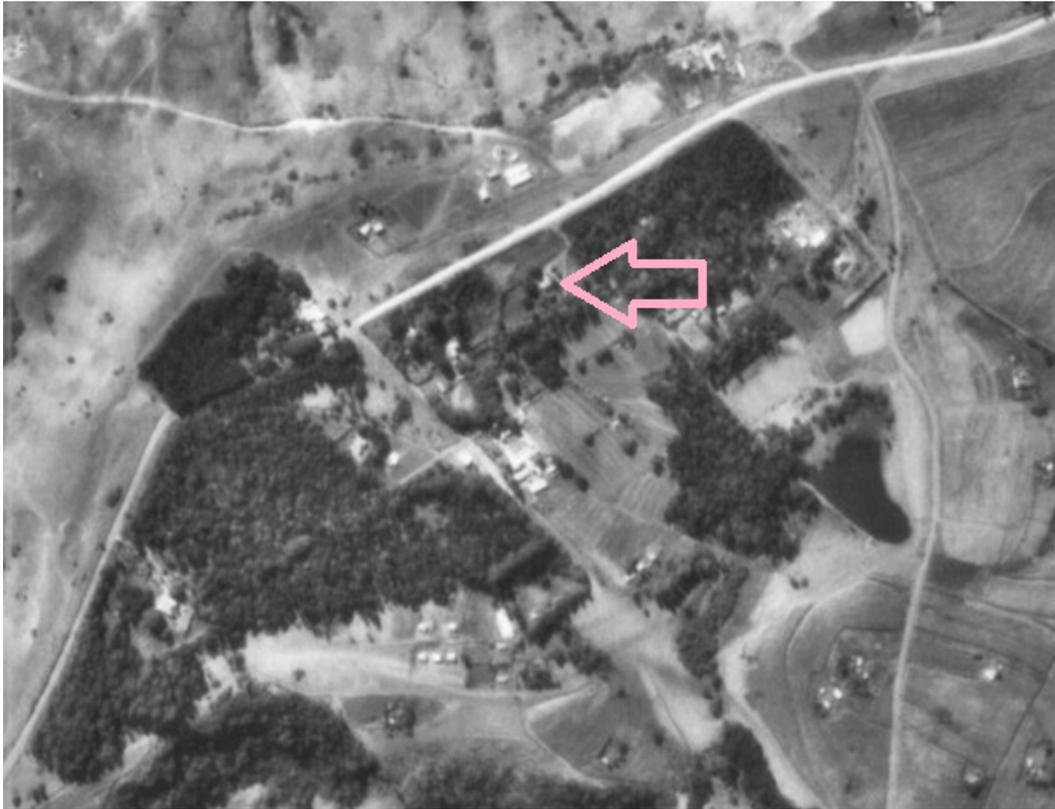
**Fig 8: 1978 aerial photograph showing the building clearly on the site – there is no evidence of another structure in front of it**

By 1978, much of the dense planting on the site has been removed, and the house is again evident, without a structure to the north of it (Figure 8). This suggests that the building has been demolished, willfully or through neglect, in the period between 1978 and 2016.
