**DUPLICATION OF THE VLAKFONTEIN (BENONI) – MAMELODI WATER SUPPLY PIPELINE WITHIN THE  
EXISTING SERVITUDE: R5 PHASE 2: FROM THE SOUTHERN BOUNDARY OF THE RIETVLEI NATURE RESERVE  
TO MAMELODI**

**ARCHAEOLOGICAL MITIGATION REPORT IN TERMS OF EIGHT LATE IRON AGE SITES**

Version 2.0

14 March 2014

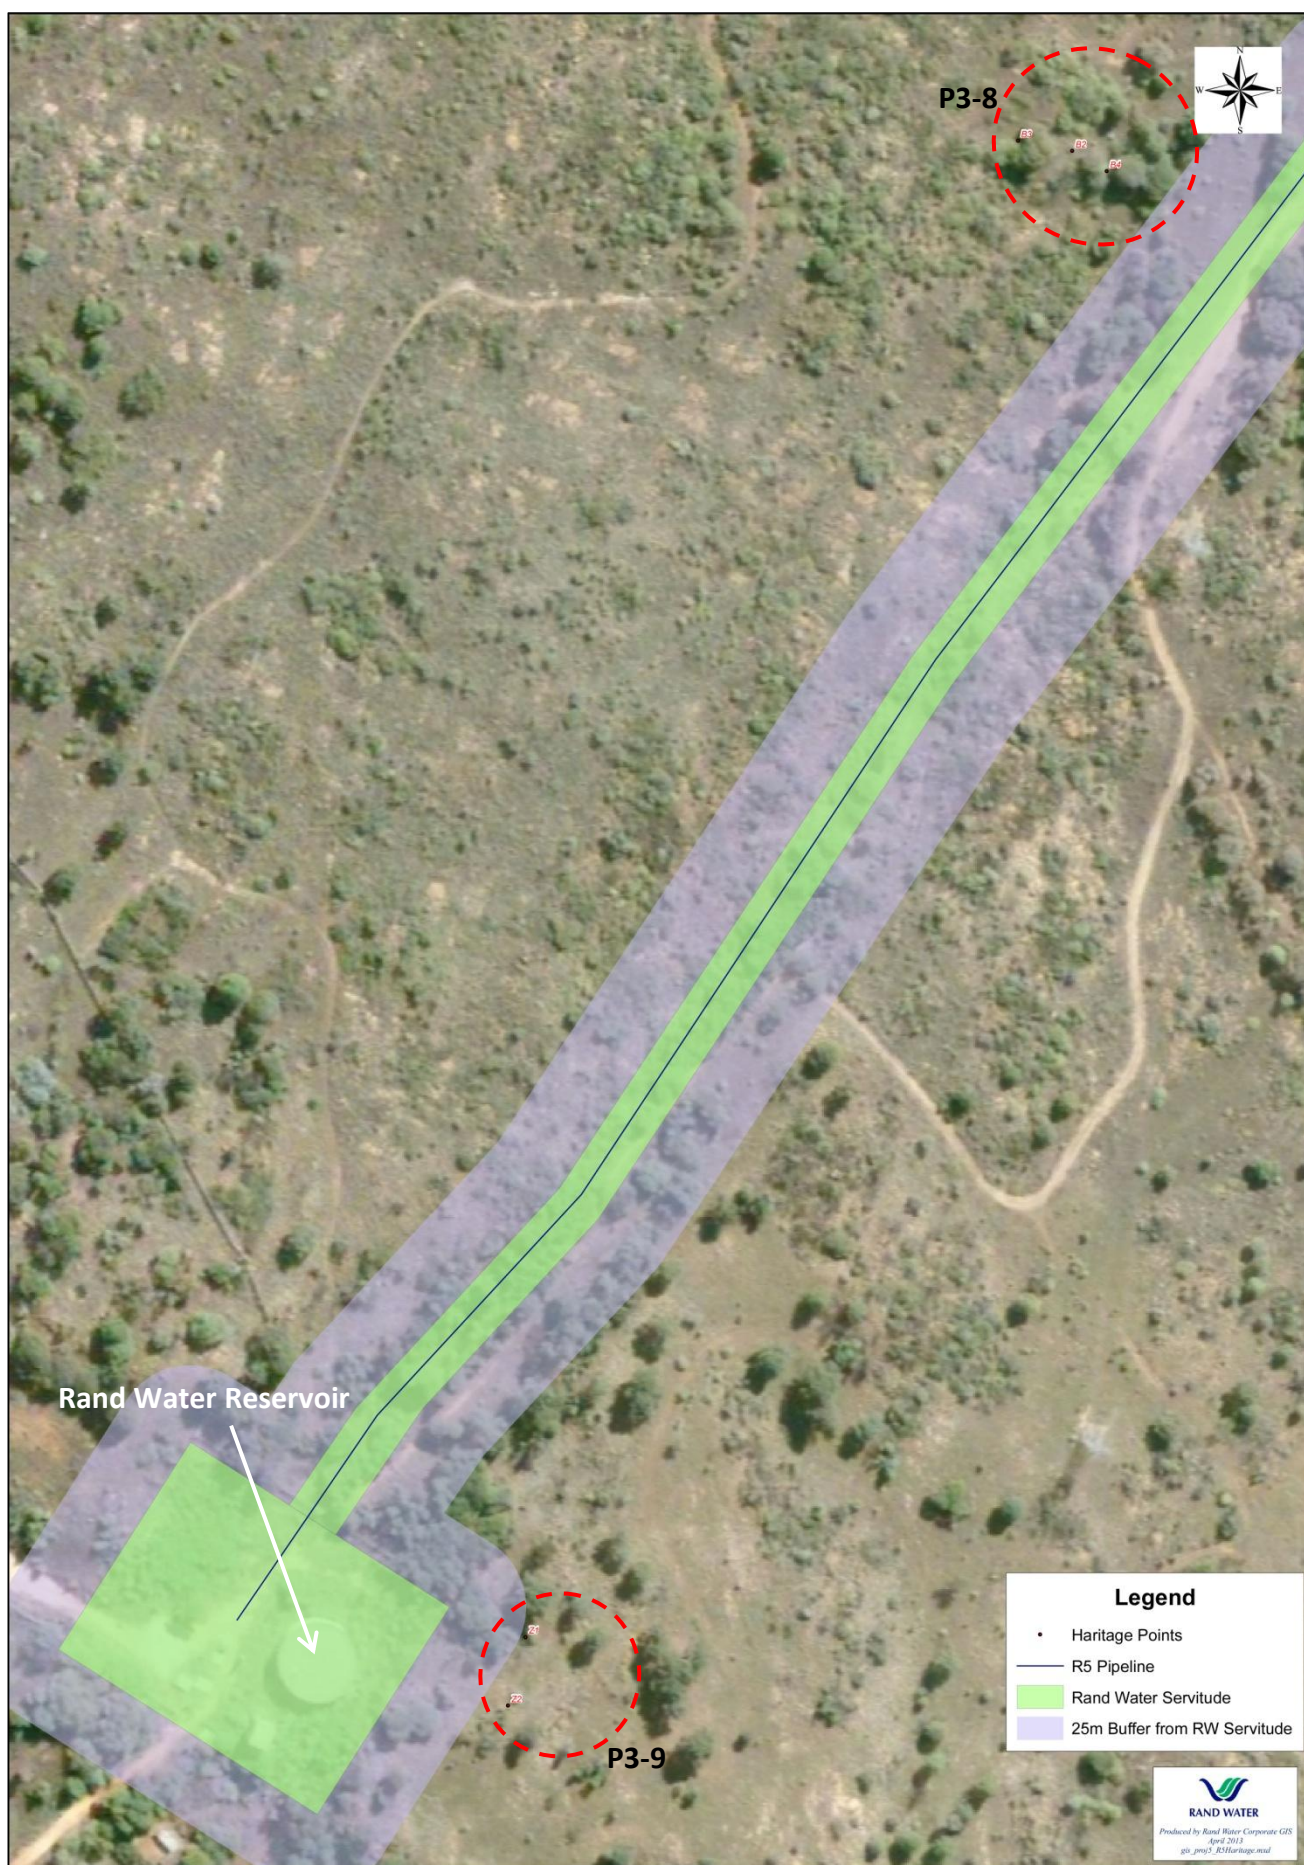
Figure 3 Site distribution map for the southern section of the proposed R5 Pipeline where sites were identified.
