**Heritage Impact Assessment and
Application for the demolition of
buildings at Girls & Boys Town
on 25 Tunny Avenue
Seatides, Tongaat
KwaZulu-Natal**

ERF 657

December 2019

MAYAT HART
ARCHITECTS

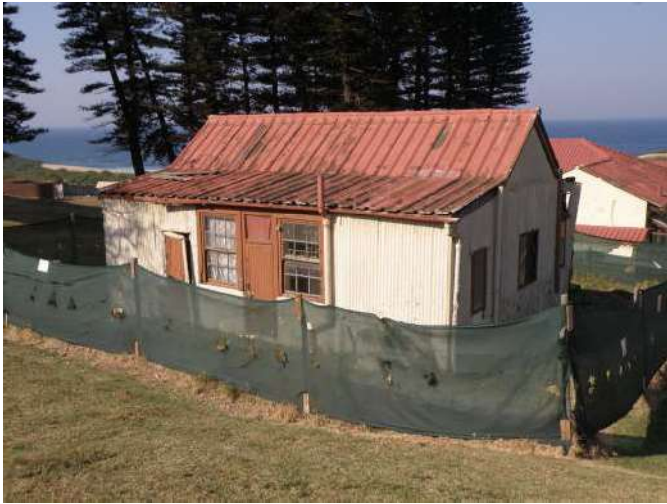
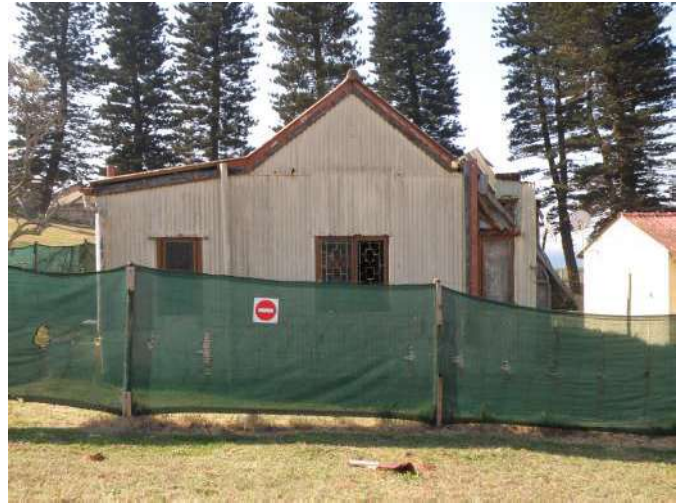
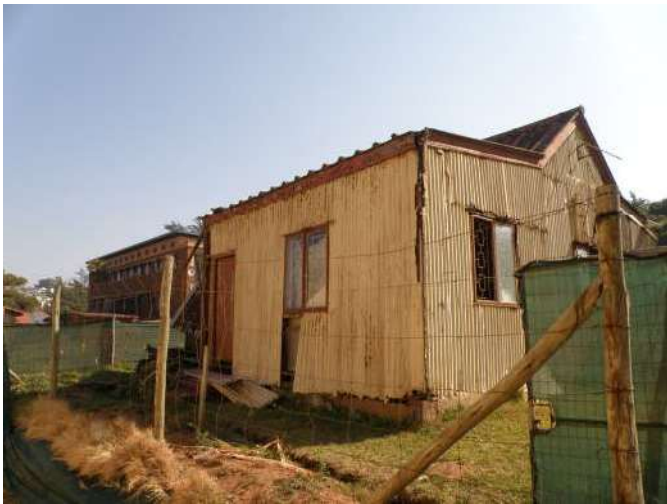
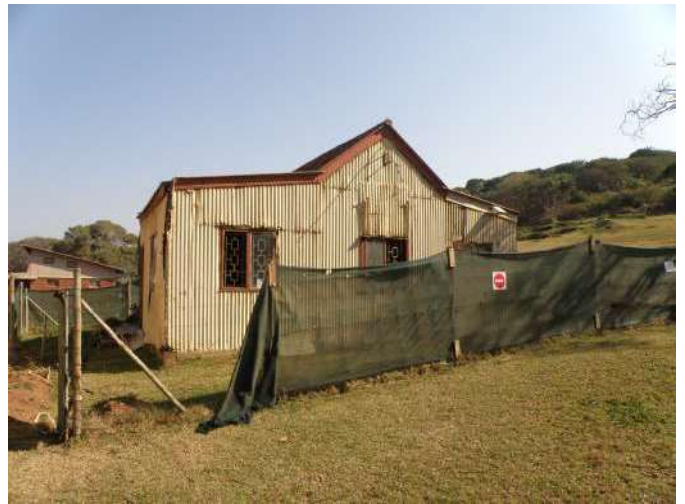
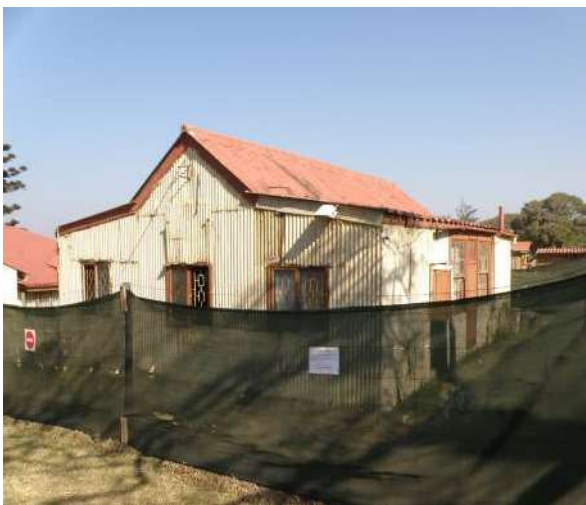
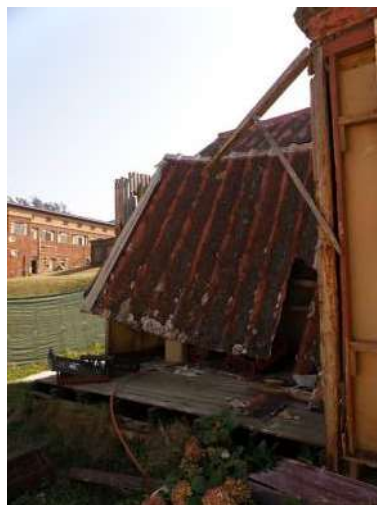
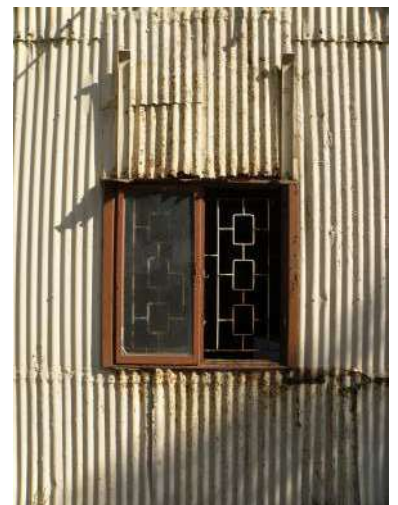
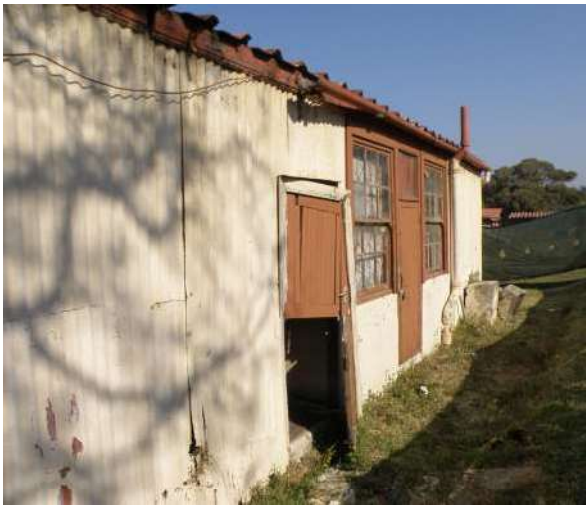
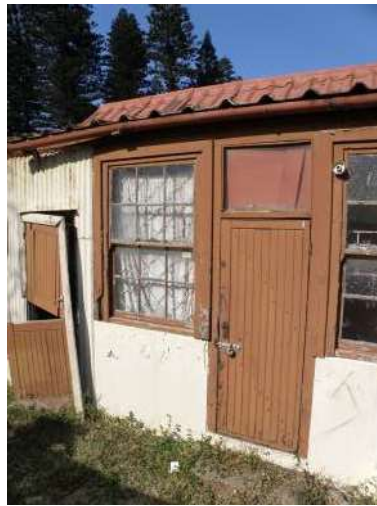
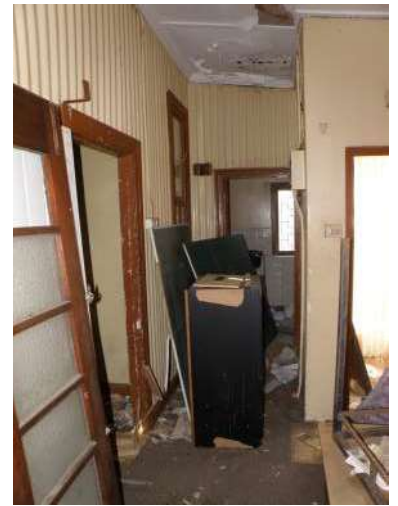
Figure 17: West Elevation

Figure 18: South Elevation

Figure 19: North East Elevation

Figure 20: North Elevation

Figure 21: North West Elevation

Figure 22: East facing lean to

Figure 23: Window detail

Figure 24: West Elevation

Figure 25: Door detail

Figure 26: Interior space

- Building 8
 - Date of Construction – Circa 1900 – 1920
 - Description – Wood and iron cottage
 - Condition Assessment
 - The building is in a very poor condition
 - A portion of the building has already collapsed
 - The building is uninhabitable
 - Engineers Report Summary
 - The building has no foundations
 - The corrugated iron walls are badly corroded
 - The timber framing is infested with borer
 - Internal drywalls are in a bad condition with rising damp
 - Engineers Recommendations
 - The building should be demolished subject to AMAFA approval
 - See appendix A for more detail

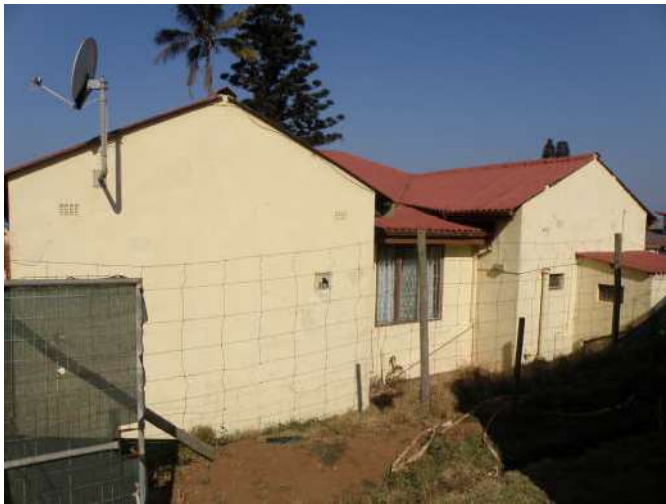
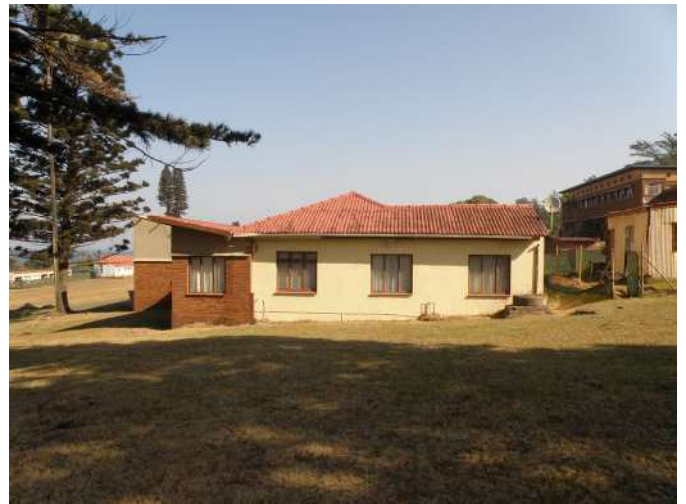
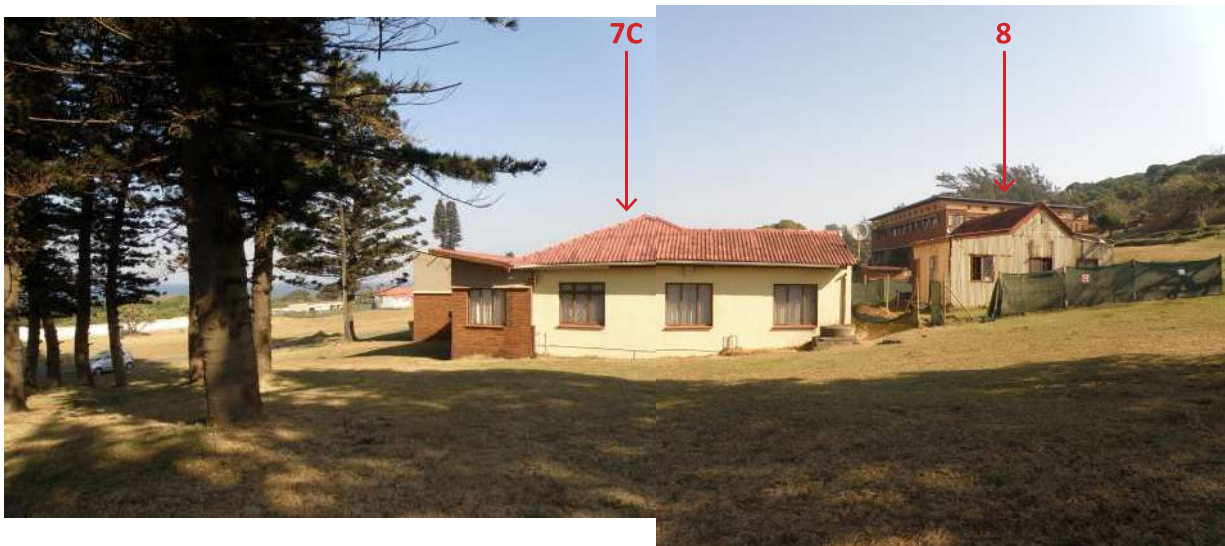
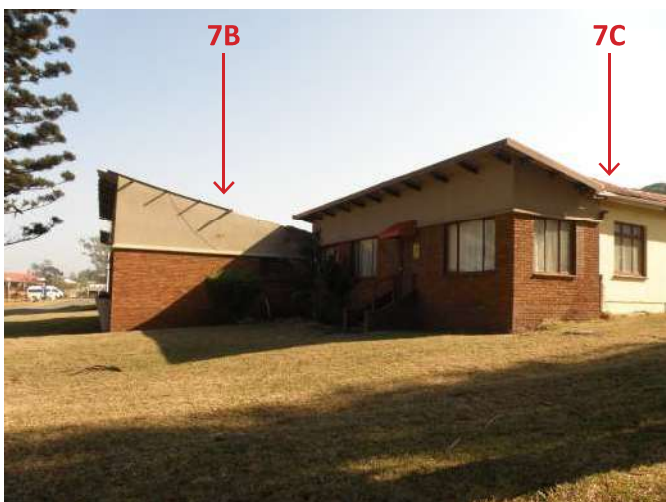
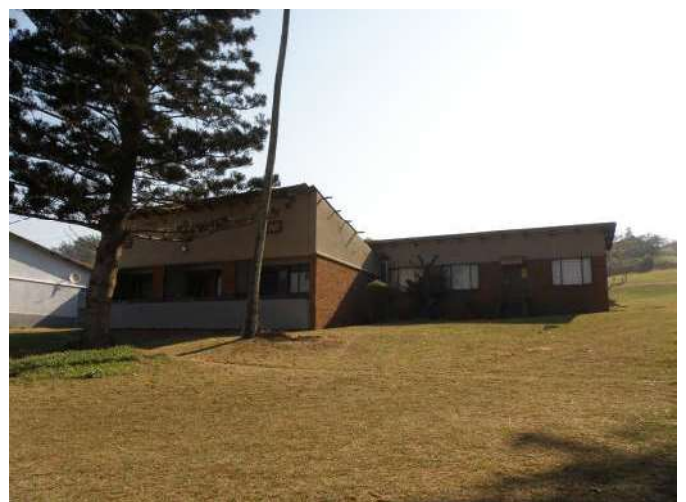
Figure 34: West Elevation

Figure 35: North Elevation

Figure 36: North Elevation

Figure 37: North Elevation

Figure 38: East Elevation

- Building 7C
 - Date of Construction – circa 1930
 - Description – 1930s house which has been integrated into the later 1950’s hostel development.
 - Condition Assessment
 - The building is in a fair condition
 - The building has been substantially altered.
 - Engineers Report Summary
 - Portions of the buildings foundations are inadequate and will need to be underpinned.
 - There is evidence of rotten roof timbers and roof borer.
 - The roof sheeting will need to be replaced.
 - Engineers Recommendations
 - The building will need substantial repair and renovation.
 - See appendix A for more detail

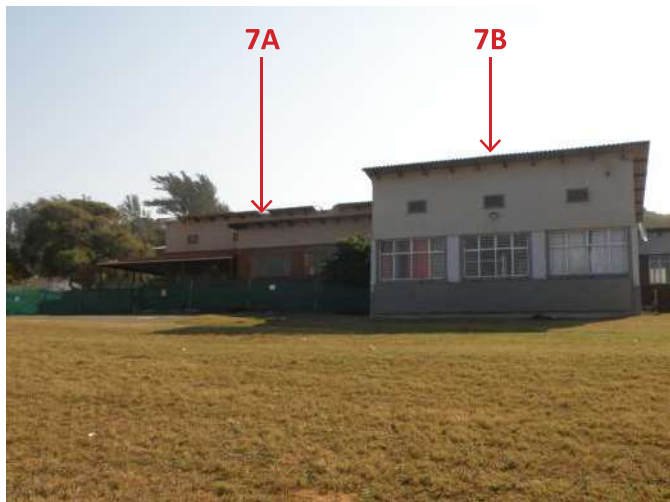
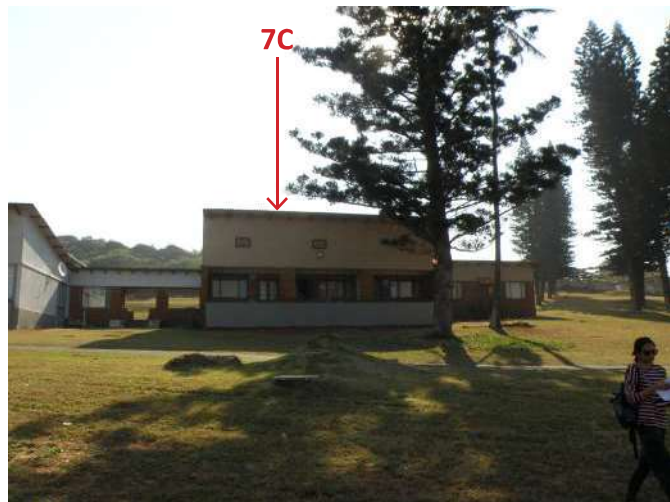
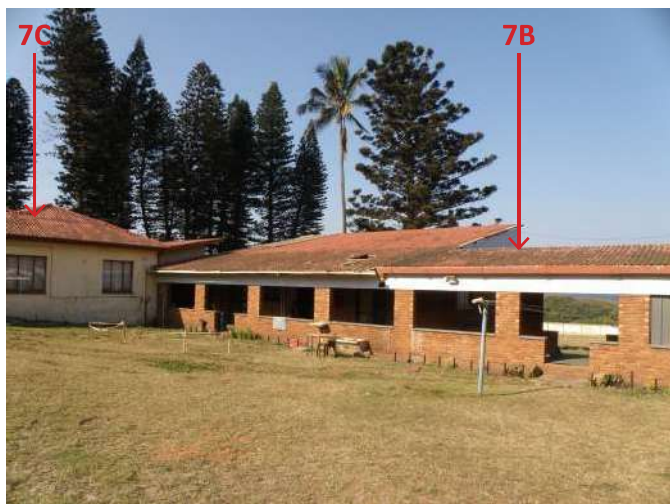
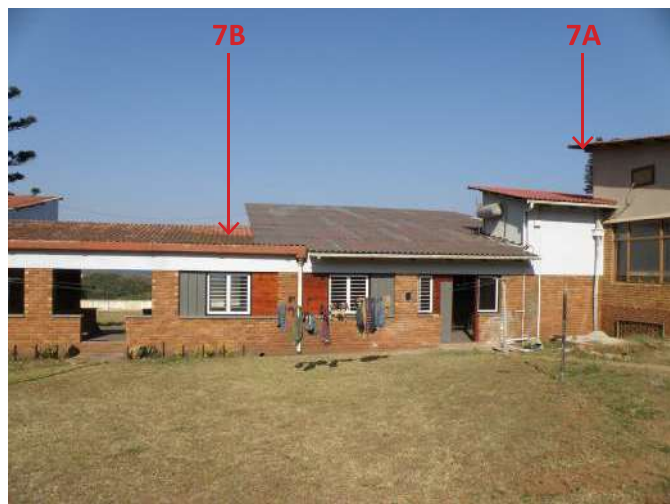
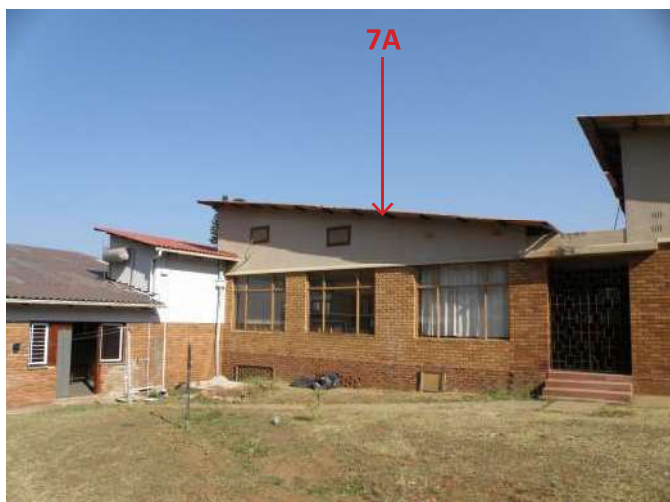
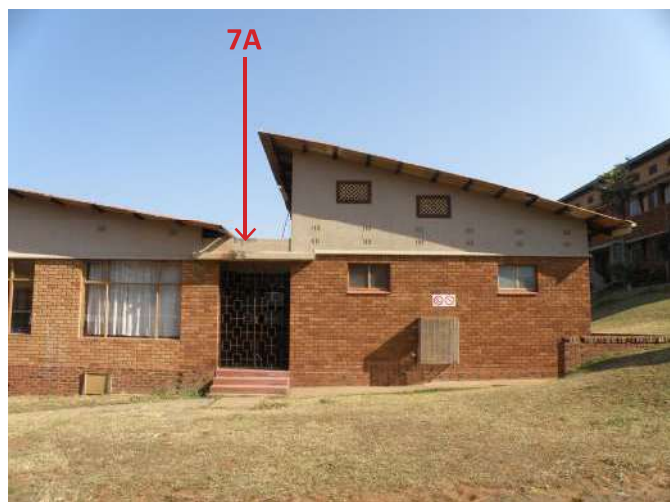
Figure 39: East Elevation

Figure 40: East Elevation

Figure 41: West Elevation

Figure 42: West Elevation

Figure 43: North Elevation

Figure 44: North Elevation

- Building 7A & 7B
 - Date of Construction – circa 1952
 - Description – 1950’s dining room and kitchen for the main hostel
 - Condition Assessment
 - A portion of the roof and ceiling has collapsed and the building uninhabitable.
 - The building shows structural issues including structural cracks, lifting surface beds etc.
 - Engineers Report Summary
 - Portions of the buildings foundations are inadequate and will need to be underpinned.
 - There is evidence of rotten roof timbers and roof borer.
 - The roof sheeting will need to be replaced.
 - Engineers Recommendations
 - The building will need substantial repair and renovation.
 - Note – a portion of the roof has collapsed subsequent to the engineer’s investigation and report.
 - See appendix A for more detail

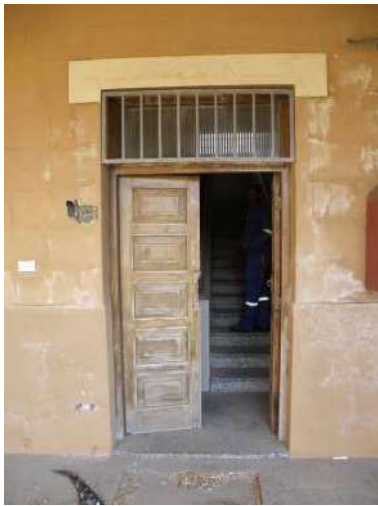
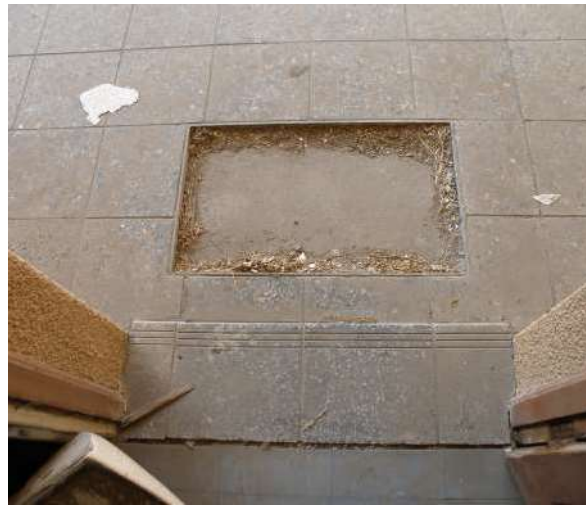
Figure 110 & 111 Door detail

- Building 13
 - Foundations are too shallow and undersized for the soil conditions which has led to cracking and settlement
 - No significant settlement is visible on the ground floor slabs
 - Significant cracking in external walls
 - Timber floor structure of the first floor is in a fair/moderate condition
 - Asbestos ceilings
 - Roof timbers are heavily infested and severely damaged. The entire roof structure needs to be replaced
 - Plumbing, tiling, doors and windows in a poor condition.
 - Recommendations – underpinning required

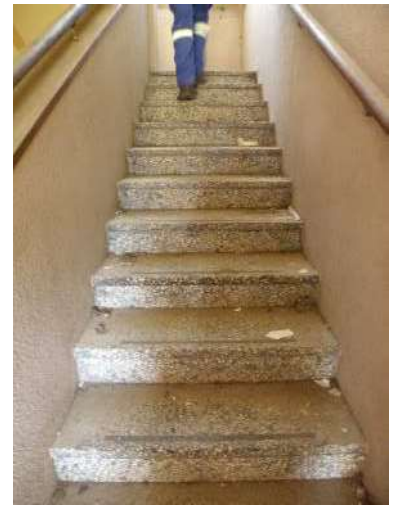
Figure 112: Stair detail

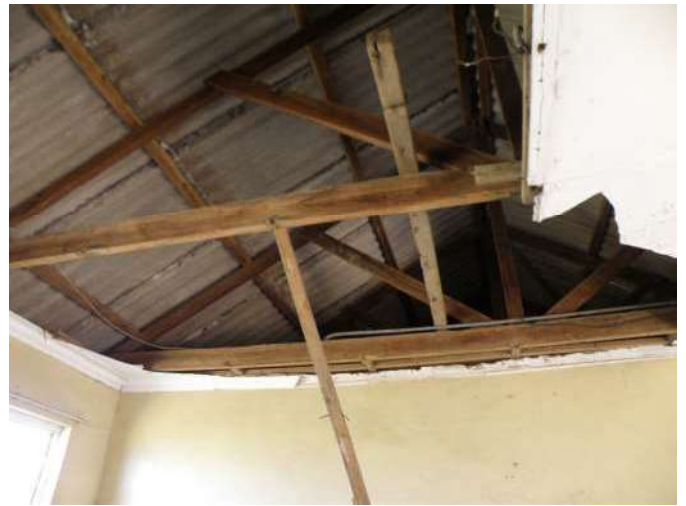
Figure 118: Ceiling damage

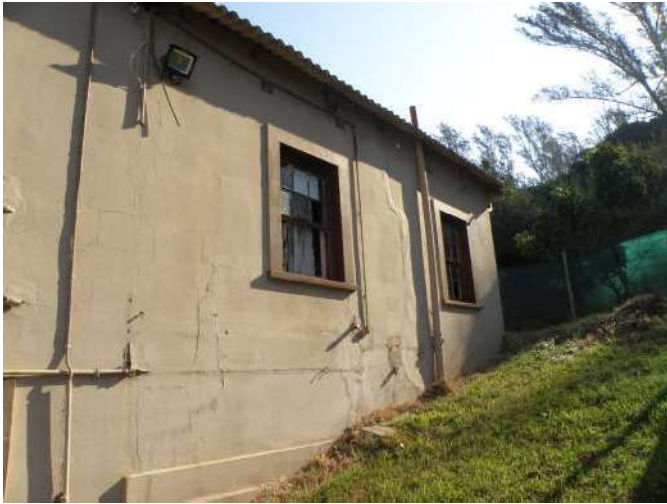
Figure 133: West Elevation

- 1: Former school building. It is unclear whether this is the original school for the Dunn Children or a later replacement building – circa 1910

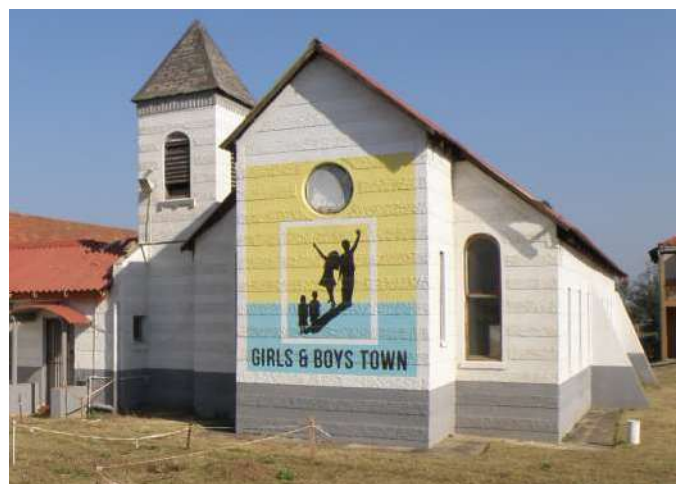
Figure 149

- The site was established as an outpost and holiday getaway for the Dominican Sisters as well as a school for the Dunn Children.
- The following buildings were developed:
 - 10A: Old Chapel – circa 1900

- Building 10A
 - Date of Construction circa 1900
 - Description – Old Chapel
 - Condition Assessment
 - The building shows structural cracking
 - The building is in need of repair and maintenance
 - The building retains some original architectural elements
 - Engineers Report Summary
 - The building has no foundations
 - The mortar in the joints is poor (probably lime) and easily raked out
 - Timber windows have evidence of dry rot and borer
 - Roof stability is directly related to the stability of the walls. While no visible there is most likely borer.
 - Engineers Recommendations
 - The building should be demolished with Amafa approval.
 - If the building is to be retained the foundations will need systematically under the existing walls.
 - See appendix A for more detail

- The report recommends the retention of the following buildings which were proposed to be demolished as shown in the diagram below:
 - 10A: Old Chapel – circa 1900

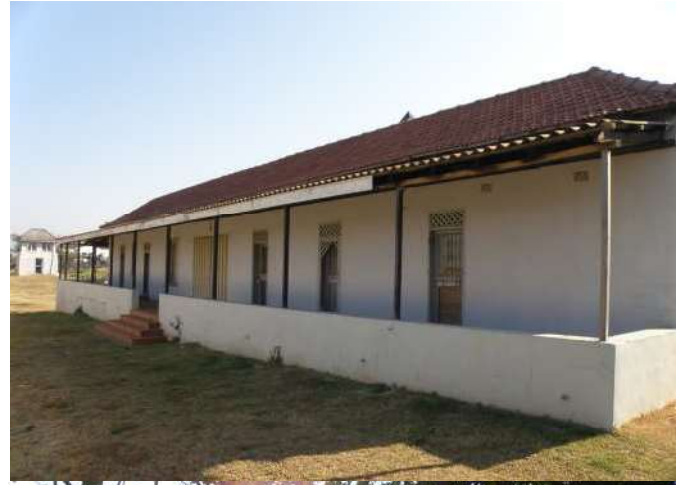
Figure 150

- 10B: Cells / accommodation for the Dominican sisters – circa 1900

- Building 10B
 - Date of Construction – circa 1900 with later additions
 - Description – Cells / accommodation for the Dominican sisters
 - Condition Assessment
 - The building shows structural cracking
 - The building is in need of repair and maintenance
 - The building retains some original architectural elements
 - Engineers Report Summary
 - The oldest portion of the building has no foundations. Later additions have adequate concrete footings.
 - The mortar in the joints is poor (probably lime) and easily raked out
 - Timber windows have evidence of dry rot and borer
 - Roof stability is directly related to the stability of the walls. While no visible there is most likely borer.
 - Engineers Recommendations
 - The building should be demolished

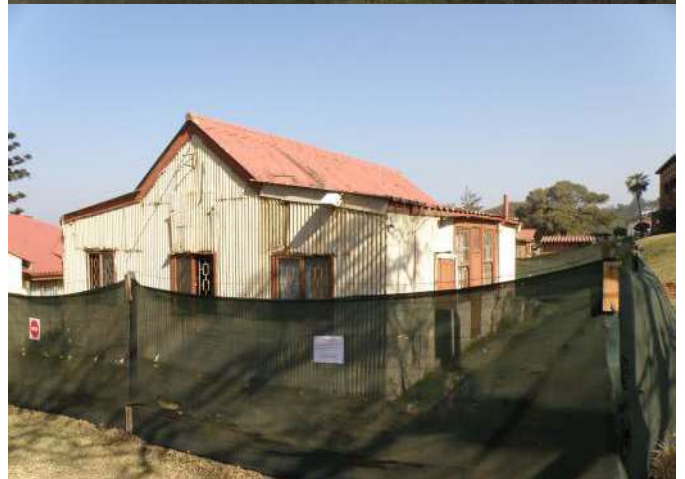
Figure 153

- 8: Wood and iron cottage – circa 1910

- The report agrees with the proposed demolition of the following buildings:
 - 8: Wood and iron cottage
 - The building is beyond repair and already collapsing.

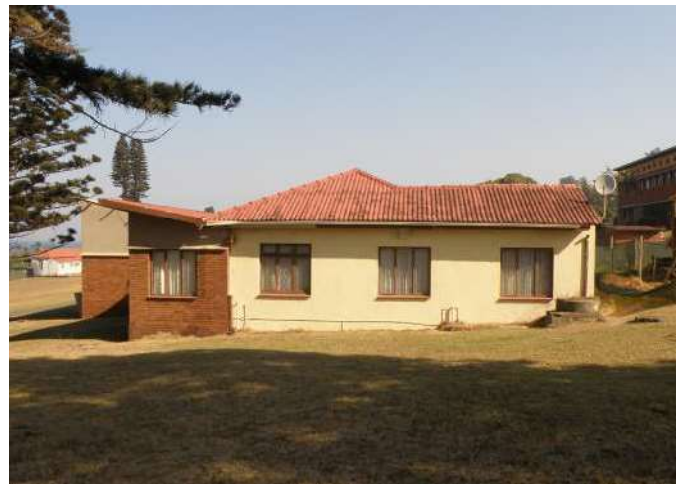
Figure 155

- 7C: Old House – circa 1930

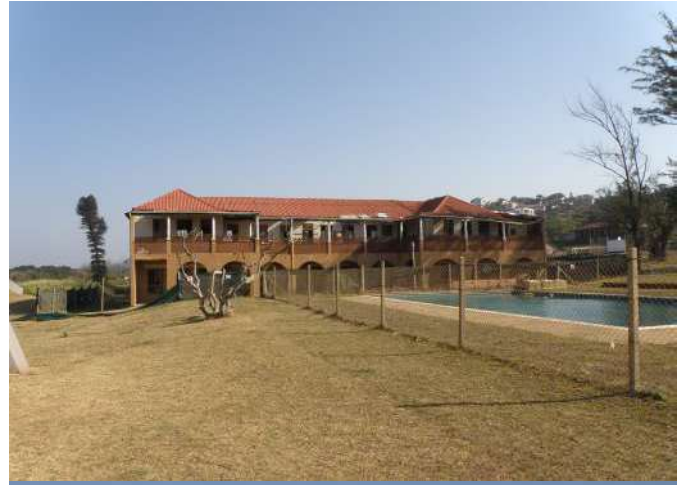
Figure 157

- 13: St Vincent's – Old school building. Built circa 1940. Reputedly built by Italian prisoners of war.

- The claim that the building was built by Italian prisoners of war has not been corroborated. This could be commemorated in other ways if required even if the building is demolished.

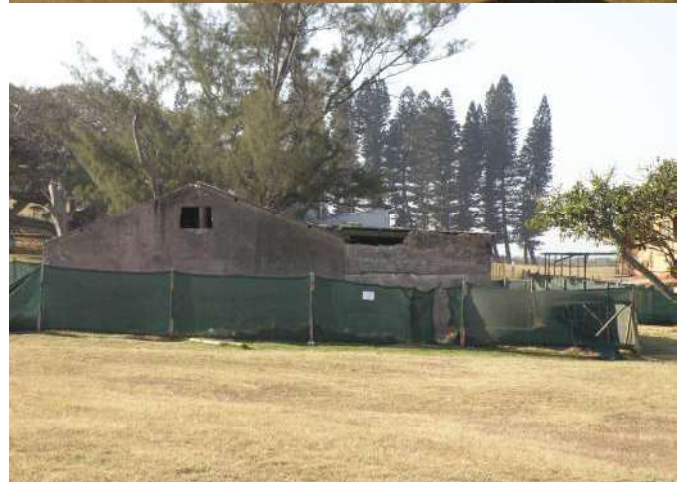
Figure 159

- 11: Former stable/piggery/dairy – circa 1930 – 1940

- Building 11
 - Date of Construction circa 1930 – 1940
 - Description – former stable/piggery/dairy
 - Condition Assessment
 - Poor condition
 - Engineers Report Summary
 - Foundations are inadequate
 - Walls have structural cracks
 - Roof structure is unstable
 - Engineers Recommendations
 - Building should be demolished subject to AMAFA approval
 - See appendix A for more detail

- 'Watch Tower'
 - The building is of low cultural significance
 - 11: Former stable/piggery/dairy
 - The building is in a poor structural condition.
 - The building is of low cultural significance

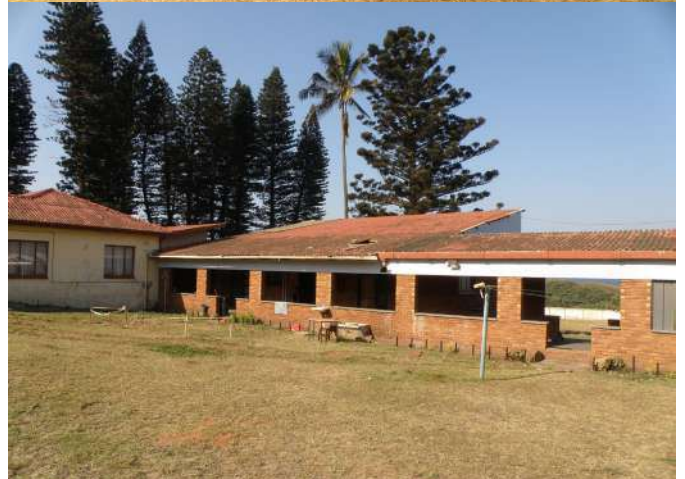
Figure 161

- 7B: Hostel – 1952

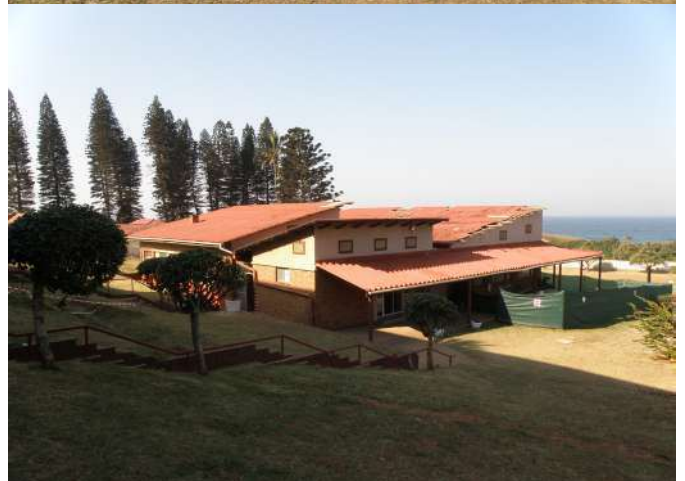
Figure 162

- 7A: Dining hall and kitchen – 1952

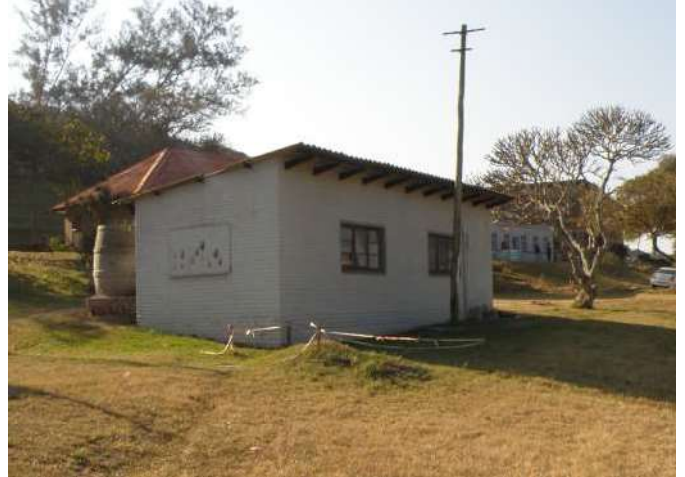
Figure 164

- 12: Garage/workshop - circa 1950

- Building 12
 - Date of Construction – circa 1950
 - Description – garage / workshop
 - Condition Assessment
 - The building is in a fair usable condition
 - It is in need of maintenance
 - Engineers Report Summary
 - The building is structurally sound
 - The roof shows signs of borer and needs to be replaced
 - Engineers Recommendations
 - Substantial repair and maintenance
 - See appendix A for more detail

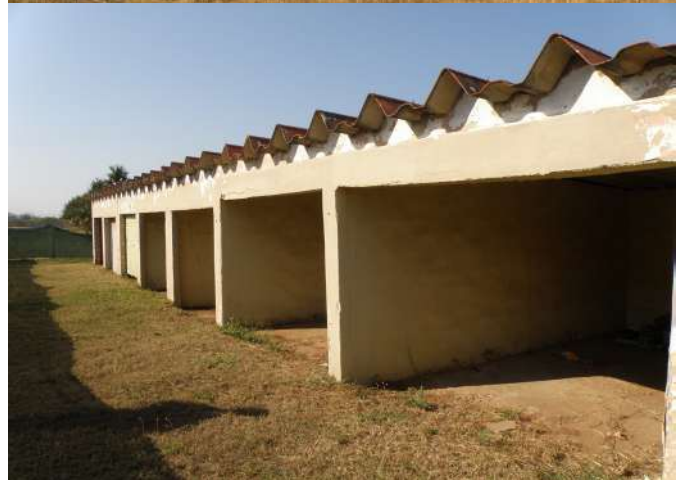
Figure 165

- 9: Garages – circa 1960

- If the building is to be retained the foundations will need to be underpinned.
 - See appendix A for more detail
- Building 9
 - Date of Construction – circa 1960
 - Description – circa 1960
 - Condition Assessment
 - Signs of structural cracking
 - Poor maintenance
 - Engineers Report Summary
 - The building has inadequately sized foundations
 - Screed floors are badly cracked
 - Concrete is spalling
 - Asbestos roof sheets are cracked. Sheeting profile is no longer available
 - Walls are badly cracked
 - Engineers Recommendations
 - The building should be demolished
 - See appendix A for more detail

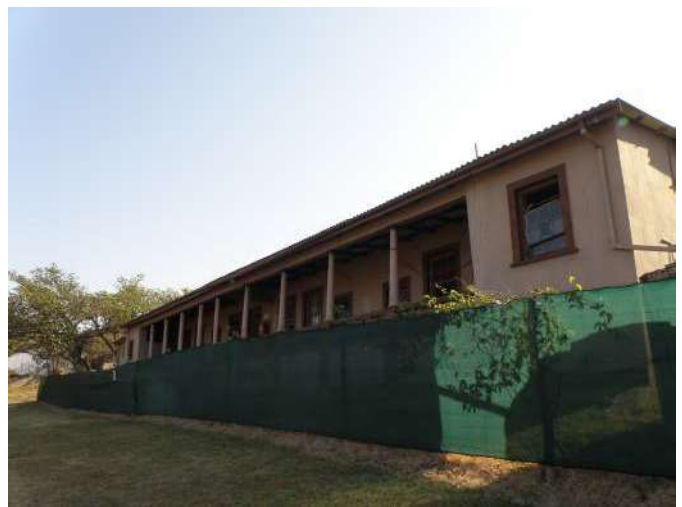
Figure 177: Building 1- Former School Building

- Building 1
 - Date of Construction – circa 1910
 - Description – former school building.
 - Condition Assessment
 - The building is in need of maintenance
 - The building has some original features that have been retained
 - There is evidence of structural cracking
 - Engineers Report Summary
 - Foundations are too shallow
 - Structural cracking
 - Doors windows and roof structure have rot and borer
 - Engineers Recommendations
 - The extent and cost of repairs and replacement required to make this building safely habitable is significant and the cost may not be warranted.
 - Underpinning is required if the building is to be retained.
 - See appendix A for more detail

- 1: former school building.
 - This building relates to the early history of the site as a school for the Dunn Children, the history of John Dunn, the history of the colonisation of Kwa Zulu Natal and the history of the Catholic Church in Natal.
