## Environmental Authorisation for the KPSX: South Project

### Heritage Impact Assessment

BHP1591

November 2014

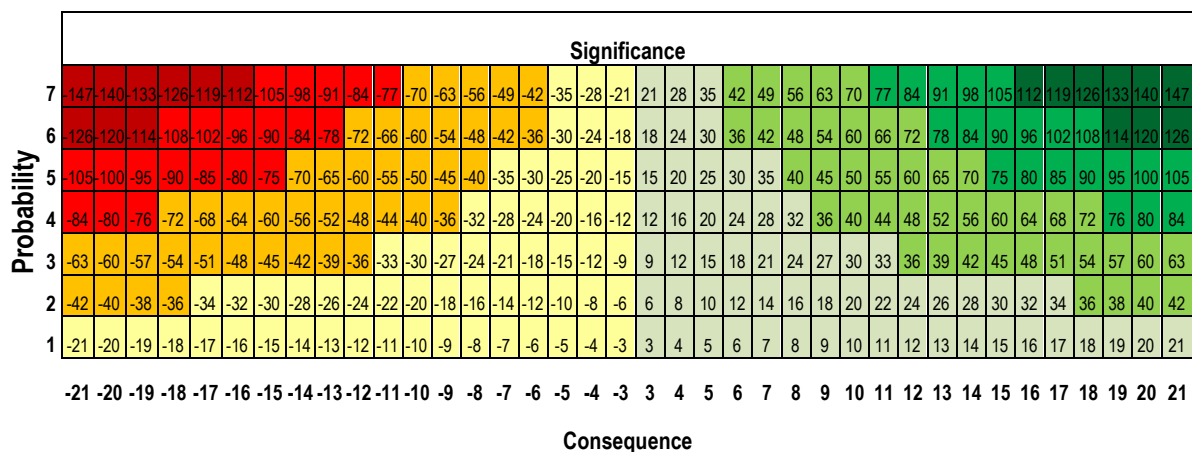
Impacts are rated prior to mitigation and again after consideration of the proposed mitigation measures. The impact is then determined and categorised into one of eight categories, as indicated in Table 3-12 and Table 3-13 below. The relationship between the consequence, probability and significance ratings is graphically depicted in Figure 3-1 below.

**Figure 3-1: Relationship between consequence, probability and significance ratings**

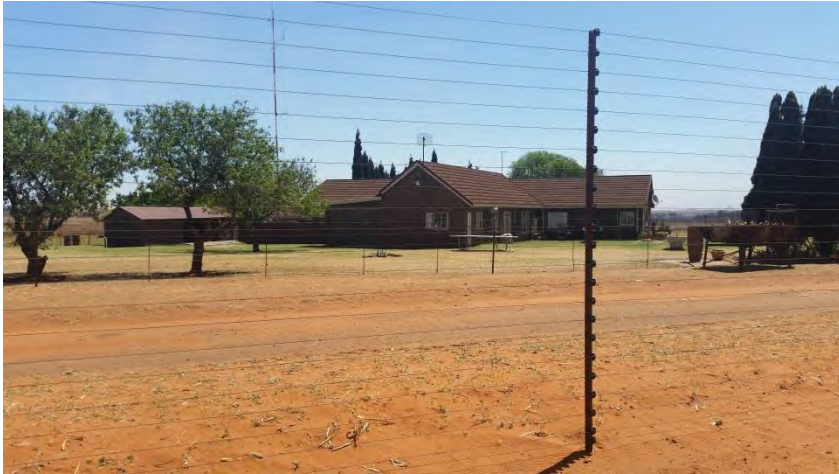
Figure 4-1: House at S.34-001. Modern house within farmstead

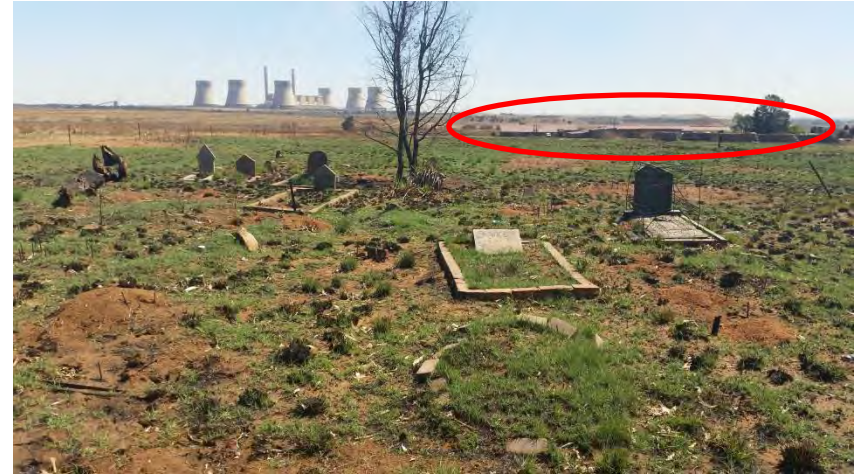
Figure 4-3: Burial ground S.36-002. Farmstead in background

The burial ground S.36-002 is located on the southern portion of the project area in close proximity to the boundary. It is recommended that the project boundary be adjusted as far as is feasible to exclude the burial ground.

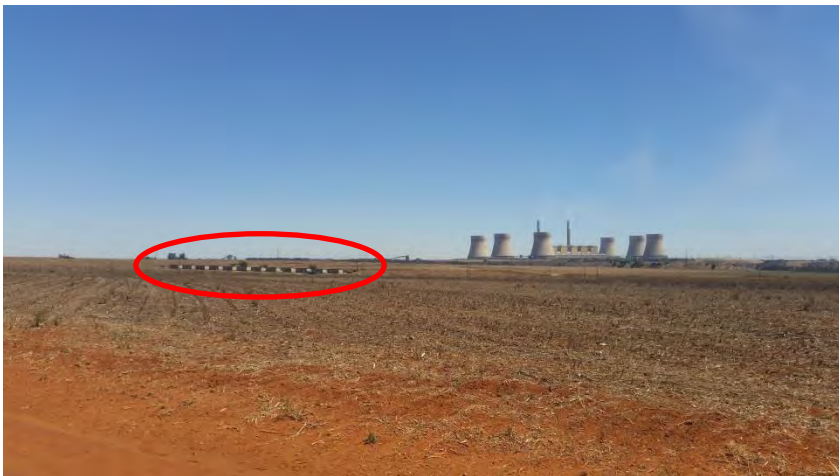
Figure 4-2: Labourer accommodation associated with farmstead

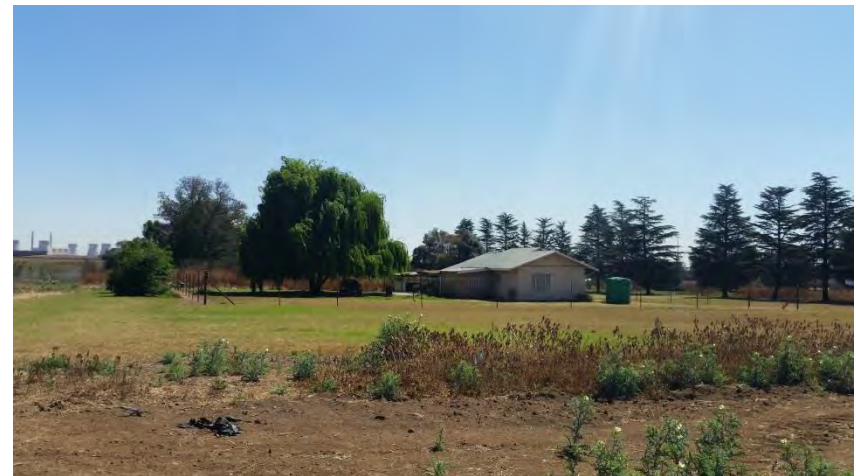
Figure 4-4: S.34-003 Modern prefab house
