# **HERITAGE IMPACT ASSESSMENT: PROPOSED KENHARDT PHOTO-VOLTAIC SOLAR POWER PLANT ON REMAINDER OF THE FARM KLEIN ZWART BAST 188, NORTHERN CAPE PROVINCE**

(Assessment conducted under Section 38 (8) of the  
National Heritage Resources Act 25 of 1999)

April 2012

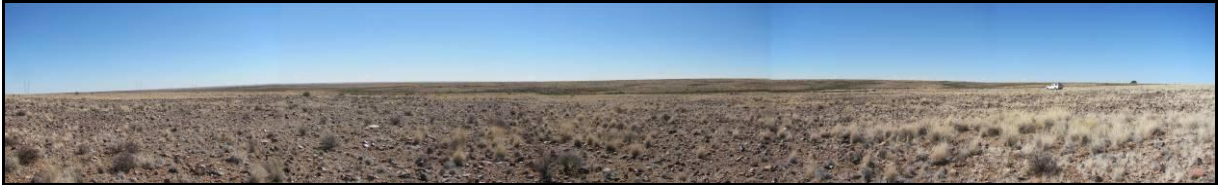
**Plate 1:** View of the landscape.

There were no significant physical limitations encountered when undertaking the field study and surface visibility was excellent. Although there are few roads across the property, the low shrub and the level topography meant that were able to access all areas of the proposed facility (Figure 4; Plate 1).

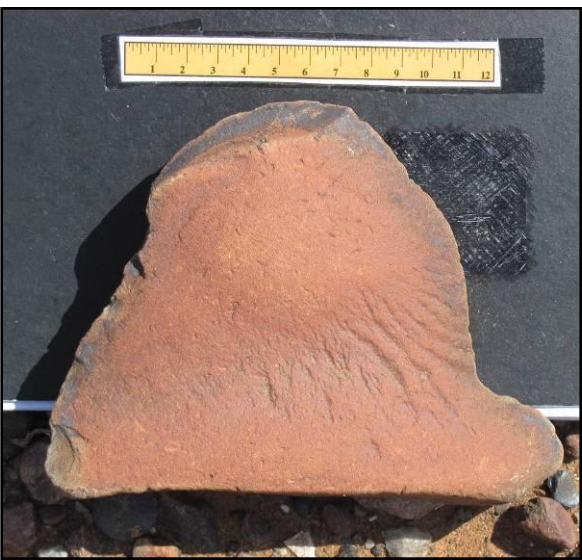
**Plate 4:** Large weathered handaxe; **Plate 5:** Large weathered flake (scale in centimetres).

A number of large implements were recovered which resembled classic bifaces (ESA). They are very weathered and occur in isolation (Plate 4). They are made on very weathered hornfels and while occasional flakes and cores may occur, there is no evidence of ESA knapping sites.

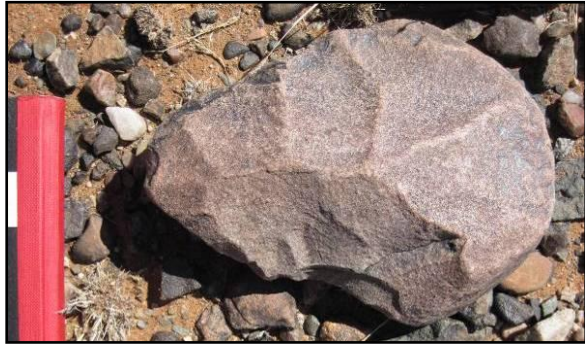
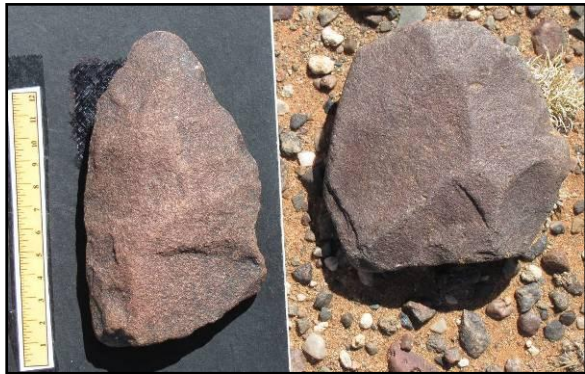
**Plate 6:** Weathered flake; **Plate 7:** Handaxe on quartzite; **Plate 8:** Weathered flake and core.

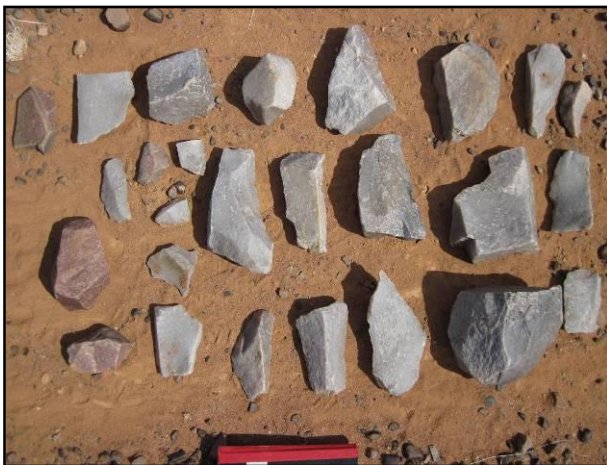
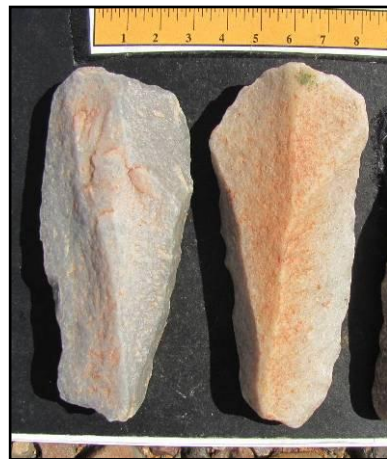
**Plate 9:** Characteristic collection of grey quartzite cores, chunks and flakes with few diagnostic elements. **Plate 10:** Typical triangular MSA flakes with convergent flake scars on the dorsal surface.

Most of the material we observed can probably be ascribed to the Middle Stone Age (MSA) (Plates 10, 11). Flakes, blades, chunks and cores make up the majority of the scatters, and retouch was present on some items. The most predominant raw material was pale grey/white quartzite, although red quartzite, banded ironstone, quartz and agate lumps were also recorded.

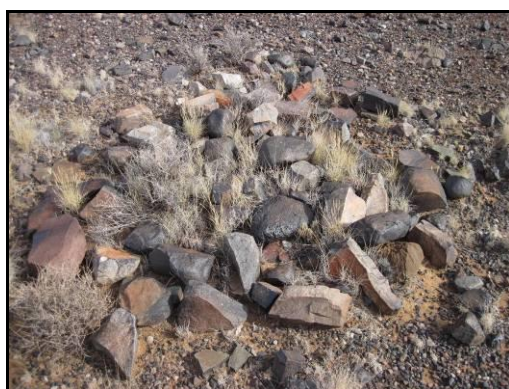
**Plate 17:** A few stone cairns were recorded in the study area.

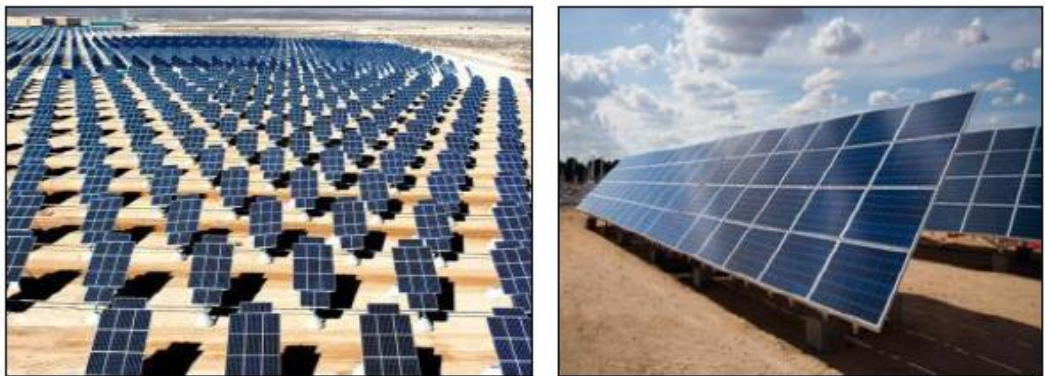
The solar PV panels will be mounted into metal frames (Figure 2) which are anchored to the ground with either concrete or screw pile foundations. These footings will be either hammered into the earth or anchored in a 1.5 m deep concrete foundation.

**Figure 2. Example of a Solar PV installation (supplied by Digby Wells).**

The solar PV panels will be mounted on metal frames (Figure 2) which are anchored to the ground with either concrete or screw pile foundations. These footings will be either hammered into the earth or anchored in a 1.5 m deep concrete foundation.

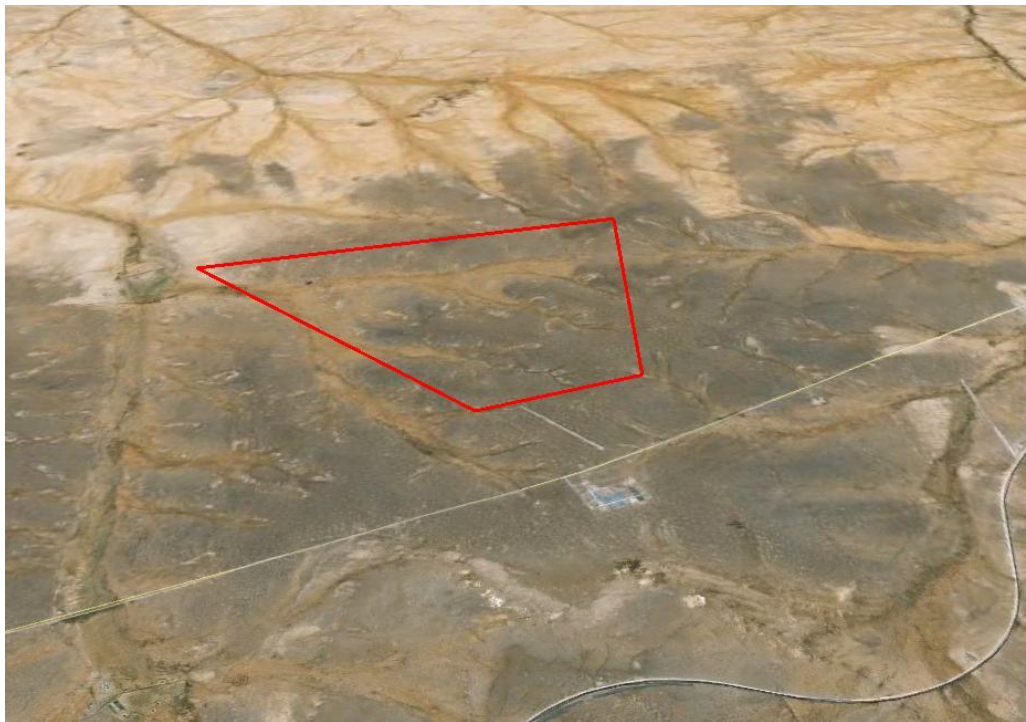
**Figure 3. Simulated oblique view of the project area, looking north. From Google Earth.**

The project area is situated on a gently sloping sandy plain (Figure 3) between ~900 m asl. in the northwest, rising to ~950 m asl. in the southeast. Ephemeral drainage lines extend northwest from the higher ground and are delineated by lighter-hued alluvium. This contrasts with the darker-hued, stony material exposed on the interfluves.

The dark hue of the stony surface of the project area (Figure 3) contrasts with the lighter hues of the surficial cover formed on the gneisses to the north. Quaternary sand cover is minimal and the thin stony soil has evidently mainly formed by the weathering of the conglomeratic Dwyka diamictites.

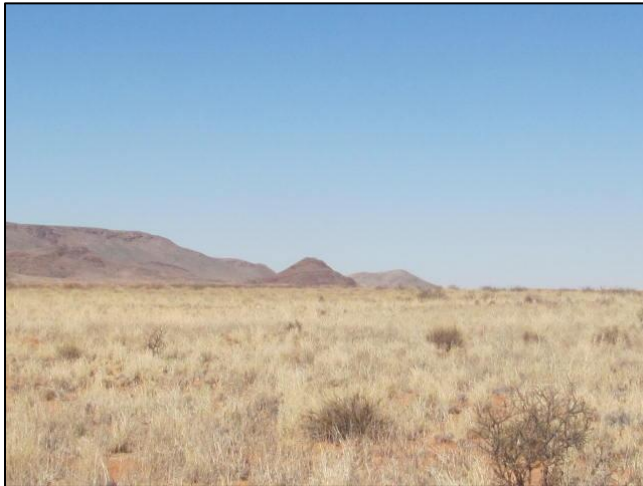
The Aggeneys study area is south facing and fairly flat, but is bordered by steep outcrops in the northern part. The study area falls within the Nama Karoo. The landscape and flora of the site and its surrounds are therefore typical of a dry climate. The area is sandy and rocky and is covered by low-lying vegetation (Figure 1). A drainage line, which spans approximately 50m in width, runs in a south-westerly direction through the study area.

**Figure 1: Aggeneys landscape, vegetation and topography**

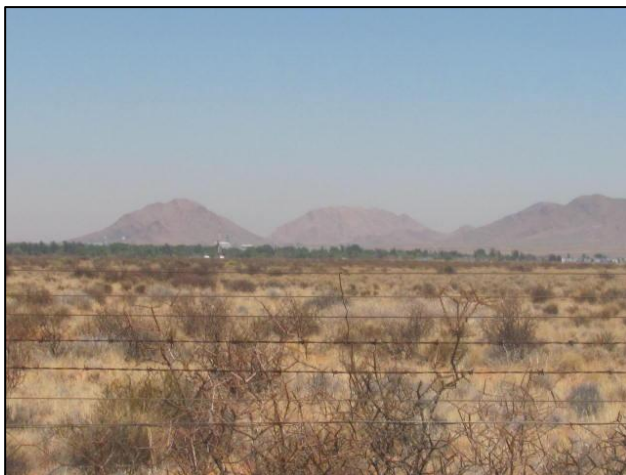
The mining town of Aggeneys is located approximately 5 km from the study area and is therefore just visible from the northern border of the study area. The N14 is the most prominent man-made feature in the area and cuts through the study area in an east-west direction. Fences, a telecommunications tower, transmission lines and a picnic site on the side of the national road are the only notable man-made features. There are very few potential visual receptors in and around the area that will experience a visual impact from the project and there is already a mining operation taking place just outside the town; the aesthetic value and sense of place of the area as a whole has, therefore, already been somewhat altered from a pristine to a somewhat transformed landscape.

**Figure 2: Fence lines on the north westerly boundary of the site - Aggeneys town just visible**

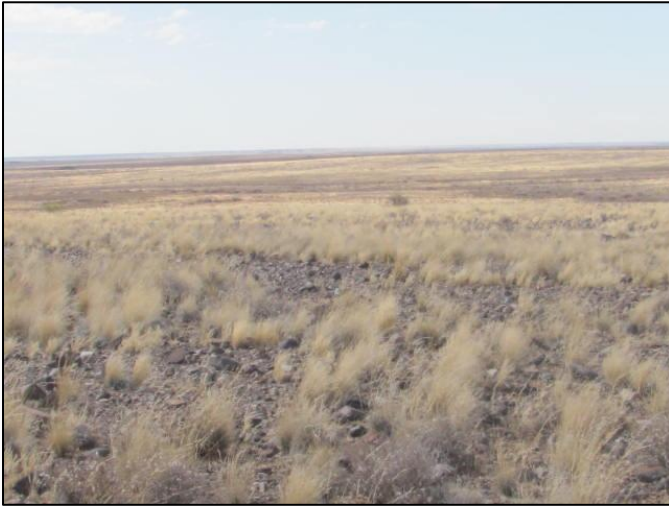
The Kenhardt study area is flat and north-easterly facing,. The study area falls within the Nama Karoo Biome and the vegetation composition is a result of a dry and hot climate. The landscape in and around the Kenhardt study area is mildly undulating (Figure 3). There are two main drainage lines within the study area.

**Figure 3: Kenhardt landscape, vegetation and topography**

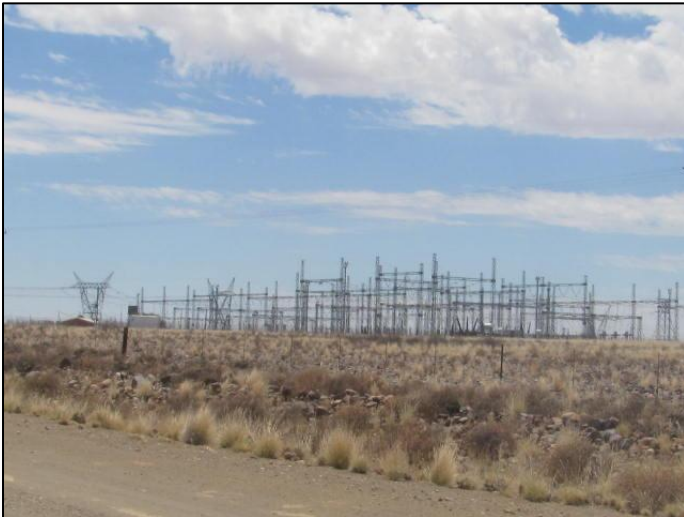
**Figure 4: Aries substation 1 km south of the study area**

The Kenhardt study area is approximately 38 km away from the town of Kenhardt. In terms of man-made structures, there is a large Eskom substation about 1 km south of the study area, on the other side of a gravel road (Figure 4). The study area is surrounded by fences and two overhead transmission lines pass through the site to connect with the substation. Besides from the farmers that utilise the gravel road, it is expected that very few receptors will experience a visual impact from the proposed Solar PV Power Plant. The aesthetic value of the site and the surrounding areas is affected by presence of the substation and transmission lines.

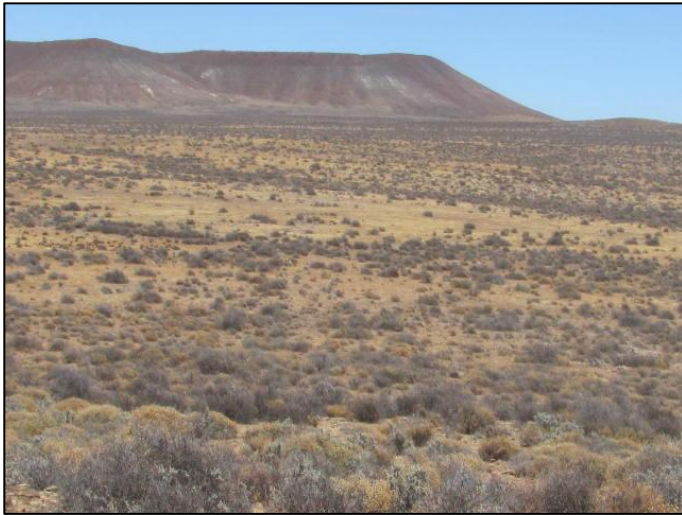
The Loeriesfontein study area is positioned on the farm Kleine Rooiberg, after the name is representative of the landscape which displays outcropping areas that are reddish in colour and dominate the west and north of the study area (Figure 5). The study area itself is flat and slightly east-facing. The Loeriesfontein study area falls within the Succulent Karoo biome. The landscape is dominated by vegetation that is comprised of low-lying shrubs and succulents and rocky areas. A number of drainage lines that vary in size are evident throughout the study area of which the largest of the drainage lines is approximately 50 m wide

**Figure 5: Landscape, vegetation and topography at Loeriesfontein study area**

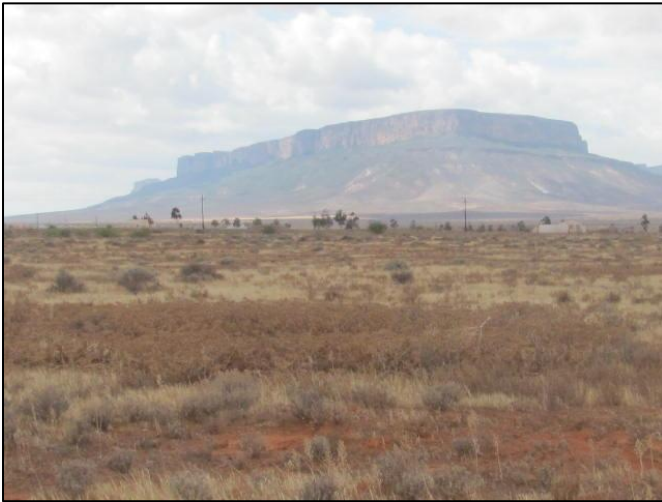
The Vanrhynsdorp study area is flat to mildly sloping. The majority of the study area is north facing as the area forms a hill with the highest point approximately 1 third to the south. The study area is covered by low-lying grassy vegetation. The study area falls within the Succulent Karoo. The town of Vanrhynsdorp borders the site to the south and the large Matzikamma Mountain is visible on the other side of the town (Figure 6).

**Figure 6: Topography, landscape and vegetation of Vanrhynsdorp study area in the fore-ground and Matzikkma Mountain in the background**

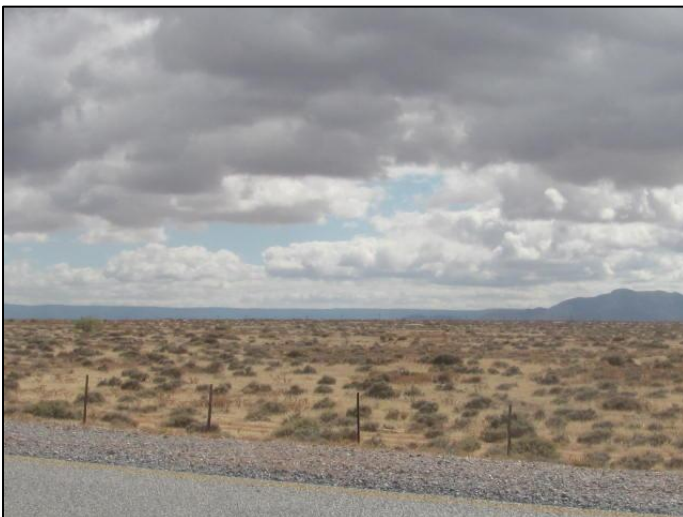
Since the study area is very close to the town itself, houses on the periphery of the town are visible from the study area and vice versa. The study area is surrounded by fences and the N7 national road runs along its western boundary (Figure 7). Due to the position of the study area from the town and the national road, there will be many visual receptors that will be impacted upon by the proposed Solar PV Power Plant.

**Figure 7: View of Vanrhynsdorp study area from the N7**

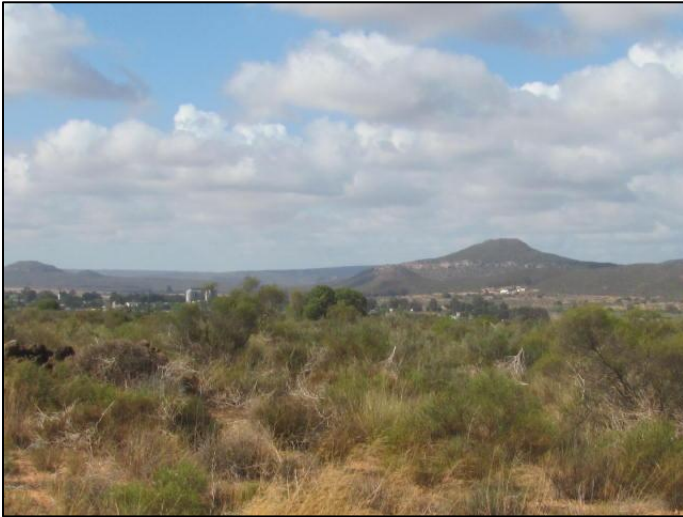
The Graafwater study area falls within the Fynbos Biome. The vegetation type that covers the study area is that of Sand Plain Fynbos and the Fynbos species on and around the study area grow up to 2 m high. Although the study area itself is fairly flat and is north facing, the topography of the general landscape of the area is much more mountainous (Figure 8).

**Figure 8: Graafwater study area vegetation, landscape and topography with Graafwater town in the background**
