**ARCHAEOLOGICAL IMPACT ASSESSMENT  
OF A PROPOSED BORROW PIT  
ON BUFFELSFONTEIN 250, NEAR VLEESBAAI,  
EDEN DISTRICT, WESTERN CAPE**

(Assessment conducted under Section 38 (8) of the National Heritage Resources Act as part  
of a Heritage Impact Assessment)

## **5.2 Borrow pit MR0336/6.5/0.05R (Vidamemoria pit no. 196):**

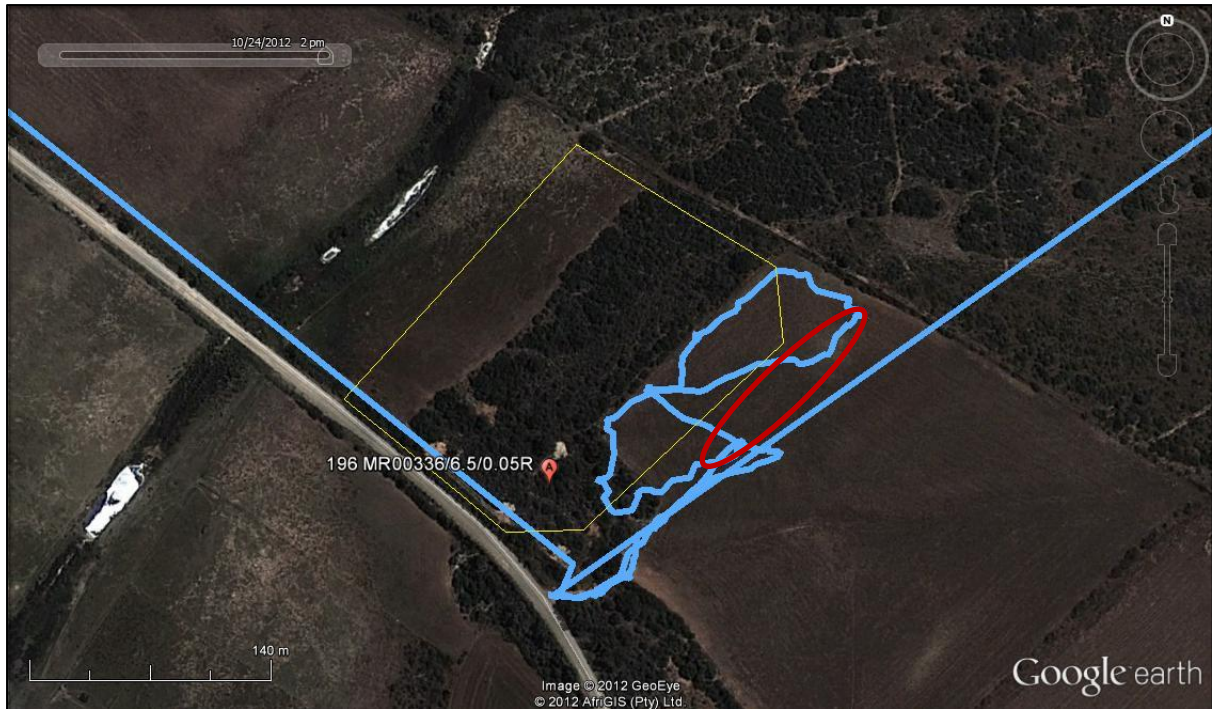
Figure 2: Google earth image showing the proposed borrow pit MR0336/6.5/0.05R (Vidamemoria pit no. 196), the polygon (in yellow) and the tracks of the field survey. The red ellipse indicates the area where most of the stone artefacts were observed. The presence of ostriches and the dense vegetation limited the extent of the field survey. Please note that the straight blue lines do not indicate survey tracks.

The presence of five ostriches in the lower two thirds of the polygon limited the survey to the upper third, where an area outside the polygon was also examined. Although most of the previously-disturbed agricultural terrain was covered by grass, herbs and a few low bushes, it was possible to see the calcrete nodules, clasts, pebbles and cobbles of the gravels, as well as any archaeological material (Figures 4, 5, 7 and 8). Most of the rocks were not flaked but some 20 quartzite artefacts were observed (Figures 9 to 13). The majority of these were observed as isolated specimens or very low density clusters of artefacts in the gravels outside the affected area, on or close to the crest of the hill which may be the remains of pediment gravels of the ancient Gouritz River system associated with an old land surface (Figures 2, 3, 5 and 8). The few artefacts seen lower down the slope probably drifted down from the top.

Given that most of the sparse archaeological material observed probably derived from the disturbed gravels of the pediment surface on the crest of the hill outside the polygon, it is unlikely that the rest of the affected area will have many stone artefacts. The proposed borrow pit site is therefore deemed to be of low archaeological heritage significance. No further archaeological studies or mitigation are thus recommended.

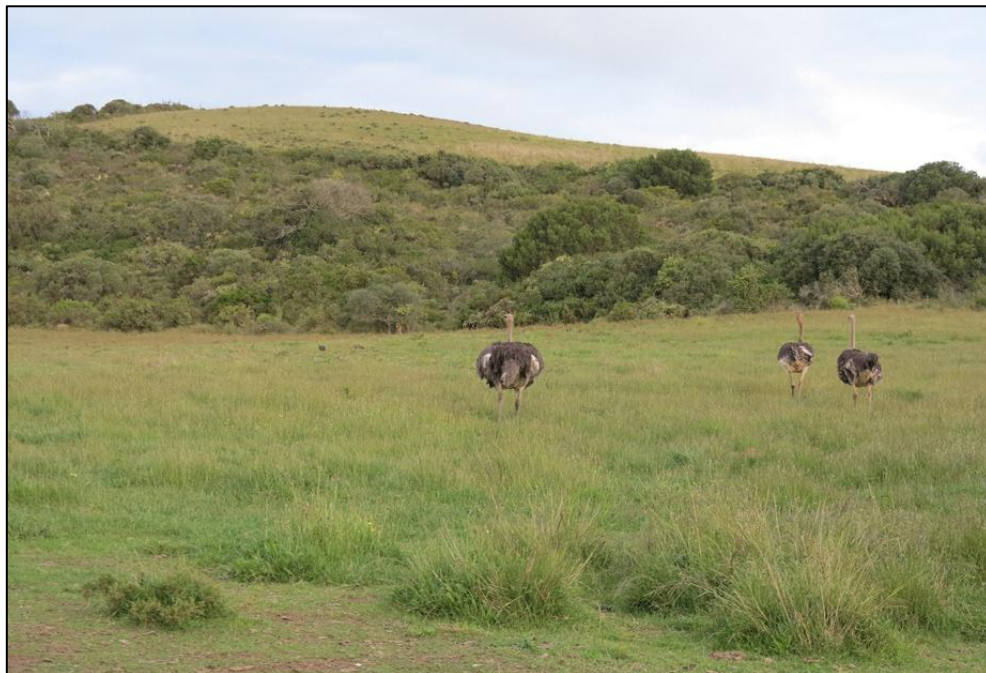
**Environment:** The proposed borrow pit lies on the lower, moderately steep margins of an alluvial floodplain eroded by the Buffels River and its tributaries. It is located immediately to the east of the MR0336 which connects Vleesbaai to the N2 further northwards (Figure 1). The polygon of the affected area has three components, namely a flat-lying field close to a small stream in the lower north-western third, a densely-vegetated northwest-facing slope with bushes and shrubs in the middle and an upper, south-eastern third consisting of a previously-ploughed grassy field and patch of shrubs close to the access gate beyond the southwest corner (Figures 2 to 7). It is bounded by the road on the southwest and a fence on the northeast. The north-western and south-eastern boundaries lie roughly parallel to the strip with dense shrubs. A fence separates the top third from the other two thirds (Figures 4 and 6).

Figure 3: View towards the east showing the three bands of terrain of the polygon – the lower and upper grassy thirds on either side of the densely-vegetated middle third.

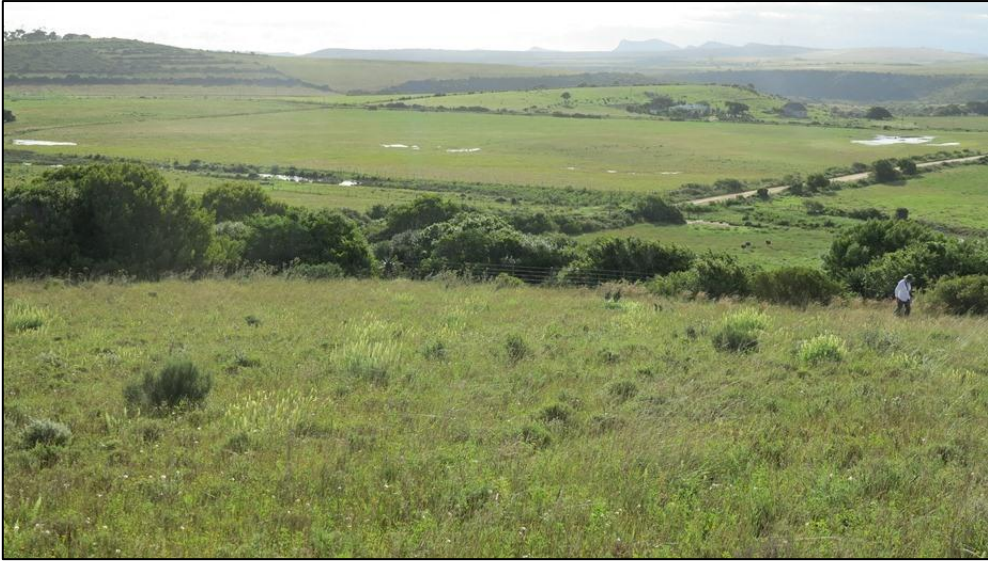
Figure 4: View towards the west taken from the upper third of the study area, with the densely-vegetated middle band visible in the middle ground and the lower third (with ostriches) beyond that.

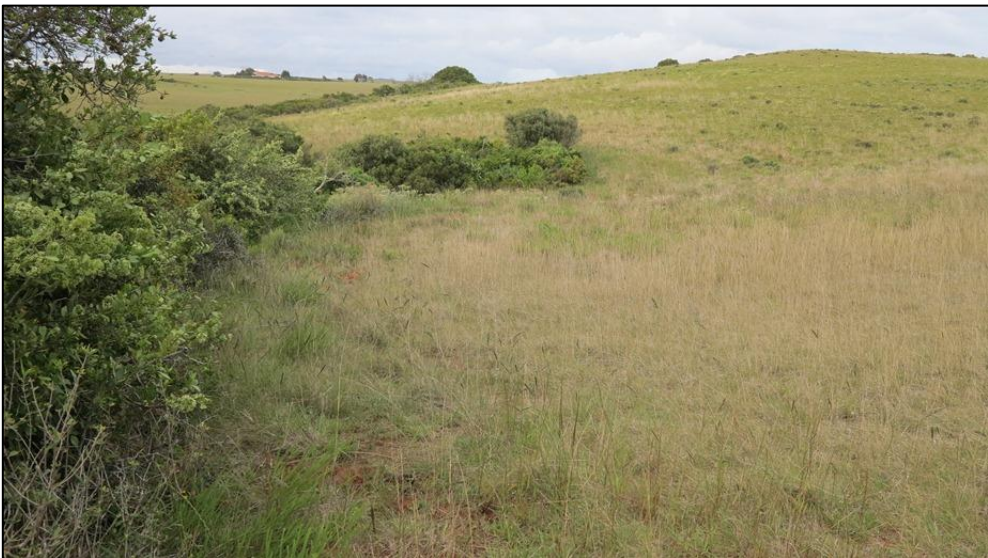
Figure 5: View towards the northeast of the previously ploughed field in the upper third of the polygon and the crest of the hill which lies outside it.

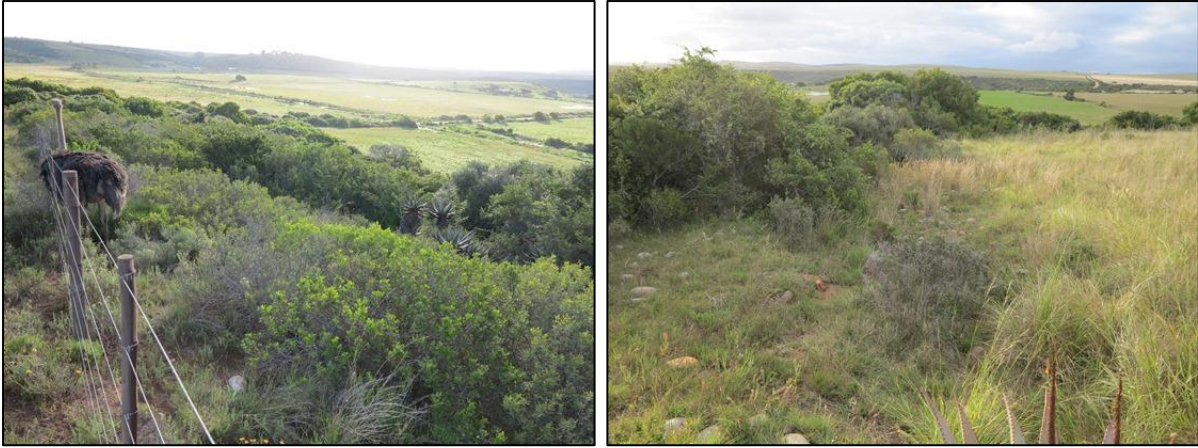
Figures 6 and 7: View towards the southwest of the densely-vegetated middle third of the study area; view towards the northwest of the area with large cobbles in the shrubby part of the upper third of the polygon.

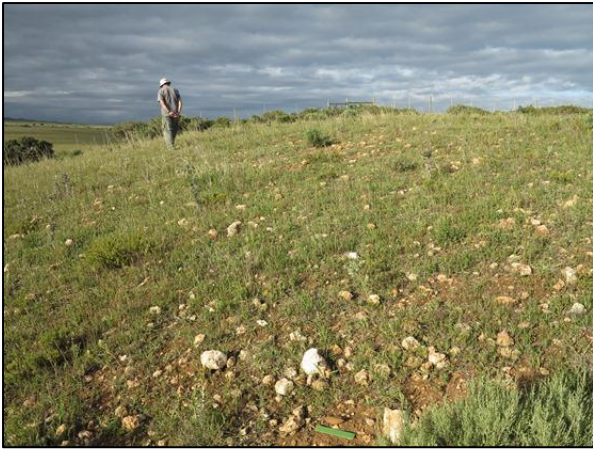
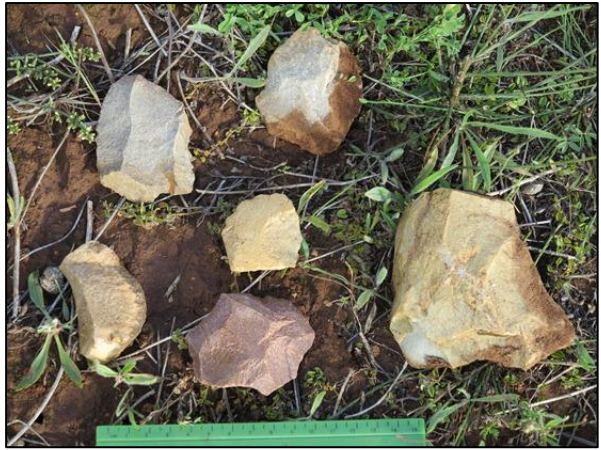
The artefacts recorded include flaked cobbles, flakes (some with cortex), chunks and cores (Figures 9 to 13). Some of these are likely to be ESA (e.g. Figure 10), with some indeterminate ESA/MSA. No formal ESA tools such as hand axes were seen. A couple of diagnostic MSA flake-blades were observed (Figure 12). No flaked material was noted amongst the large cobbles in the shrubby part of the upper third of the study area (Figure 7), nor were any artefacts seen in the heaps of soil dug up by dune molerats. Only isolated ESA material was noted in the vicinity of the proposed pit in the Avery & Avery survey (2006) so I feel confident that no dense concentration of artefacts was missed in the lower areas not covered on foot.

Figures 8 and 9: View towards the northeast showing the possible pediment surface on the crest of the hill; a cluster of quartzite artefacts from the ellipse shown in Figure 2. The scale is in cm.

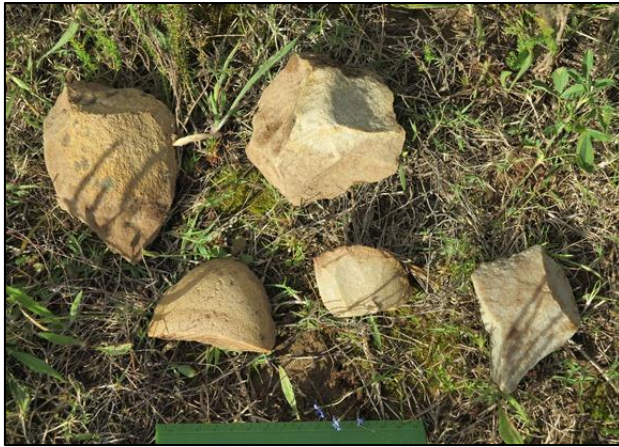
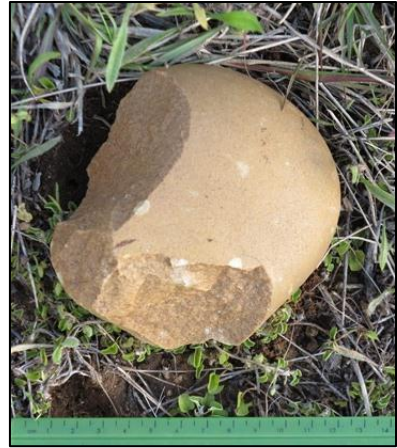
Figures 10 and 11: A cluster of quartzite artefacts; flaked cobble. The scale is in cm.

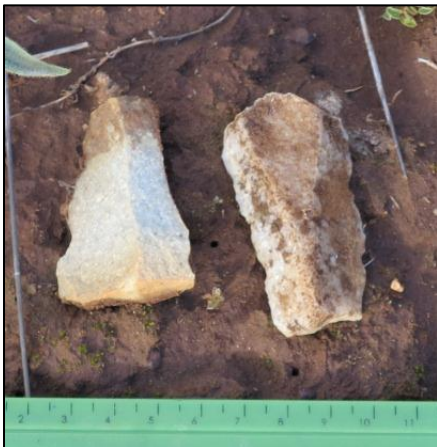
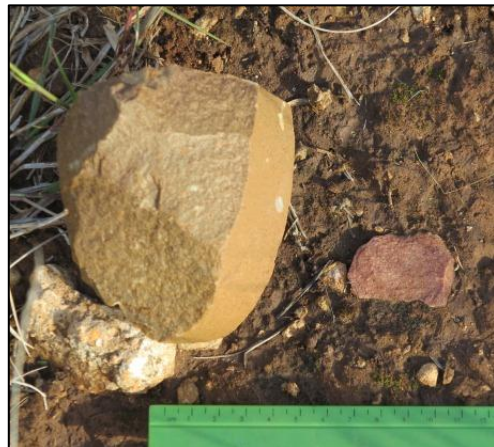
Figures 12 and 13: Quartzite MSA artefacts; flaked cobble and flake. The scale is in cm.
