**PROPOSED UPGRADE OF BALENI ROAD NEAR
EDENDALE, MSUNDUZI LOCAL MUNICIPALITY,
KWAZULU-NATAL**

Phase 1 Heritage Impact Assessment

25 April 2022

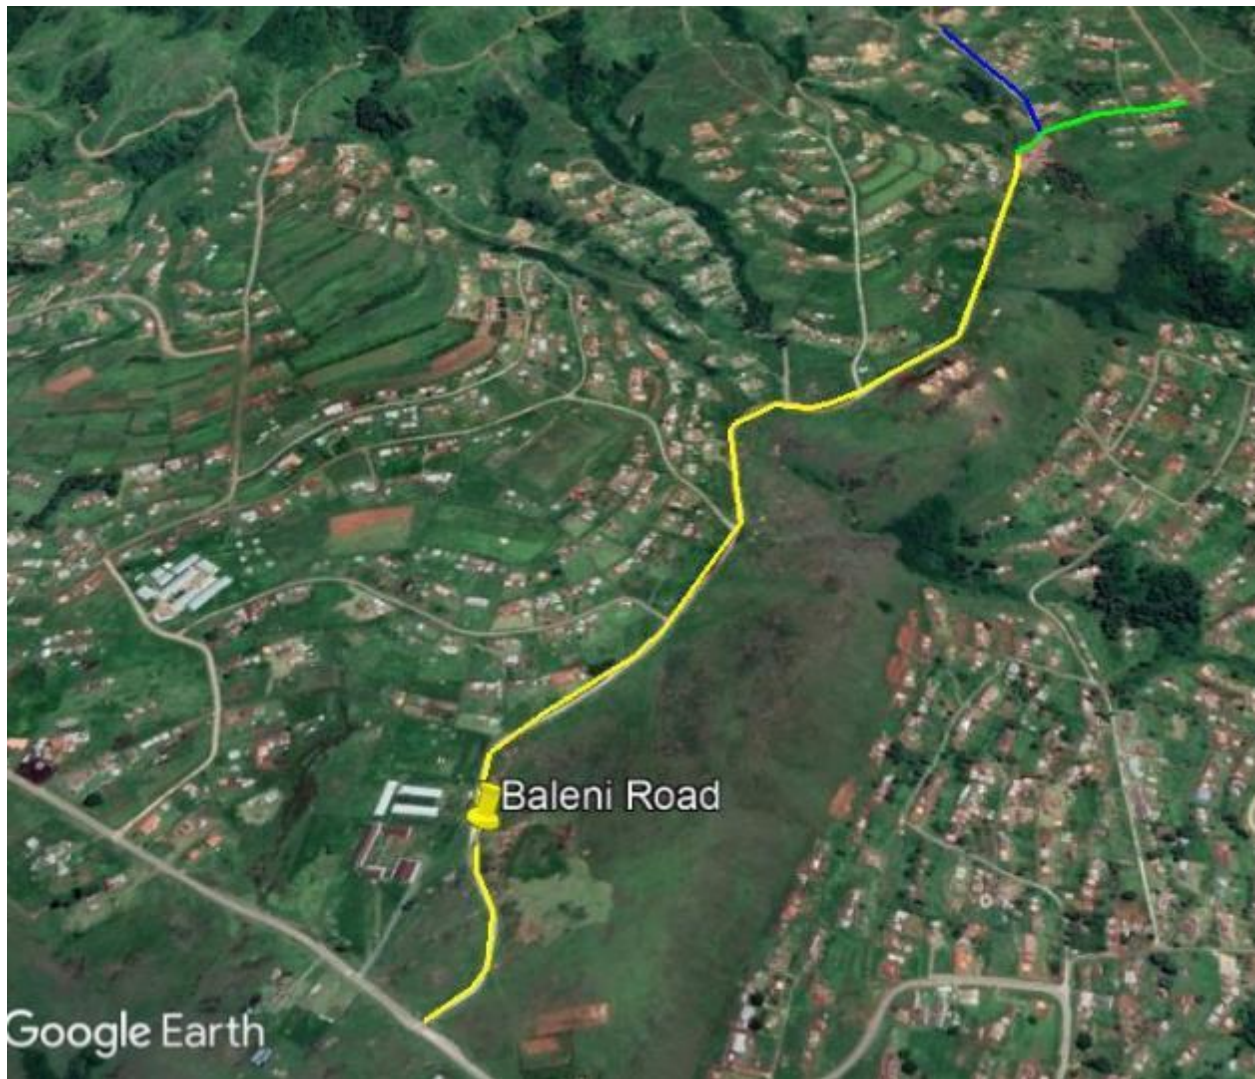
Figure 2: Closer image of road upgrade

Towards the northern end of Baleni Road, a road diverts to the left which is indicated in blue on **Fig. 2** above. This section of road was inspected. Both Andile Khanyile and Sibusiso Zuma indicated that old graves were located in the small plantation of trees to the west of the road. The graves are no longer visible and the area is overgrown. The graves are located west of the power lines and about 15m from the road. Existing infrastructure for water reticulation was visible along this road.

The extension of Baleni Road (indicated in green in **Fig. 2**) was inspected. Ntombithula Phakathi showed the specialist several graves along this road. The graves are mounds of ground without additional markings. The graves situated closest to the road are 16m north of Baleni Road. Some

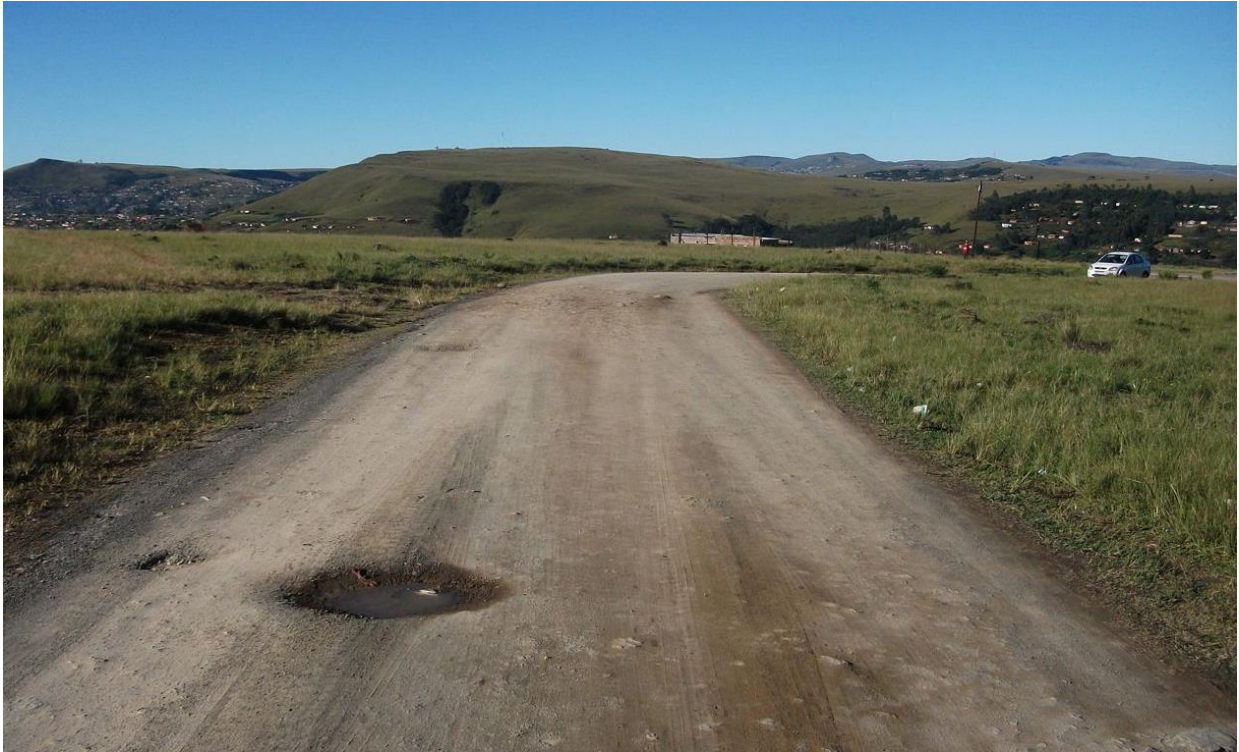
Figure 4: Looking southwards along Baleni Road

The road upgrade was inspected on foot starting at the southern end/start of the road near Zwartkop Primary School. The specialist spoke to several residents during the inspection. Most of the homesteads are located to the west of the road as can be seen in **Fig. 6**.

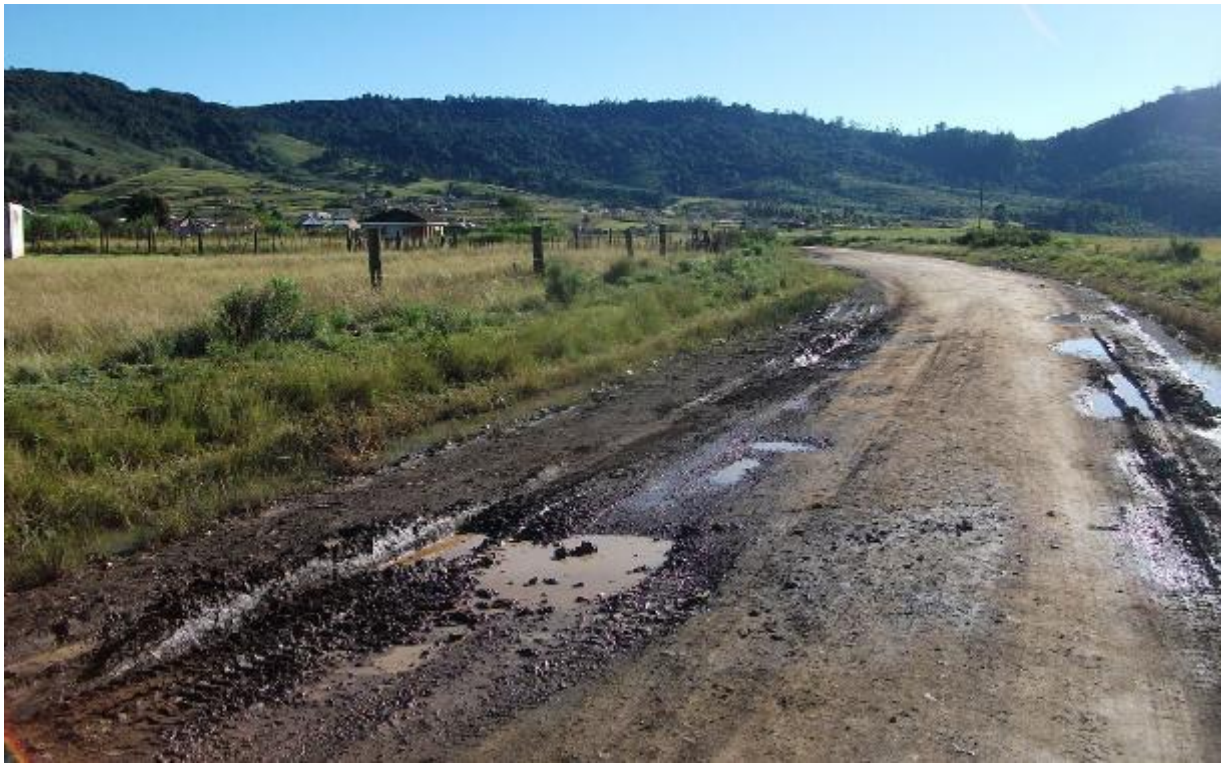
Figure 5: View of condition of Baleni Road looking northwards

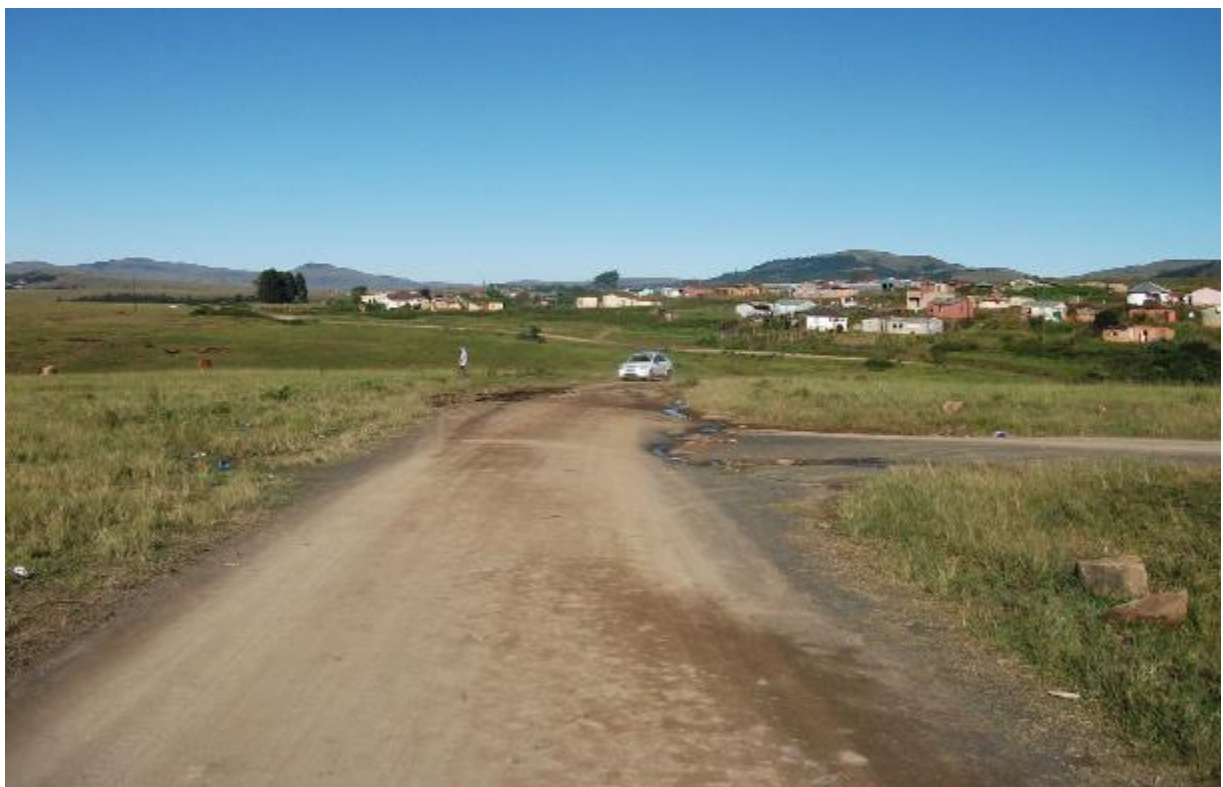
Figure 6: View of Baleni Road and surroundings

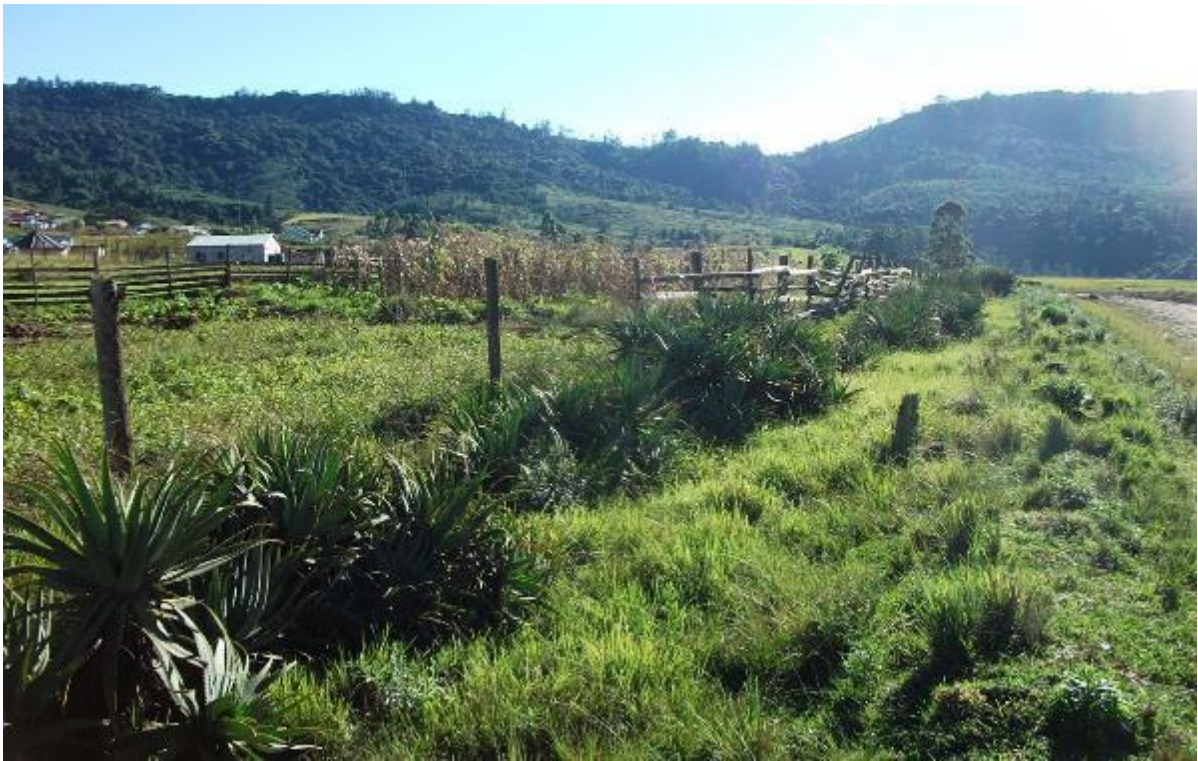
The gardens and fields of some homesteads abutt the road as can be seen in **Fig. 7**.

Figure 7: Fields next to road

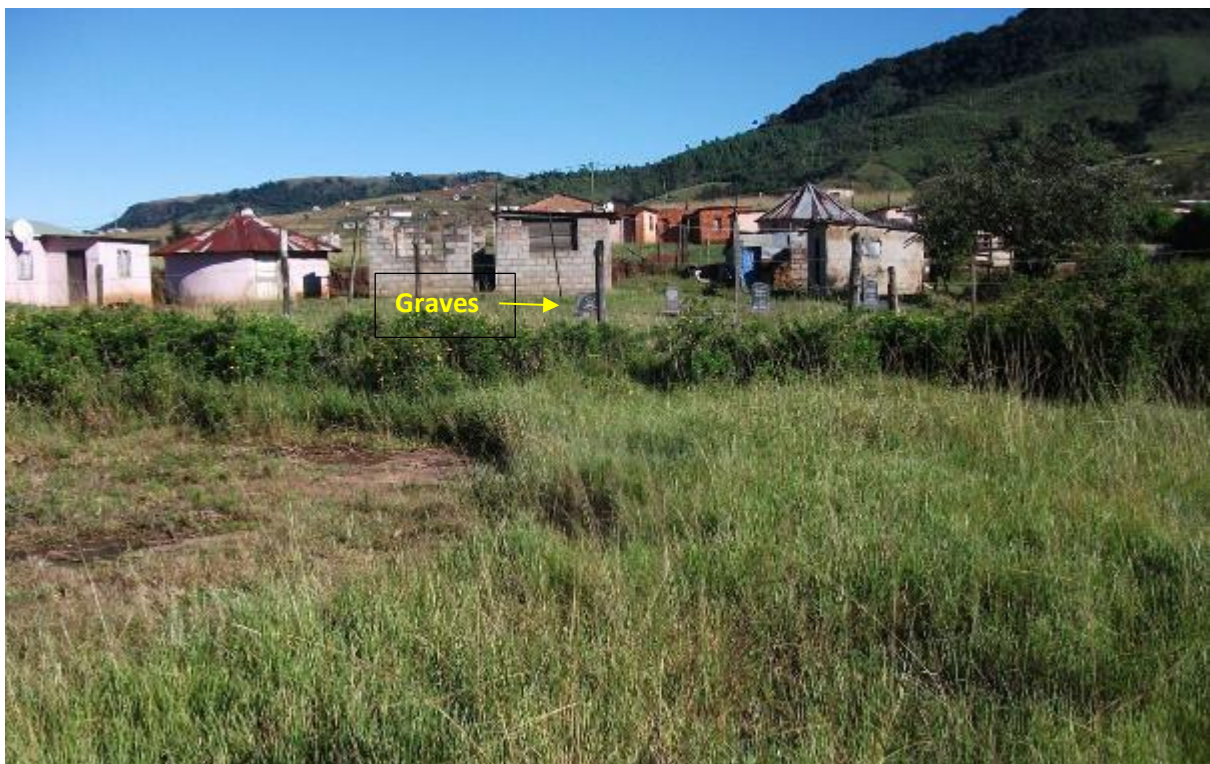
At the start of the inspection, the specialist spoke to Thembekile Mbanjwa who said that most graves are located within the boundaries of homesteads such as the four graves pictured in **Fig. 8** below. These graves are located over 30m west of the road and will not be impacted by the road upgrade.

Figure 8: Graves within boundary of homestead

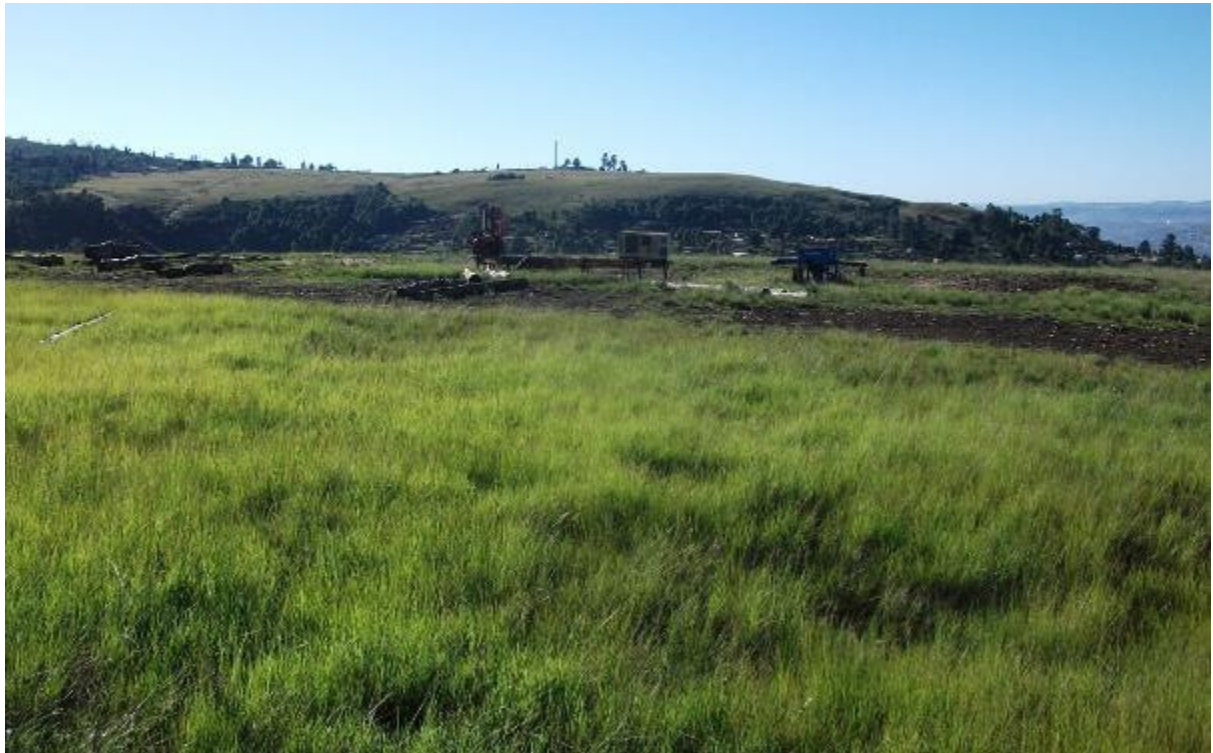
An area was found on the eastern side of the road which had been used to cut timber. Some machinery was still on the site as well as the remains of the cut timber. A resident of the homestead opposite the site, Sbusiso Mkhize, pointed out the site of an old grave. He said that

Figure 9: Area used to cut timber with machinery still on site

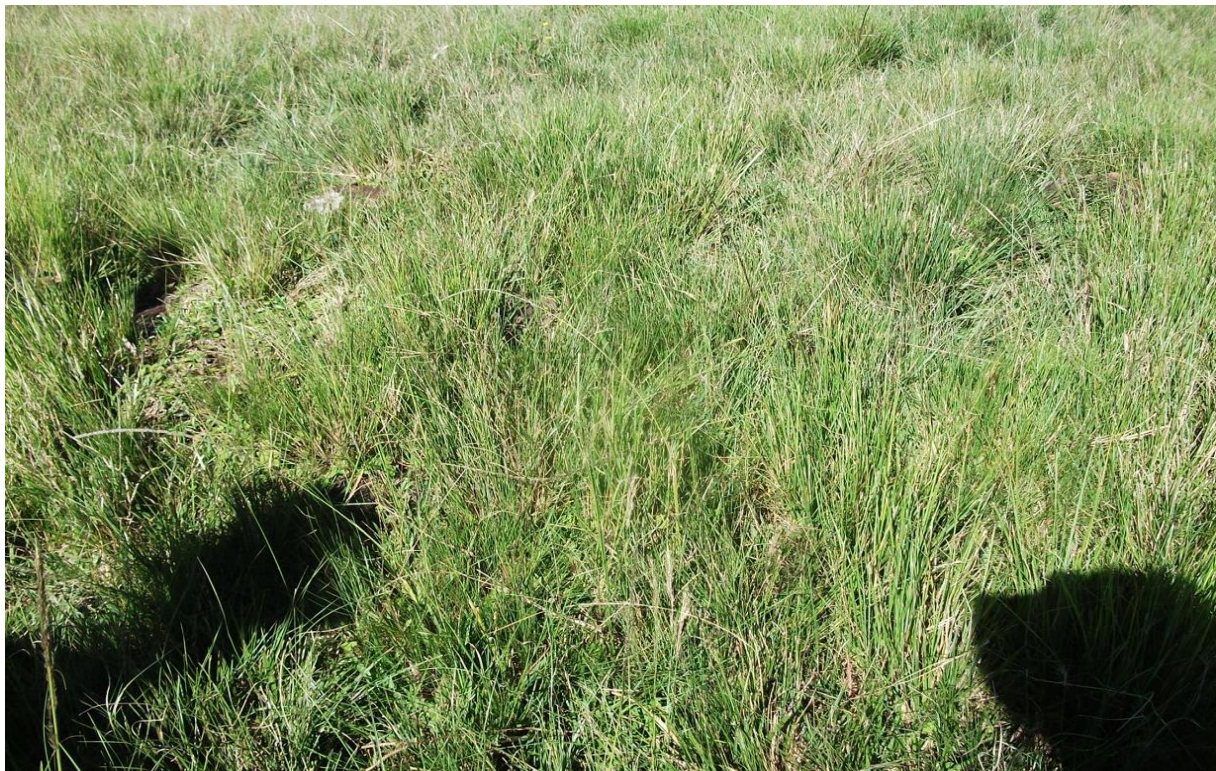
there used to be a home near the grave but there are no remains of the home apart from a slight indentation in the ground. The grave is a slightly raised mound of grass with a few rocks on it. The grave is situated 10m from the existing road and could be impacted by the road upgrade.

Figure 10: Old grave on eastern side of road

No.	Description	Coordinates	Significance	Mitigation
1	One grave	29°36'26.3" S 30°13'54.9" E	High heritage significance	Located 10m south-east of road; grave to be fenced with 5m buffer to ensure grave is not impacted by road upgrade
2	Four graves with headstones	29°36'21.7" S 30°13'56.1" E	High heritage significance	Located >30m west of road within homestead boundary; should not be impacted by proposed upgrade
3	Graves between residences	29°36'20.8" S 30°13'56.2" E	High heritage significance	Located >30m west of road; will not be impacted by road upgrade
4	Graves	Approx. location 29°36'12.4" S 30°14'00.0" E	High heritage significance	Located less than 5m from road; area to be cleared of vegetation prior to any upgrade work being done; confirmation of graves to be done with assistance of residents; graves to be fenced off with 5m buffer to avoid impacts
5	Graves in small plantation of trees	29°36'05.4" S 30°13'58.7" E	High heritage significance	Located 18m west of road; should not be impacted by road upgrade; area to be fenced off with 5m buffer

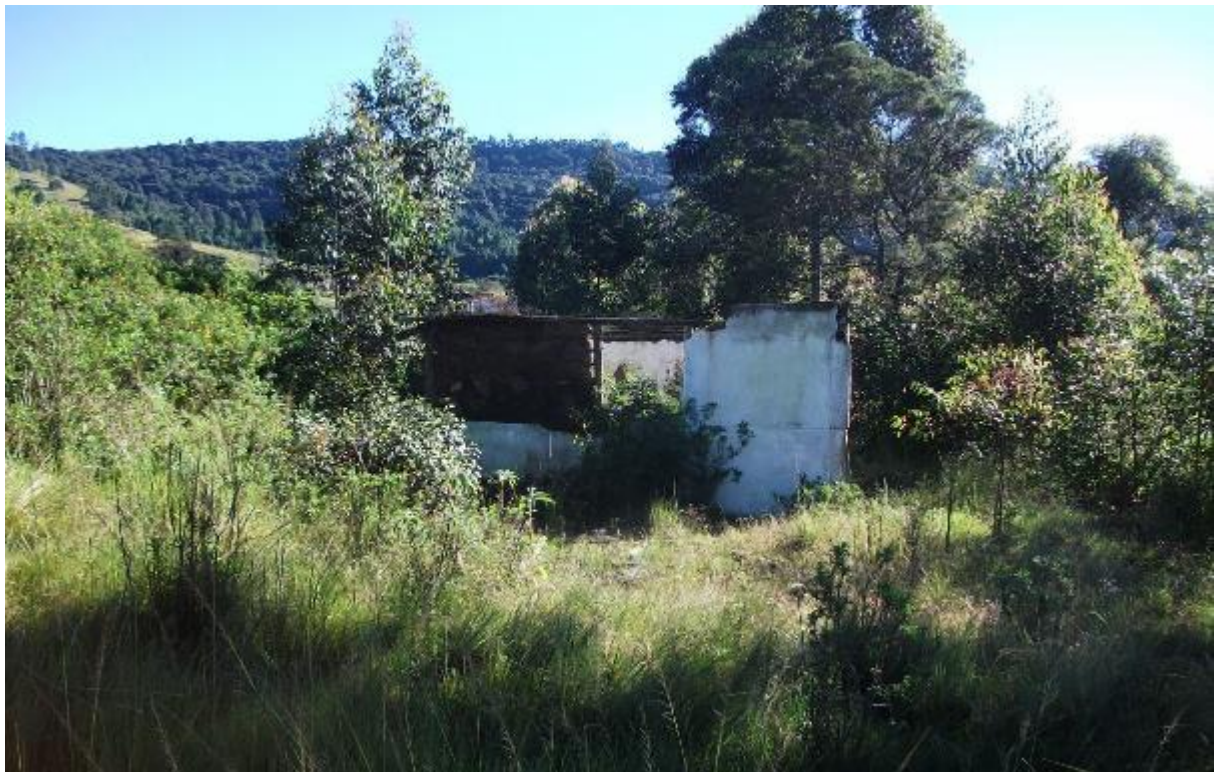
An abandoned house was found east of Baleni road. A resident, Sintu Nqambi, indicated that there were graves between the house and the road in an area overgrown with dense vegetation. Due to the thick undergrowth (see **Fig. 12**), the graves were not visible and it could not be determined how close the graves are to the road but they could be located as close as 5m to the road.

Figure 11: Abandoned structure to east of Baleni Road

- Where there is limited space between the proposed buffer and road then strict precautions must be taken to avoid damaging graves such as no machinery been used in those sections of the road or consideration must be given to moving grave sites No. 1 and 4 as listed in **Table 1**, where the one grave is located 10m from the road and the other could be located less than 5m from the road.

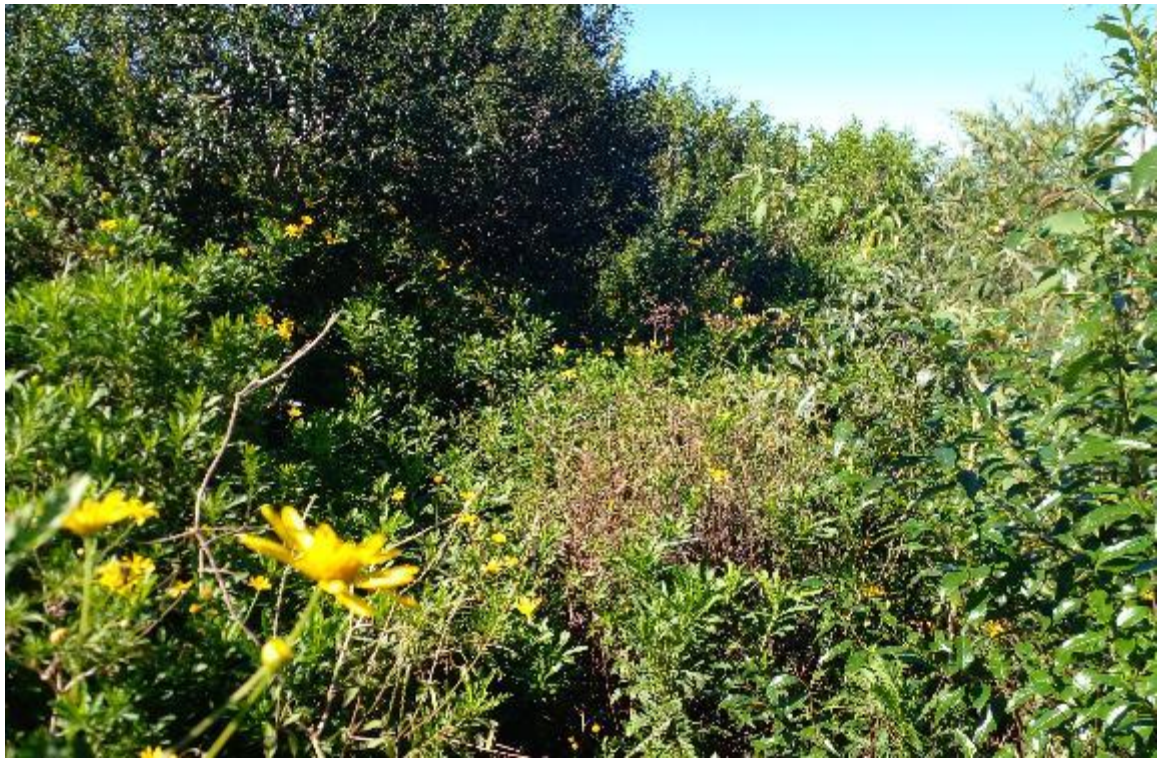
Figure 12: Dense vegetation where graves are reportedly located

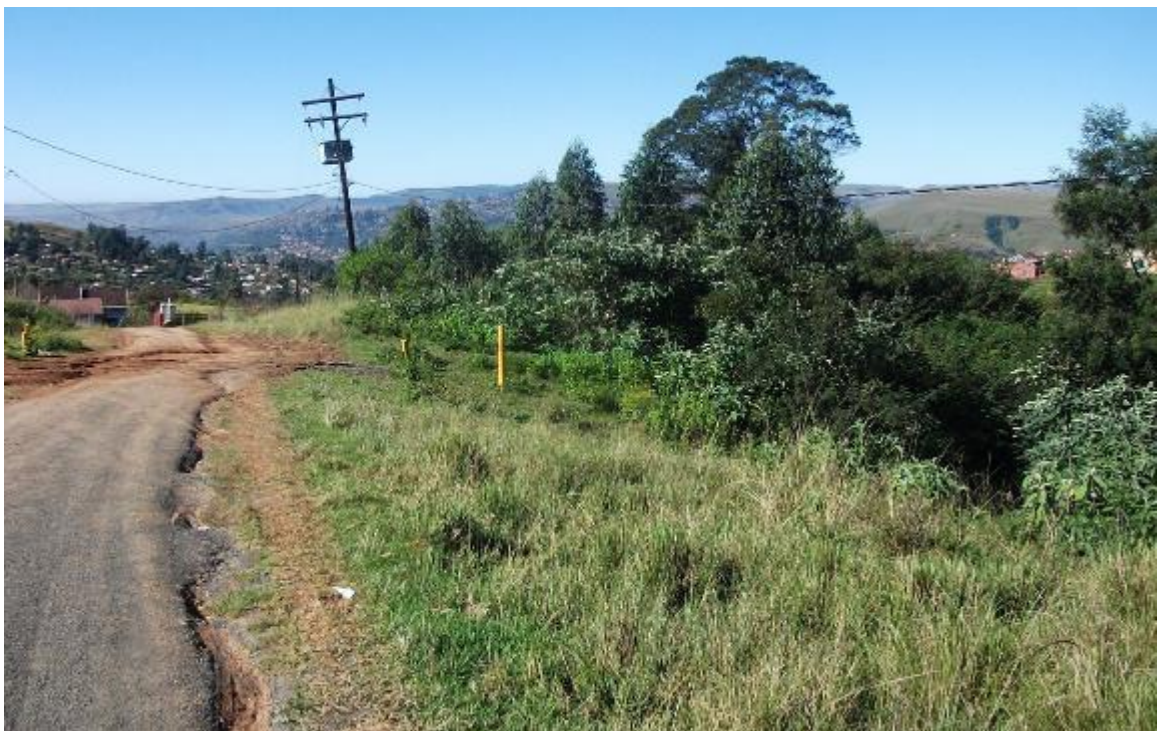
Figure 13: Road in relation to small plantation of trees

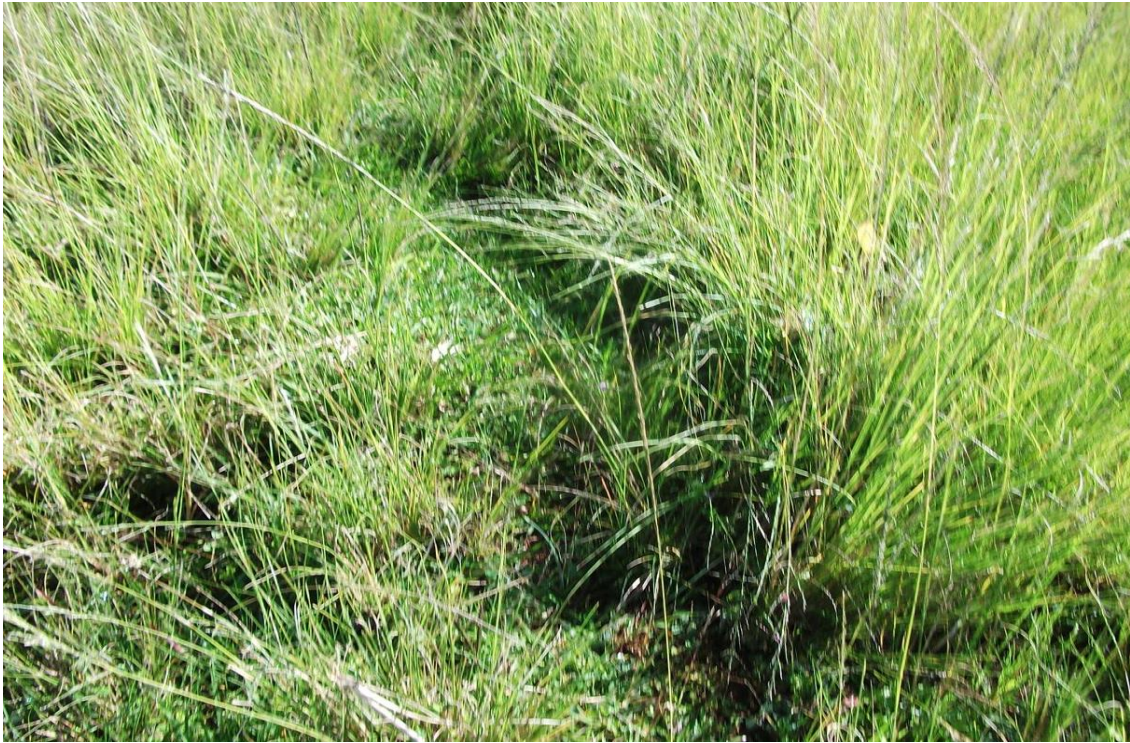
of the graves are situated in an open field and could be impacted by upgrade activities if they are not clearly marked and protected.

Figure 14: Mound indicating site of grave

6	Three graves	29°36'05.9" S 30°14'07.0" E	High heritage significance	Located 16m north of road; 5m buffer around graves to prevent upgrade activities from impacting graves
7	Graves	29°36'05.5" S 30°14'07.3" E	High heritage significance	Located 26m north of road; they are located in an open field which may be used for construction camp therefore graves to be fenced with 5m buffer
8	One grave	29°36'05.5" S 30°14'07.8" E	High heritage significance	Located 20m north of road; as it is located in an open field which may be used for construction camp, the grave to be fenced with 5m buffer
9	One grave	29°36'05.3" S 30°14'07.9" E	High heritage significance	Located 30m north of road; as it is located in an open field which may be used for construction camp, the grave to be fenced with 5m buffer
