**HERITAGE SURVEY OF THE PROPOSED N2 BALLITO
INTERCHANGE UPGRADE**

FOR AFZELIA ENVIRONMENTAL CONSULTANTS CC

DATE: 7 May 2010

**Umlando: Archaeological Tourism and Resource
Management**

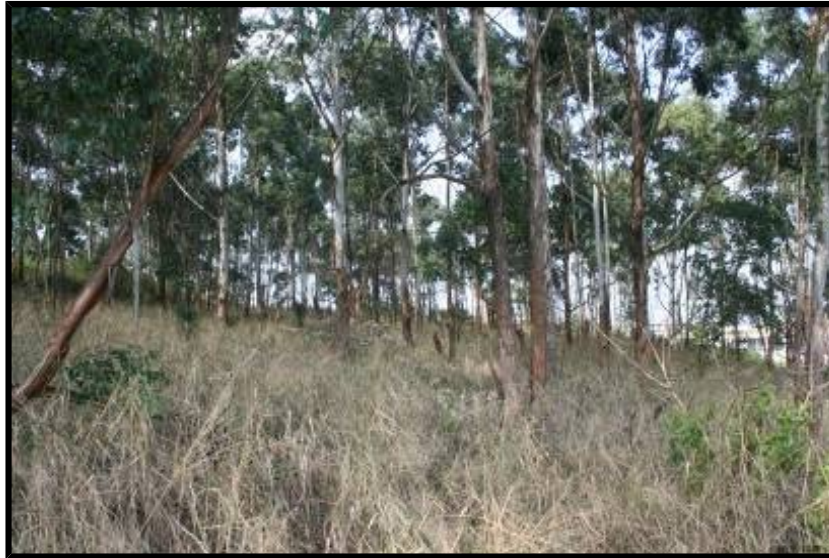
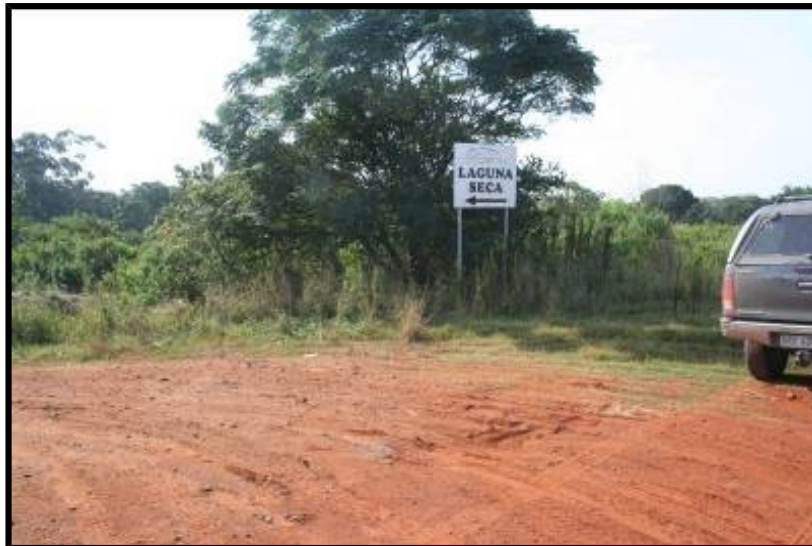
FIG. 3: STUDY AREA

One archaeological site was observed in the southeast area of the proposed development. The site consists of a scatter of adiaagnostic sherds at the top of the hill. The vegetation was very dense at the time of the survey, and thus visibility was poor (fig. 3). More artefacts would probably occur when the vegetation is removed.

Significance: The site cannot be assessed at the moment.

Mitigation: The site needs to be re-assessed after the vegetation has been cleared and before construction begins.

The archaeological site needs to be properly assessed. This can only occur after the vegetation has been adequately cleared. This will allow for an estimate of the extent, age and significance of the site to be made. If the material dates to the Late Iron Age, then there is a possibility of human remains occurring on the site. The assessment will need to occur before construction activity begins. On-site supervision during earth moving and/or construction activity may be required.
