Phase 1 Archaeological and Heritage Impact Assessment on the farms  
Barclay Vale 288 JT and Montrose 290 JT in respect of proposed  
agricultural development, Mpumalanga Province.

**For Henwood Environmental Solutions**

16 October, 2017

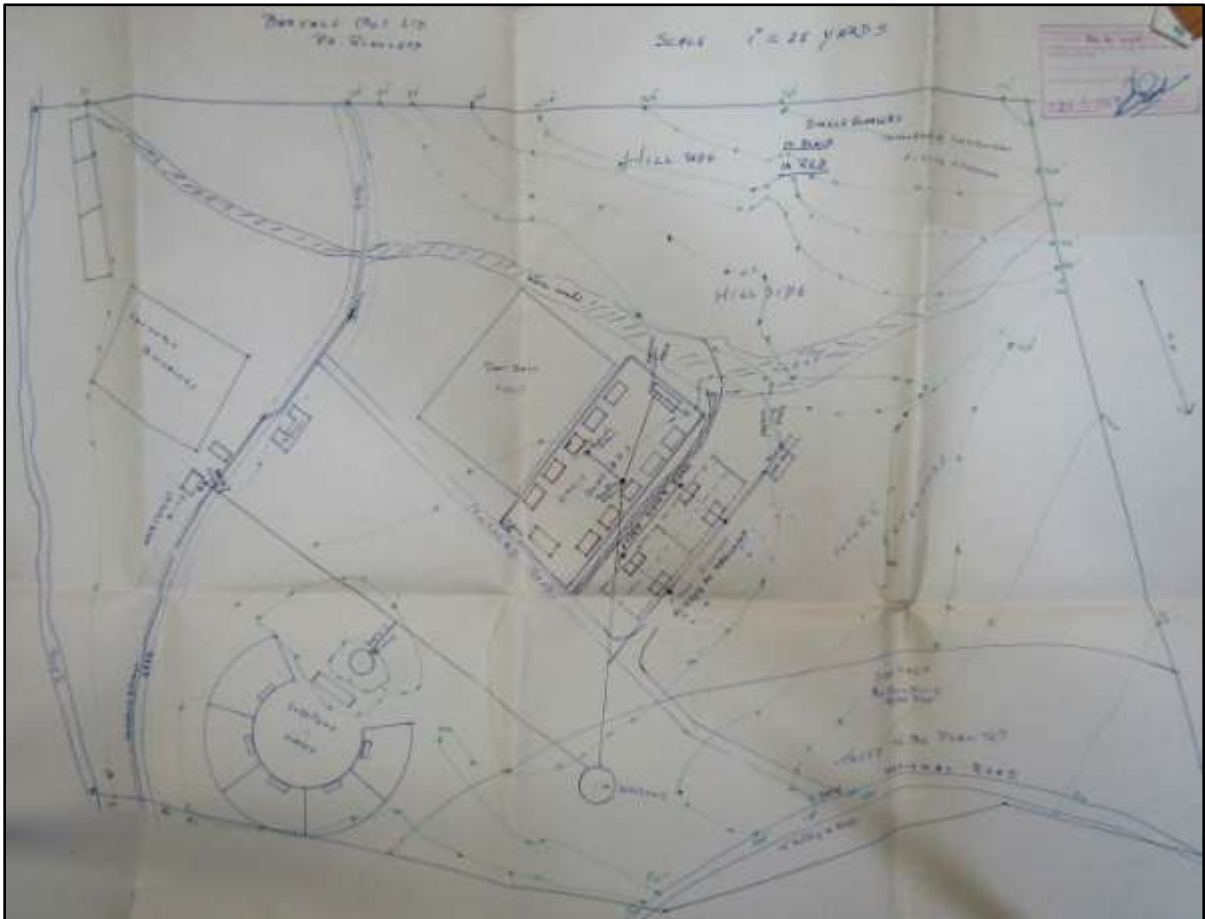
**Fig. 4.10.** A layout plan of the Barvale Factory housing in 1956 (NASA SAB, NTS: 10056 166/408Z).

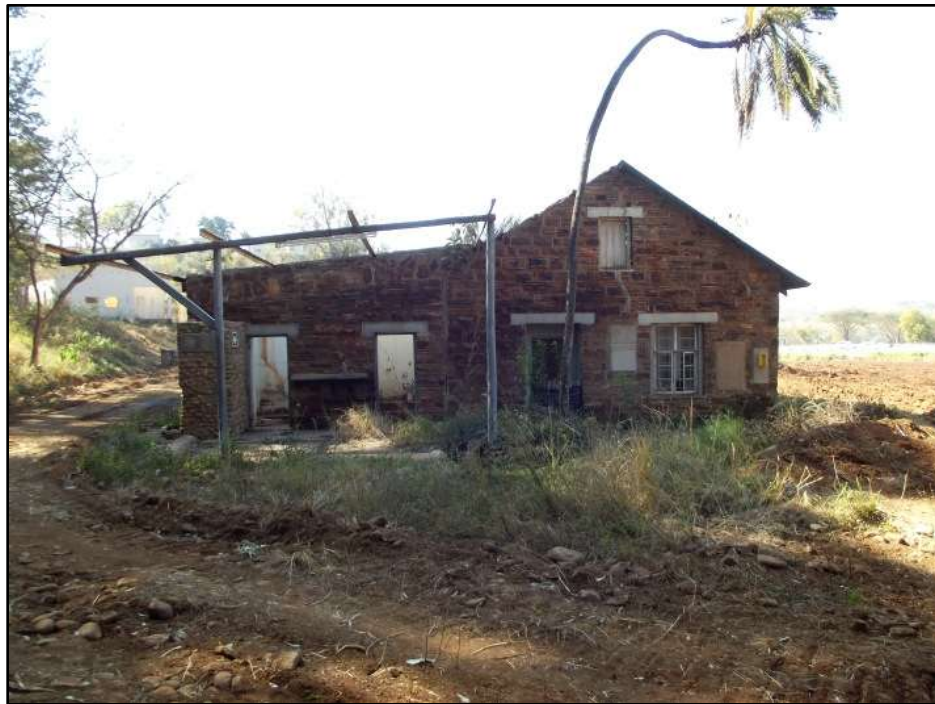
**Fig. 86.** Site BV 4. Photo taken in northern direction. This is the old Barvale Road Stall.

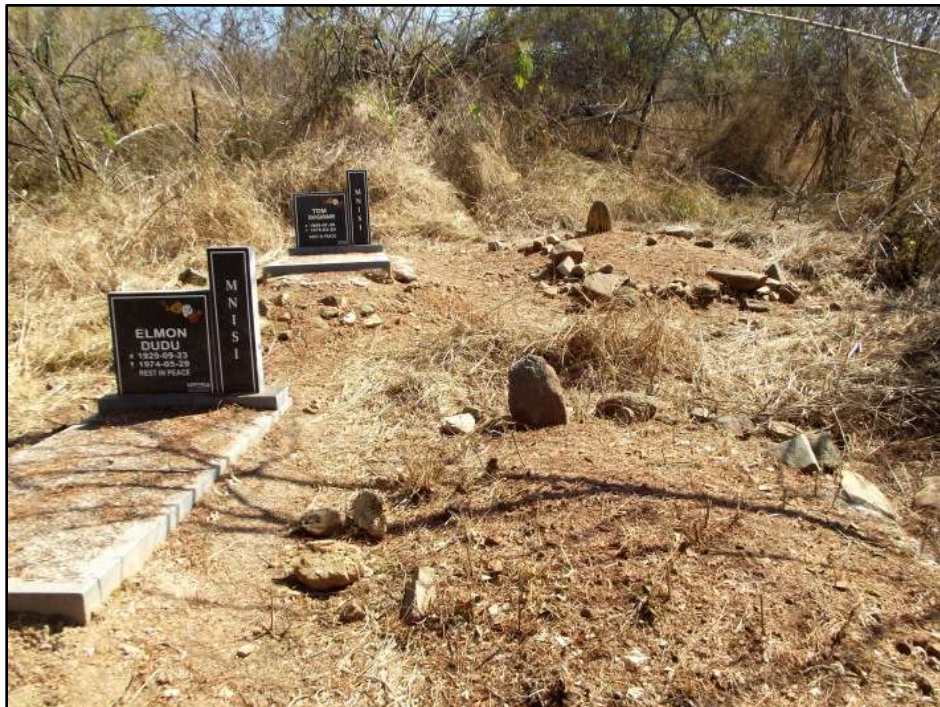
**Fig. 92.** Site BV 9. Photo taken in a western direction. Some of the graves have headstones while others do not. There are at least 20 graves located here.

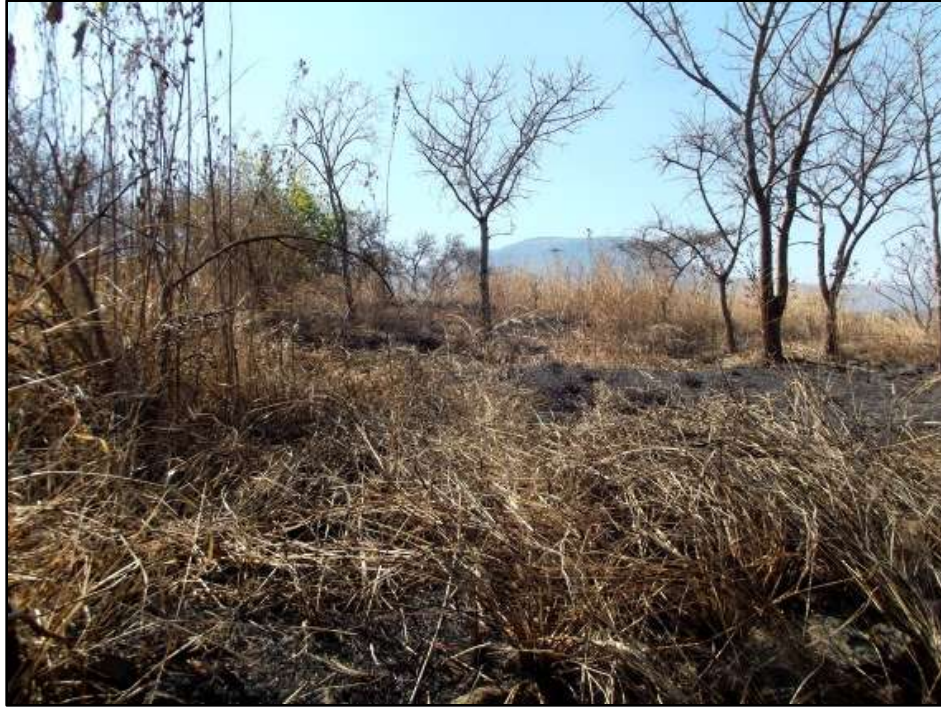
**Fig. 97.** Site MR 1. A photo of the site towards the north.

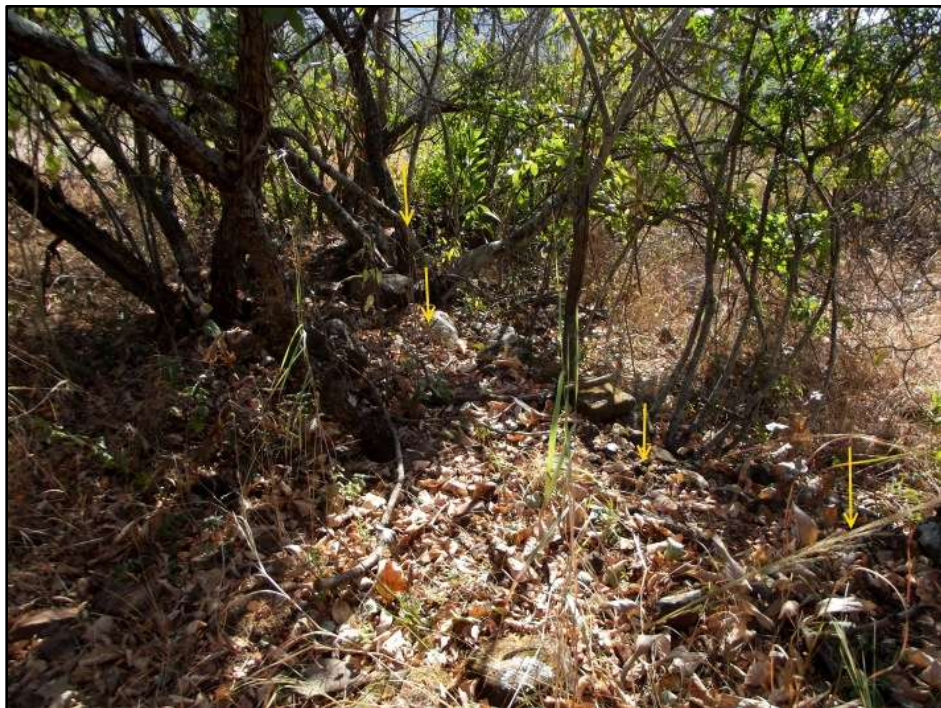
**Fig. 98.** Site MR 2. A photo of the site towards the northwest. Ruins of dwellings of farm workers.

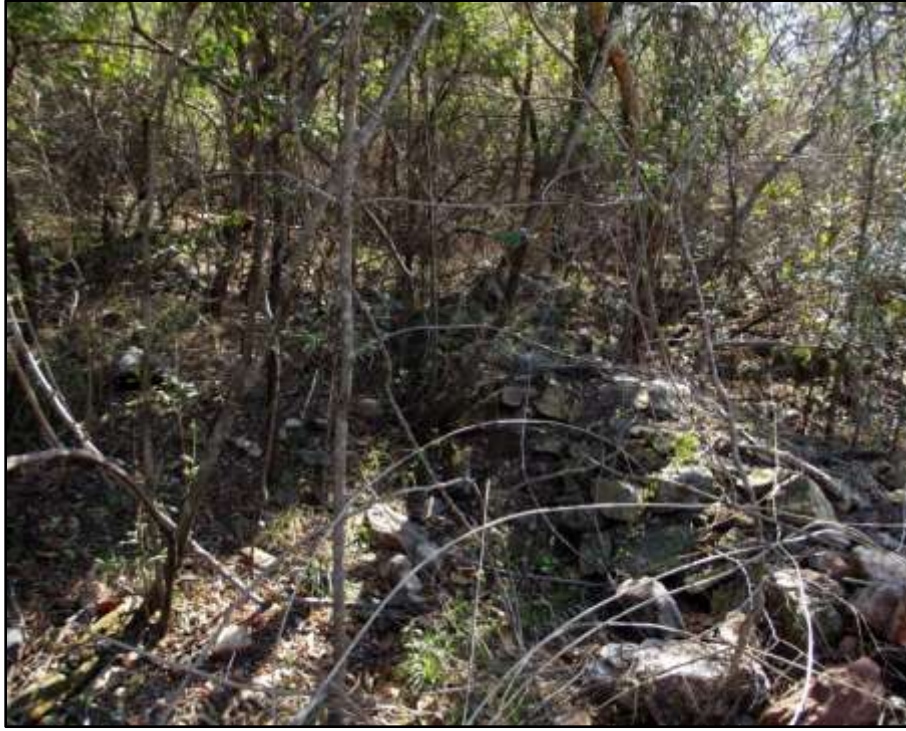
**Fig. 99.** Site MR 3. A photo of the site towards the north east. The stone walling is visible on the right of the photo.

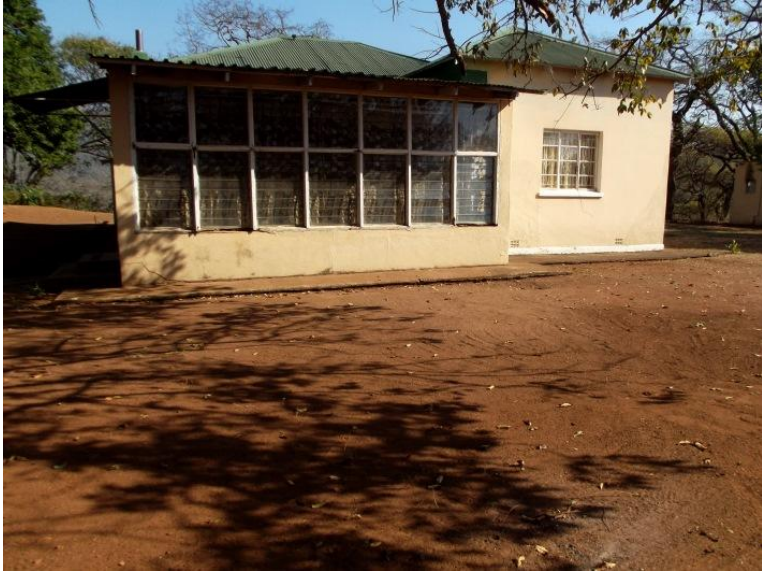
Location: Barclay Vale 288 JT		DATE RECORDED: 21/07/2017	
SITE NUMBER: BV 1 – House		GPS CO-ORDINATES: S25°25'31.98" E030°45'04.10"

TYPE OF SITE: A farmstead	
		GEOGRAPHICAL SETTING & LANDSCAPE: Manicured, maintained landscape.	
		ARCHITECT / BUILDER: Not known	
		AGE ESTIMATE: Before 1970. The house is indicated on a topographical map of 1970.	
		BUILDING/S OLDER THAN 60 YEARS (yes/no): No	
		BUILDING STYLE: Utilitarian	
		BUILDING TYPE: House/ residence	
		PRESENT USE: House/ residence	
		OCCUPIED (yes / no): Yes	
CONDITION (good / fair / poor / derelict): Fair			
DESCRIPTION: A rectangular brick and mortar structure, plastered and painted. Timber roof structure covered with corrugated iron sheeting. Large steel frame windows.			
CONSTRUCTION: Walls of brick and mortar, timber roof structure covered with corrugated iron sheeting, steel frame windows, timber doors.			
ALTERATIONS: Not known

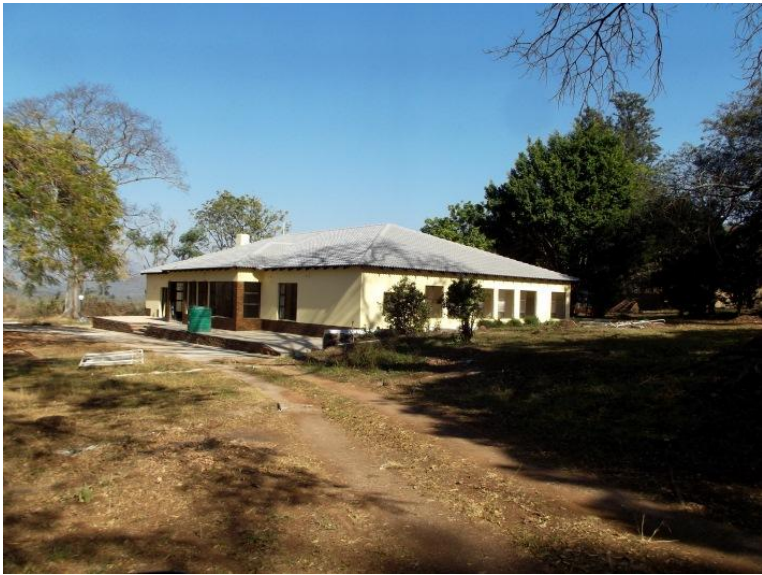
Location: Barclay Vale 288 JT		DATE RECORDED: 21/07/2017	
SITE NUMBER: BV 2 – House		GPS CO-ORDINATES: S25°25'39.98" E030°45'01.43"

TYPE OF SITE: A farmstead	
		GEOGRAPHICAL SETTING & LANDSCAPE: Manicured, maintained landscape.	
		ARCHITECT / BUILDER: Not known	
		AGE ESTIMATE: Before 1970. The house is indicated on a topographical map of 1970.	
		BUILDING/S OLDER THAN 60 YEARS (yes/no): No	
		BUILDING STYLE: Utilitarian	
		BUILDING TYPE: House/ residence	
		PRESENT USE: House/ residence	
		OCCUPIED (yes / no): Yes	
CONDITION (good / fair / poor / derelict): Good			
DESCRIPTION: A rectangular brick and mortar structure, plastered and painted with some stone cladding in places. Timber roof structure covered with roof tiles. Large aluminium frame windows. Timber doors.			
CONSTRUCTION: Walls of brick and mortar, timber roof structure covered with roof tiles, aluminium frame windows, timber doors.

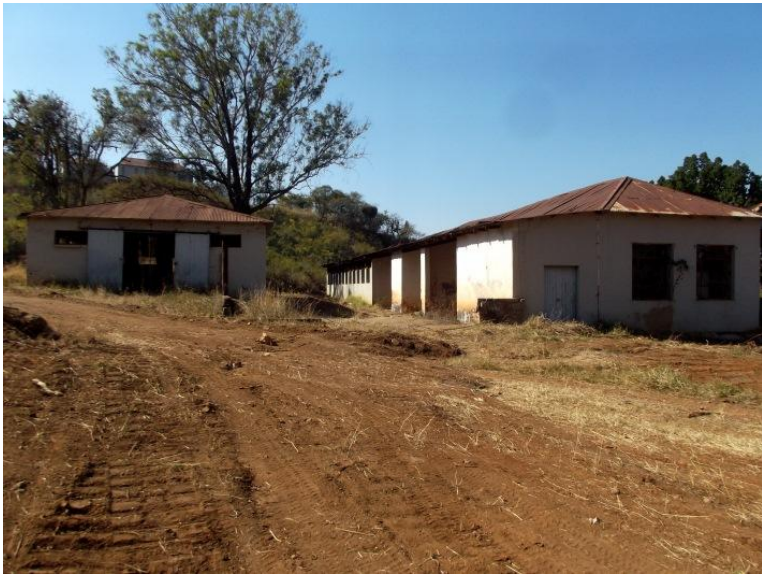
Location: Barclay Vale 288 JT		DATE RECORDED: 21/07/2017	
SITE NUMBER: BV 5 – Farm workshop and shed		GPS CO-ORDINATES: S25°25'40.34" E030°45'11.70"

TYPE OF SITE: Farm workshop and shed	
		GEOGRAPHICAL SETTING & LANDSCAPE: Located a few hundred metres from the N4 freeway next to agricultural land.	
		ARCHITECT / BUILDER: Not known	
		AGE ESTIMATE: Before 1970. The building is indicated on a topographical map of 1970	
		BUILDING/S OLDER THAN 60 YEARS (yes/no): Not known	
		BUILDING STYLE: Utilitarian	
		BUILDING TYPE: Workshop and shed	
		PRESENT USE: None, neglected	
		OCCUPIED (yes / no): No	
CONDITION (good / fair / poor / derelict): Derelict			
DESCRIPTION: Two large rectangular buildings of brick and mortar plastered and painted. Timber roof structure covered with corrugated iron sheets. Steel frame windows. Timber and steel doors.			
CONSTRUCTION: Walls built of bricks and mortar which is plastered and painted. Timber roof structure covered with corrugated iron sheeting, steel frame windows, timber doors.

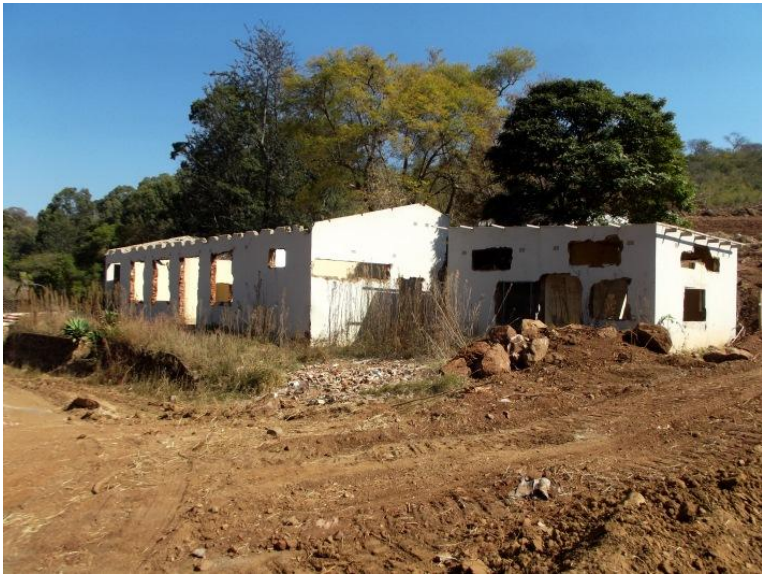
Location: Barclay Vale 288 JT		DATE RECORDED: 21/07/2017	
SITE NUMBER: BV 6 – Farm workshop or shed		GPS CO-ORDINATES: S25°25'38.95" E030°45'12.12"

TYPE OF SITE: Farm workshop or shed	
		GEOGRAPHICAL SETTING & LANDSCAPE: Located a few hundred metres from the N4 freeway next to agricultural land.	
		ARCHITECT / BUILDER: Not known	
		AGE ESTIMATE: Before 1970. The building is indicated on a topographical map of 1970	
		BUILDING/S OLDER THAN 60 YEARS (yes/no): Not known	
		BUILDING STYLE: Utilitarian	
		BUILDING TYPE: Workshop or shed	
		PRESENT USE: None, neglected	
		OCCUPIED (yes / no): No	
CONDITION (good / fair / poor / derelict): Derelict			
DESCRIPTION: A large rectangular building of bricks and mortar plastered and painted. The building has been vandalized and no roof structure, doors or windows remain.			
CONSTRUCTION: Walls built of bricks and mortar which is plastered and painted.			
ALTERATIONS: Not known

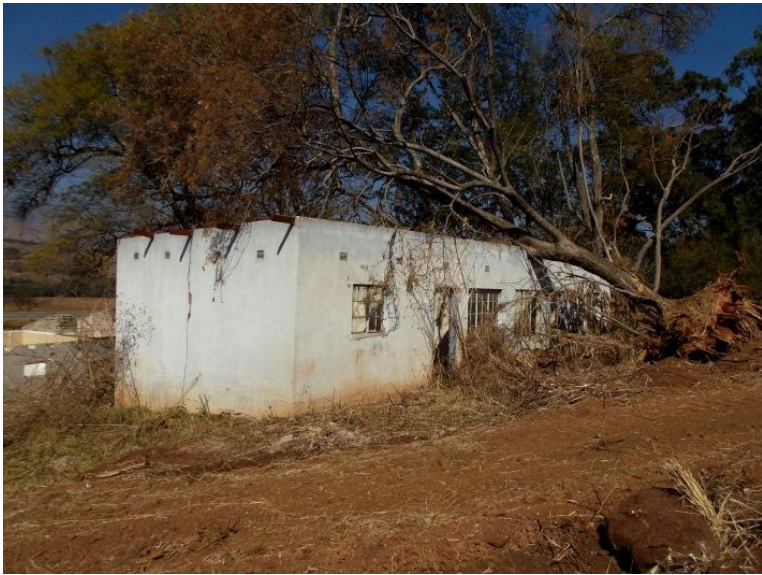
Location: Barclay Vale 288 JT		DATE RECORDED: 21/07/2017	
SITE NUMBER: BV 7 – Dwelling or storage facility		GPS CO-ORDINATES: S25°25'38.22" E030°45'11.21"

TYPE OF SITE: Small dwelling or storage facility		
	GEOGRAPHICAL SETTING & LANDSCAPE: Located a few hundred metres from the N4 freeway next to agricultural land.		
	ARCHITECT / BUILDER: Not known		
	AGE ESTIMATE: After 1984. The building is not indicated on a topographical map of 1984		
	BUILDING/S OLDER THAN 60 YEARS (yes/no): No		
	BUILDING STYLE: Utilitarian		
	BUILDING TYPE: Small dwelling or storage facility		
	PRESENT USE: None, neglected		
	OCCUPIED (yes / no): No		
CONDITION (good / fair / poor / derelict): Derelict			
DESCRIPTION: A small rectangular building of bricks and mortar plastered and painted. The building has been vandalized and no roof structure, doors or windows remain.			
CONSTRUCTION: Walls built of bricks and mortar which is plastered and painted.
