**BAYVIEW HOUSING PROJECT, PORTION 215 OF ERF
80, CHATSWORTH, ETHEKWINI MUNICIPALITY,
KWAZULU-NATAL**

Phase 1 Heritage Impact Assessment

April 2023

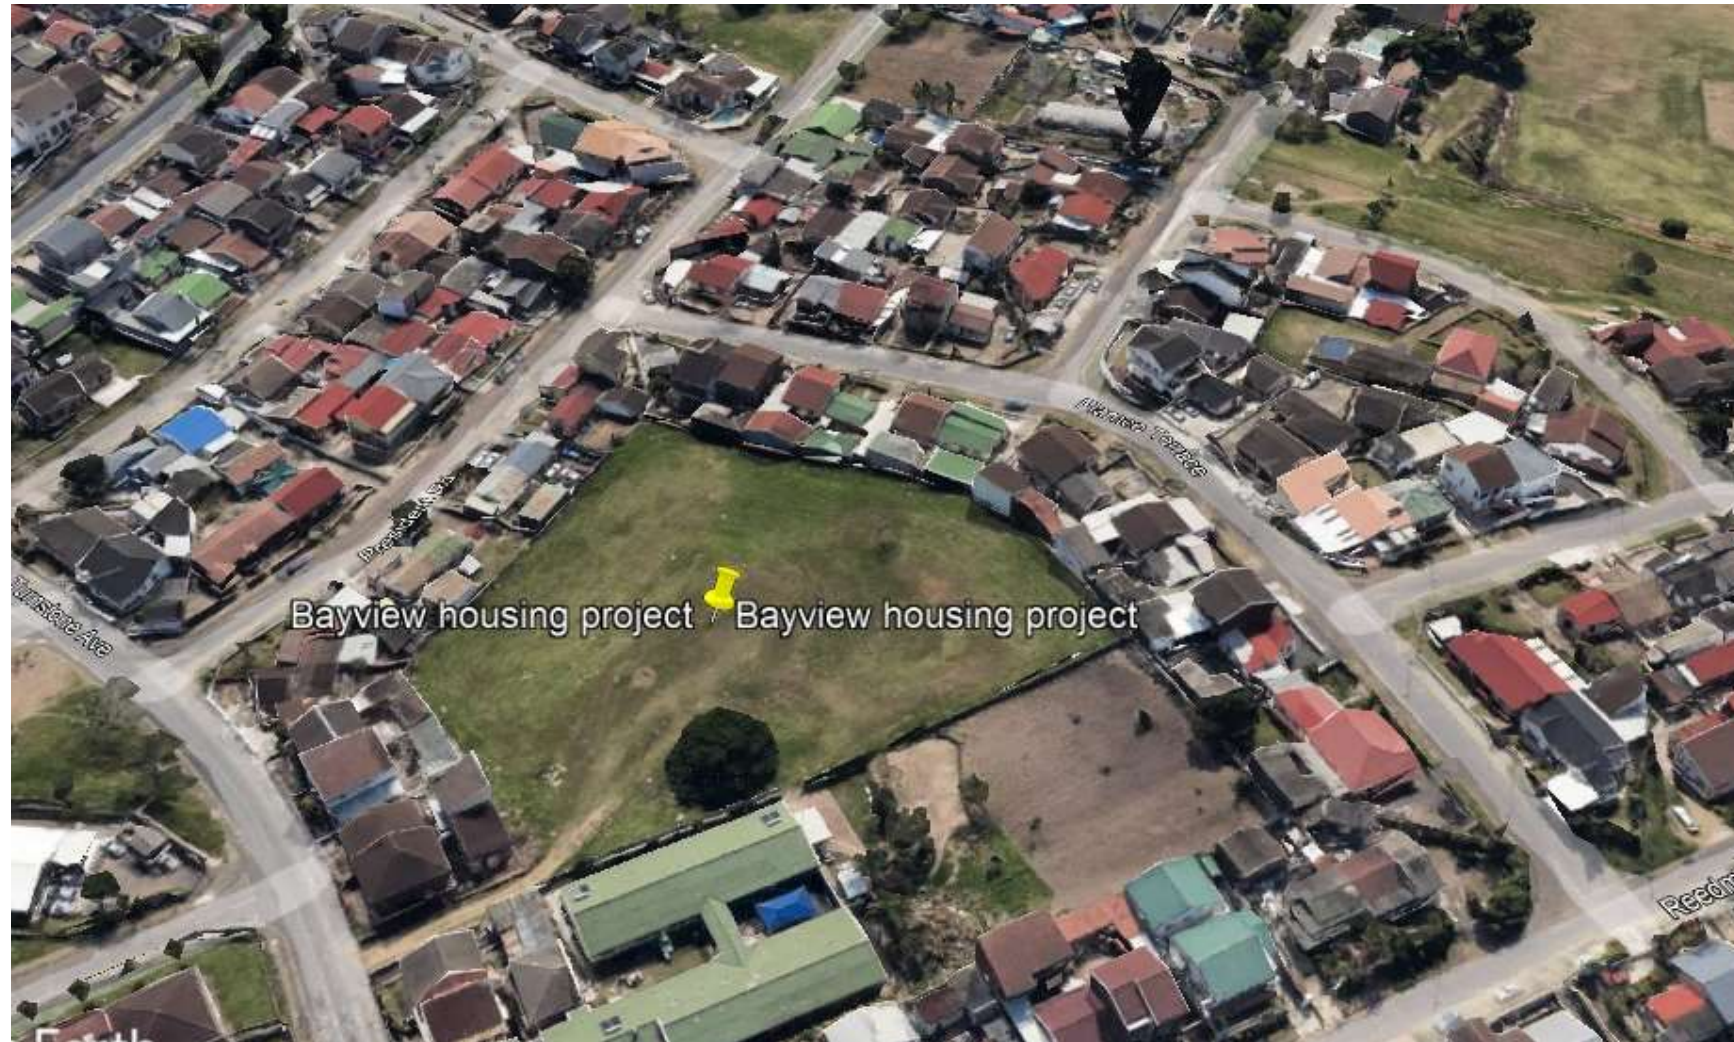
Figure 1: Project site for the Bayview housing project

The site of the proposed housing project is located within the suburb of Bayview in Chatsworth in Durban. The site is bordered by Reedmace Road, Turnstone Avenue, President Road and Flamco Terrace (see **Fig. 1**). A wider view of the surrounding area is depicted in **Fig. 2** which shows the M20 / Lenny Naidu Drive and the M1 / Higginson Highway.

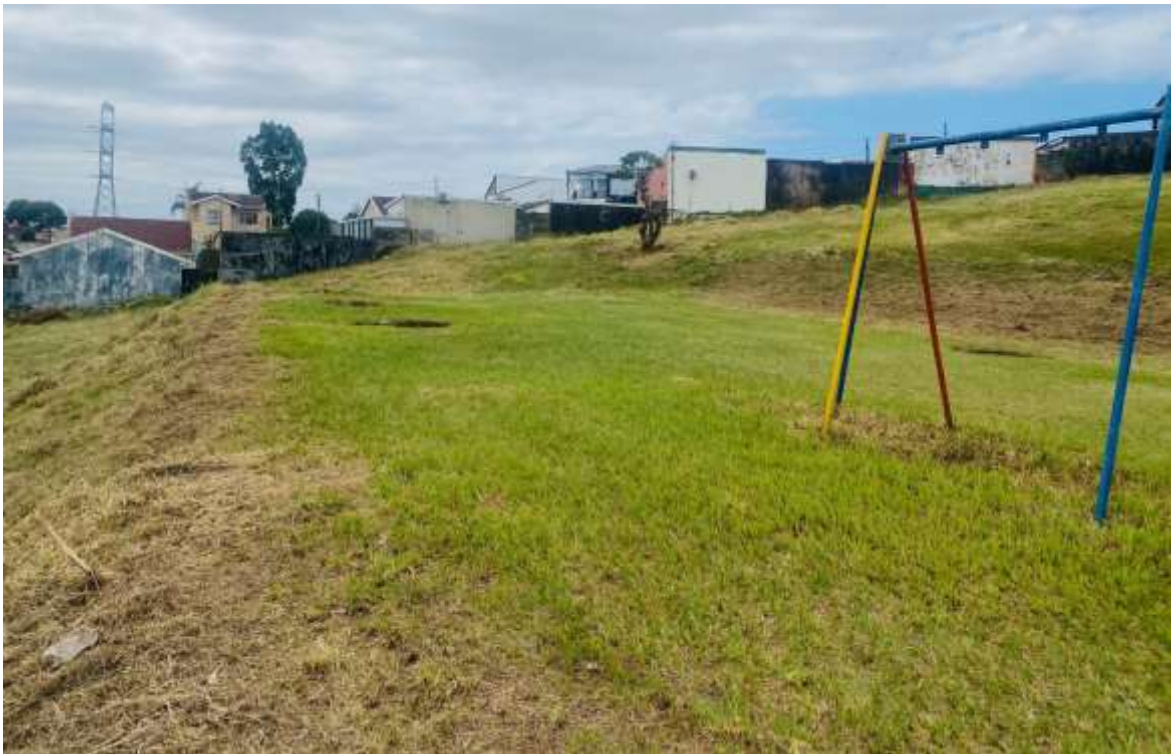
Figure 5: Project site with various levels indicated

As indicated previously, the site of the proposed housing project has been and is currently used recreationally by the surrounding community. A few swings testify to this fact. The site is made up of a number of levels that can be seen in **Fig. 5** where a swing is also visible.

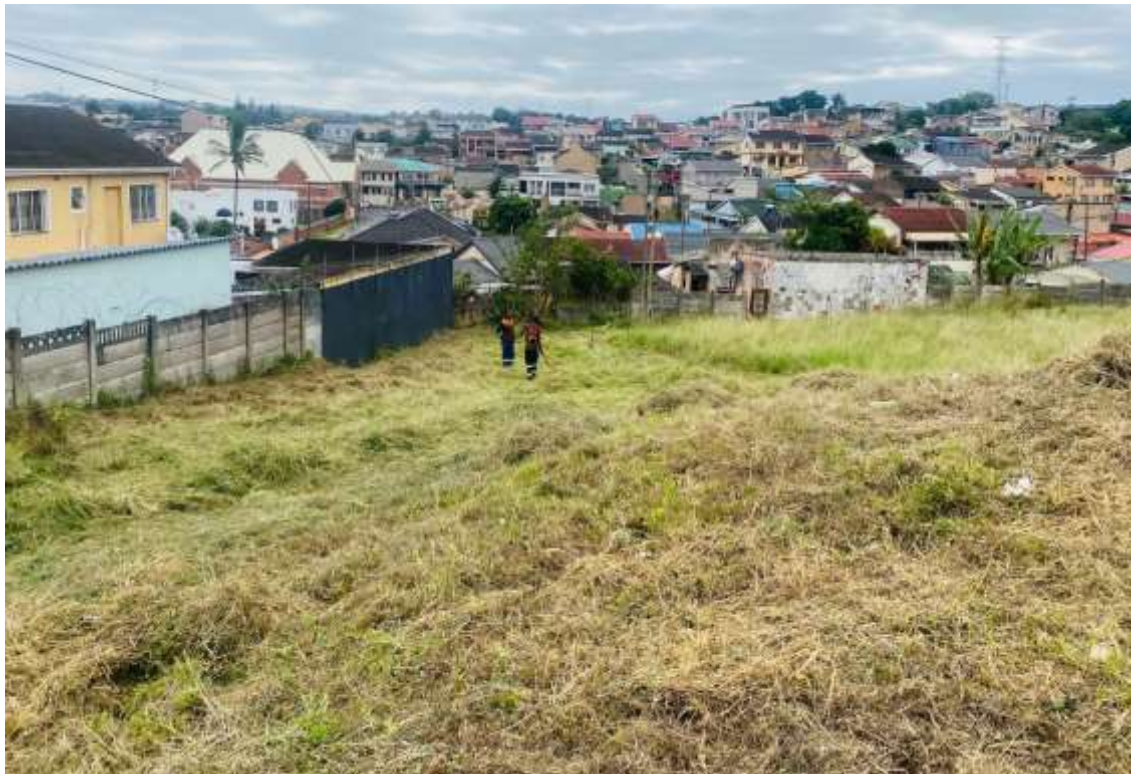
Figure 7: Grass cutting on project site

Fig. 7 below shows the project site looking northwards with municipal workers cutting the grass on the site. No heritage sites were found during the site inspection.

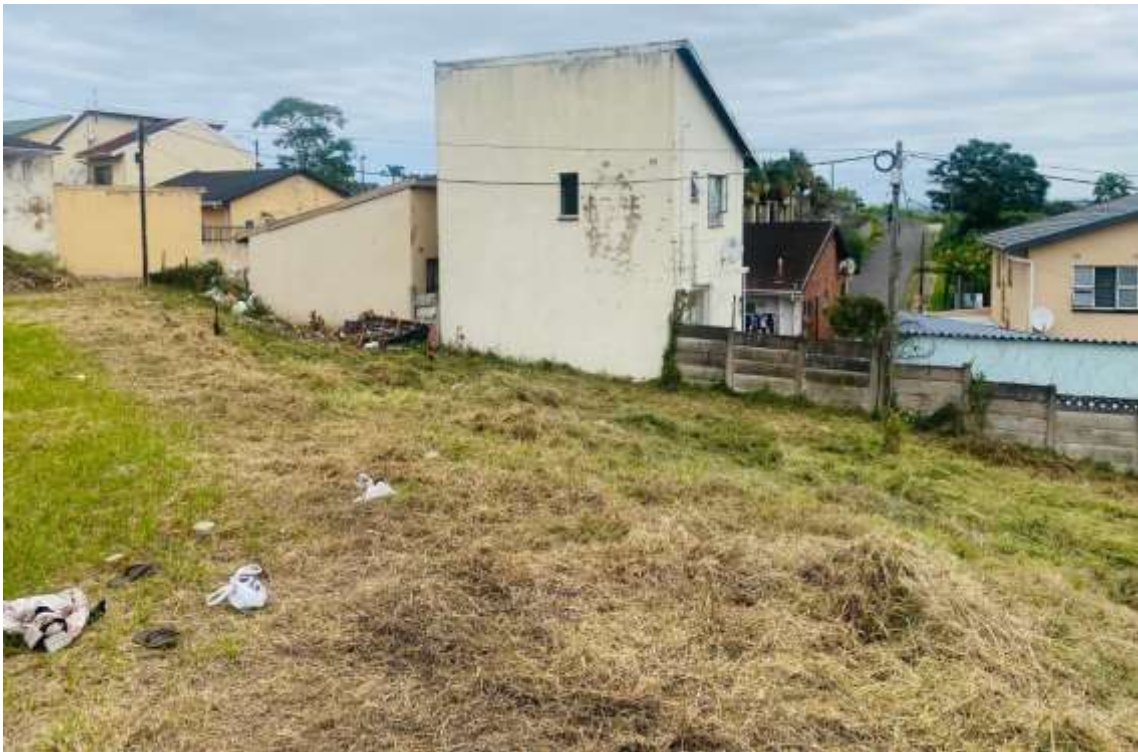
Figure 8: View across project site

During the site inspection, no heritage sites were found on the project site. This is unsurprising as the area has been and is currently used for recreational purposes by the surrounding community. Visibility was good especially as the grass cover on the site had recently been cut.

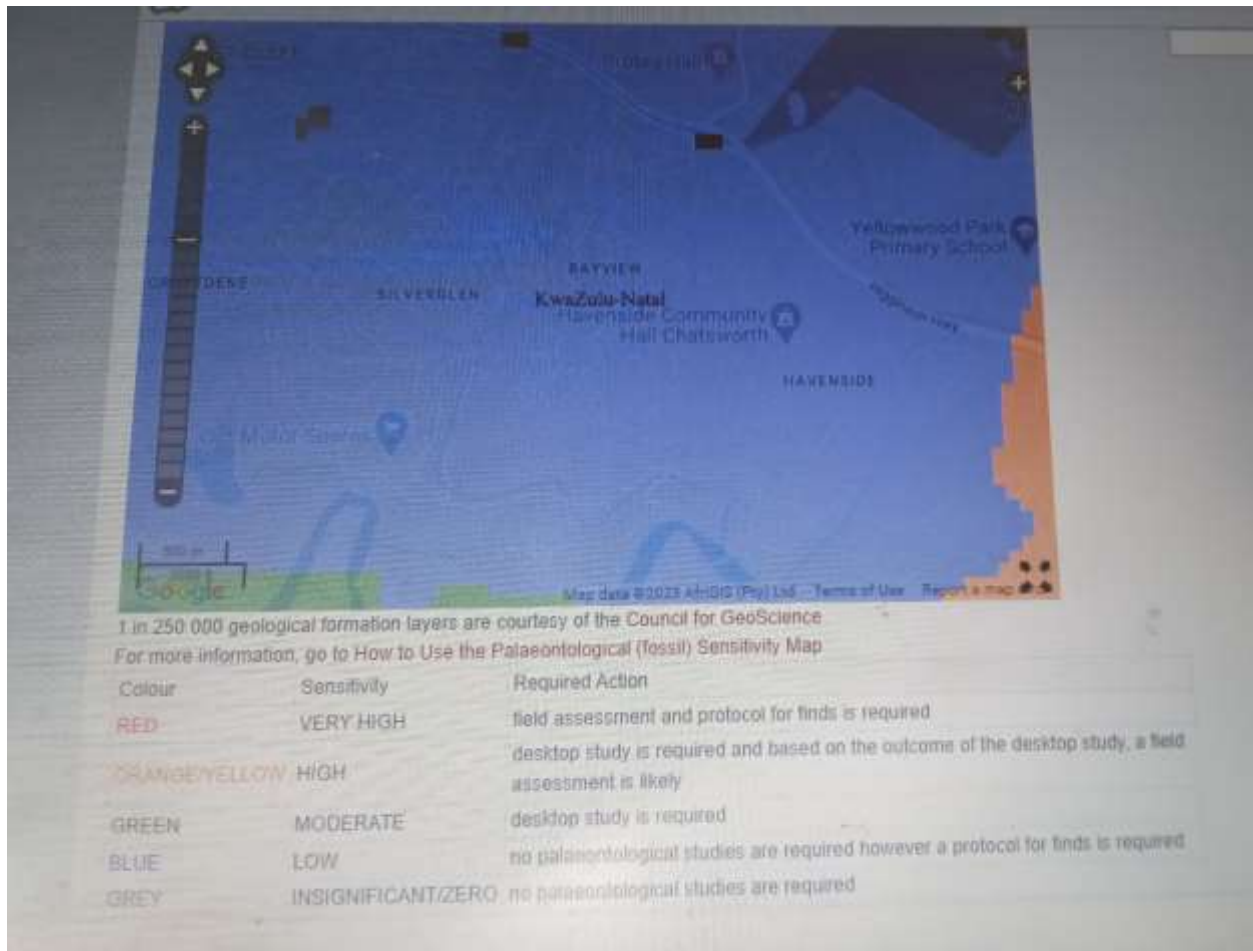
Figure 10: Fossil sensitivity of project area

The South African fossil sensitivity map indicates that the project falls within an area of low fossil sensitivity (blue area as indicated on **Fig. 10**). This means that no further studies are required but that a protocol for chance fossil finds must be included in the Environmental Management Programme (EMPr) for the proposed housing once it is granted environmental authorisation. The protocol can be found in [Chapter 9](#) of this report.

- A Fossil Chance Find Protocol must be included in the EMPr for the proposed construction of the housing project. The following should be adhered to in terms of chance fossil finds:

- When construction activities begin, any rocks disturbed during this process must be given a cursory inspection by the environmental officer or designated person. Any fossiliferous material (trace fossils, plants, insects, bone, and coal) should be put aside in a suitably protected place.

- Photographs of possible fossils should be sent to a palaeontologist for preliminary assessment.
 - If there is any fossil material found by the environmental officer, then a qualified palaeontologist must be sub-contracted in order for them to visit the site to inspect the selected material and check the dumps where feasible.

- Fossil plants or vertebrates that are considered to be of good quality or scientific interest by the palaeontologist must be removed, catalogued and housed in a suitable institution where they can be made available for further study. Before the fossils are removed from the site, permit must be obtained from the Institute. Annual reports must be submitted to the Institute as required by the relevant permits.
