**Palaeontological impact assessment report for the proposed
building of the Bhatha Road (upgrade to type 7A) between the
D799 and P263, Kleinfontein village, Ladysmith, KwaZulu-Natal**

Compiled by Gary Trower

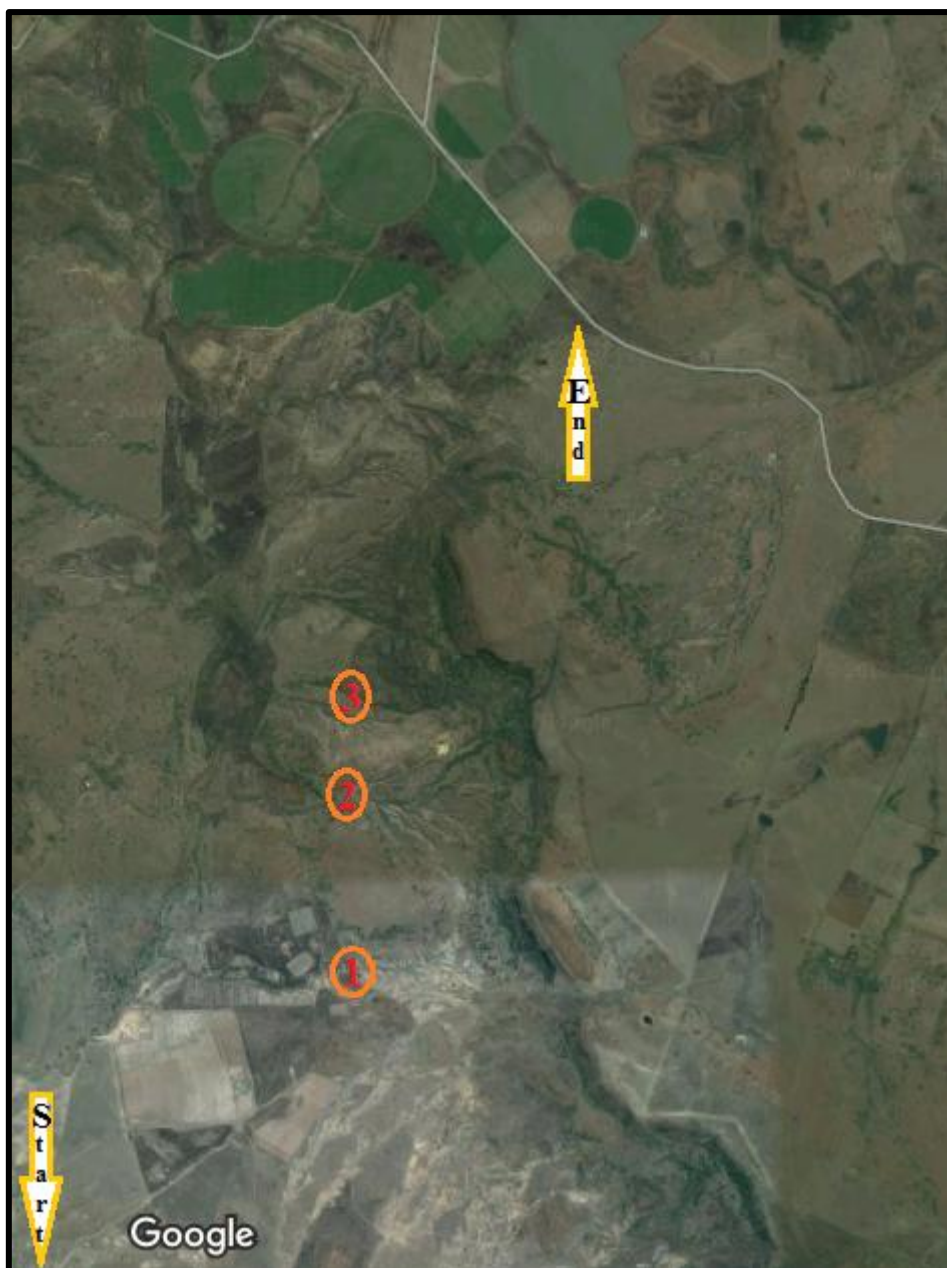
Figure 2: Satellite image of valley where Bhattha road development will take place. The **Start** arrow ($S28^{\circ} 17' 59.1''$, $E29^{\circ} 42' 51.1''$) indicates where it branches off the D799 and the **End** arrow ($S28^{\circ} 14' 58''$, $E29^{\circ} 44' 52''$) indicates where it joins the P263. Number **1** ($S28^{\circ} 17' 01.5''$, $E29^{\circ} 43' 52.4''$) indicates the watercourse where the fossils were observed, number **2** ($S28^{\circ} 16' 27.4''$, $E29^{\circ} 43' 35.6''$) is referred to as “Drainage Line 1” on the map of the original proposal and number **3** ($S28^{\circ} 16' 09.7''$, $E29^{\circ} 43' 33.6''$) is referred to as “Drainage Line 2”. North is at the top of the page. Image courtesy of Google Earth, DigitalGlobe (2016).

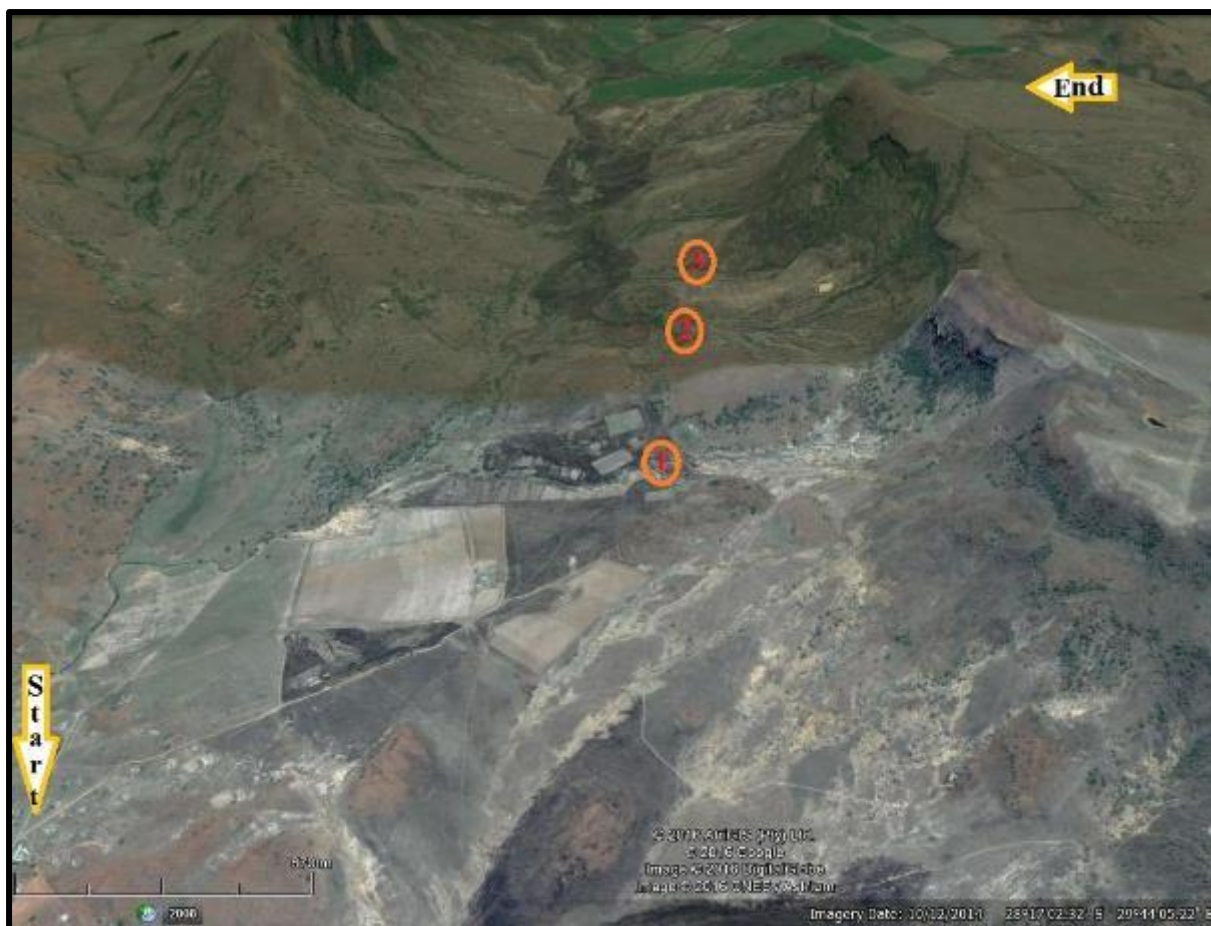
Figure 3: Satellite image of the valley where Bhatha road development will take place. The Start arrow (S28° 17' 59.1", E29° 42' 51.1") indicates where the road branches off the D799, the End arrow (S28° 14' 58", E29° 44' 52") indicates where it joins the P263. At points 1, 2 & 3 the Ecca bedrock (Volksrust Formation) was visible, but at the watercourse (1) a mudstone containing fossils was also noted, possibly representing some pockets of Beaufort lower down in the stratigraphy. The elevation of the landscape is exaggerated to emphasize the topography, North is at the top of the page. Image courtesy of Google Earth, DigitalGlobe (2016).

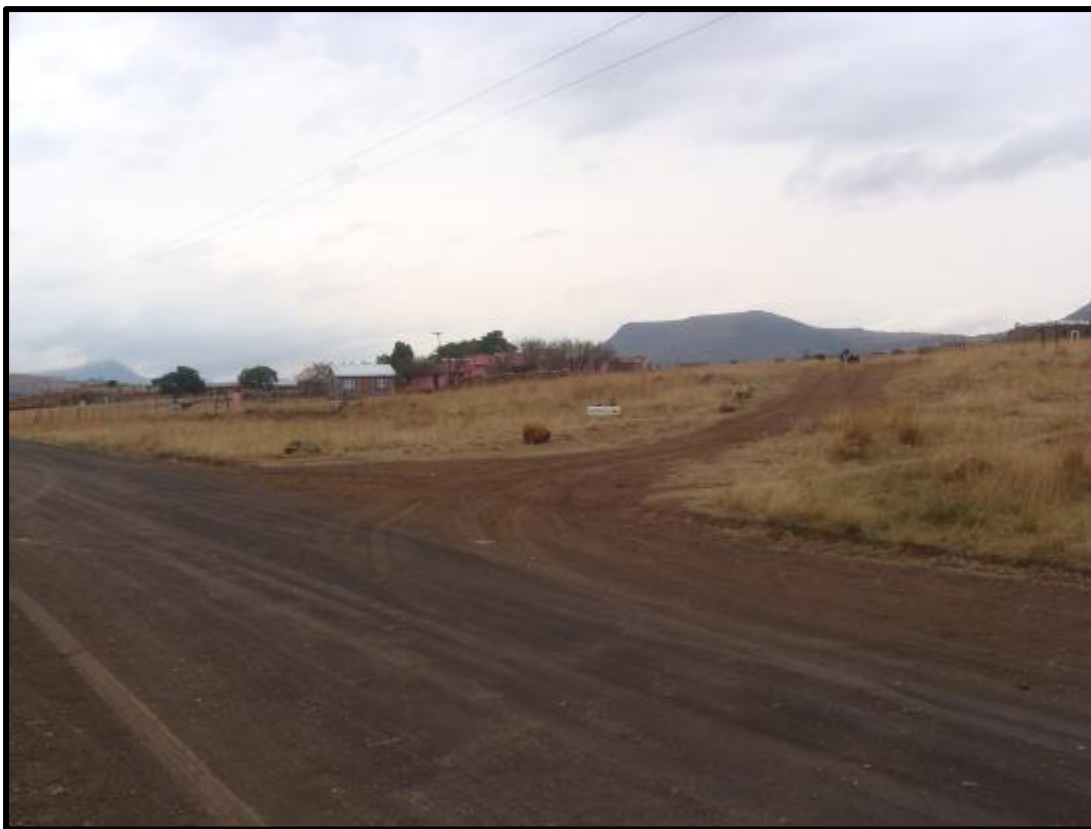
Figure 4: Photo indicating the start of the Bhatha road, off the D799, heading in an easterly direction (S 28° 17' 59.1", E 29° 42' 51.1")

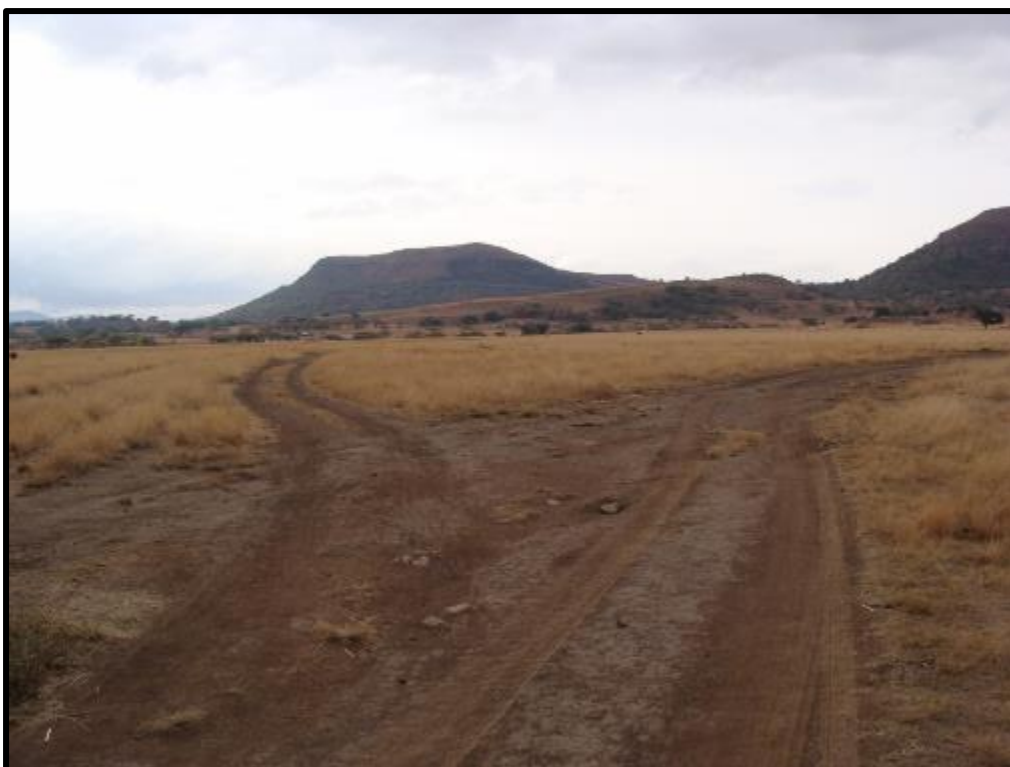
Figure 5: Adjacent to mielie field mud road splits in two. The original map indicates that the road will follow the route to the left on the way to the "Watercourse" (point 1)

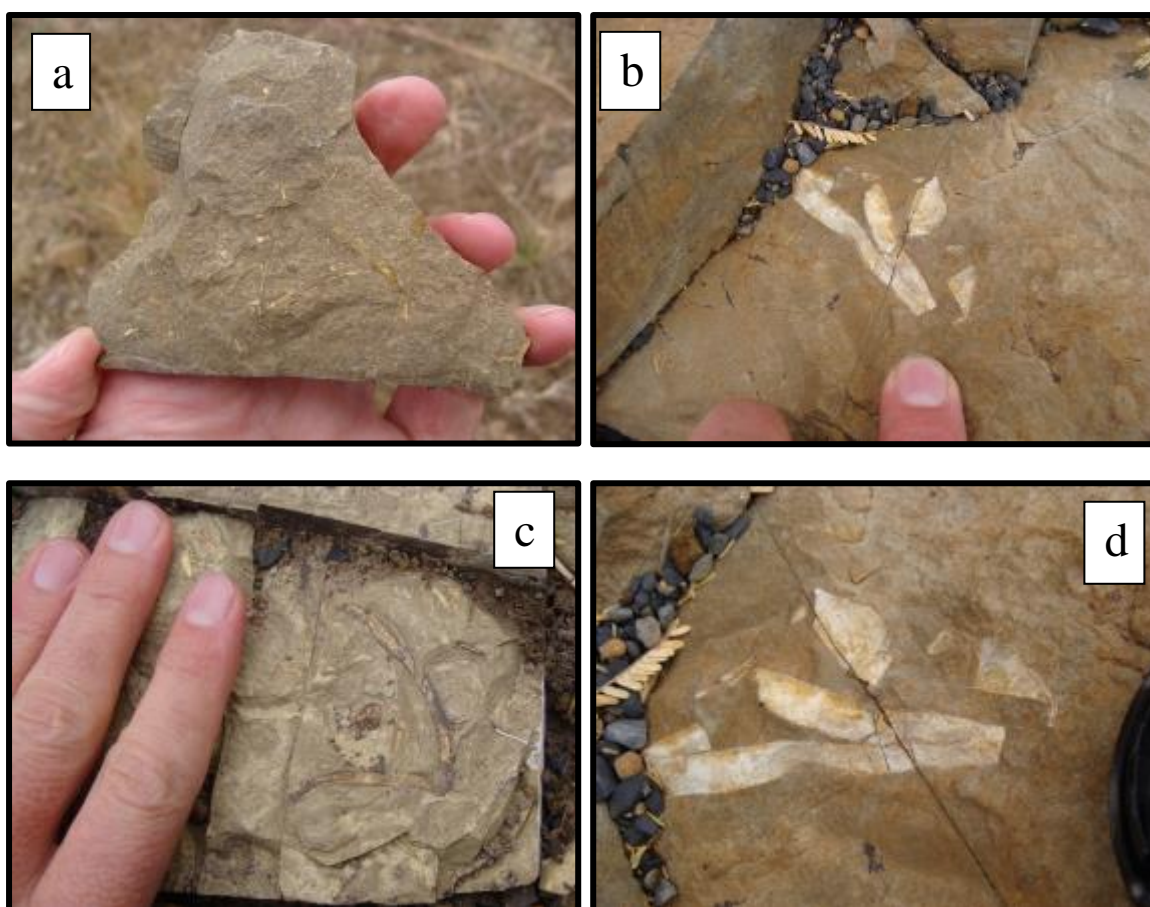
Fossils were only observed at one location, at the site known at “Watercourse” on the original map or as point 1 in Figure 2 and 3 above. The fossils all seem to be plant in origin and are very fragmentary in nature. Fossil stems were recorded, as well as a possible fruiting body (Figure 6 and 7). Some recorded observations were likely geological and chemical in nature, such as several possible nodules, as well as flat disc-like observations which were likely chemical in nature (Figure 8).

Figure 6a,b,c,d: Plant fossils observed at “Watercourse” (point 1), located in a Beaufort grey-green mudstone. 6a possibly represents thin stems or branches, and could have been herbaceous in structure. 6b-d represents plant stems which appear to have been woodier in nature. 6d is the same fossil as 6b, taken from above and with the tip of a shoe for further scale

building activities to rescue specimens or a recommendation for a follow-up site inspection during construction. The fossils are very fragmentary in nature and their incompleteness restricts scientific identification, making the knowledge they can contribute to science negligible. This mudstone outcrop extends over several metres in the area of the bridge (causeway), but even careful inspection of the length of this unit not directly affected by construction failed to yield any vertebrate or invertebrate fossils, trace fossils or any visible fossil communities or relationships. Therefore the construction of this road will not pose any significant threat to observed and recorded palaeontological resources in the landscape.

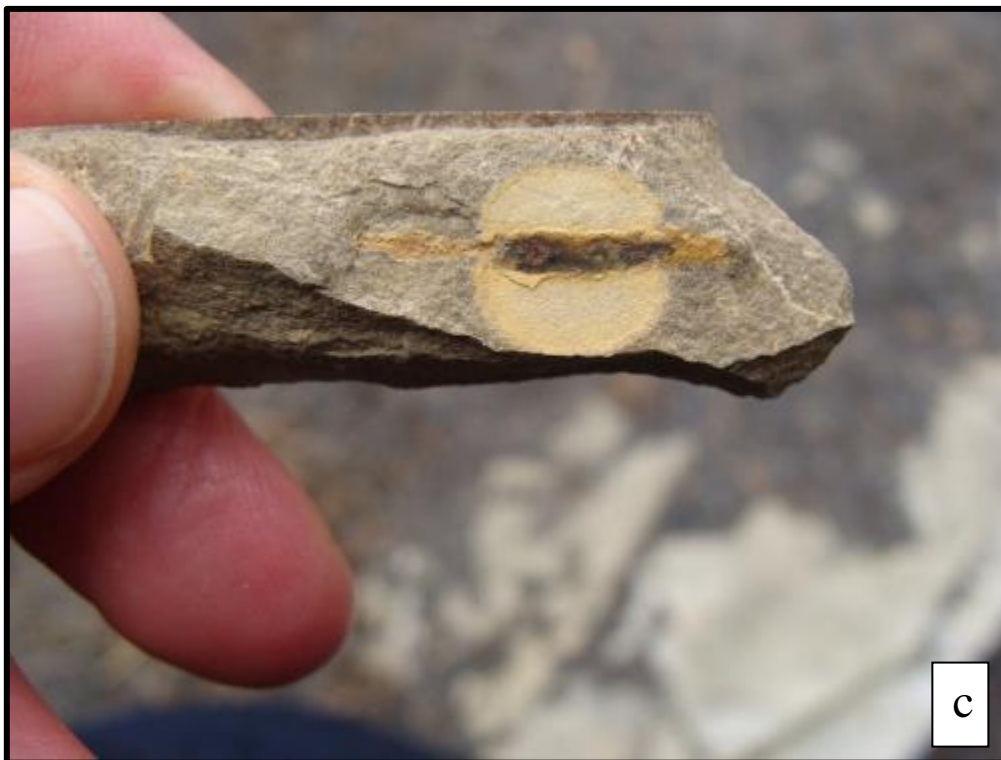
Figure 7a,b,c: Figure 7a is the zoomed in version of Figure 7b. Although this may be a chemical structure, the image may also be that of a reproductive or fruiting body of a plant, with the green arrows pointing to possible outgrowths on the edge of the structure. 7c bears some resemblance to 7a and b but is most probably a biochemical signature, e.g. some form of decay

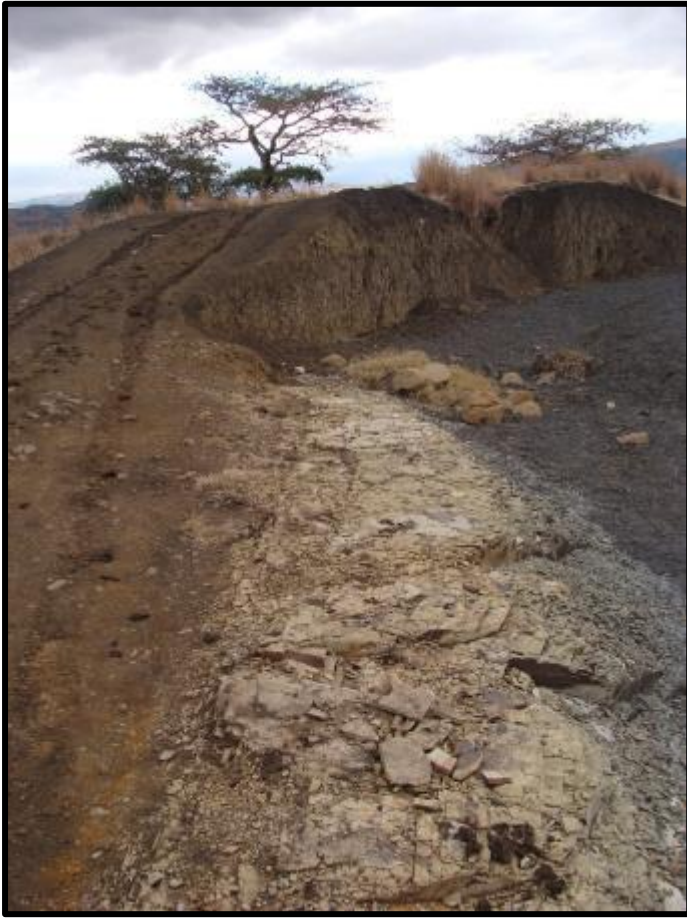
Figure 9: Point 1, (“Watercourse”) depicting the existing road running over bedrock in the form of fossiliferous Beaufort mudstone. This is the approximate place where the causeway will be positioned. Looking up the valley in a northerly direction

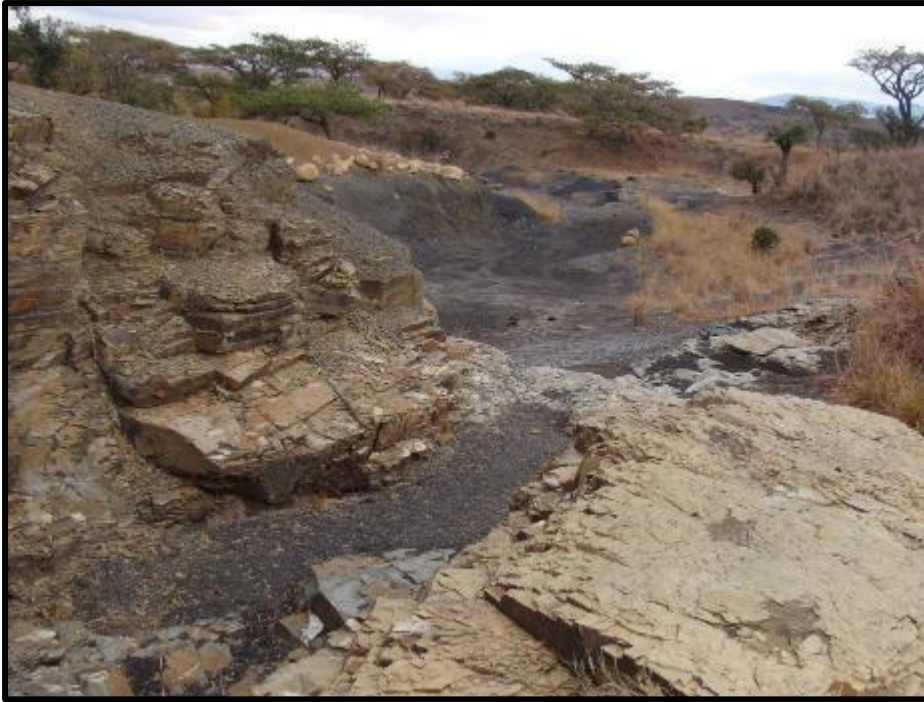
Figure 10: Beaufort mudstone and dark grey Ecca shale. The few recorded fossil fragments were observed within the mudstones of this site. Younger deposits in the form of large dolerite boulders, alluvial clays and topsoil are seen lying above the shale (top left, below bright green tree).

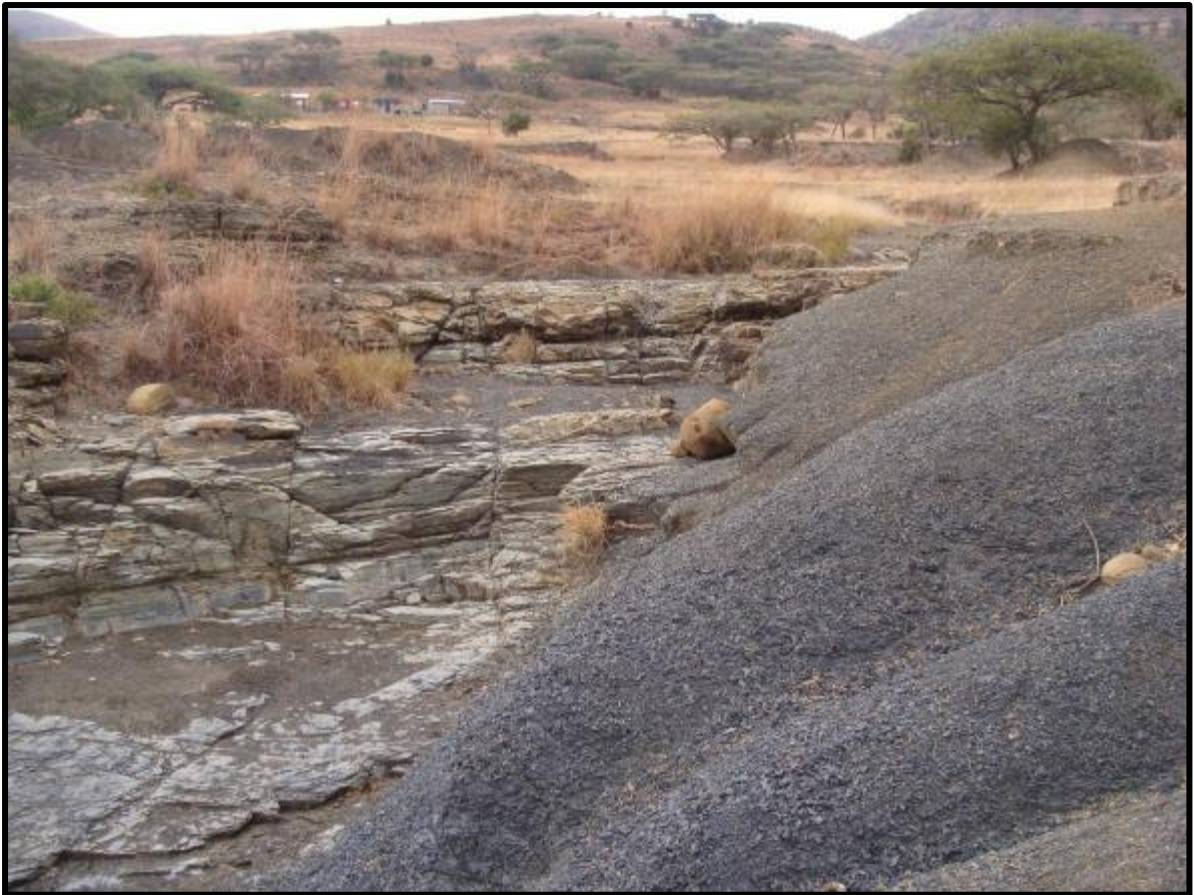
Figure 11: Looking east at point 1 (“Watercourse”). On the right is dark grey shale, on the left grey-green mudstone. The bridge or causeway will be built in this position, resting on bedrock.

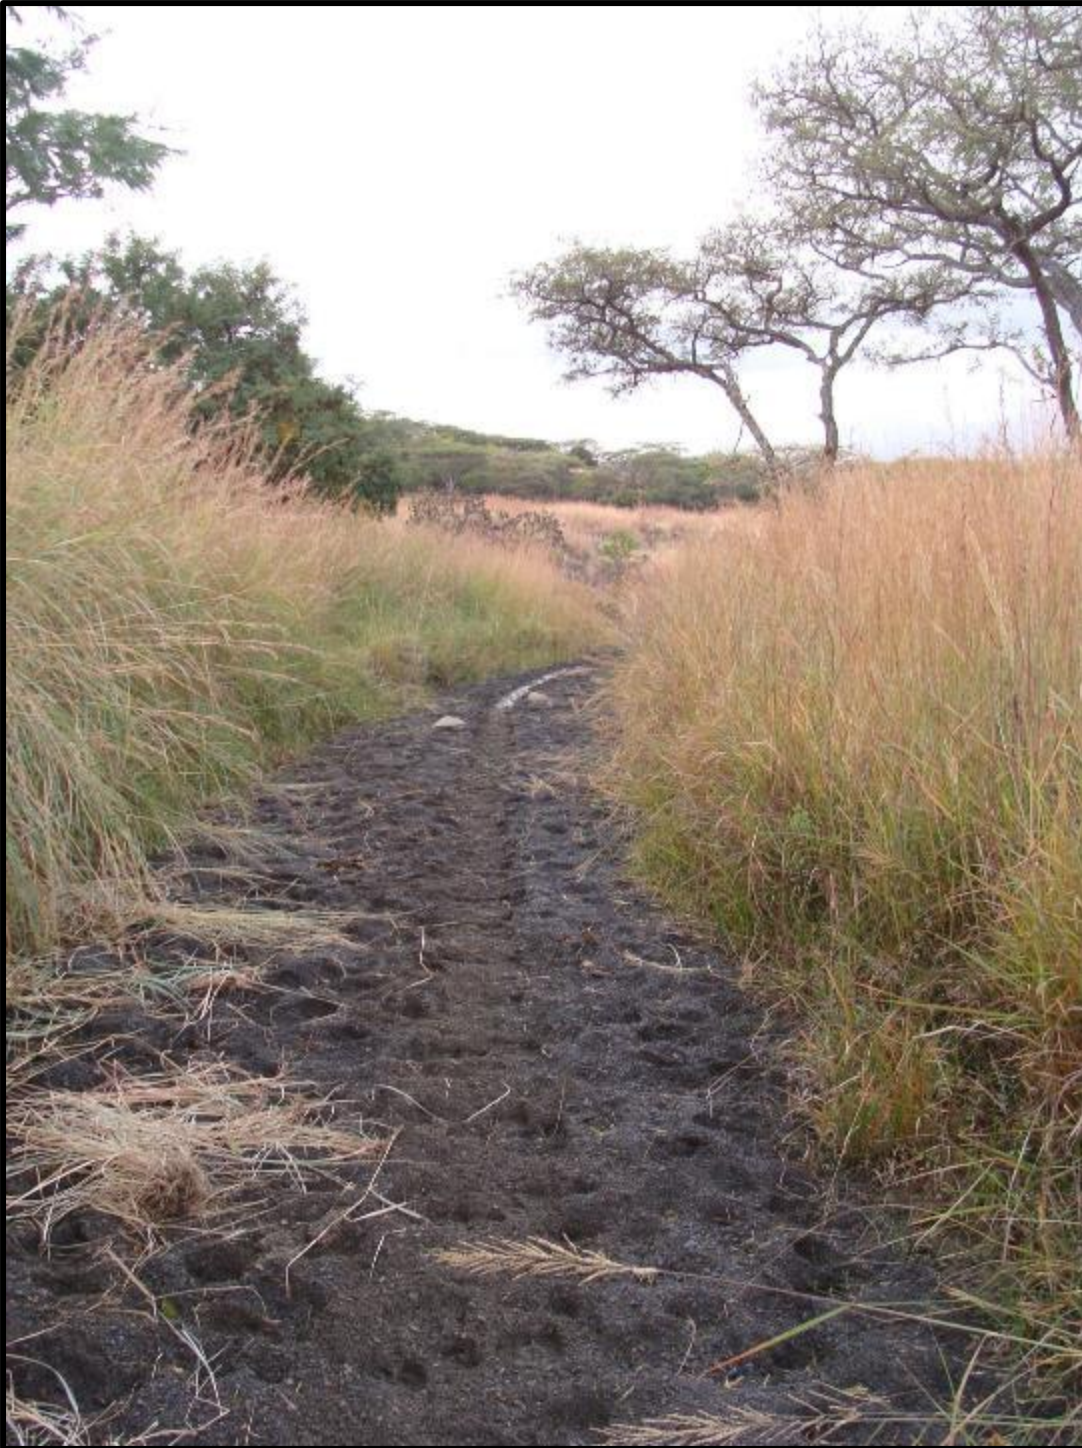
Figure 12: Point 2 (“Drainage 1”), looking east towards the mountain. This is the position of the probable culvert as the crossing is narrower and free of rocks and bedrock.

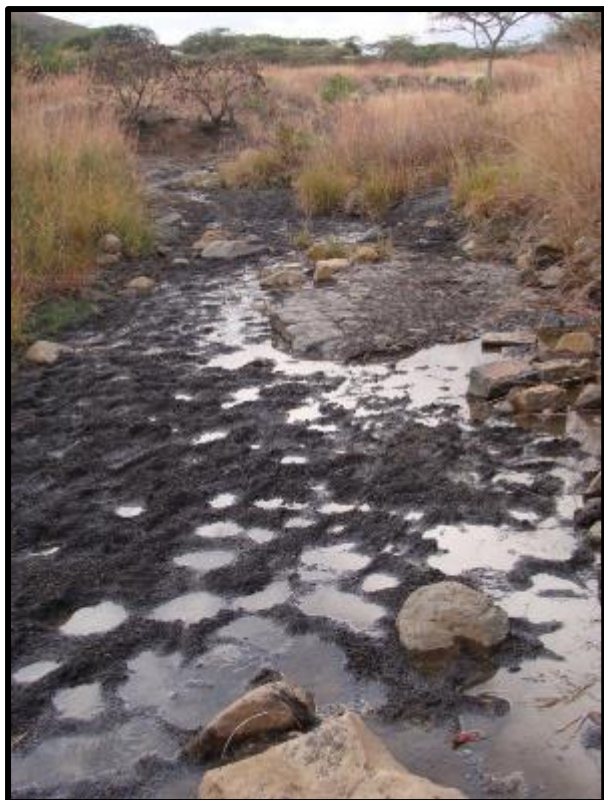
Figure 13: Within the stream channel of “Drainage 1”, looking east. There were patches of bedrock within the stream bed, but the majority of the shale was transported and redeposited. Higher up in the stream bed carbonaceous shales, as well as a thin band of sandstone, was visible within the stratigraphy, indicating typical elements of the Beaufort deposits. In spite of intensive searching in the general area, no fossils were recorded in the area of the proposed culvert of “Drainage 1”.

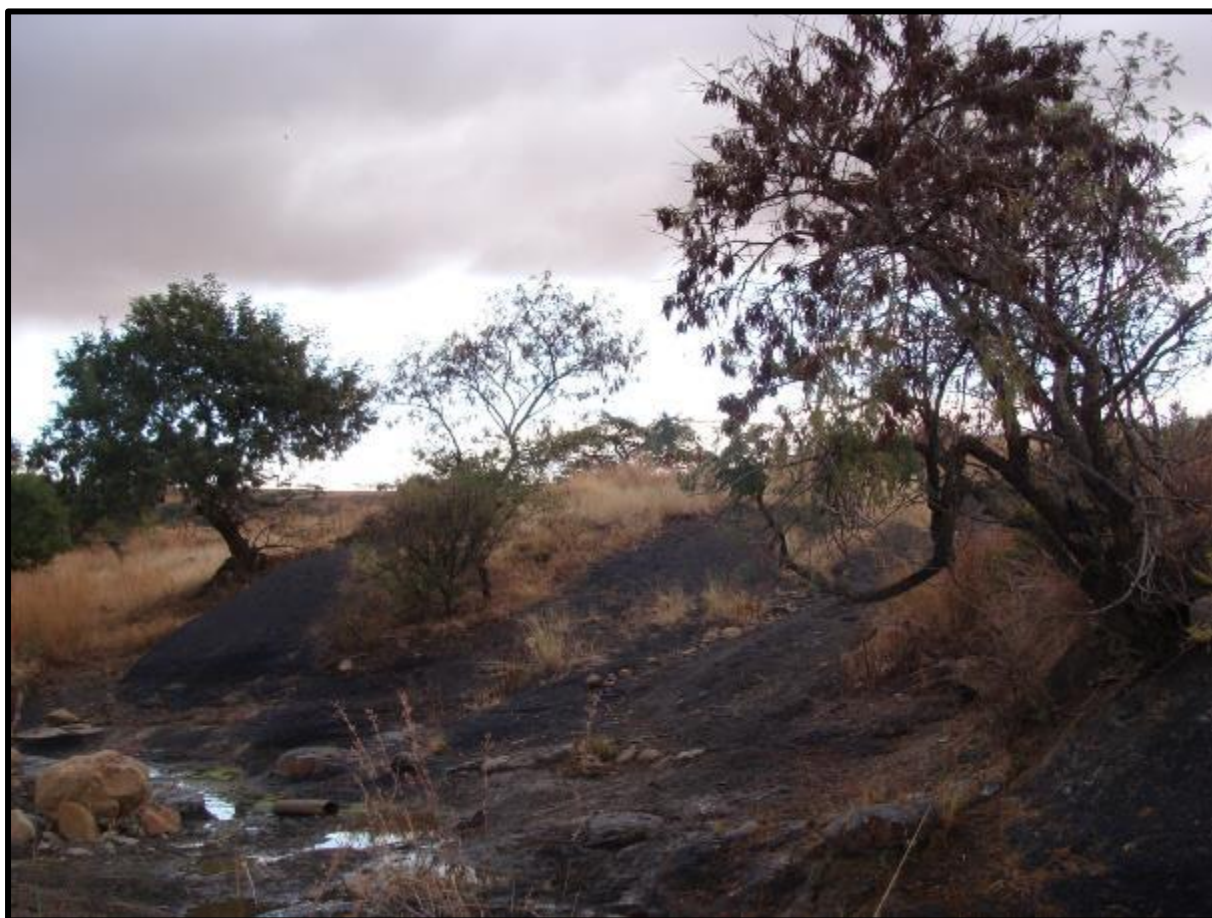
Figure 14: Looking west along drainage 1, point 2. There were two roads crossing the stream in close proximity, the one further downstream was narrower whereas this one had more boulders and bedrock which prevented effective vehicular access. No archaeological or palaeontological material was recorded during the survey of drainage 1

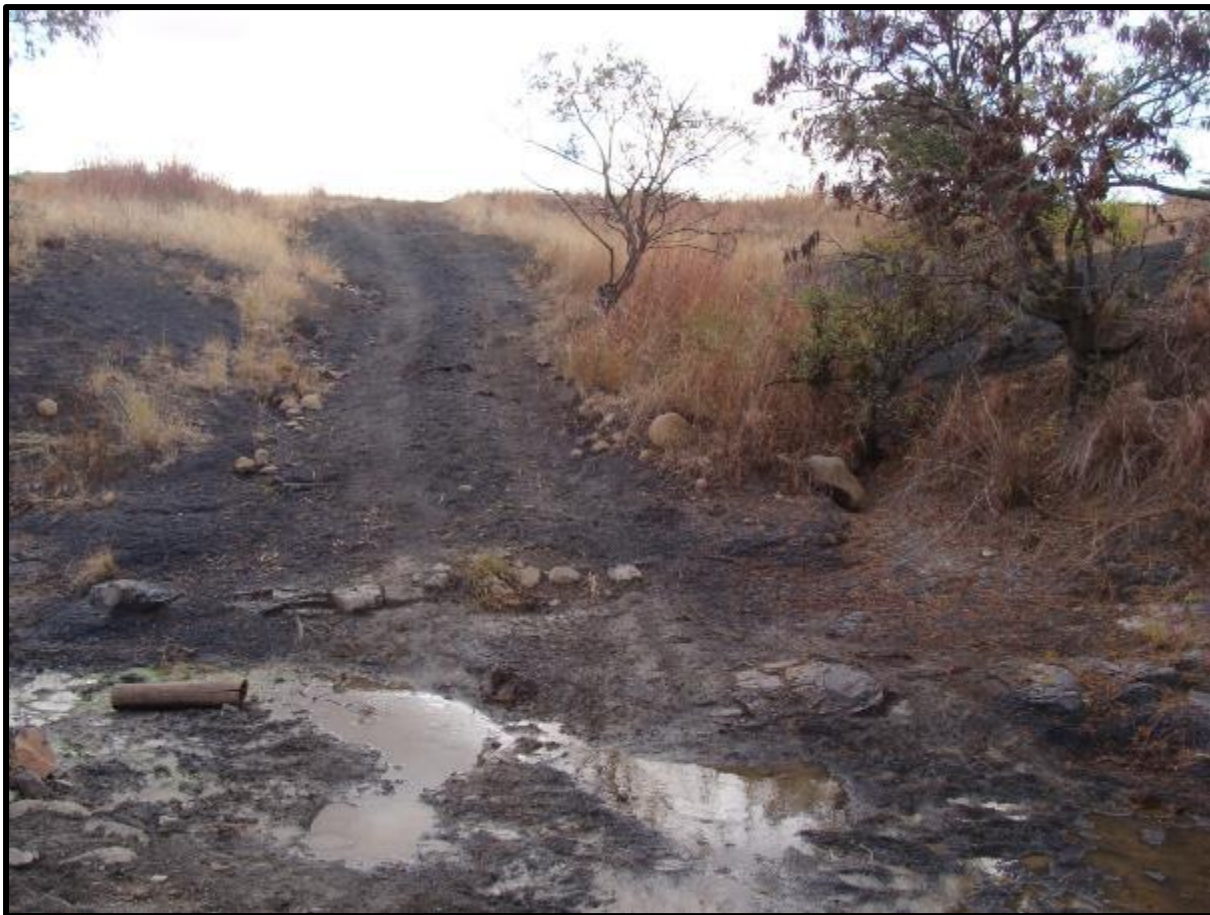
Figure 15: Looking north up the valley and standing next to the stream of drainage 1. This is the crossing further upstream and I was uncertain which of these two points would be chosen for the culvert so both were surveyed but neither contained any archaeological or palaeontological material

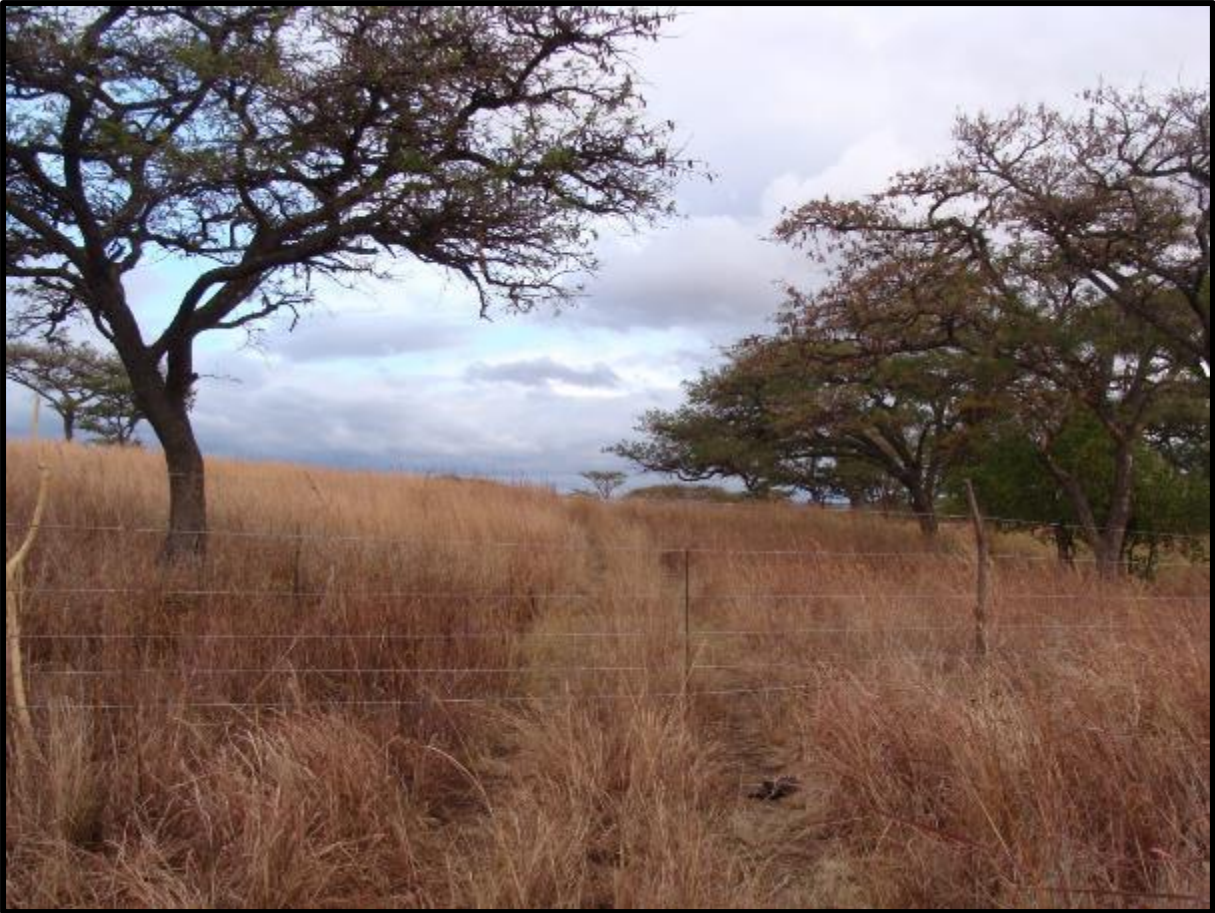
Figure 16: The rest of the survey was done on foot as the grass was getting too high and the road was beginning to fade out. Furthermore, just a hundred metres from Drainage 1 on route to Drainage 2, the road had been blocked off by a newly erected fence. A gentleman was working on the fence and had created a gate further down in a corner of a camp he had fenced in.

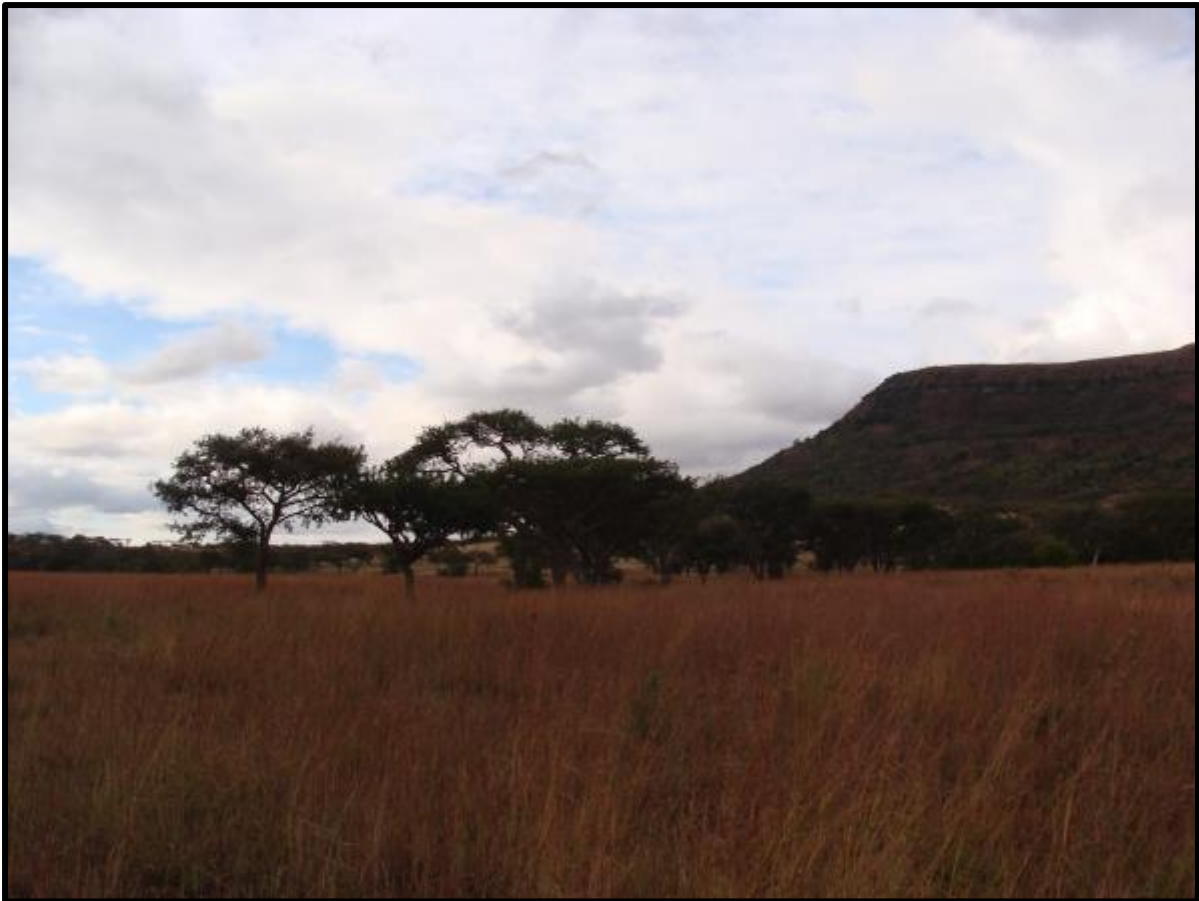
Figure 17: The position of “Drainage 2” (point 3), indicated by the trees growing in the streambed. Behind the trees is the path that the road will follow as it curves right, goes around the mountain and joins with the P263

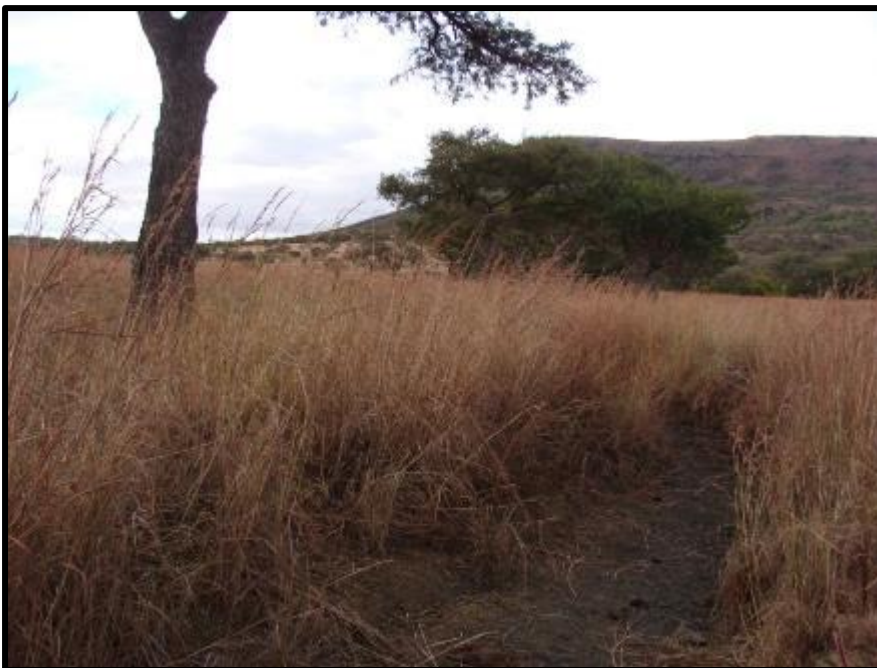
Figure 18: The view from where the road crosses the stream of Drainage 2 (point 3) and where the second culvert will be positioned. The road disappeared soon afterwards and the rest of the survey was done by following the GPS to the junction with the P263

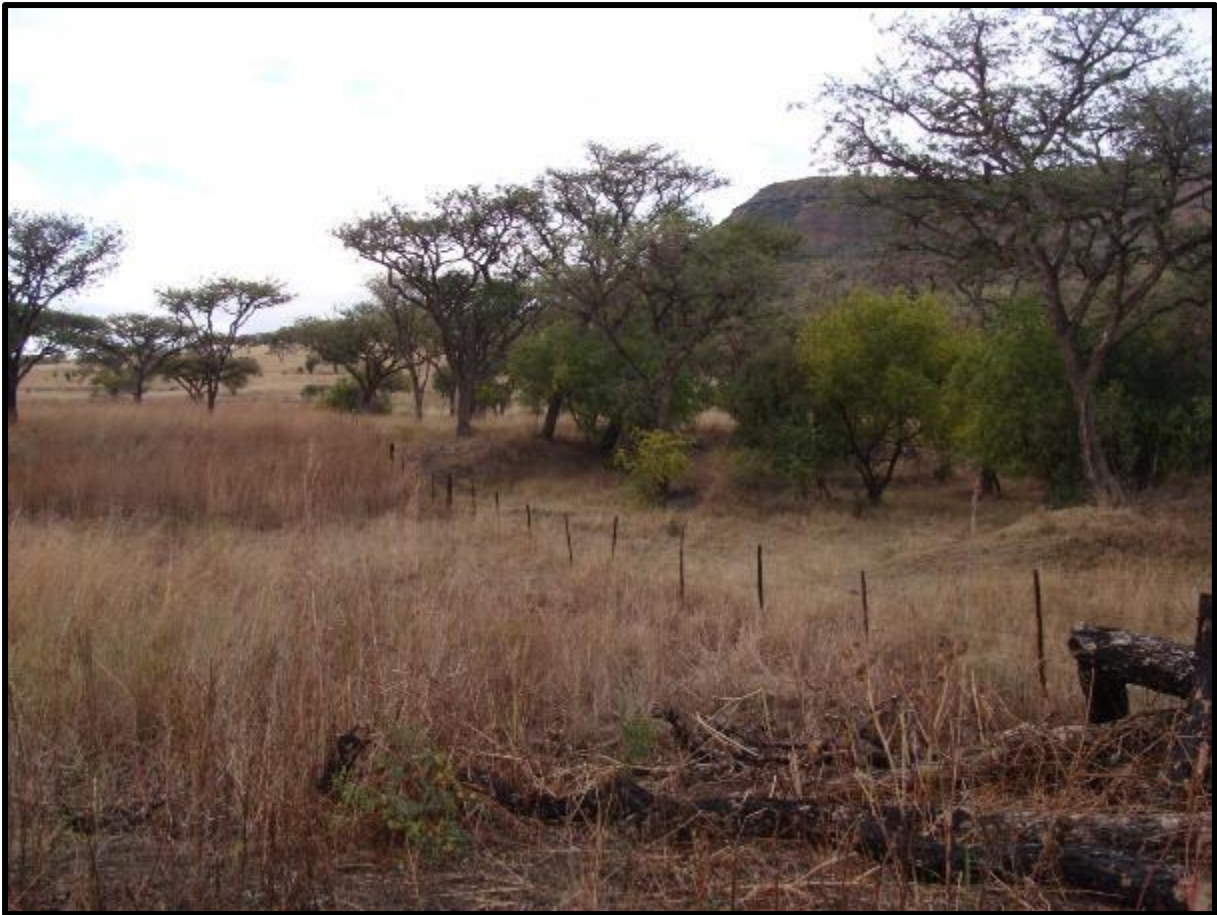
Figure 19: Close to Drainage 2 (point 3) but further upstream, approximately 2.2 km from the junction with P263. Heading towards the corner where the road will round the mountain and meet the existing road
