**A PHASE ONE GEOTECHNICAL INVESTIGATION REPORT ON PORTION 8
OF THE FARM BOSCHOEK 103 JQ FOR A PROPOSED RESIDENTIAL
TOWNSHIP ESTABLISHMENT**

Report Number: 2020/J014/NDC

Prepared by: Soilkraft cc

On Behalf of: Nkanivo Development Consultants

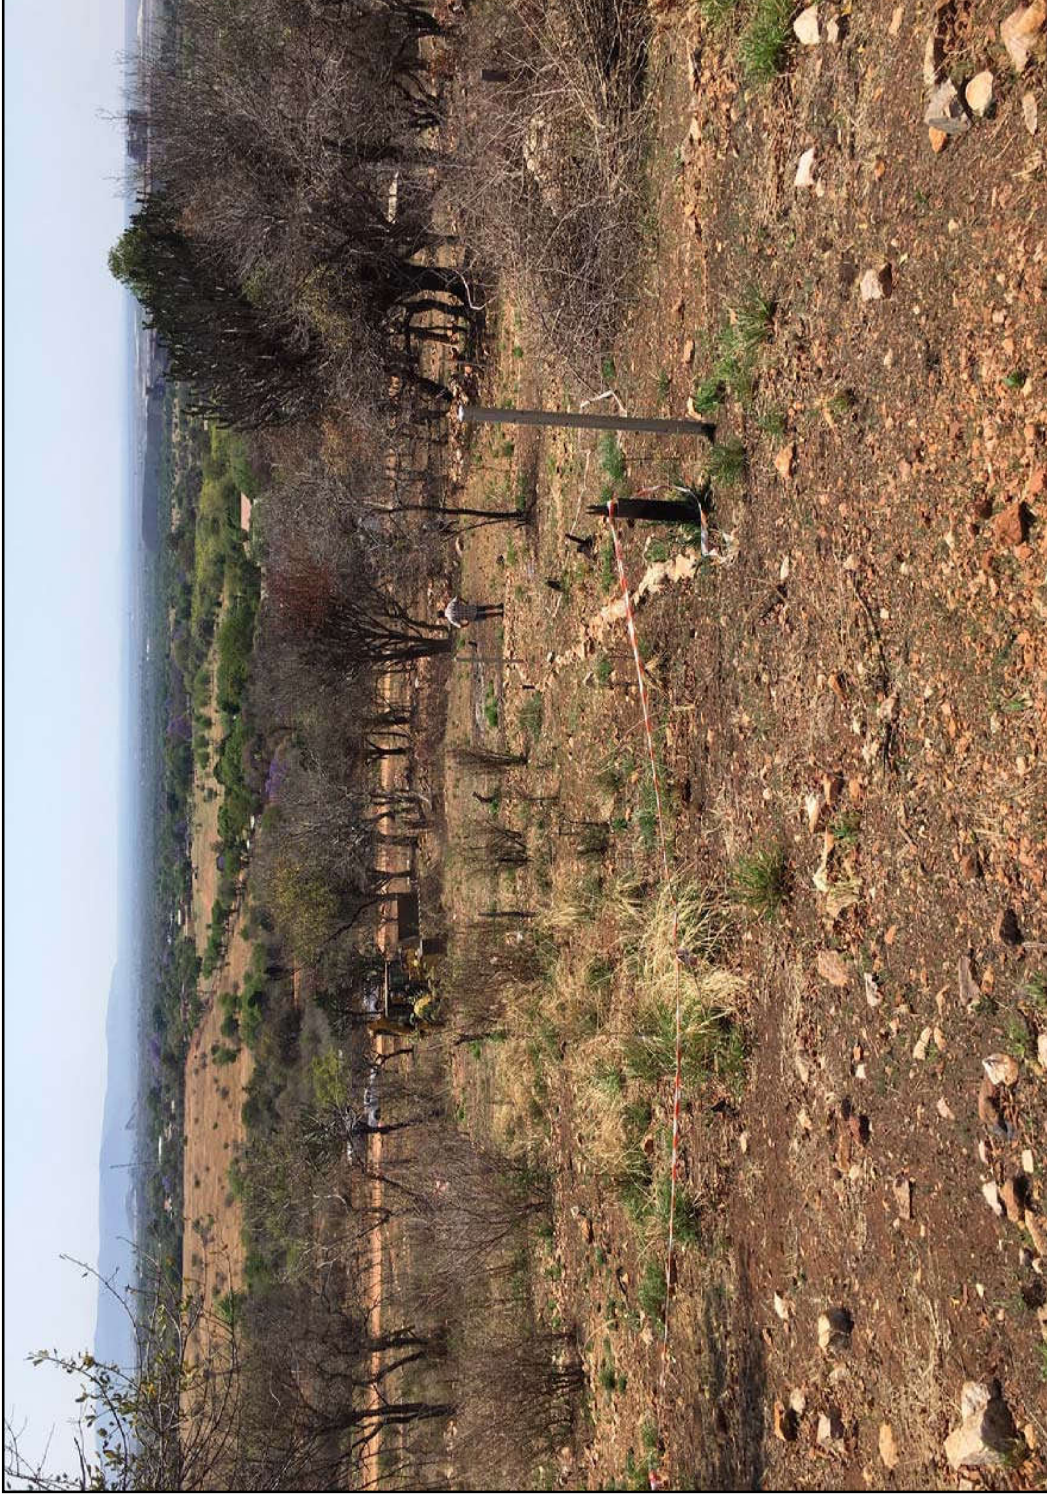
PHOTO 1

At the time of the investigation, the study area was partially occupied by ongoing settlement. Stands were actively being allocated, cleared and used to settle upon. In addition, the northernmost portion of the site was in use as a commercial facility for concrete and brick production and sales. Elevated water storage tanks and communal taps were installed on the site to supply water to local residents, and an overhead electrical powerline crossed the site. No other services were noted on the site.

A number of small, abandoned and largely demolished buildings were found near the southern corner of the site. These appeared to consist of abandoned farm houses. In addition, stockpiles of what appeared to be waste material and a defunct crushing and loading plant were found in the north western corner of the site.

SITE CONDITIONS

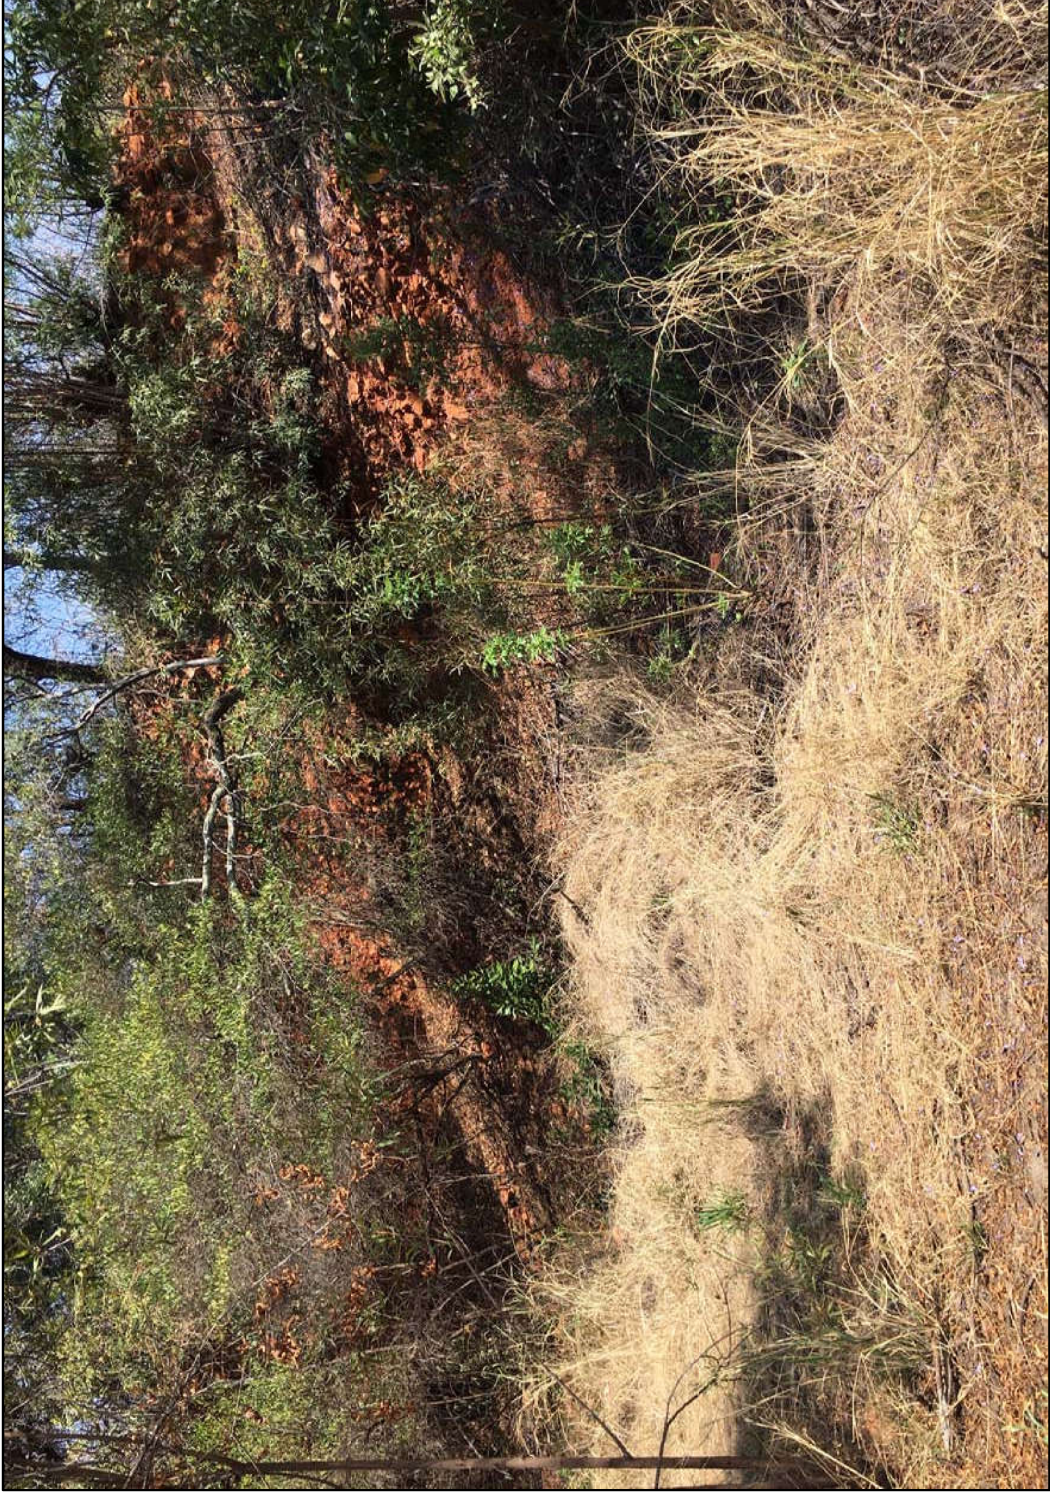
PHOTO 2

- *Excavations*: The area surrounding trial hole 8 appeared to form part of a fairly deep excavation, as illustrated in Photo 2. This area appears to have been excavated decades ago and was presumably used to procure gravel, following which it was left unrehabilitated.

DEEP EXCAVATION

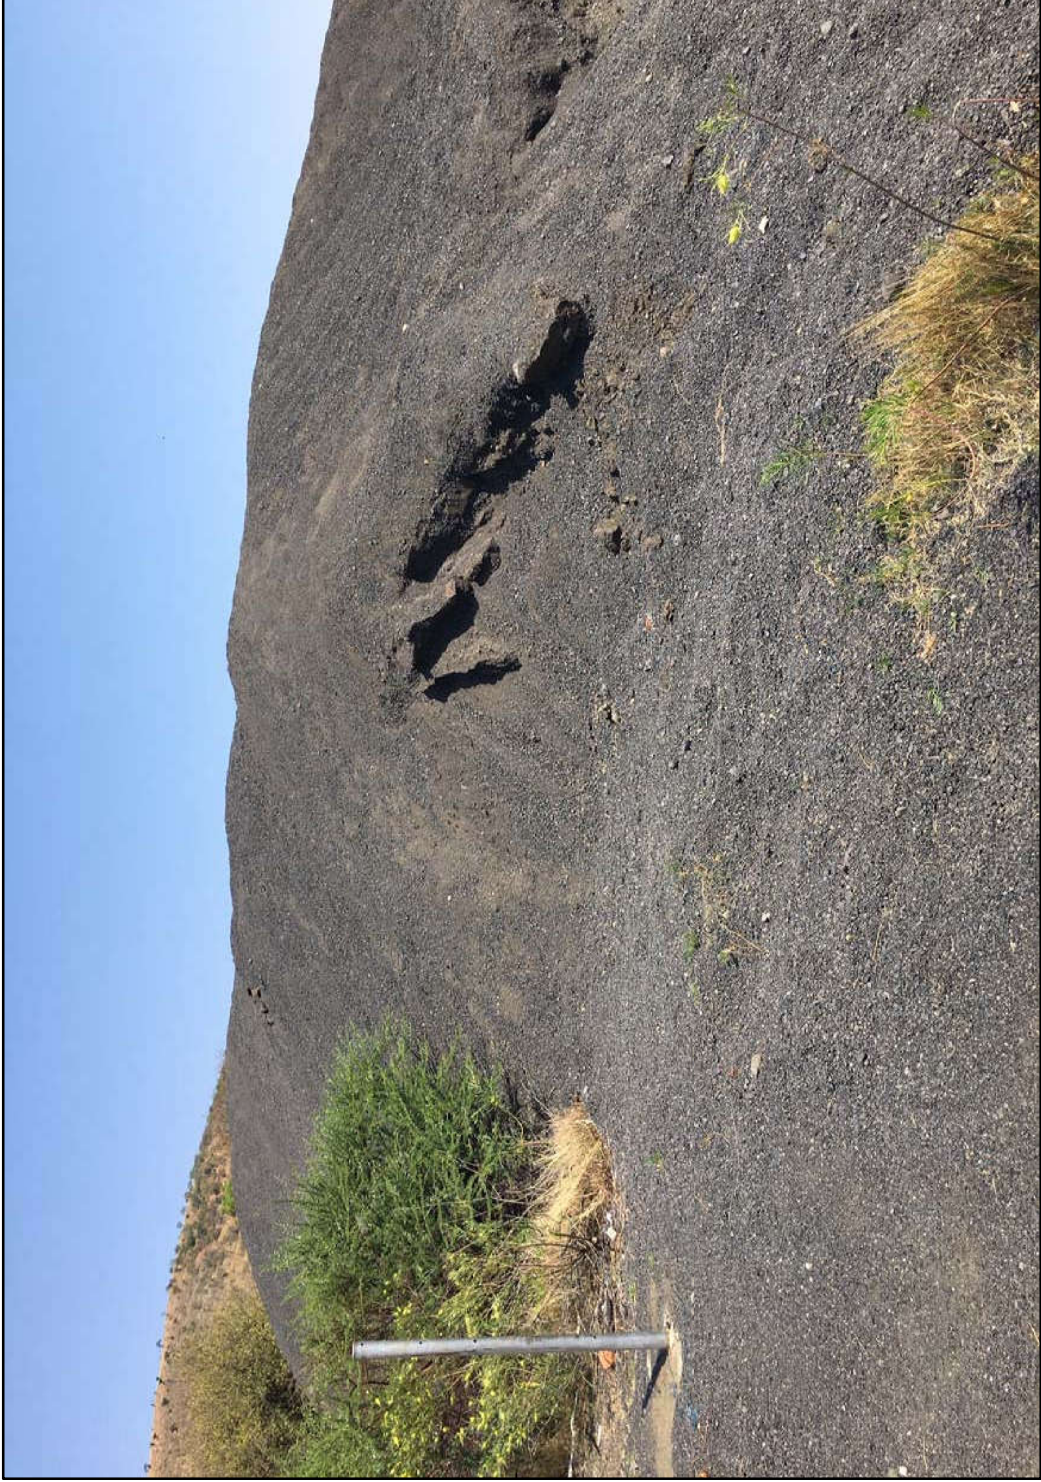
PHOTO 3

- *Fill Materials:* Fill materials were erratically distributed across the site as surficial pockets which are of minor significance. However, in the vicinity of trial holes 8, 9 and 10, extensive fill material was encountered, mostly in the form of stockpiled waste or earth. The stockpiled materials appeared to resemble some waste or leftover material sourced from mining operations, or even possibly metal processing waste or slag. The fill materials were not sampled as the composition was variable and it was clearly not suitable for construction or founding.

- **Zone 4: P_{Fill}**: Zone 4 includes the area where fill materials have been stockpiled. As this area is covered, it is not known what the underlying soil profile consists of, though it is likely that the underlying profile is similar to that of Zone 2. In its present state, however, this zone is not suitable for development. It is possible that this site may be rendered suitable for development at a later stage, provided all fill materials are removed and limited supplementary geotechnical work is undertaken to ensure that the underlying soil profiles (and geotechnical conditions) comply with those of the surrounding area.

FILL MATERIAL

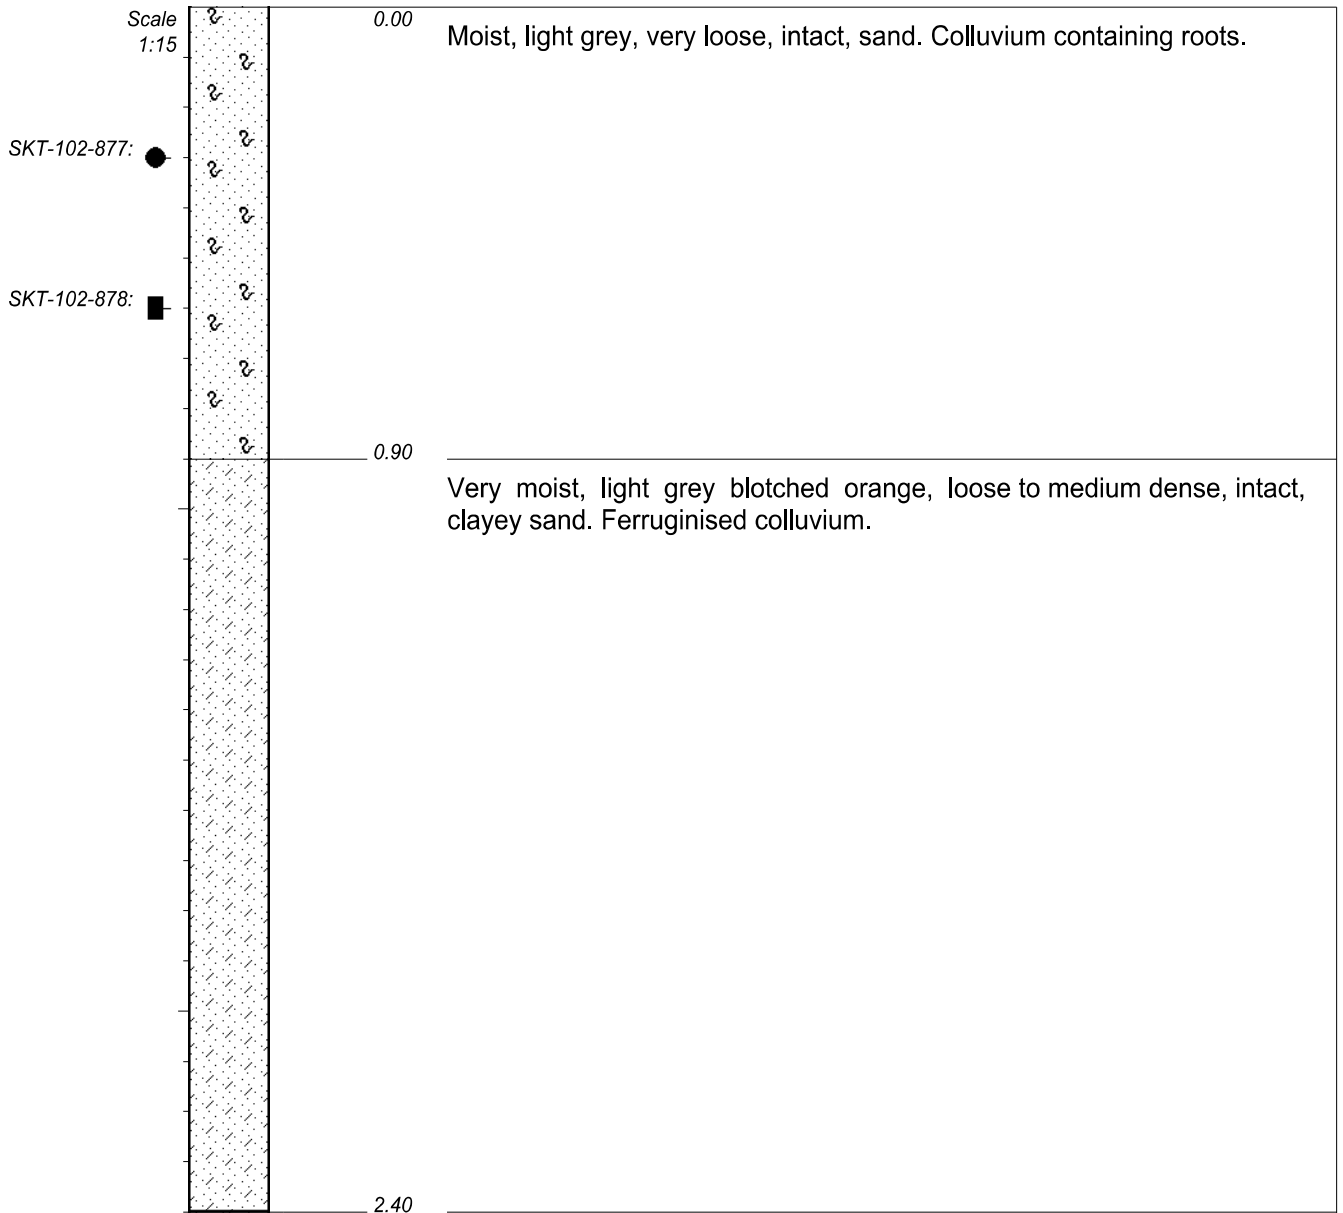
- 1) No refusal of excavation.
- 2) No seepage.
- 3) Seasonal seepage expected in soil profile.
- 4) Disturbed Sample SKT-102-877: 0.30m.
- 5) Undisturbed Sample SKT-102-878: 0.60m.

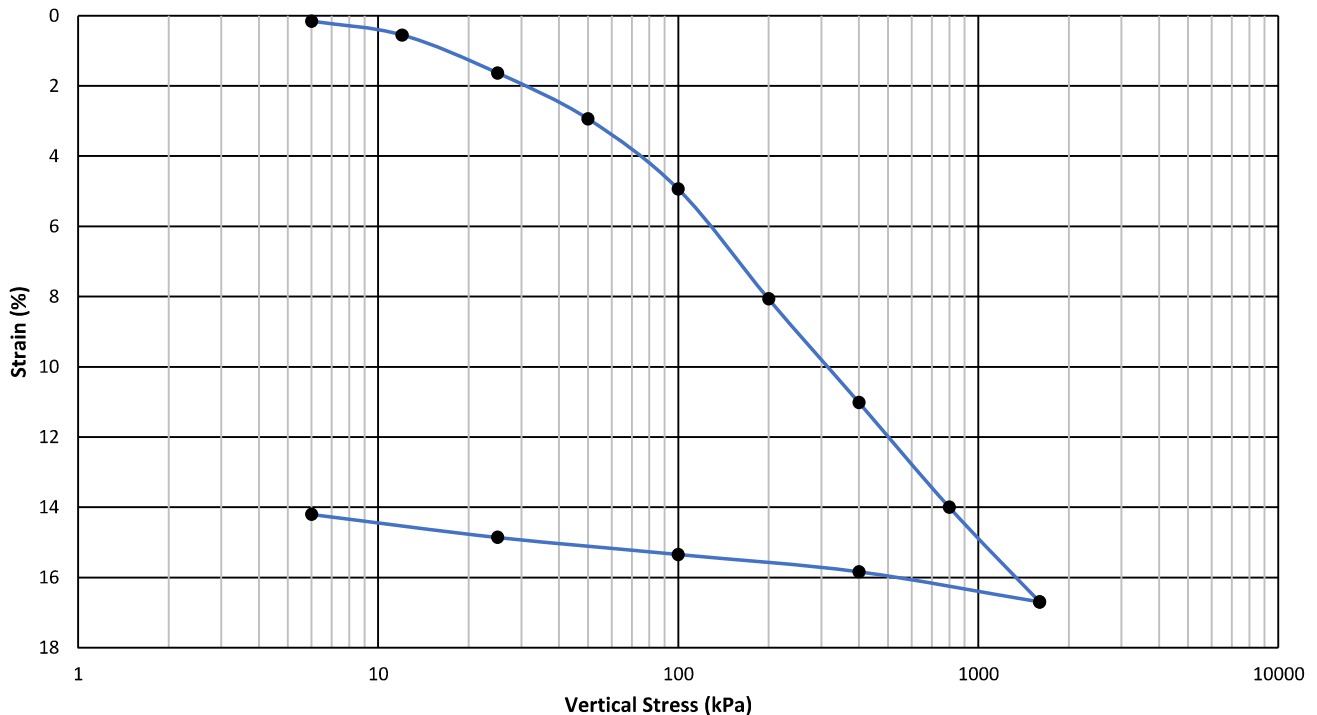
Strain vs Log Stress

Vertical Stress Applied:	kPa	6	12	25	50	100	200	400	800	1600	400	100	25	6
Load applied for:	Hrs	12	12	12	12	12	12	12	12	12	3	3	3	3
Height after increment	mm	25.36	25.26	24.99	24.65	24.15	23.35	22.60	21.84	21.16	21.38	21.50	21.63	21.79
Total Strain	%	0.16	0.55	1.63	2.94	4.94	8.07	11.02	14.00	16.70	15.84	15.35	14.86	14.21
Void Ratio	-	0.531	0.525	0.509	0.489	0.458	0.410	0.365	0.319	0.278	0.291	0.298	0.306	0.316
Mv (1/Mpa)	-	-	0.660	0.838	0.532	0.412	0.329	0.161	0.084	0.039	0.009	0.020	0.077	0.404

- *Properties of Settlement*: Consolidation test results suggest that colluvial soils are very susceptible to compression, even at loads as low as 50kPa. The total settlement that may occur depends on the vertical thickness of the material underlying future foundations and hence settlement was estimated for each trial hole soil profile.

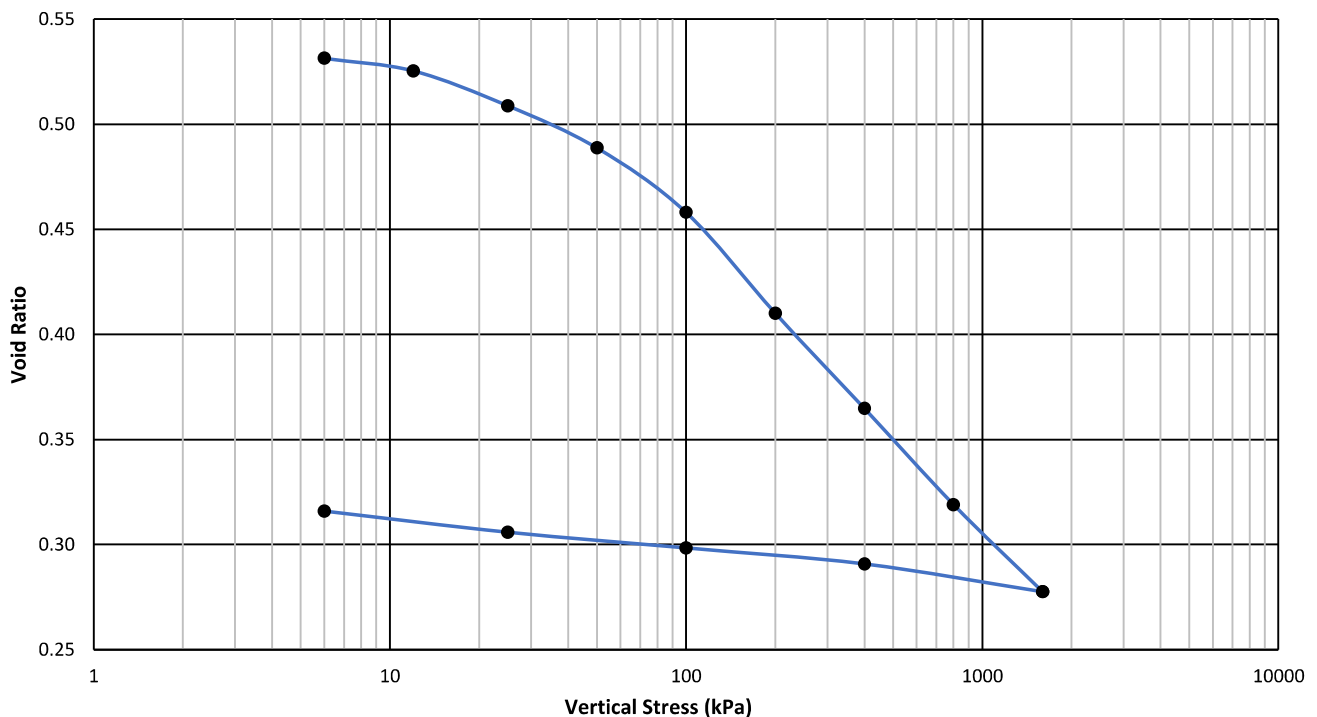
Void Ratio vs Log Stress

Vertical Stress Applied:	kPa	6	12	25	50	100	200	400	800	1600	400	100	25	6
Load applied for:	Hrs	12	12	12	12	12	12	12	12	12	3	3	3	3
Height after increment	mm	25.36	25.26	24.99	24.65	24.15	23.35	22.60	21.84	21.16	21.38	21.50	21.63	21.79
Total Strain	%	0.16	0.55	1.63	2.94	4.94	8.07	11.02	14.00	16.70	15.84	15.35	14.86	14.21
Void Ratio	-	0.531	0.525	0.509	0.489	0.458	0.410	0.365	0.319	0.278	0.291	0.298	0.306	0.316
Mv (1/Mpa)	-	-	0.660	0.838	0.532	0.412	0.329	0.161	0.084	0.039	0.009	0.020	0.077	0.404

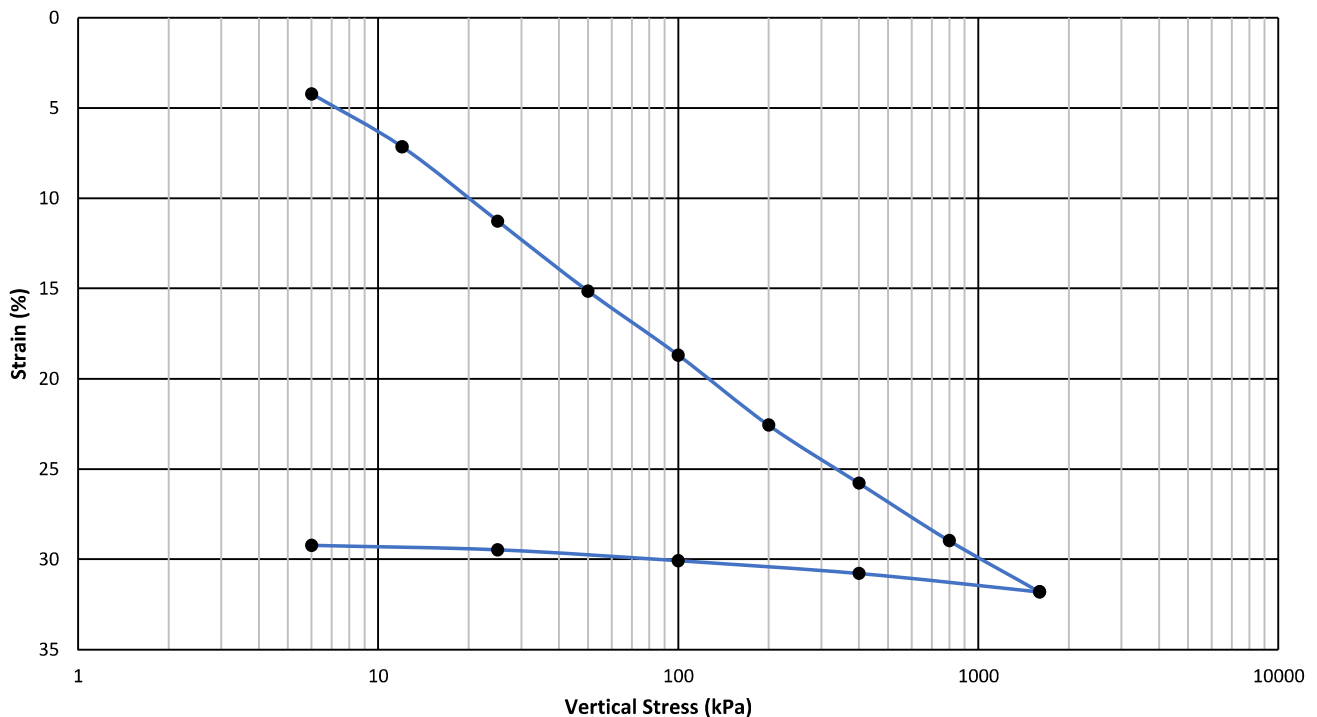
Strain vs Log Stress

Vertical Stress Applied:	kPa	6	12	25	50	100	200	400	800	1600	400	100	25	6
Load applied for:	Hrs	12	12	12	12	12	12	12	12	12	3	3	3	3
Height after increment	mm	24.33	23.58	22.54	21.56	20.65	19.67	18.85	18.04	17.32	17.58	17.76	17.91	17.98
Total Strain	%	4.22	7.15	11.27	15.14	18.69	22.57	25.78	28.97	31.81	30.78	30.08	29.48	29.22
Void Ratio	-	0.849	0.792	0.712	0.638	0.569	0.494	0.432	0.371	0.316	0.336	0.349	0.361	0.366
Mv (1/Mpa)	-	-	5.102	3.413	1.744	0.837	0.477	0.208	0.107	0.050	0.013	0.034	0.116	0.192

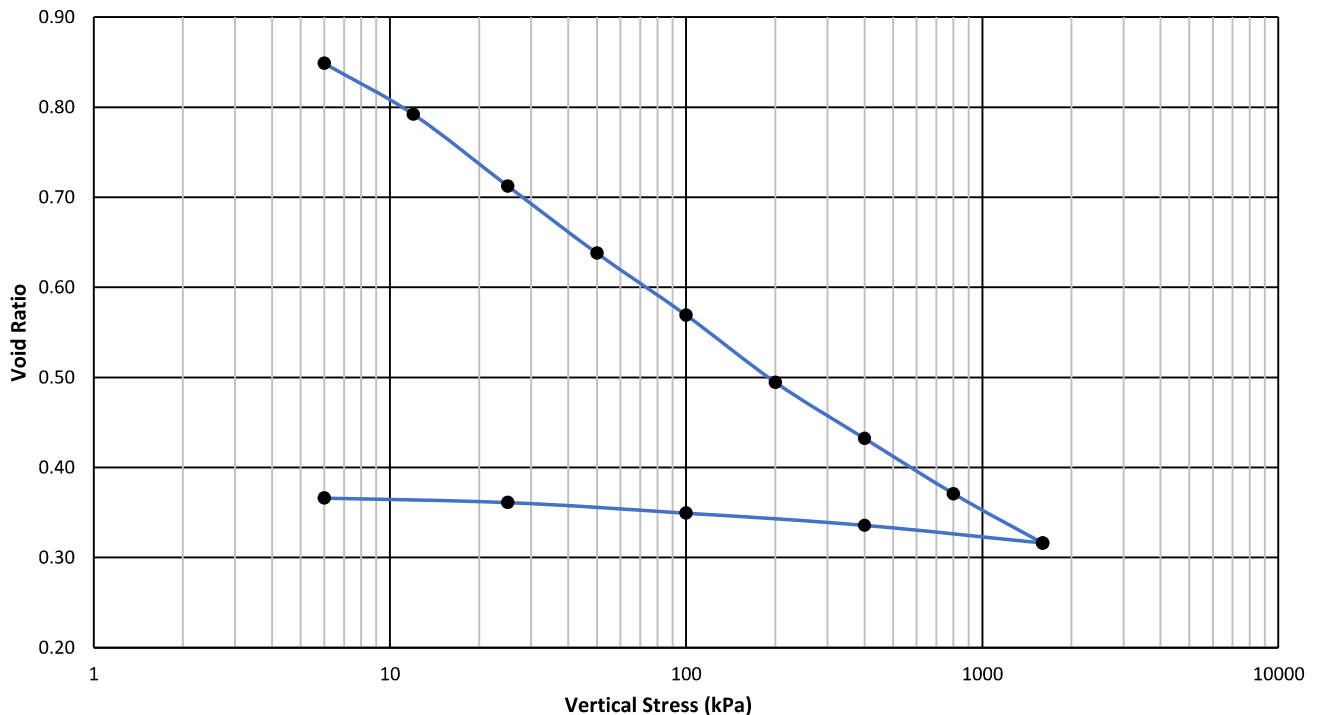
Void Ratio vs Log Stress

Vertical Stress Applied:	kPa	6	12	25	50	100	200	400	800	1600	400	100	25	6
Load applied for:	Hrs	12	12	12	12	12	12	12	12	12	3	3	3	3
Height after increment	mm	24.33	23.58	22.54	21.56	20.65	19.67	18.85	18.04	17.32	17.58	17.76	17.91	17.98
Total Strain	%	4.22	7.15	11.27	15.14	18.69	22.57	25.78	28.97	31.81	30.78	30.08	29.48	29.22
Void Ratio	-	0.849	0.792	0.712	0.638	0.569	0.494	0.432	0.371	0.316	0.336	0.349	0.361	0.366
Mv (1/Mpa)	-	-	5.102	3.413	1.744	0.837	0.477	0.208	0.107	0.050	0.013	0.034	0.116	0.192
