**HERITAGE SURVEY OF THE PROPOSED
BURLINGTON HOUSING PROJECT**

**FOR KERRY SEPPINGS ENVIRONMENTAL
MANAGEMENT SPECIALISTS**

DATE: MAY 2009

Brief Assessment of the wood-and-iron house at Burlington, Chatsworth, KwaZulu-Natal

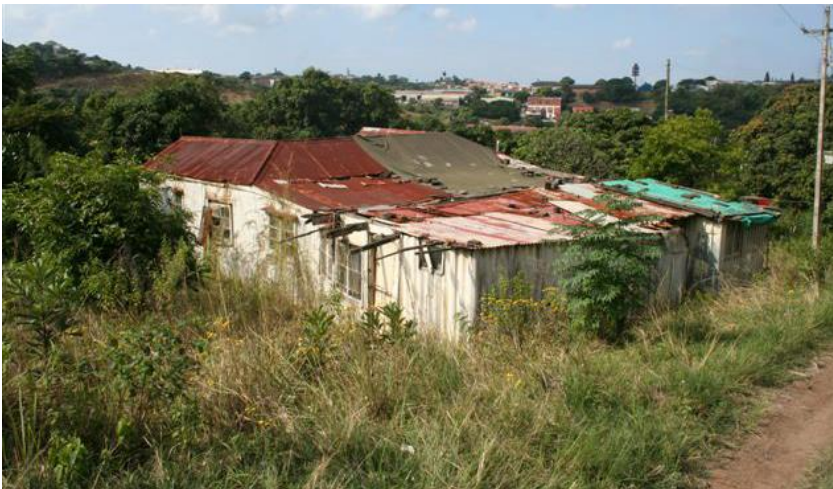
Fig 1: Wood-and-iron structure from the rear.

The likelihood of this structure being over 60 years old is great. This is firstly as the core of the structure is an example of wood-and-iron kit buildings, popular from the last decades of the nineteenth century, and well into the twentieth. Wood-and-iron buildings were a cheap and popular solution to immediate shelter, and popular amongst Indian and European settlers. HV Marsh in Pietermaritzburg was a purveyor of such structures, which were ordered out of a catalogue and then delivered in parts. Fig 3 shows an example of a wood-and-iron catalogue building from the 1915 Marsh Catalogue. Assistance in dating the building is lent by the existence of a finial. (see Fig 2) These were typical of the style, material and period, particularly of Late Victorian Architecture.

- The building has been much altered and lack of maintenance has taken its toll on a building solution that requires maintenance in this climate. It has also been subject to building accretions which are not complimentary, and detract from its original simplicity.
- The structure is situated in an environment which is not likely to be conducive to practical conservation and it is suspected that both the demographics of the area and the landscape/ context have changed dramatically from its situation in the past.
- Any connotations with historic figures and events is beyond the scope of this initial study.

That adaptive reuse be considered as an option if there is a practical possibility, but that the siting, position, condition and current format make this difficult, and that demolition could be considered if required. It is suggested that a member of Amafa's Built Environment Section visit the site prior to any demolition requests being considered to establish the possibility of reuse of materials.

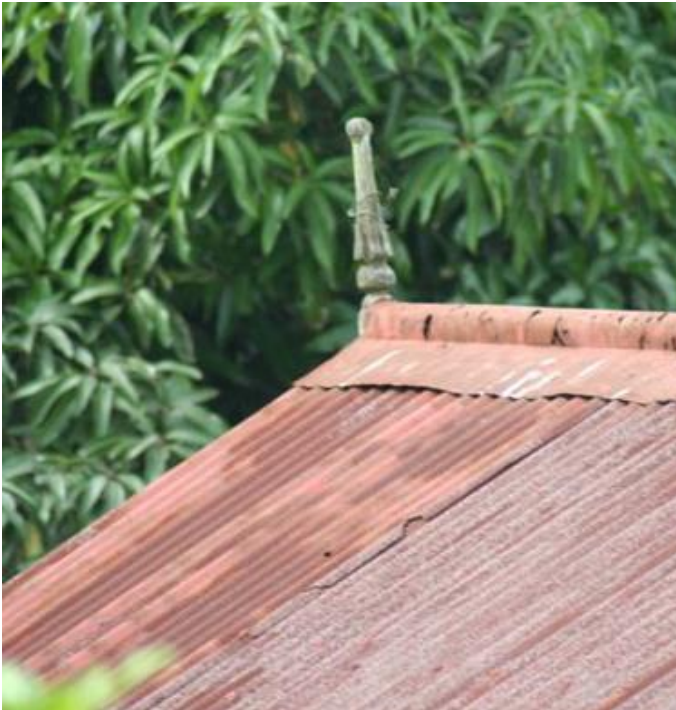
Fig 2 (left): Finial on roof of structure.
