**AN ARCHAEOLOGICAL IMPACT ASSESSMENT REPORT FOR THE
MERENSKY-UCHOBA 132KV POWERLINE SECOND ROUTE DEVIATION (FINAL
ROUTE, MAY 2023), MPUMALANGA PROVINCE**

REPORT NO.: AE02321V

30 May 2023

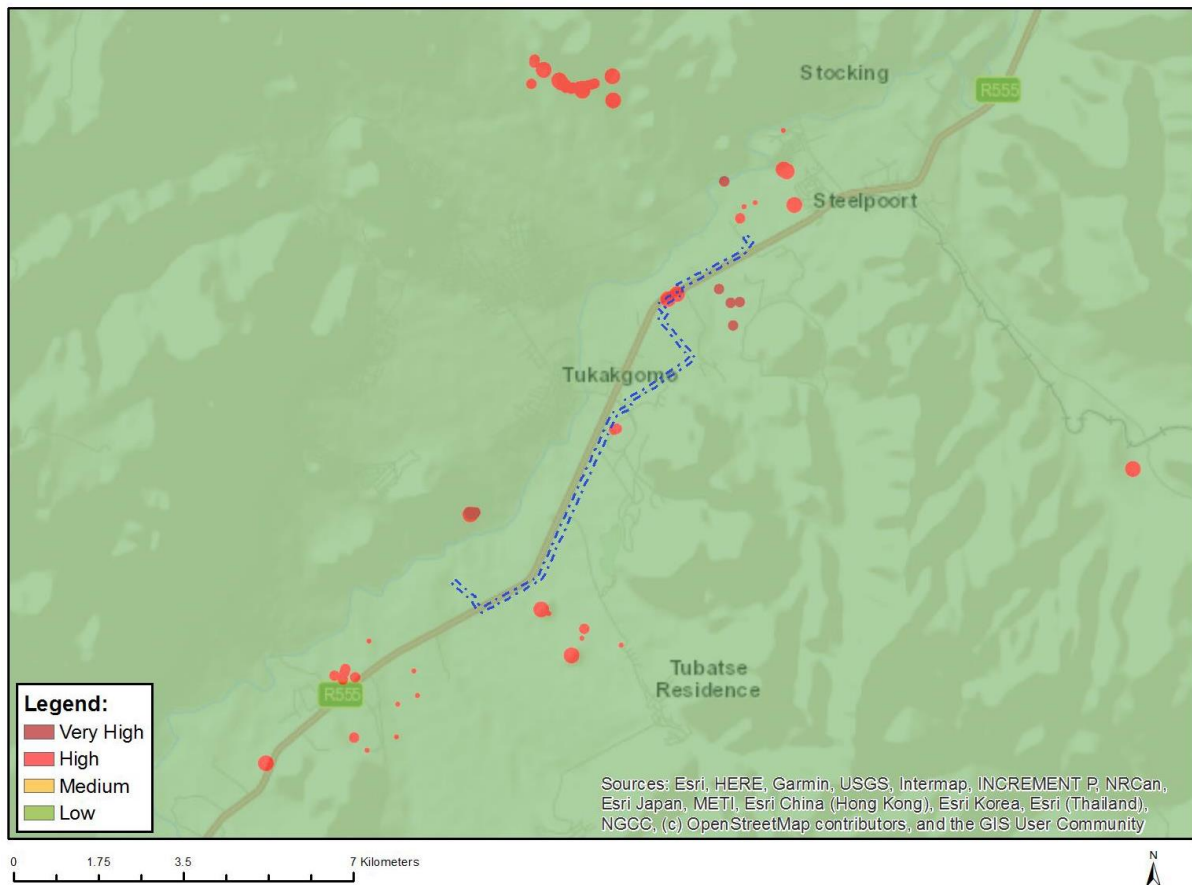
It needs to be indicated that the environmental screening tool indicates that the area has high to very high archaeological potential (Figure 18). This roughly coincides with known information from surveys done in the area and likely are included in the figures below.

Figure 18: Map from Environmental Screening Tool indicating heritage sensitivity in the area.

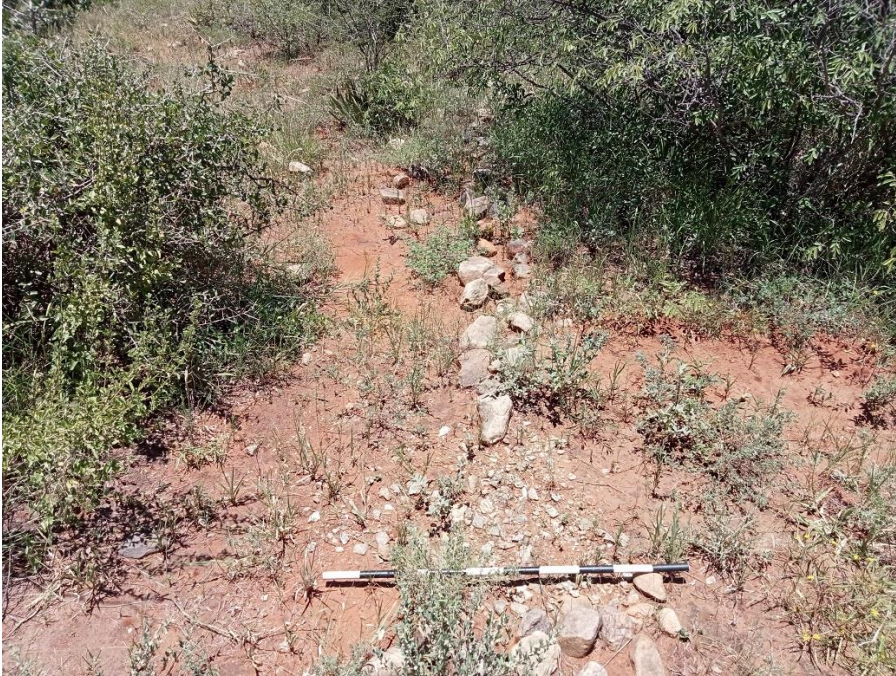
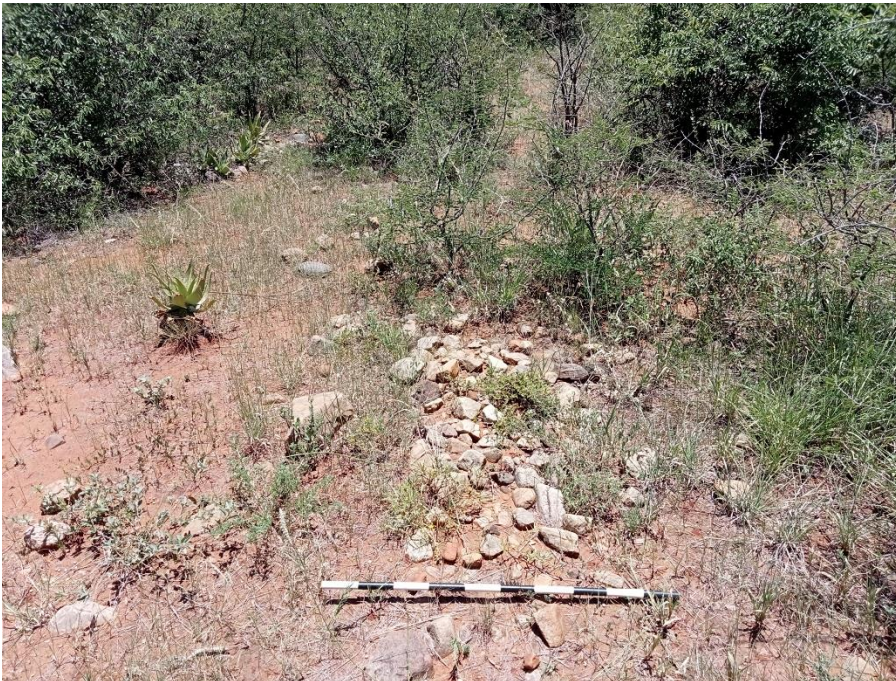
GPS: 24°44'44.55"S; 30°10'45.45"E

The site likely is older than 60 years, but without artefactual evidence this is difficult to tell. It is in a poor state and not very unique.

Figure 23: View of remains of a terrace wall.

Figure 24: Another view of the remains of the terrace walling

1. Site no 1 are stone terraces and receives a field rating of Local Grade IIIC. The description in the phase 1 heritage report is seen as sufficient recording (low significance) and it may be granted destruction at the discretion of the relevant heritage authority without a formal permit application, subjected to the granting of Environmental Authorisation.

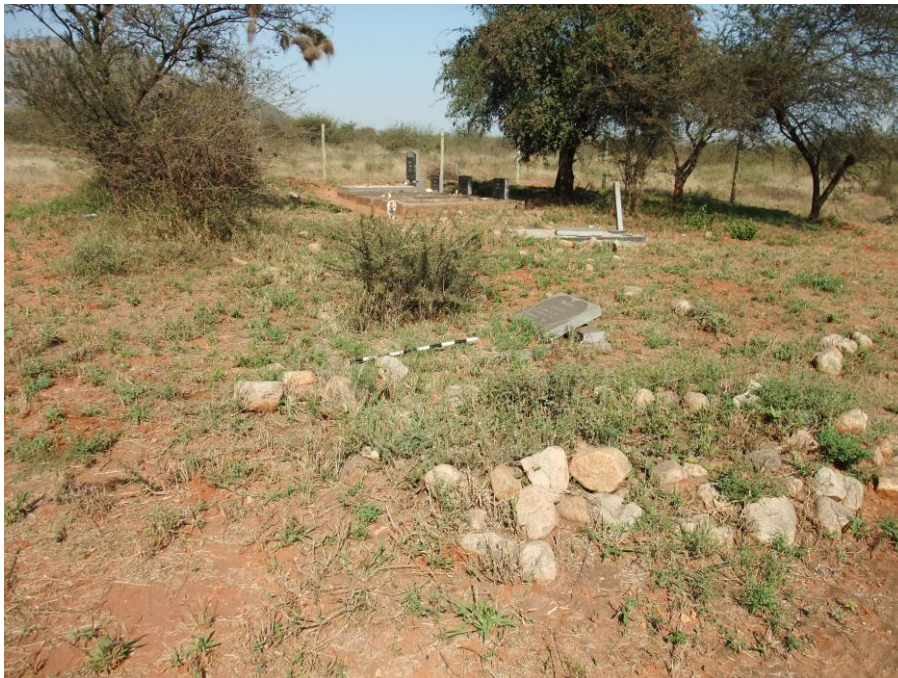
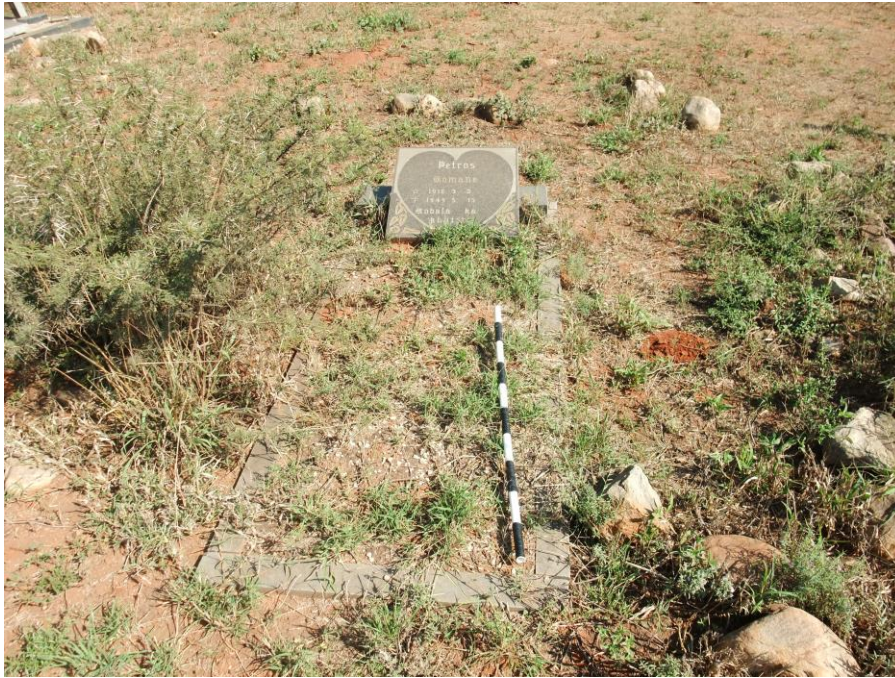
Surnames identified are Mdebele, Ndimande, Sekwere, Moroga and Komane. The site is fenced by a wire fence.

GPS: 24°44'52.57"S; 30°10'42.93"E

Figure 25: View of graves at site no. 2.

Figure 26: One of the graves at site no. 2.

Two possibilities exist. The first option would be to fence the graves in for the sustainable preservation thereof. This option is relevant when the graves are in no danger of being damaged or destroyed by the development (direct impacts). Secondary impact due to the development activities may still exist and must be managed.

The second option is to exhume the mortal remains and to have it relocated. This usually is relevant when the graves will be directly affected (damaged or destroyed) by the development. In this case specific procedures should be followed which includes social consultation. Graves younger than 60 years may be exhumed only by an undertaker. For those older than 60 years, and unknown graves, an undertaker and archaeologist should be appointed. Permits must be obtained from the Burial Grounds and Graves unit of SAHRA. This procedure is quite lengthy and involves social consultation.

Option 1 is recommended. The graves needs to be fenced in. Although it is unlikely that the graves will be overs panned by any lines it needs to be emphasised that this should not be allowed. It also would be necessary to ensure no impact during construction of the new lines. The graves should thus be clearly demarcated and inspected during this time.

However, since the graves are only 15 m from the proposed line this means the line needs to shift. If not possible, option 2 is recommended.

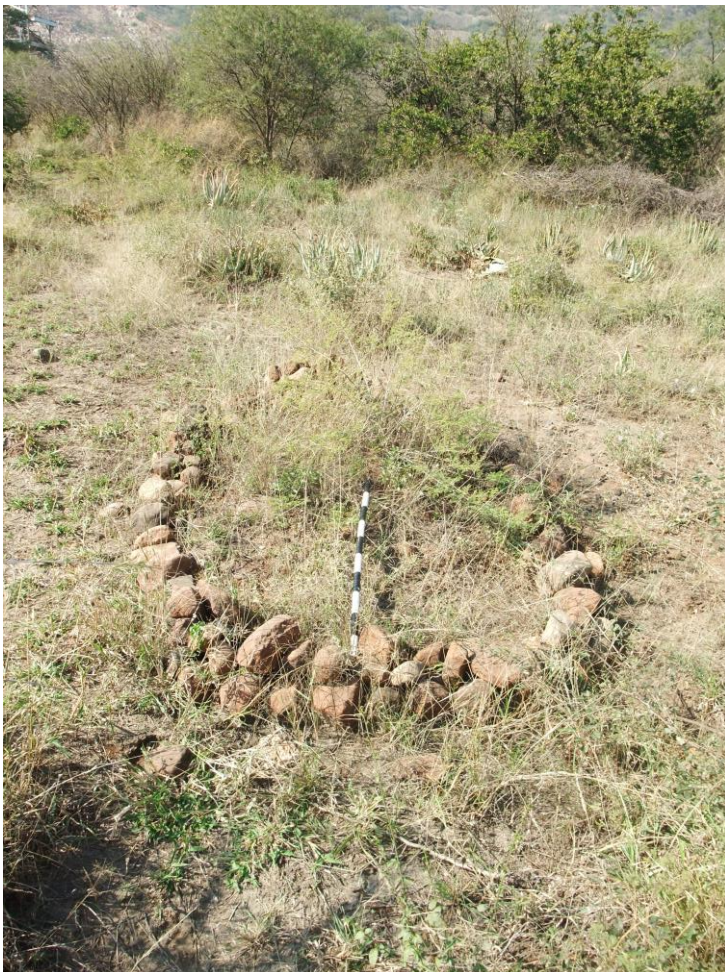
This is a single grave with a stone packed border and stone headstone (Figure 27). There is no legible information and thus the grave is categorised as being unknown, meaning it needs to be handled as a heritage grave.

GPS: 24°45'58.72"S; 30°10'8.95"E

Figure 27: View of the grave at site no. 3.

Two possibilities exist. The first option would be to fence the graves in for the sustainable preservation thereof. This option is relevant when the graves are in no danger of being damaged or destroyed by the development (direct impacts). Secondary impact due to the development activities may still exist and must be managed.

The second option is to exhume the mortal remains and to have it relocated. This usually is relevant when the graves will be directly affected (damaged or destroyed) by the development. In this case specific procedures should be followed which includes social consultation. Graves younger than 60 years may be exhumed only by an undertaker. For those older than 60 years, and unknown graves, an undertaker and archaeologist should be appointed. Permits must be obtained from the Burial Grounds and Graves unit of SAHRA. This procedure is quite lengthy and involves social consultation.

Option 1 is recommended. The grave need to be fenced in. It is over spanned by the current power lines, but no new lines should be allowed to over span it. It also would be necessary to ensure no impact during construction of the new lines. The grave should thus be clearly demarcated and inspected during this time.

Although the grave is only 17 m from the proposed line, the line does not need to shift as the grave is already over spanned by current lines. If it is not possible to preserve the grave *in situ*, option 2 is recommended.

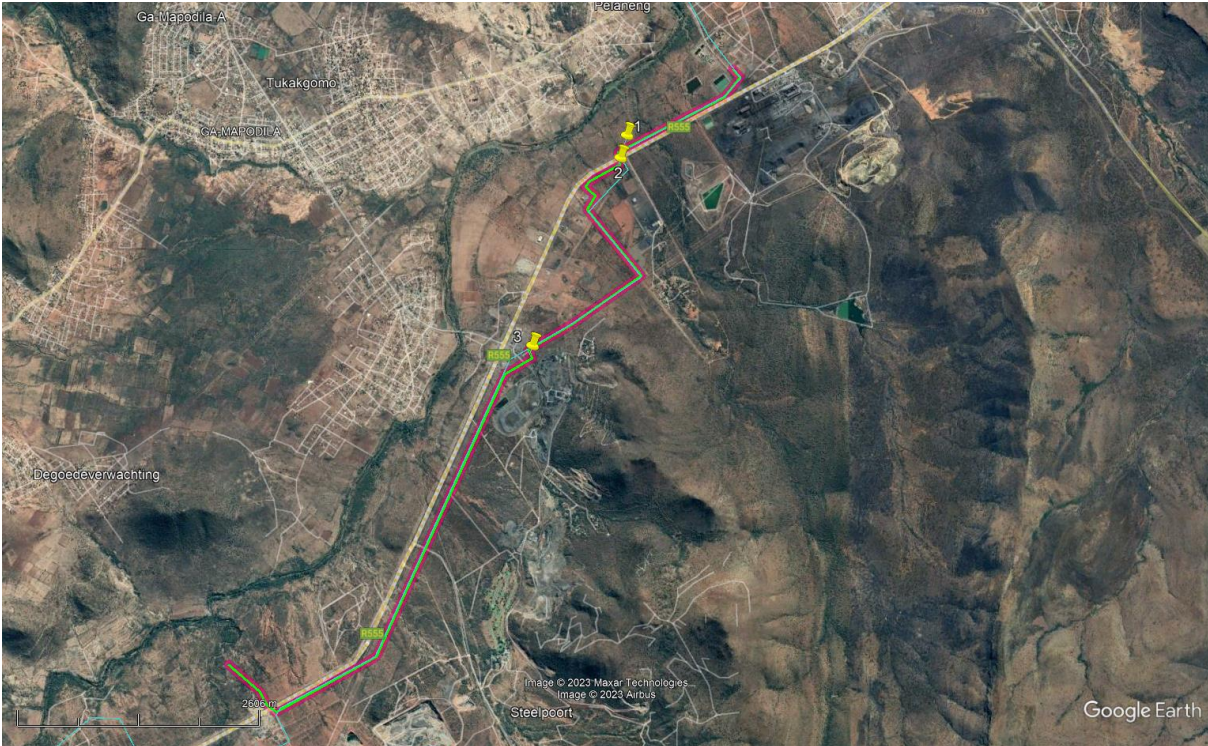
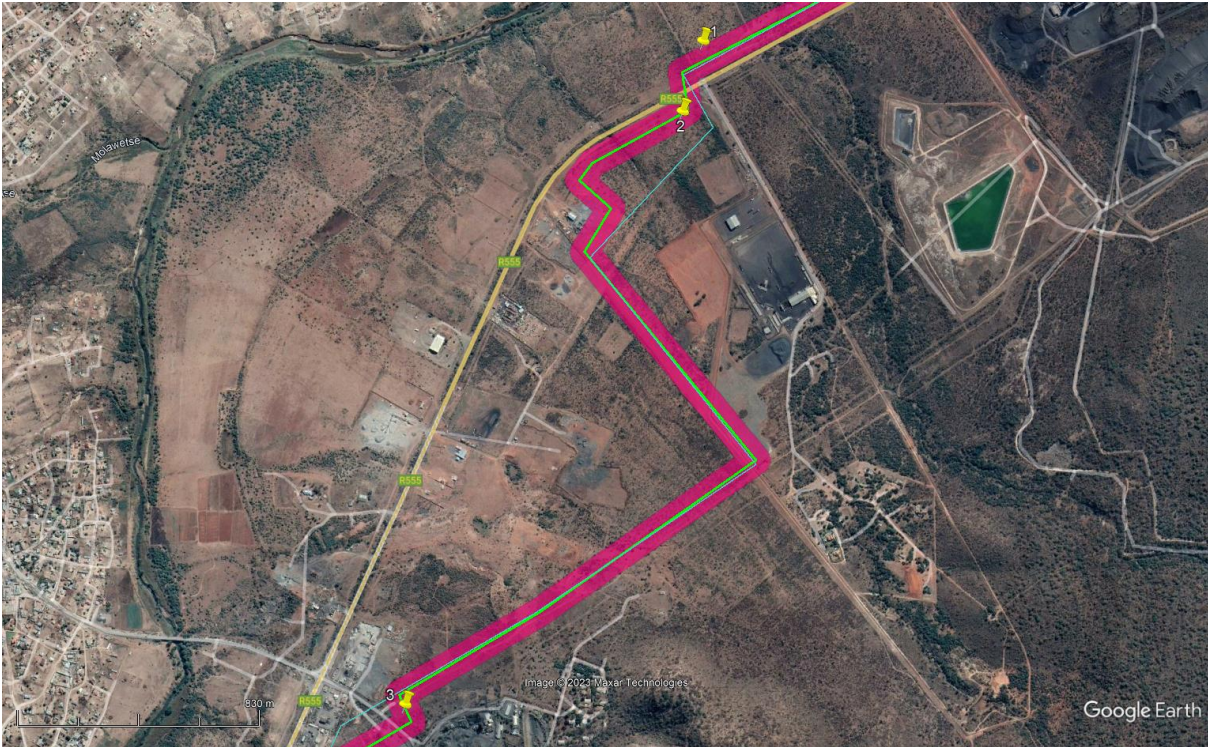
The heritage survey in the indicated area was completed successfully. Three sites was identified during the survey (Figure 28-29). The first site found during the survey has a low heritage significance (see table below), but the second and third have a high heritage significance.

Figure 28: Sites identified during the survey.

Figure 29: Closer view of the three identified sites.
