HERITAGE IMPACT ASSESSMENT FOR THE PROPOSED GAMKA SUBSTATION AT CALITZDORP, CALITZDORP MAGISTERIAL DISTRICT, WESTERN CAPE

(Assessment conducted under Section 38 (8) of the
National Heritage Resources Act (No. 25 of 1999) as part of a Basic Assessment)

1st draft: 25 June 2012
Final report: 30 July 2012

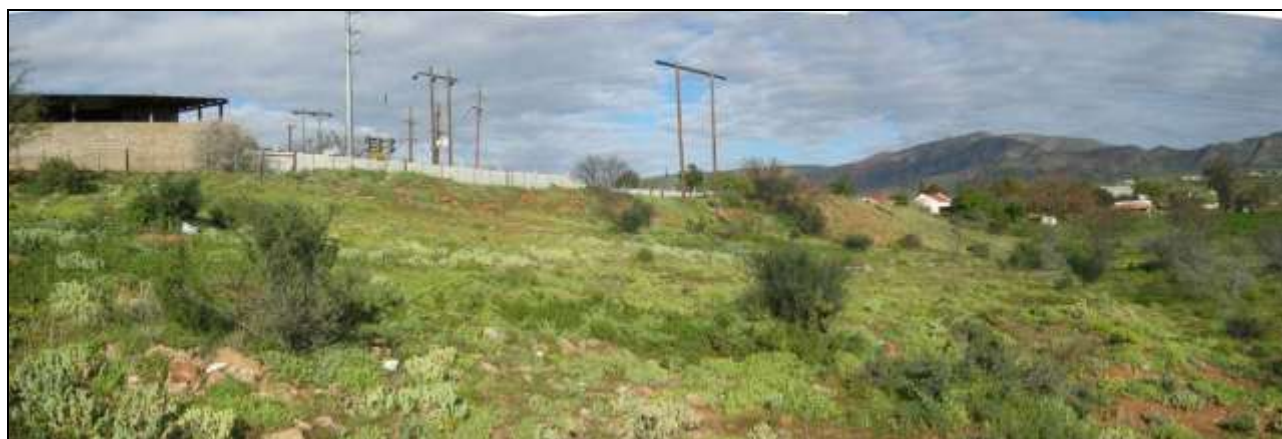
Site A is on a slope adjoining a road at the very northern edge of Calitzdorp (Figures 3 & 4). An existing substation lies just to the south of this road. The site is covered with very low vegetation and isolated bushes and the surface substrate is almost entirely of loose gravel. The higher lying parts have been disturbed by road construction, while at the northern edge of the site the land becomes flat and some agricultural activities have been carried out.

Figure 3: View across Site A towards the southwest showing its proximity to the town and the existing substation.

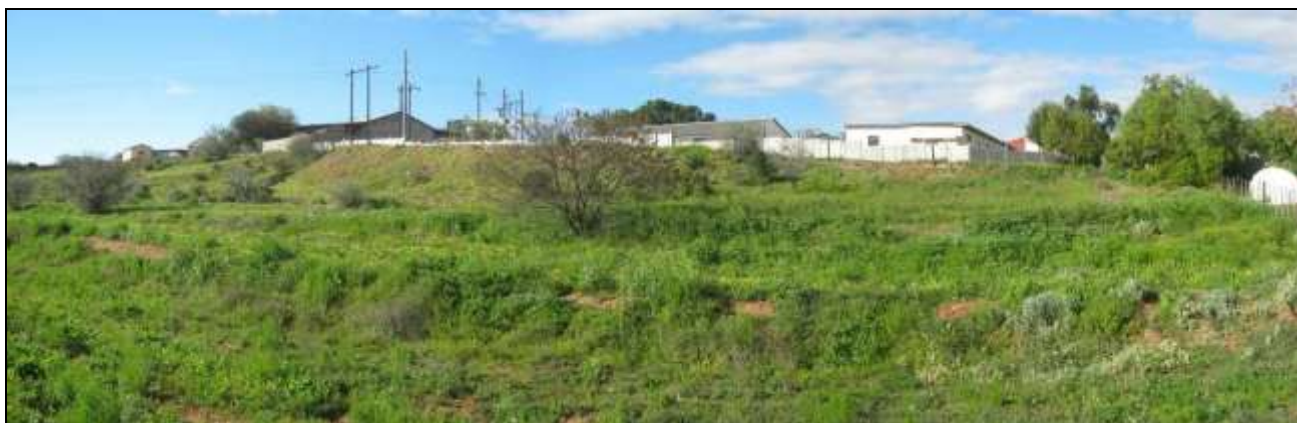
Figure 4: View across Site A towards the southeast showing its proximity to the town and the existing substation. The agricultural activities are evident in the foreground.

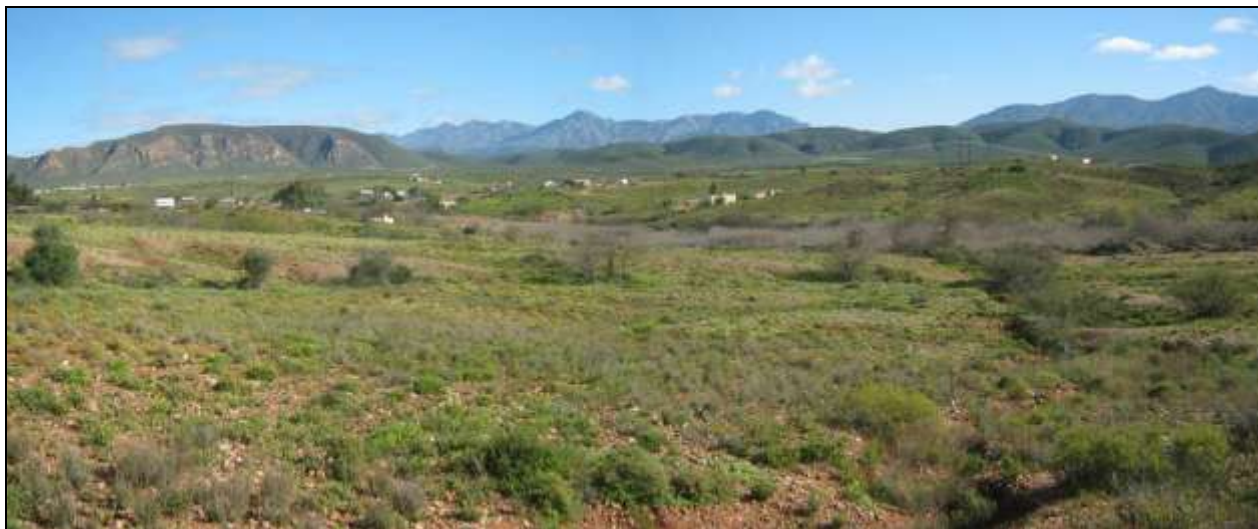
The Site B area consists of gently rolling terrain on the south side of a small stream some 320 m to the north of Site A (Figure 5). The ground surface is gravelled and vegetated with low plants. A small gravel track currently provides access to the site (Figure 6) and limited disturbance is evident in one or two places (Figure 7).

Figure 5: View towards the northwest across the Site B location with the small stream in the right hand half of the picture. The substation would lie approximately in the hollow in the centre of the picture. Calitzdorp town is out of picture to the left.

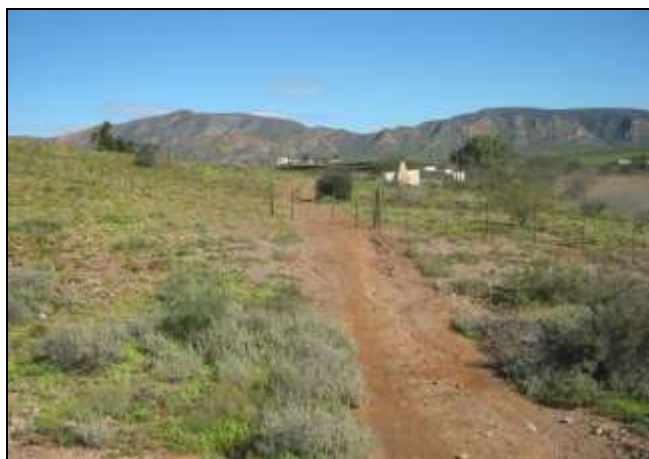
Figure 6: View towards the northwest along the small gravel track that currently provides access to Site B.

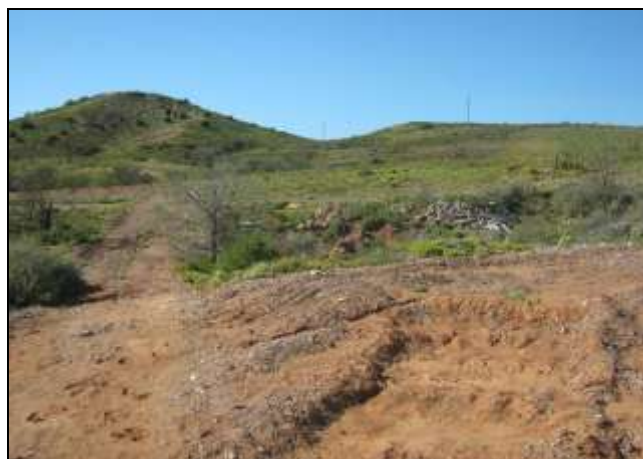
Figure 7: View towards the southeast showing limited disturbance alongside the gravel track.

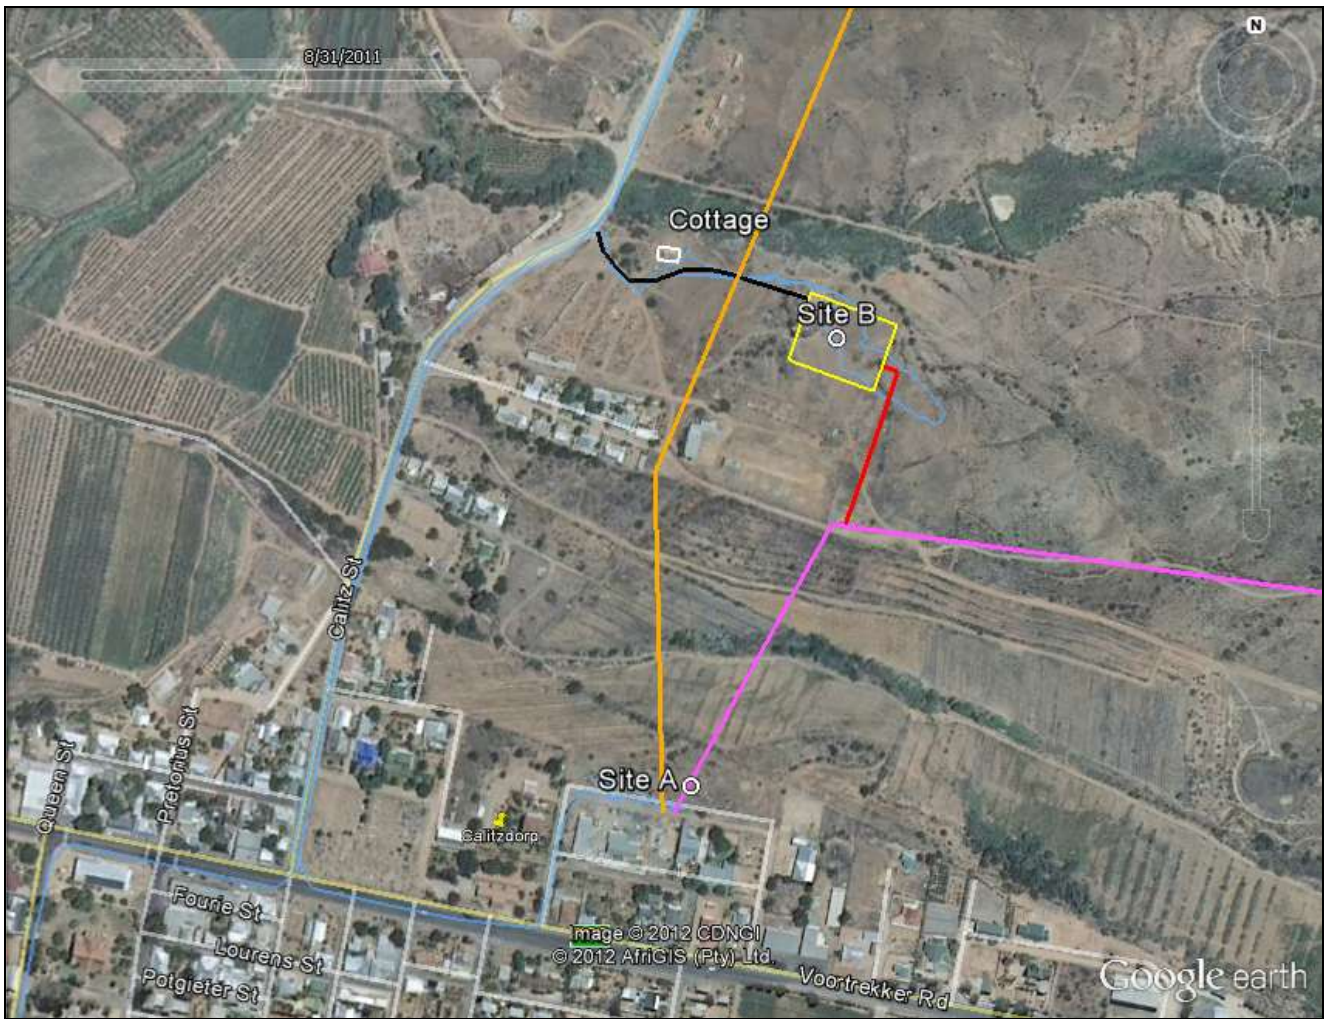
Figure 8 shows an aerial photograph of the site and locates the single proximate heritage resource of value recorded during the field survey.

Figure 8: Aerial view of the study area showing the location of the two sites in relation to the built-up part of Calitzdorp, the general landscape character around the sites and the proposed infrastructural layout for Site B. The yellow rectangle represents the substation footprint, the orange and pink lines are existing power lines and the red line the proposed new power line. The black line is the proposed access road to the substation.

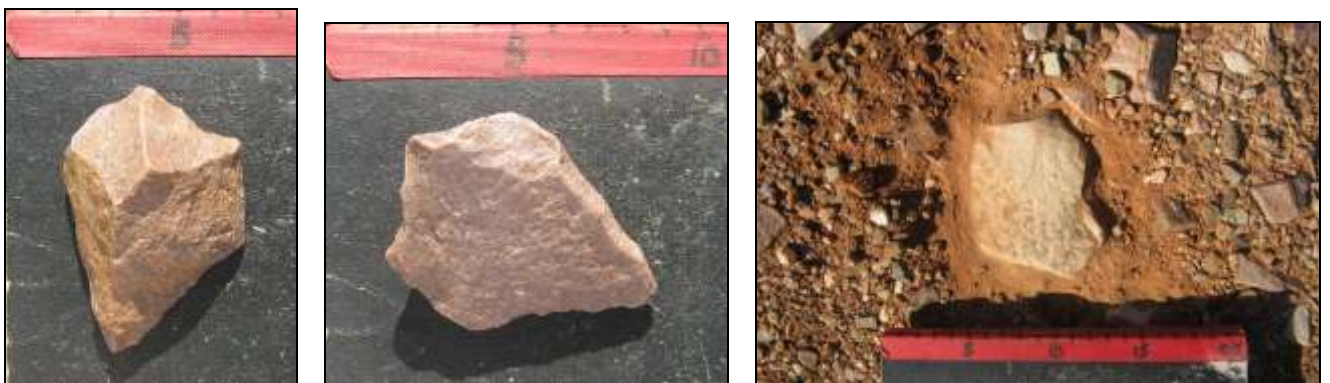
The field survey showed that occasional stone artefacts were present in the study area among the gravels coating the surface of the ground, although all three that were seen came from the more eroded Site B. These were all of quartzite and likely pertain to the MSA (Figures 9 to 11). No *in situ* material or occupation sites were found.

Figures 9 to 11: Stone artefacts noted on Site B. That on the right was firmly embedded in the substrate.

Archaeological material was extremely sparsely distributed on both sites and found to be of very low significance. No mitigation is required. Impacts would occur during construction and Table 2 thus assesses construction phase impacts.

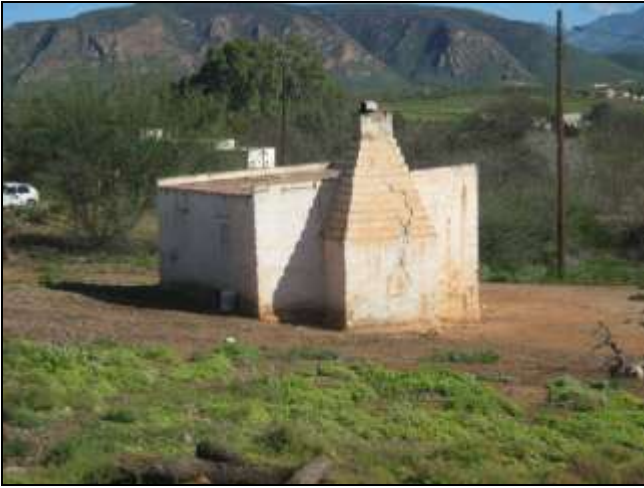
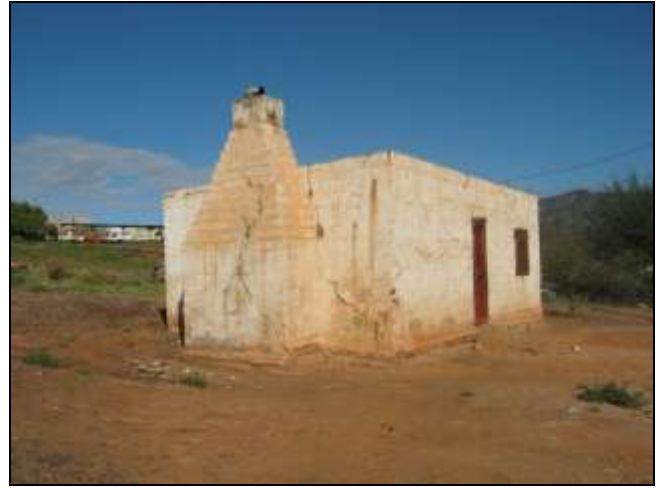
Although not specifically requested by HWC, it is pertinent to note the presence of a small historical structure immediately alongside the access road to Site B. At the time of the field inspection, the house was inhabited. It is likely of early 20th century age but is nevertheless certainly greater than 60 years of age and thus generally protected by the NHRA. It has architectural value in that it is a very typical vernacular farm labourers cottage. Such cottages characterise this rural area (Figures 12 to 14).

Figures 12 & 13: Small labourer's cottage immediately alongside the access road to Site B.

It is recommended that construction of the proposed substation be allowed to proceed on either site. It is noted that Site A is preferred from a heritage point of view but that noise impacts have effectively screened it out leaving Site B as the developer's favoured alternative. Palaeontological monitoring should be carried out by the ECO and/or a palaeontologist, while visual mitigation measures as suggested by the visual specialist should be adhered to. The only other specific recommendation is to ensure that the small cottage located close to Site B is not disturbed in any way during construction or operation of the substation.

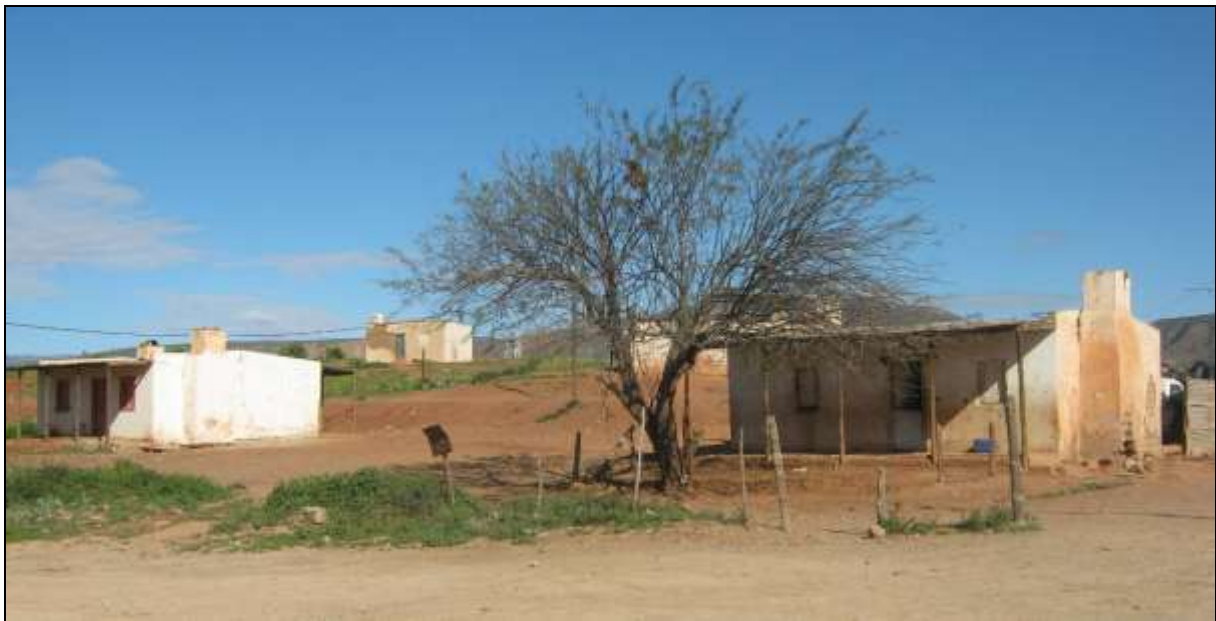
Figures 14: Other labourers' cottages located on the northern outskirts of Calitzdorp.

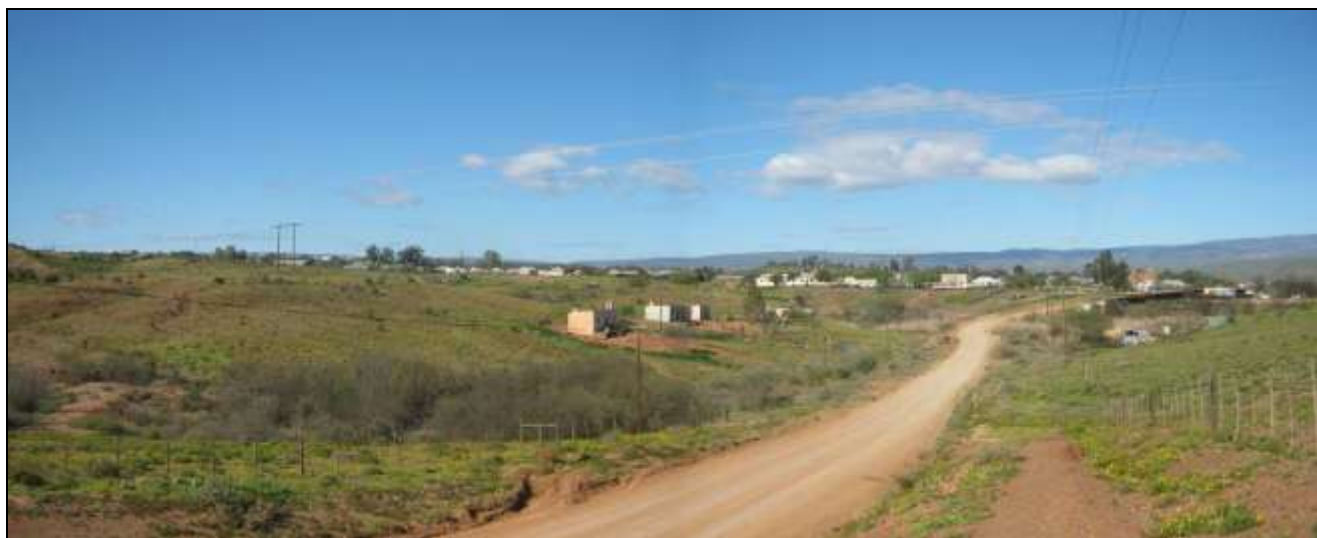
Again, no specific cultural landscape study was requested, but the landscape around the sites is significant for its intactness (Figure 15). It is distinctly rural and undeveloped and imparts a very pleasant sense of place to the local environment. That the main road through the area is gravel contributes to the rural feel.

Figures 15: View southwards over the general study area. The edge of Calitzdorp can be seen in the background, while the pleasant rural character of the surroundings is evident.
