SIDNEY MILLER
Architectural Conservation Consultant

**Cultural Heritage Impact Assessment
for
Shafts #1 to #7, Orkney, Northwest Province, South Africa,
for
CAPM Gold.**

March 2015.

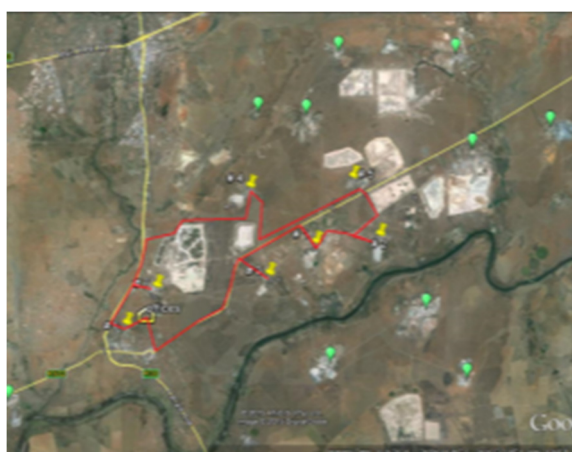
Fig. 03. *Left is an image showing the route (marked in red) undertaken in Orkney to visit the eight CAPM Gold sites under investigation. The seven shaft sites and the old office building complex in Orkney were visited in the following order:-. #7 shaft site, #6 shaft site, the offices in the town, #3 shaft, #1 shaft, #2 shafts, #5 shaft and #4 shaft. The round trip to the eight sites was undertaken by motor vehicle owing to the distances involved. Each individual site was inspected on foot according to the historical merit of the site. For this on-foot site routes see individual site recordings in Section 9. (Google Earth image 2014.)*

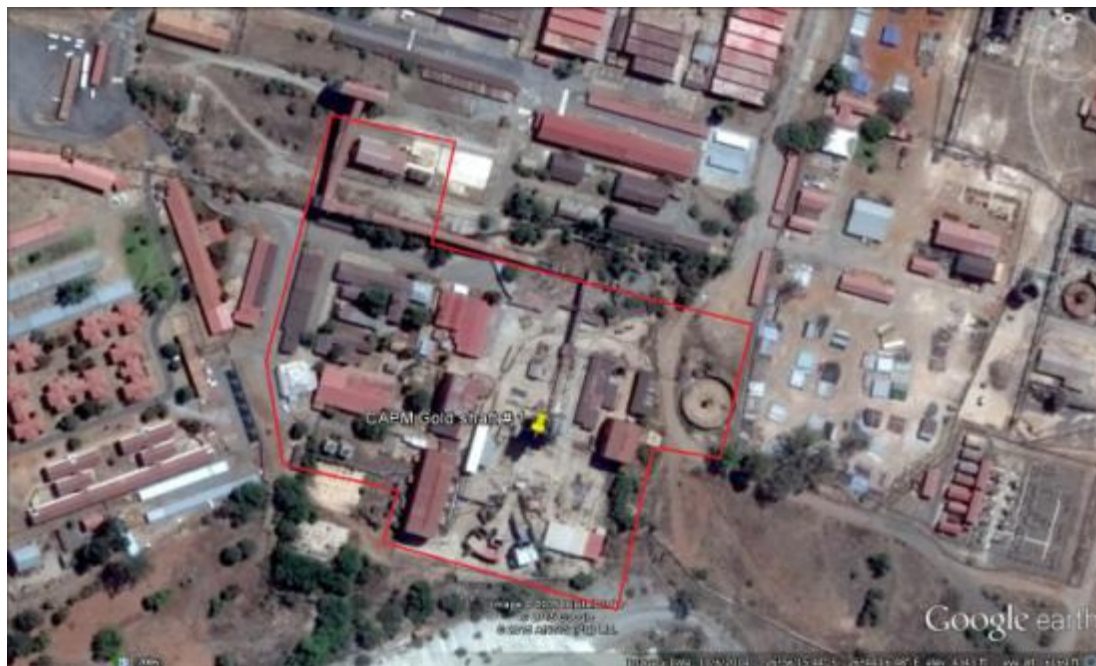
Fig. 14. Above is the site map of the #1 shaft and its associated infrastructure. (Google Earth image (2014) with the investigation area outlined in red.⁷)

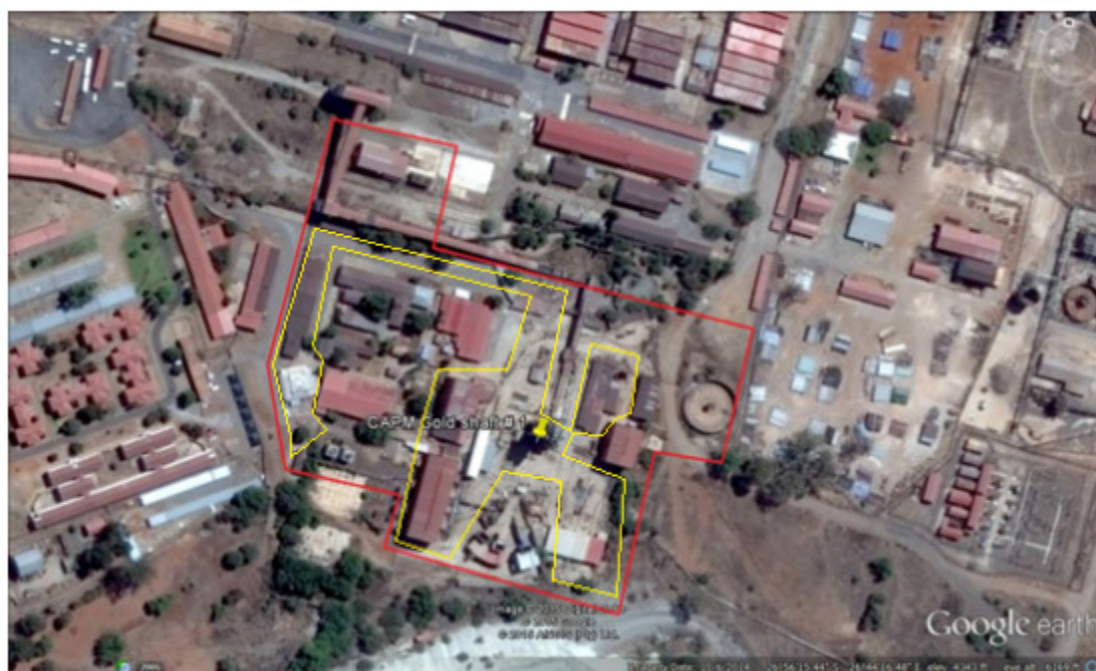
Fig. 15. Above is the site map of the #1 shaft and its associated infrastructure showing the on-foot route used during the site investigation. Investigation route is outlined in yellow. (Google Earth image 2014)

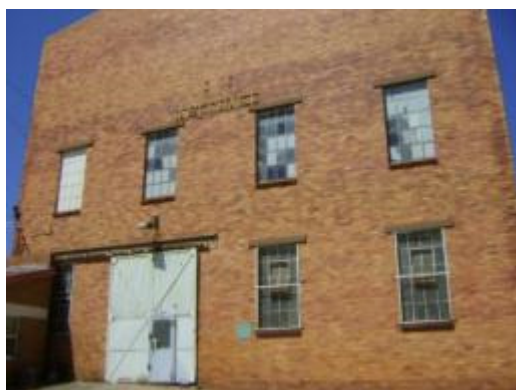
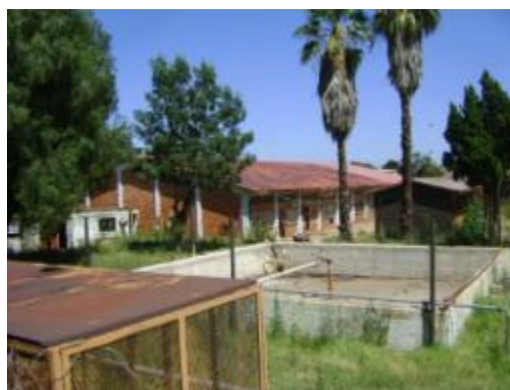
Figs. 16 to 17. Above are typical buildings and structures on site of #1 shaft. All date from circa 1960 and onwards. The entire infrastructure on this site is to be retained and re-used. (Photographs, S.M. Miller 2015.)

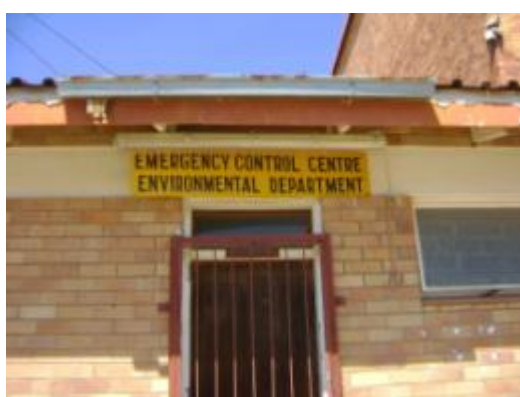
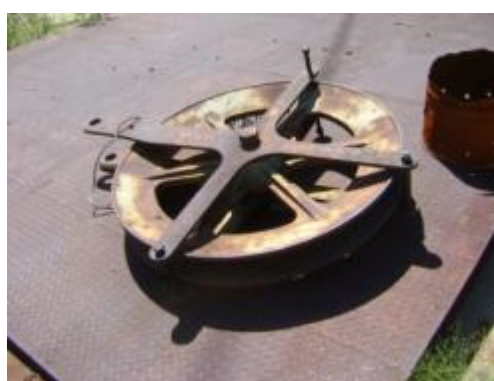
Figs. 18 to 19. Above are typical buildings and machinery on site of #1 shaft. All date from circa 1960 and onwards. The entire infrastructure is to be retained and re-used. (Photographs, S.M. Miller 2015.)

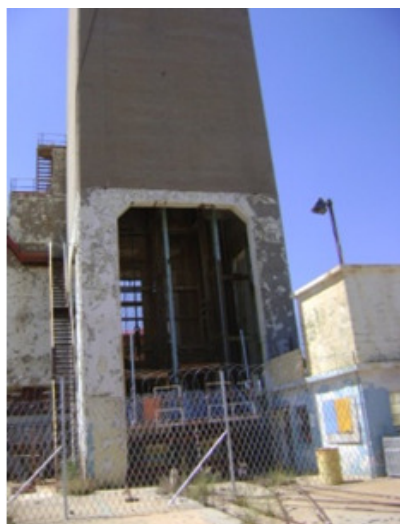
Fig. 20. Left is the concrete headgear structure of #1 shaft. The presence of a concrete headgear such as this one normally indicates modern technology and origin period post 1950⁸. (Photograph, S.M. Miller 2015.)

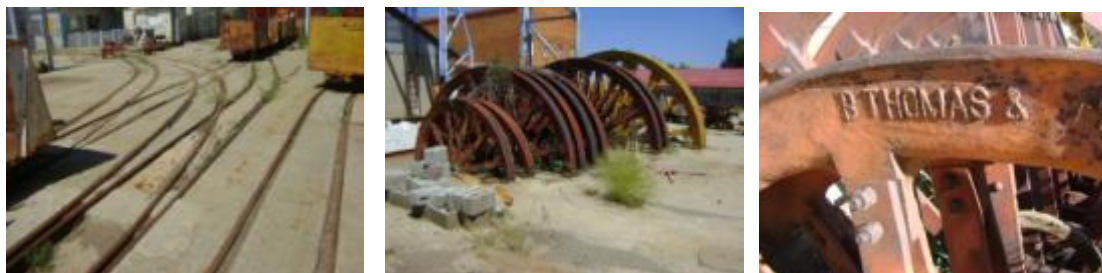
Figs. 21 to 23. Above are typical rails, coco-pans, rope wheels and structures on site of #1 shaft. All of the infrastructure is to be retained, upgraded to modern safety regulations and re-used. (Photographs, S.M. Miller 2015.)

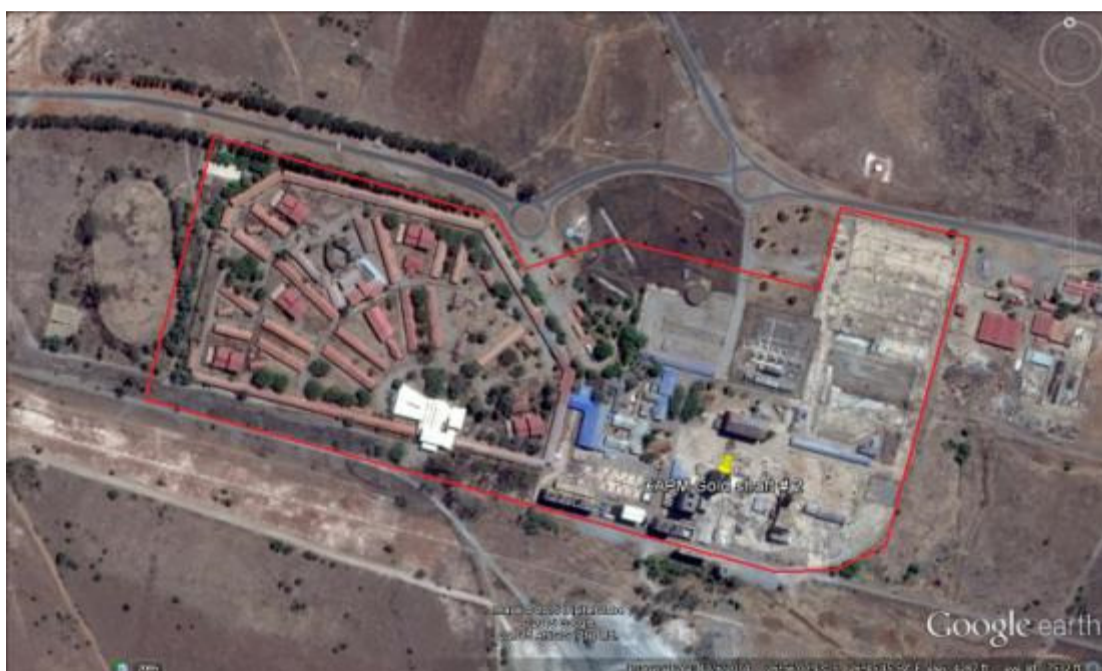
Fig. 24. Above is the site map of the #2 shaft and its associated infrastructure. (Google Earth image (2014) with the investigation area outlined in red.⁹)

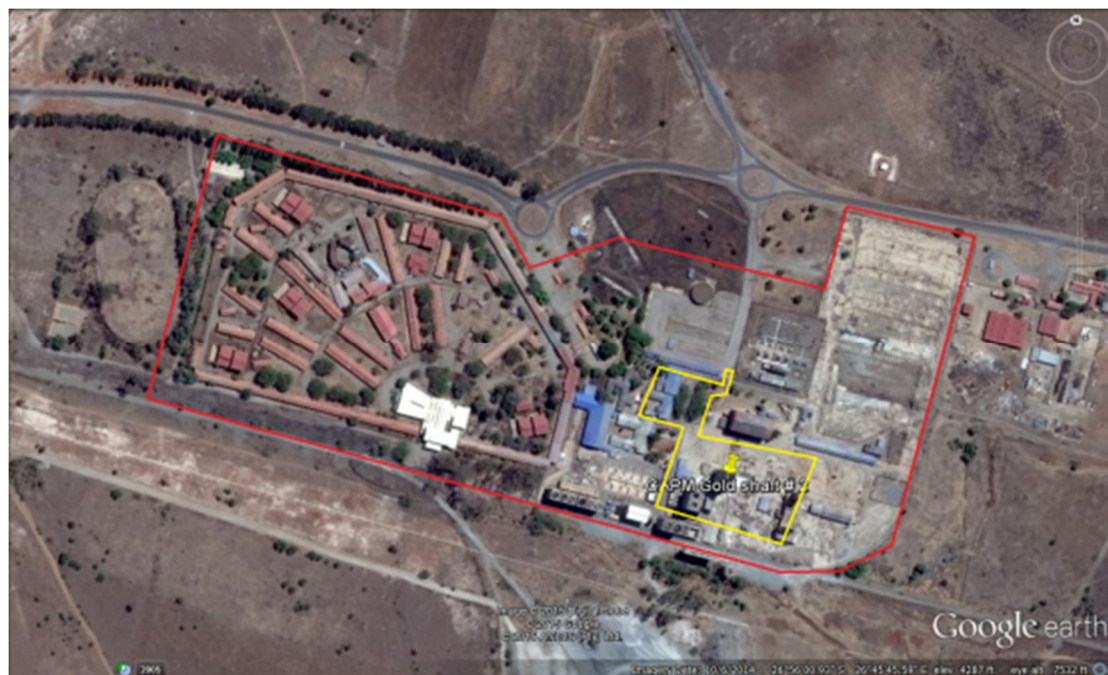
Fig. 25. Above is the site map of the #2 shaft and its associated infrastructure showing the on-foot route used during the site investigation. Investigation route is outlined in yellow. (Google Earth image 2014)¹⁰

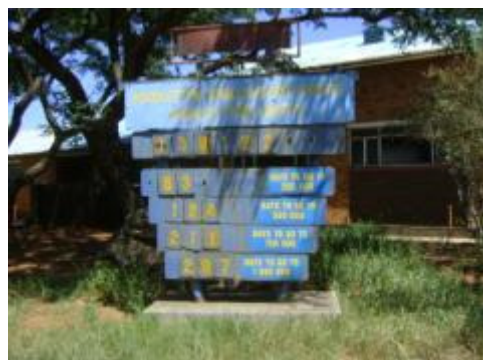
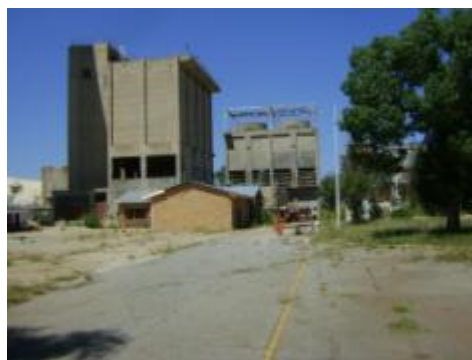
Figs. 26 to 27. Above are typical buildings and structures on site of #2 shaft. All date from circa 1960 and onwards. All of the infrastructure on this site is to be retained and re-used. (Photographs, S.M. Miller 2015.)

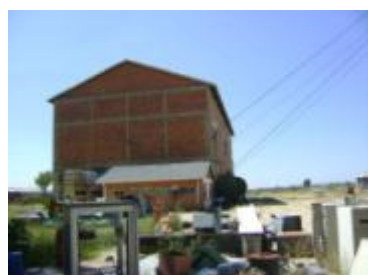
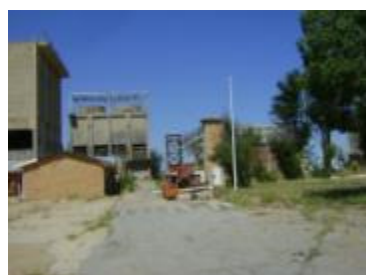
Figs. 28 to 29. Left are typical buildings and structures on site of #2 shaft. All date from circa 1960 and onwards. The entire infrastructure on this site is to be retained and re-used. (Photographs, S.M. Miller 2015.)

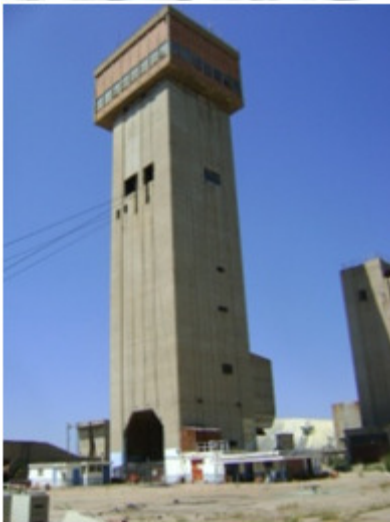
Fig. 30. Left is the concrete headgear structure of #2 shaft. The presence of a concrete headgear such as this one normally indicates modern technology and origin period post 1950⁸. (Photograph, S.M. Miller 2015.)

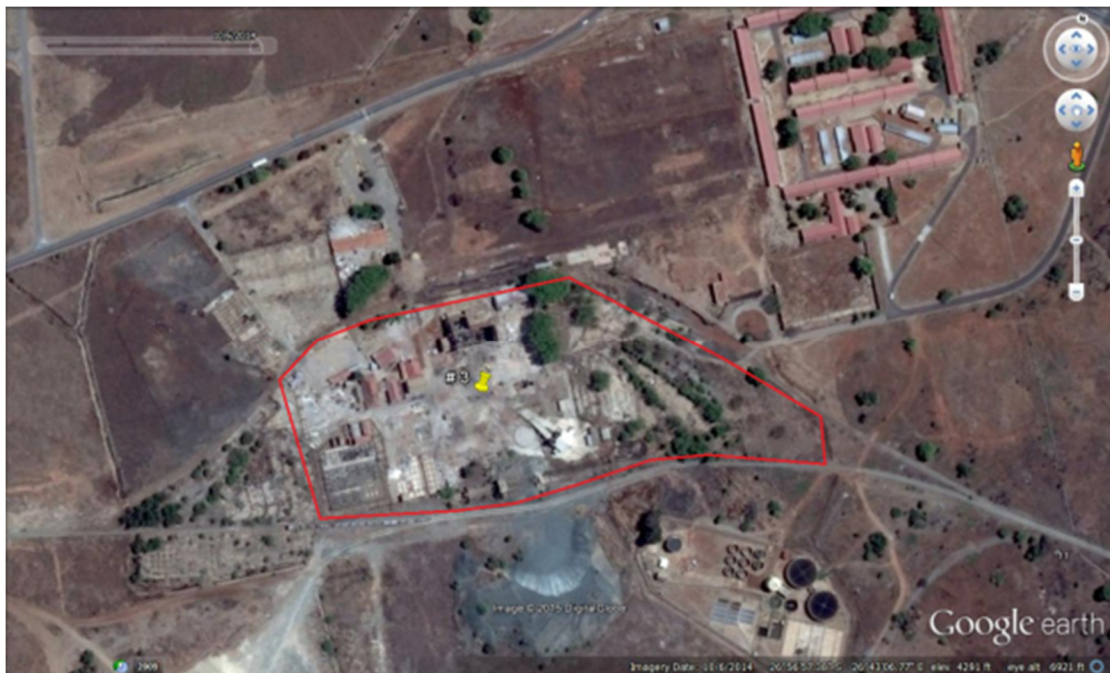
Fig. 31. Above is the site map of the #3 shaft and its associated infrastructure. (Google Earth image (2014) and the investigation area is outlined in red.) (For full list of official buildings and infrastructure see appendix in the 2015 E.I.A complied by Shangoni Management Services.)

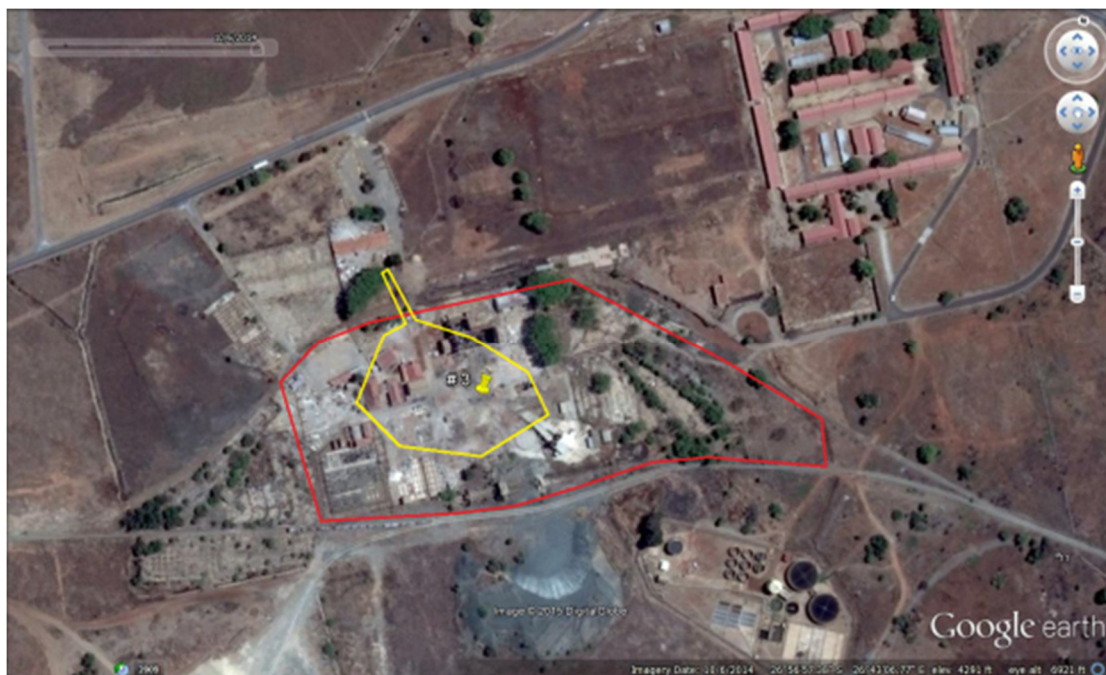
Site #3. This site with traditional riveted steel headgear is dated to the end of the 1930's. The whole of the site has been demolished apparently without a demolition permit. When this event occurred and on whose responsibility is not clear but Google Earth images suggests that it was an ongoing process from 2009 onwards culminating between 2011 and 2015. *The site is protected by section 34 (1) of Act 25 of 1999, and is rated as "General protection" A (Field Rating IV A) by the SAHRA minimum standards May 2007, therefore cannot be altered or destructed without a demolition permit issued by the relevant heritage authorities. (See figures 32 to 43.)*

Fig. 32. Above is the site map of the #3 shaft and its associated infrastructure showing the on-foot investigation route used. Investigation route is outlined in yellow. (Google Earth image 2014)

13.3. It is recommended that CAPM Gold must comment on the demolition of site #3 and that this comment must be evaluated by the appropriate heritage authorities.

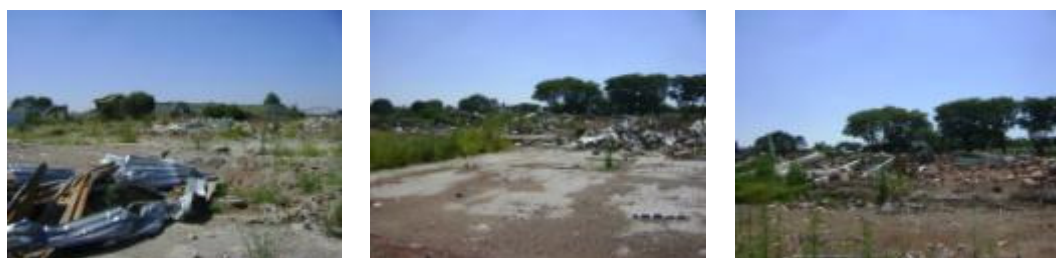
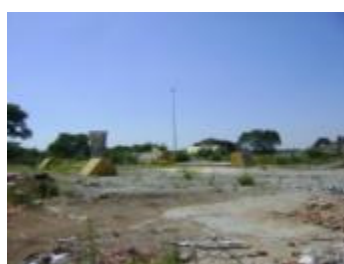
Figs. 33 to 36. Top and left are general views of the demolished site buildings and structures on site of #3 shaft. Only nominal buildings remain at the entrance to the site. The steel and iron headgear had been removed and the shaft had been plugged for safety. From the photographs supplied by CAPM Gold it appears as if the buildings and structures on this site may have been protected resources under the National Heritage Act. It does not appear as if a demolition permit was obtained for the site. (Photographs, S.M. Miller 2015.)

13.3. It is recommended that CAPM Gold must comment on the demolition of site #3 and that this comment must be evaluated by the appropriate heritage authorities.

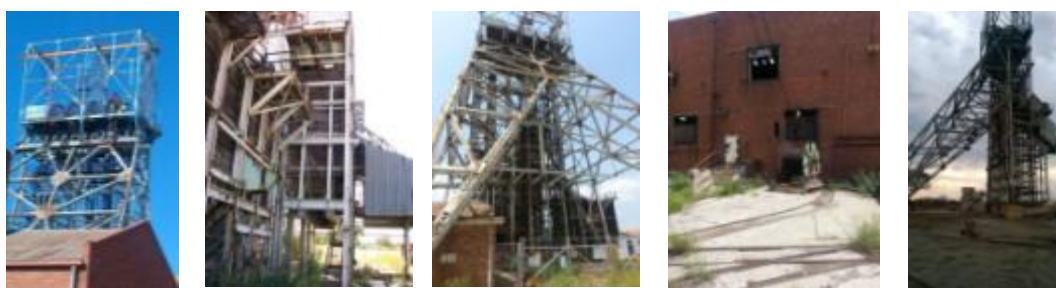
Figs. 37 to 41. Top are general views of the demolished site buildings and structures on site of #3 shaft supplied by CAPM Gold. As no other images are available it is difficult to determine the heritage status of the site in general. The iron headgear appears to be a protected structure. (Photographs, CAPM Gold)

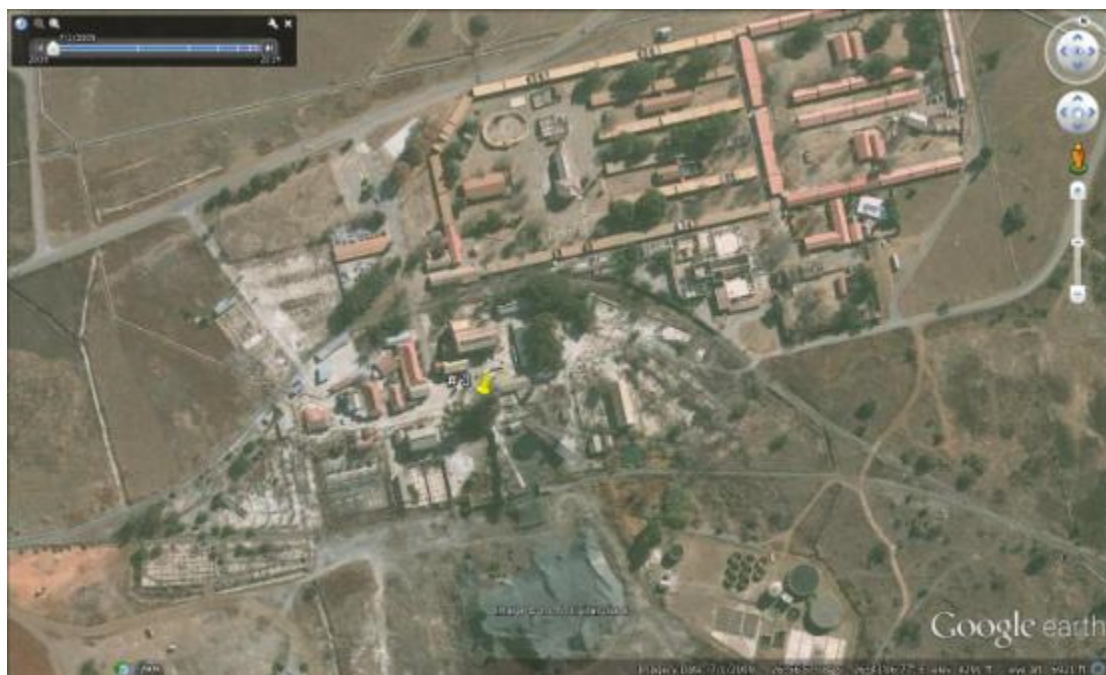
Fig. 42. Above is the site map of the #3 shaft and its associated infrastructure. (Google Earth image 2009.) From this image it is clear that the site is still intact. Note that a large portion of the compound visible here is absent in **figure 32** in 2014. ¹¹

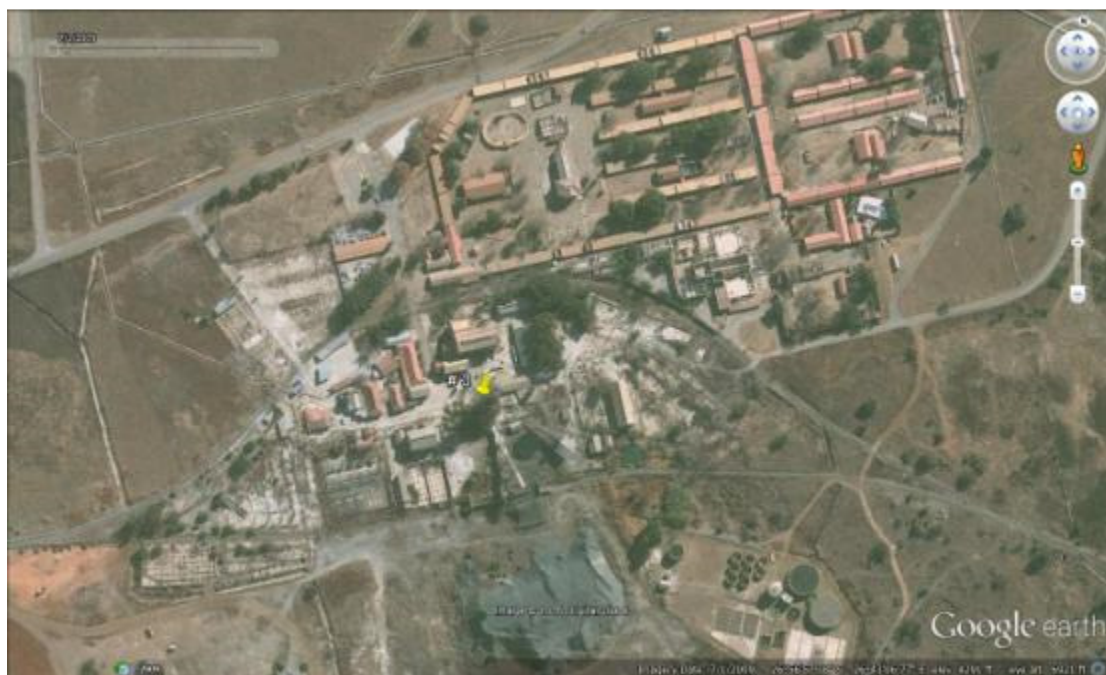
Fig. 43. Above is the site map of the #3 shaft and its associated infrastructure. (Google Earth image 2011.) From this image it is clear that the site is still intact. Note that a large portion of the compound visible here is absent in **figure 32**. From the information in **figures 32, 42 and 43** it appears that the demolition took place between 2011 and 2015. ¹²

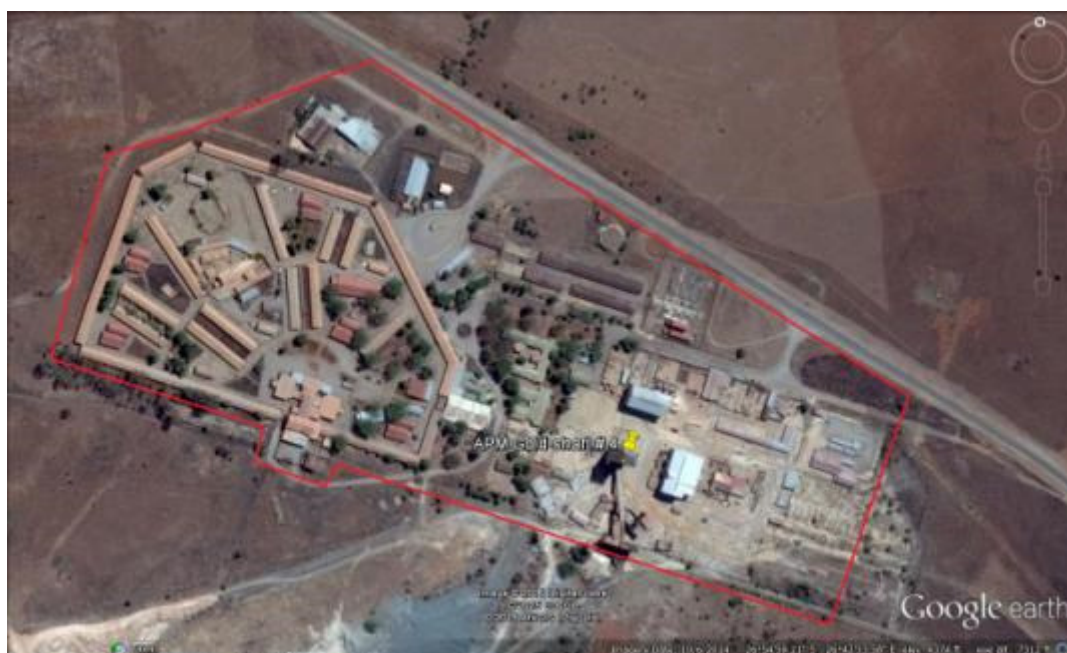
Fig. 44. Above is the site map of the #4 shaft and its associated infrastructure. (Google Earth image (2014) and the investigation area is outlined in red.)(For full list of official buildings and infrastructure see appendix in the 2015 E.I.A complied by Shangoni Management Services.)

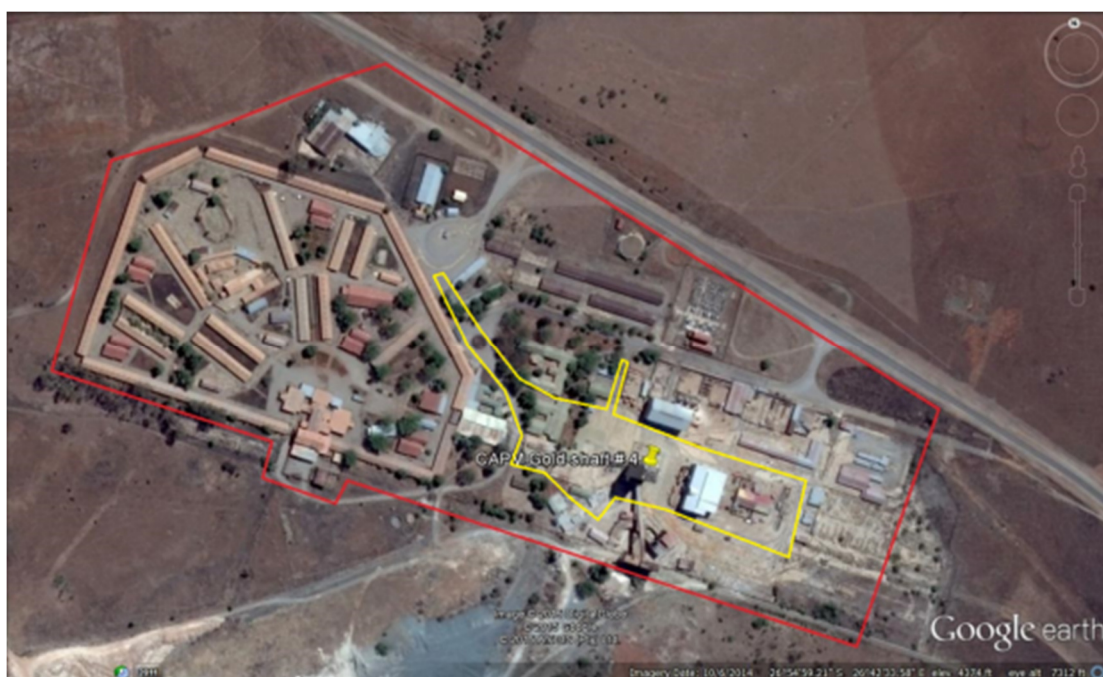
Fig. 45. Above is the site map of the #4 shaft and its associated infrastructure showing the on-foot route used during the site investigation. Investigation route is outlined in yellow. (Google Earth image 2014)¹³

¹³ The compound site was not visited as it probably dates post 1960 and CAPM Gold intends to retain it as an accommodation facility, either for its own use or for rental to the public.

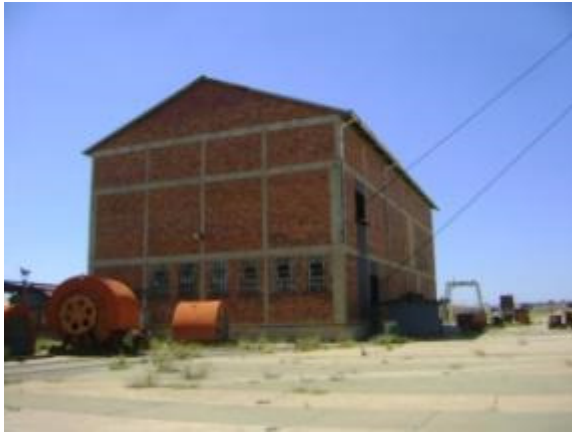
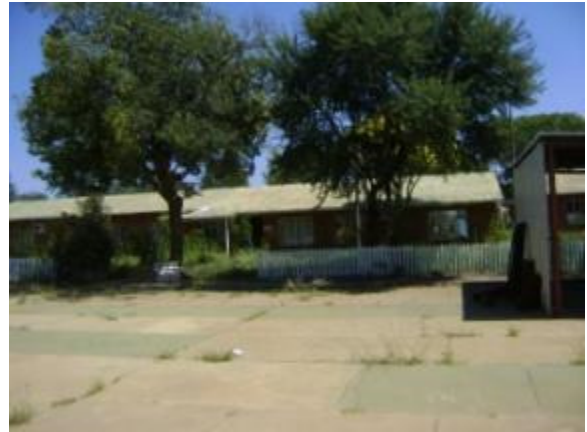
Figs. 46 to 47. Above are typical buildings and structures on site of #4 shaft. All date from circa 1960 and onwards. The entire infrastructure on this site is to be retained and re-used. (Photographs, S.M. Miller 2015.)

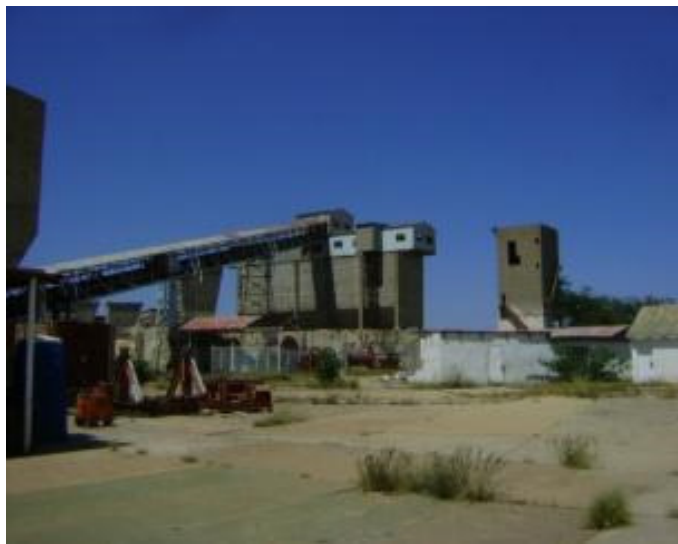
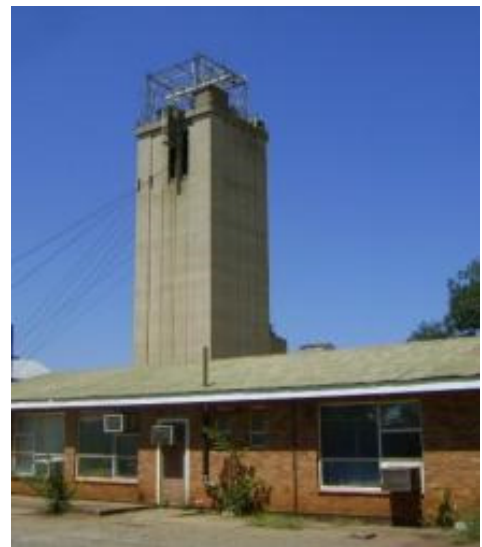
Figs. 48 to 49. Above are typical buildings and structures on site of #4 shaft. All date from circa 1960 and onwards. The entire infrastructure on this site is to be retained and re-used. (Photographs, S.M. Miller 2015.)⁸

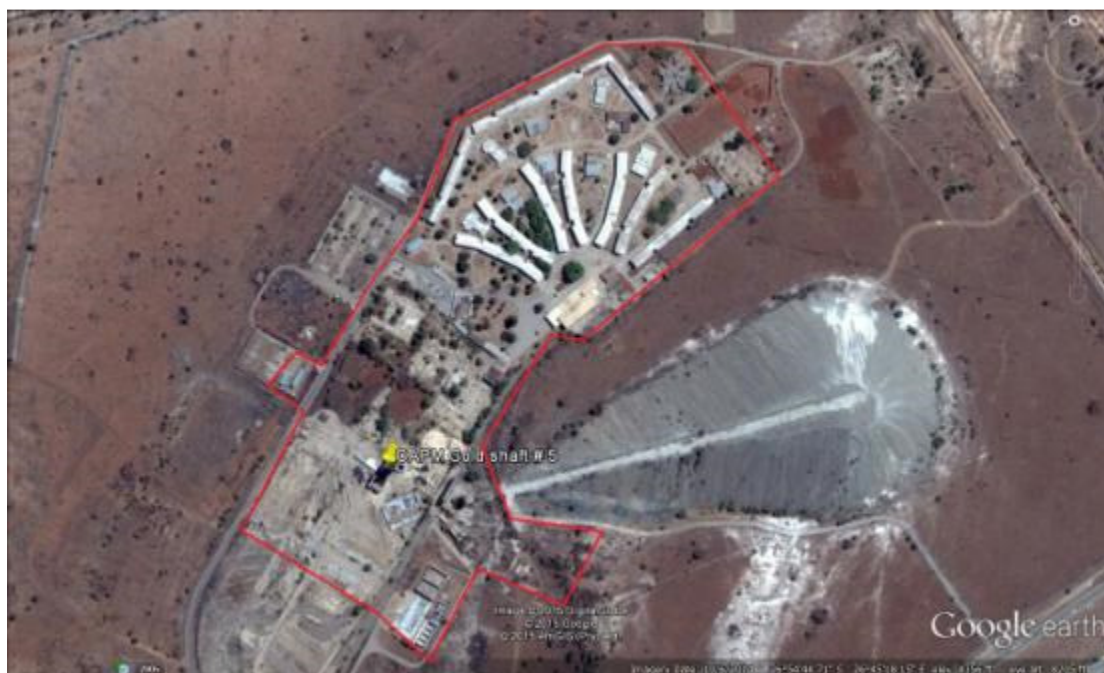
Fig. 50. Above is the site map of the #5 shaft and its associated infrastructure. (Google Earth image (2014) and the investigation area is outlined in red.)(For full list of official buildings and infrastructure see appendix in the 2015 E.I.A complied by Shangoni Management Services.)

Fig. 54. Above is the site map of the #5 shaft and its associated infrastructure. (Google Earth image 2011.) From this image it is clear that the site has been completely demolished. Compare to figure 50 dated 2014. From figures 50, 53 and 54 it appears that the demolition took place before 2011.

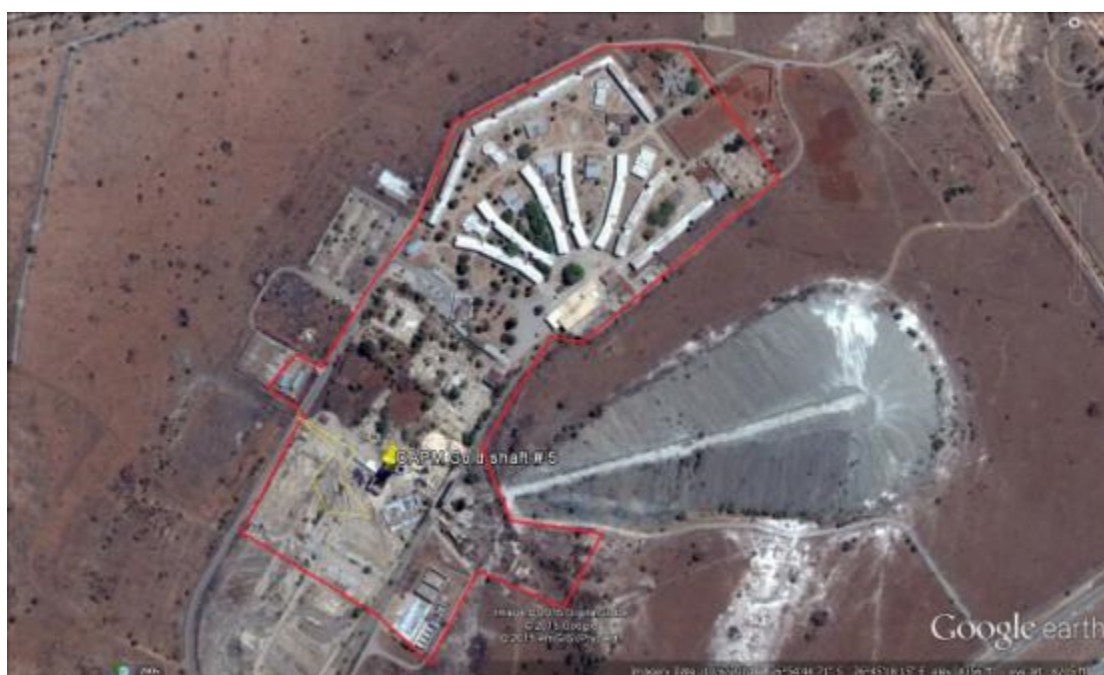
Fig. 51. Above is the site map of the #5 shaft and its associated infrastructure showing the on-foot route used during the site investigation. Investigation route is outlined in yellow. (Google Earth image 2014)¹⁴

¹⁴ The compound site was not visited as it probably dates post 1960 and CAPM Gold intends to retain it as an accommodation facility, either for its own use or for rental to the public.

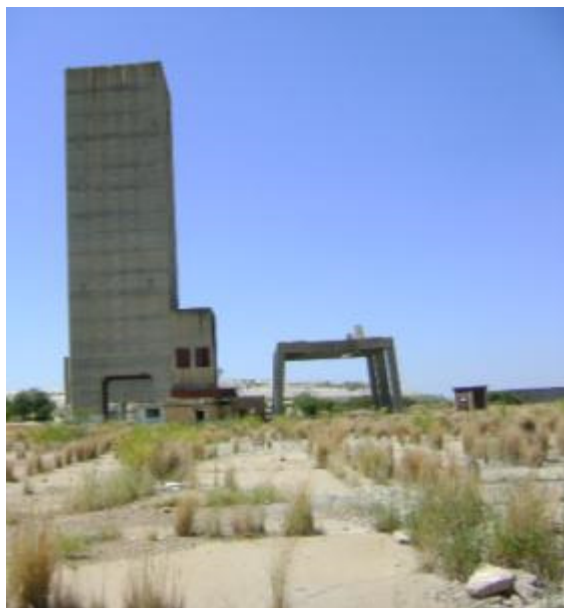
Fig. 52. Left is the concrete headgear structure of #5 shaft. The presence of a concrete headgear such as this one normally indicates modern technology and origin period post 1950⁸. Apart from this lone structure nothing remains from the original infrastructure of the site. (Photograph, S.M. Miller 2015.)

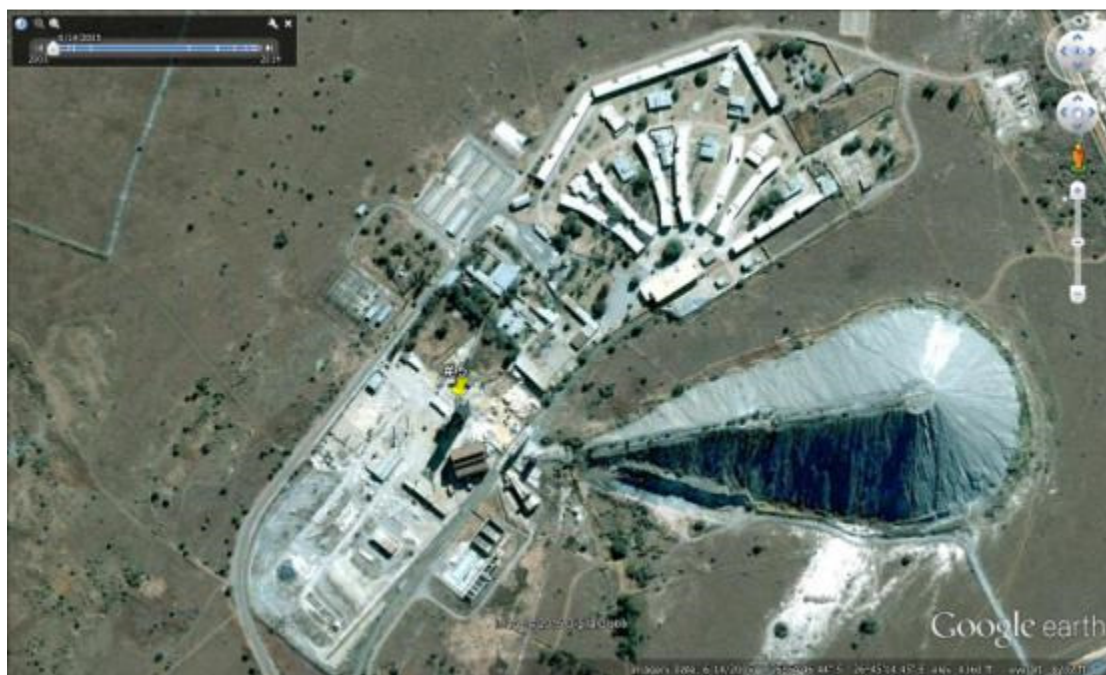
Fig. 53. Above is the site map of the #5 shaft and its associated infrastructure. (Google Earth image 2005.) From this image it is clear that portions of the site are still intact although demolition has already commenced.¹⁵ Compare to figure 50 dated 2014.

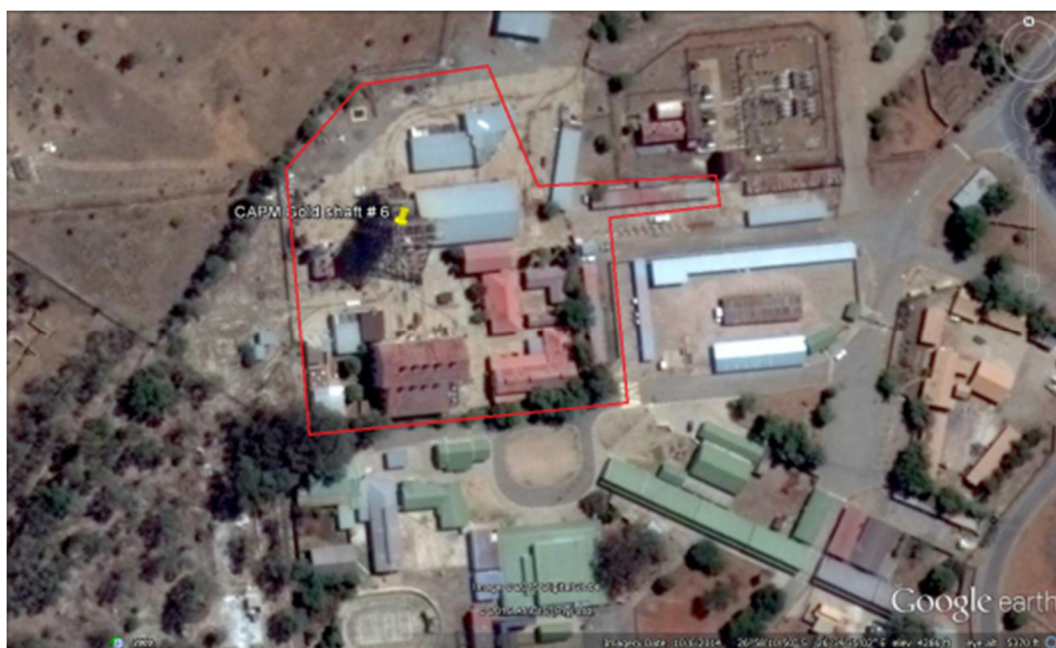
Fig. 55. Above is the site map of the #6 shaft and its associated infrastructure. (Google Earth image (2014) and the investigation area is outlined in red.) (For full list of official buildings and infrastructure see appendix in the 2015 E.I.A complied by Shangoni Management Services.)

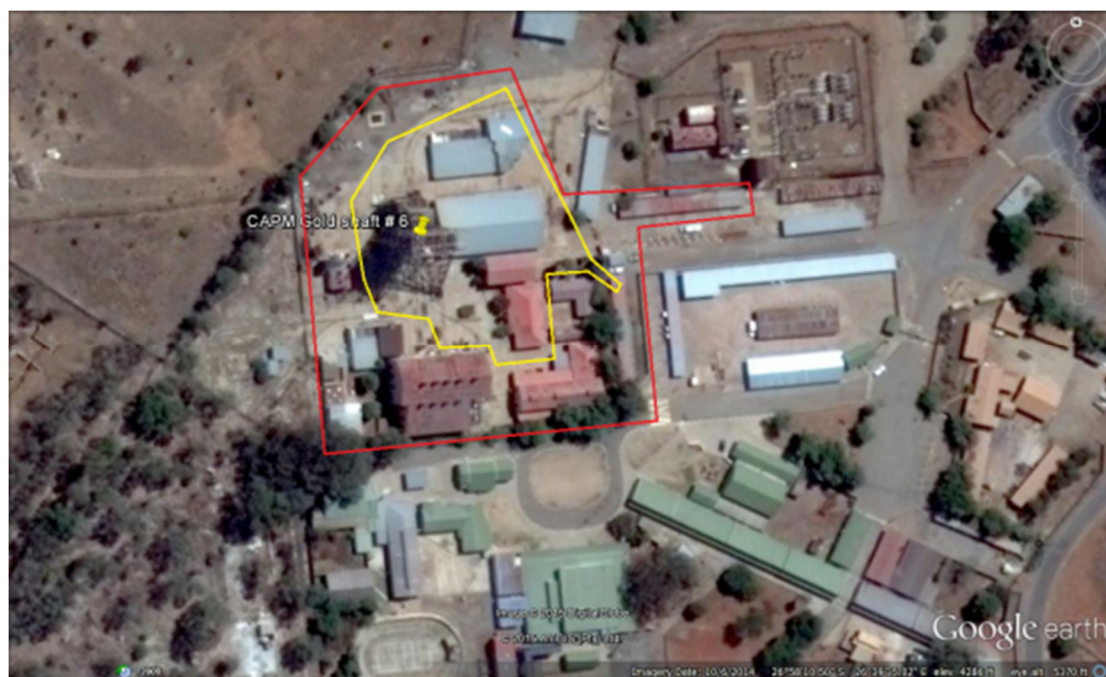
Fig. 56. Above is the site map of the #6 shaft and its associated infrastructure showing the on-foot route used during the site investigation. Investigation route is outlined in yellow. (Google Earth image 2014.)

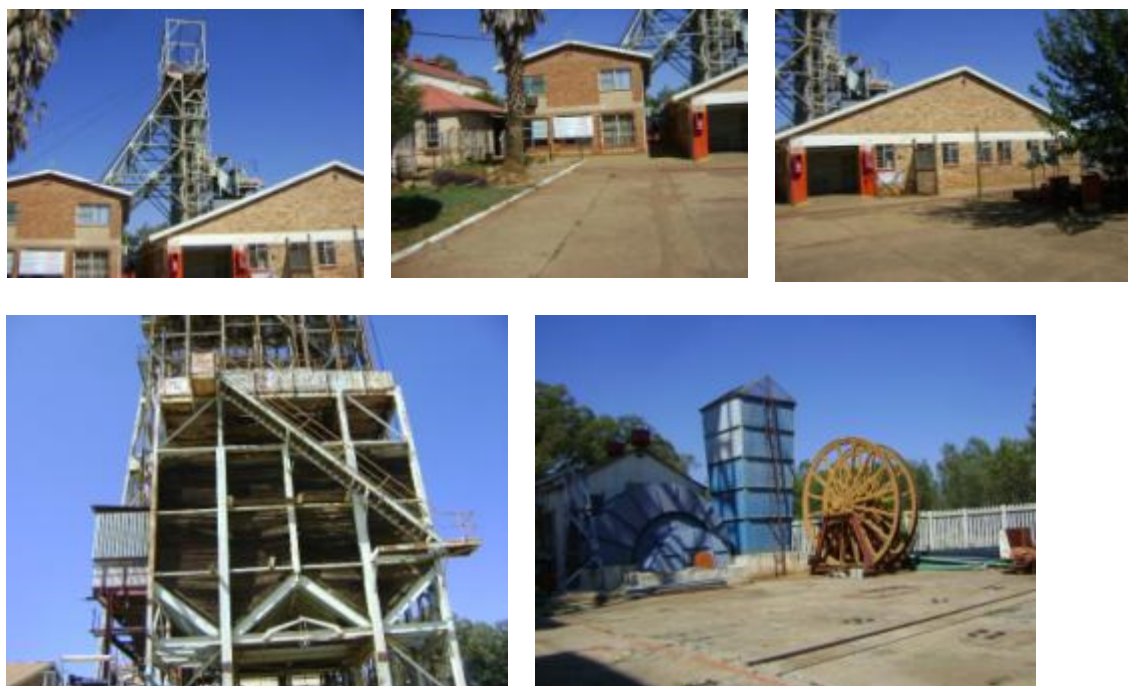
Figs. 57 to 61. Above are typical buildings and structures on site of #6 shaft. All date from circa 1940 and onwards. The entire infrastructure on this site is to be retained and re-used. (Photographs, S.M. Miller 2015.)¹⁶

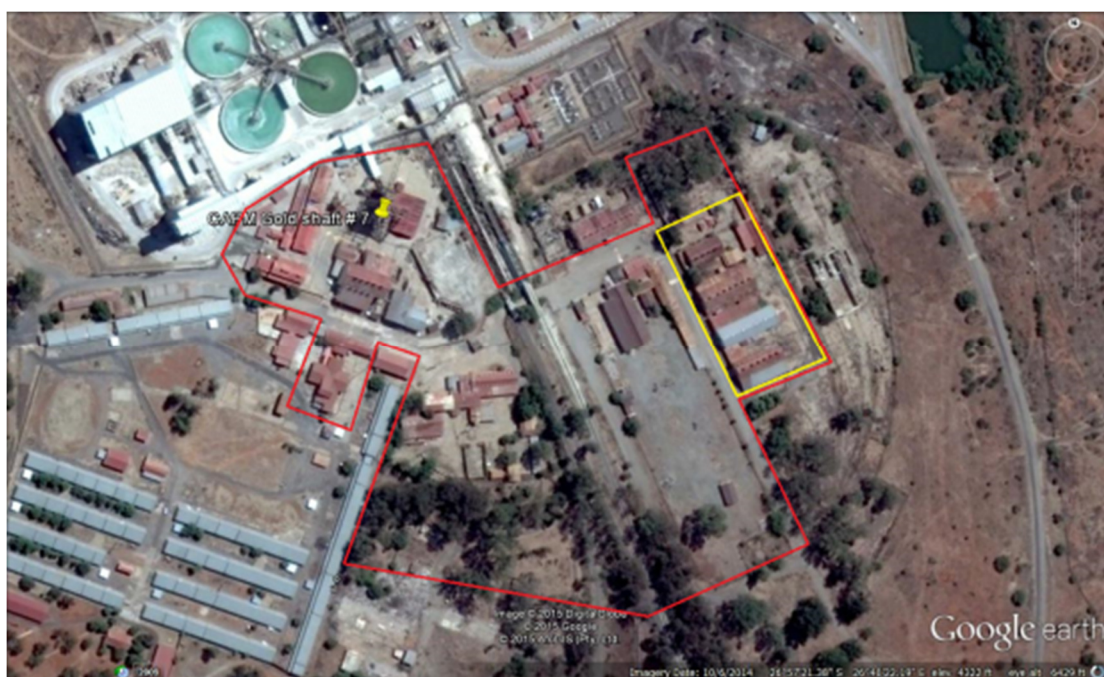
Fig. 62. Above is the site map of the #7 shaft and its associated infrastructure. (Google Earth image (2014) and the investigation area is outlined in red.)(For full list of official buildings and infrastructure see appendix in the 2015 E.I.A complied by Shangoni Management Services.)

Figs. 64 to 81. Above are typical buildings and structures on site of #7 shaft in the area defined by a yellow lined rectangular in **figure 62**. All date from circa 1940 and onwards and are protected by the National Heritage Act. It is the intent of CAPM Gold to apply for demolition permits as these buildings are superfluous to mining objectives. It is provisionally foreseen that the three larger steel framed workshops will be earmarked for relocation when suitable clients can be obtained. (**Photographs, S.M. Miller 2015.**)

Figs. 82 to 92. Above are typical buildings and structures on site of #7 shaft outside the area defined by a yellow lined rectangular in **figure 62**. All date from circa 1940 and onwards and are protected by the National Heritage Act. It is the intent of CAPM Gold to retain these buildings as they are pivotal to mining objectives. (Photographs, S.M. Miller 2015.)¹⁶

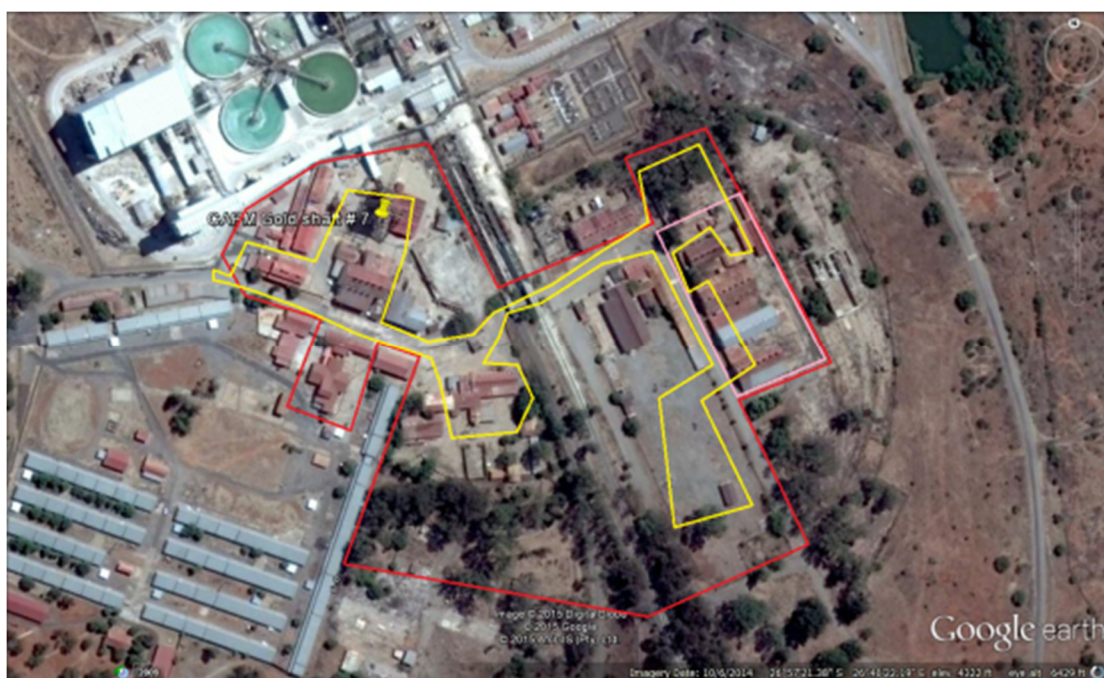
Fig. 63. Above is the site map of the #7 shaft and its associated infrastructure showing the on-foot route used during the site investigation. Investigation route is outlined in yellow. (Google Earth image 2014.)

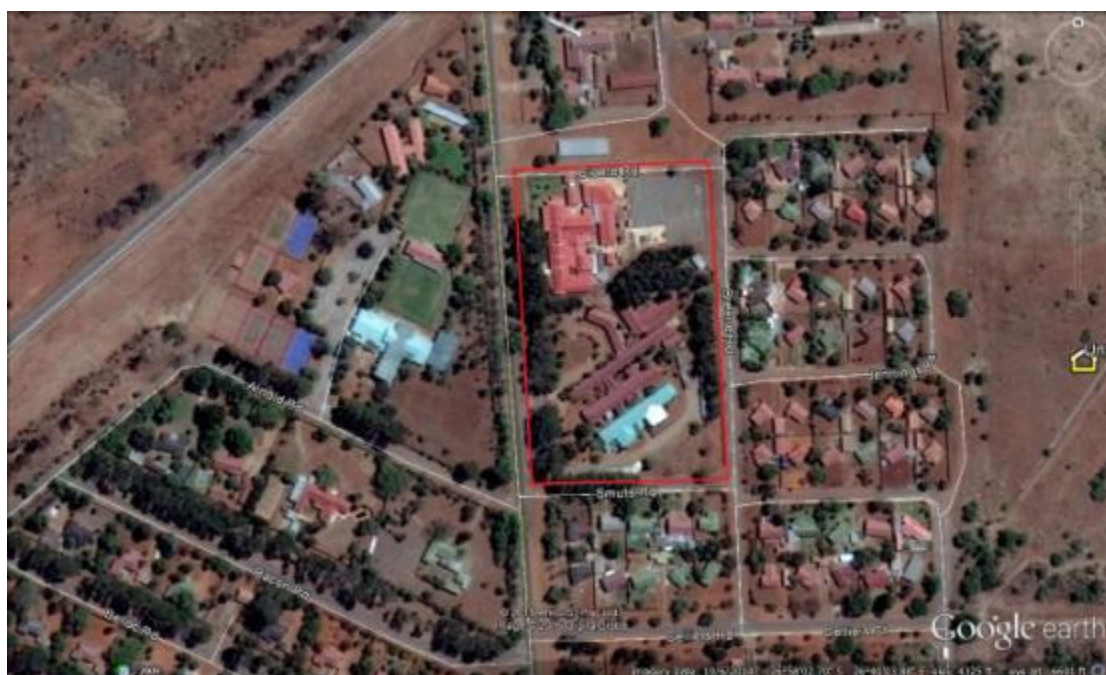
Site 8. Office complex.

Fig. 93. Above is the site map of the office complex in Orkney and its associated infrastructure. (Google Earth image (2014) and the investigation area is outlined in red.)(For full list of official buildings and infrastructure see appendix in the 2015 E.I.A complied by Shangoni Management Services.)

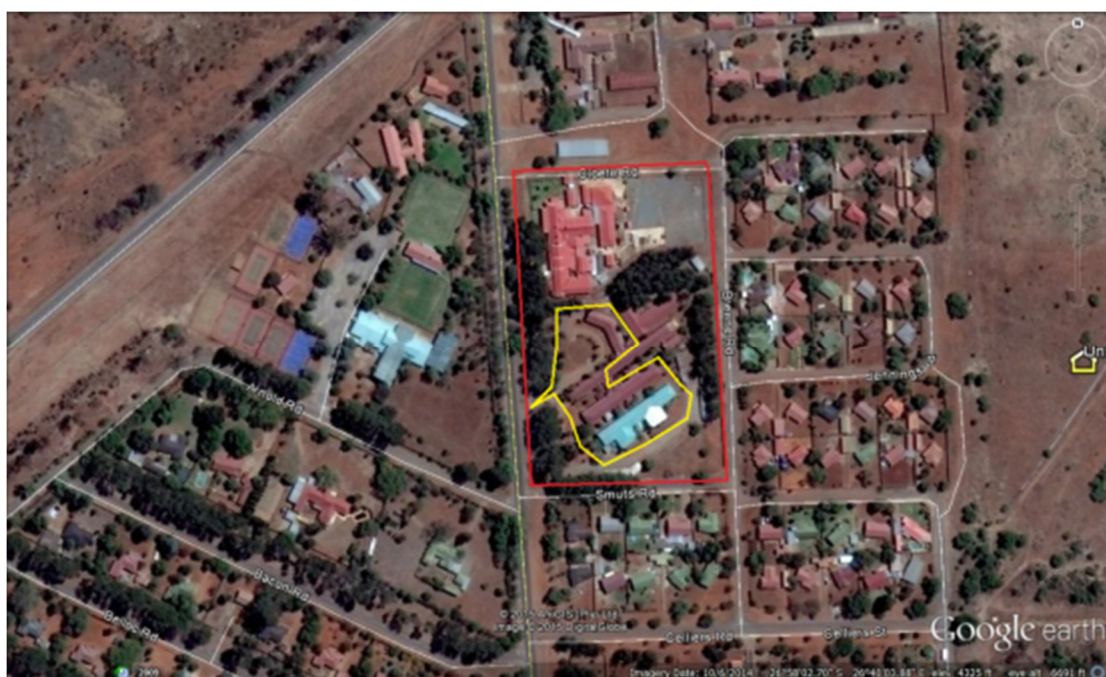
Fig. 94. Above is the site map of the site offices in Orkney town and its associated infrastructure showing the on-foot route used during the site investigation. Investigation route is outlined in yellow. (Google Earth image 2014.)

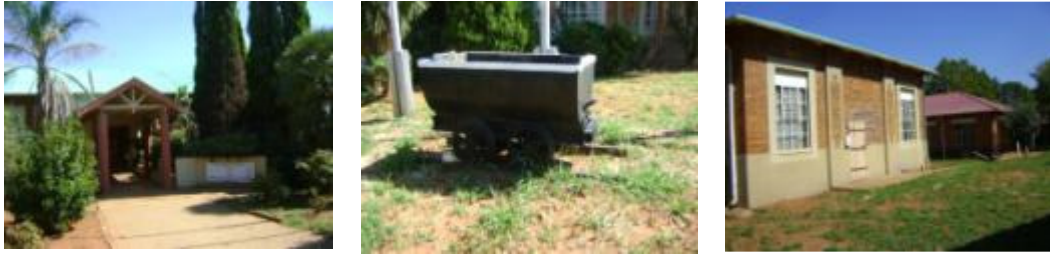
Figs. 95 to 96. Above are typical buildings and structures on site of the Satellite Offices. All date from circa 1960 and onwards. The entire infrastructure on this site is to be retained and re-used. (Photographs, S.M. Miller 2015.)
