**ARCHAEOLOGICAL IMPACT ASSESSMENT
OF THE PROPOSED EXTENSION OF TWO BORROW PITS
ON PORTIONS 12 & 18, WATERKLIP NO. 103,
VREDENBURG AREA, WEST COAST DISTRICT,
WESTERN CAPE**

(Assessment conducted under Section 38 (8) of the National Heritage Resources Act as part
of a Heritage Impact Assessment)

JULY 2012

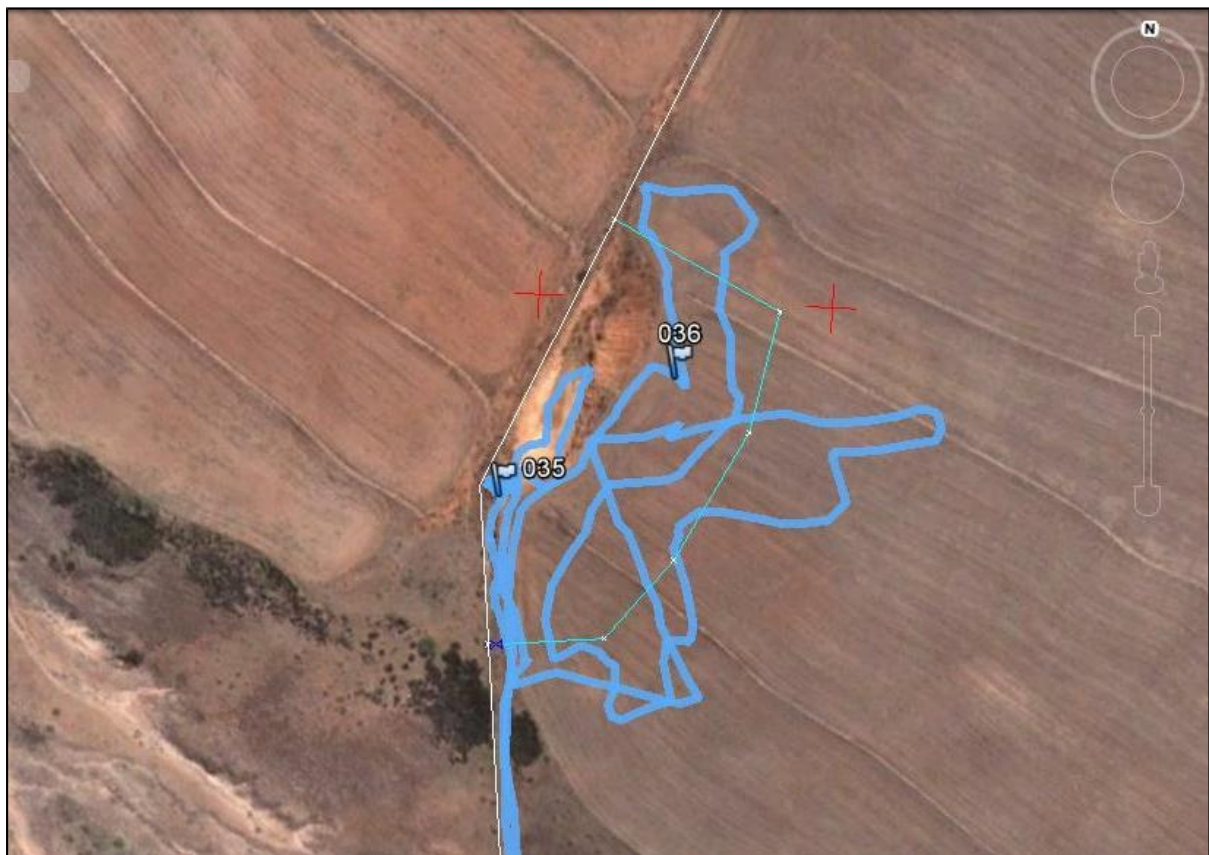
Figure 2: Google earth image showing the proposed extension of the existing borrow pit 104 with the tracks and waypoints of the field survey. The existing quarry is the lighter patch on the left side of the polygon.

Environment: The affected area lies on a south-facing slope approximately 280m to the north of the MR0240 from Vredenburg to Paternoster. The existing quarry, a gully and a fence form the western boundary of the proposed extension (Figures 2 and 3). There are no markers for the other boundaries. A colluvially transported gravelly silty sand horizon that varies in thickness is underlain by ferruginised soils. The gravel component of the soils varies from fine to medium subangular ferricrete and weakly cemented ferruginised sand nodules. Clay content also varies across the site. The ferruginised soils overlie weathered granite. The presence of termite mounds ('heuweltjies') results in some undulations in the terrain. The area is used for farming and wheat had been planted with the result that the visibility of archaeological material on the ground was somewhat limited (Figures 3 and 4).

Waypoint	South	East	Description of material found
035	S32 53 02.9	E17 58 11.1	Rounded, possibly ground, cobble
036	S32 53 01.5	E17 58 13.4	Worn tooth, probably of recent sheep origin

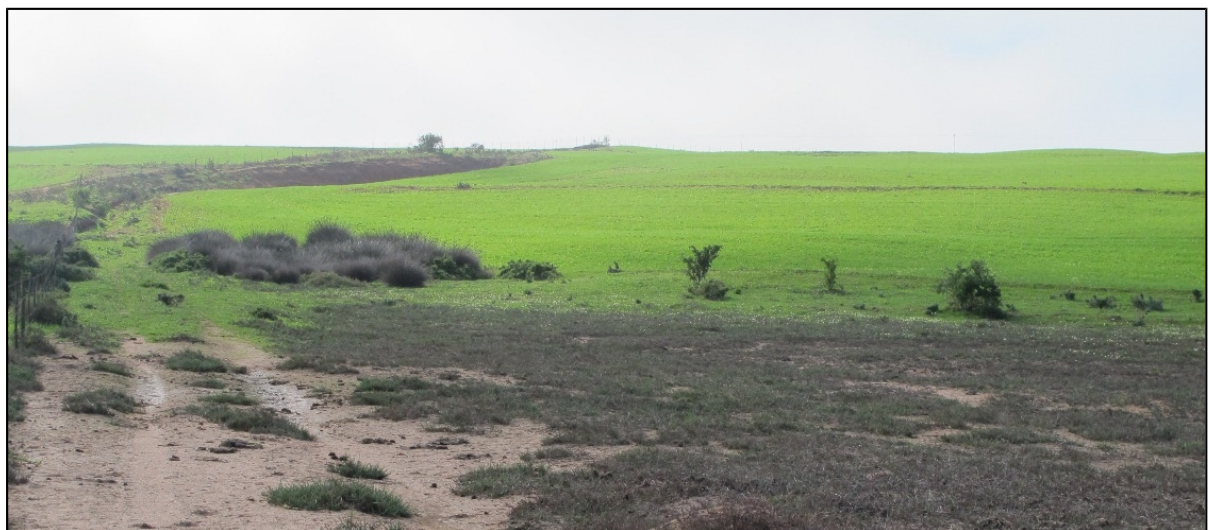
Figure 3: Pit 104 – view towards the north. The dark area on the left indicates the existing borrow pit with gully along the fence line.

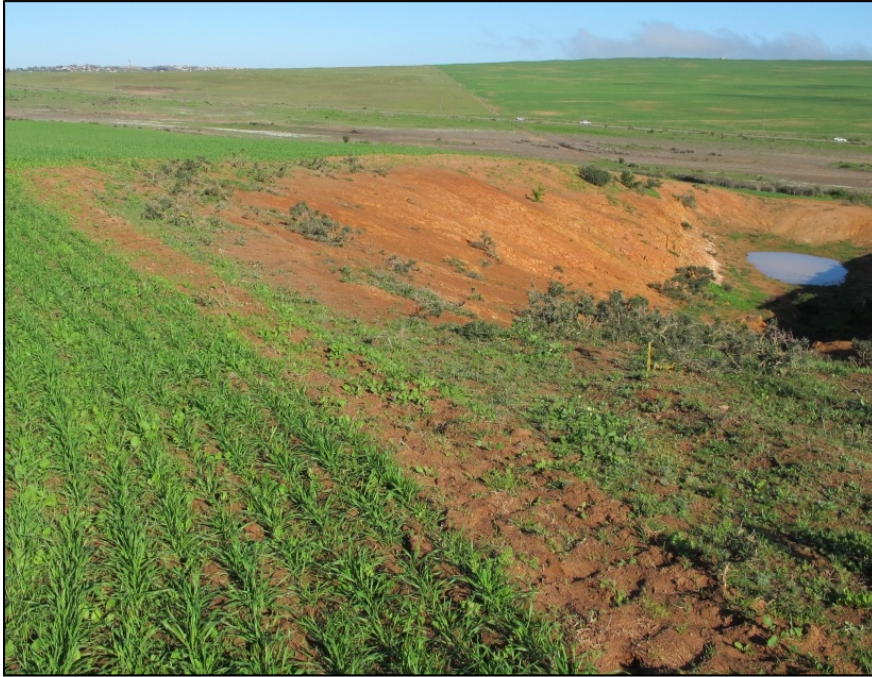
Figure 4: Pit 104 – view towards the south from the northern part of the affected area. Vredenburg is visible on the horizon to the left. Rows of planted wheat are evident.

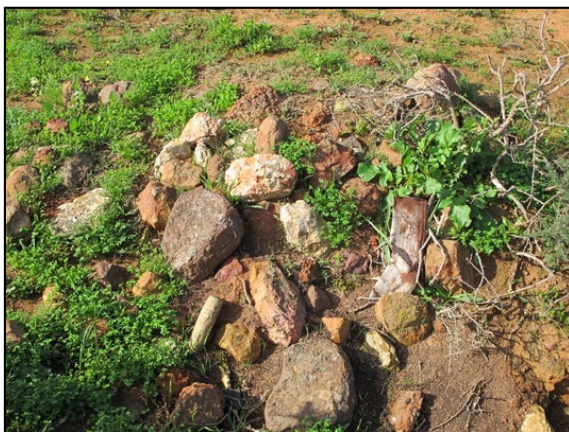
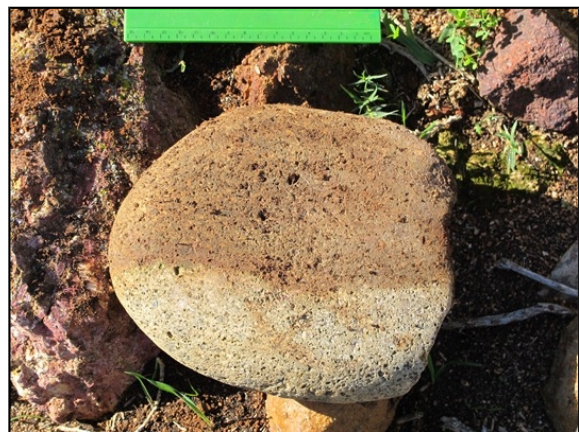
Results of the survey: The only objects of potential archaeological interest observed were a rounded granite cobble with flat upper and lower surfaces (possibly ground) found in a heap of larger blocks removed from the fields (Figures 5 and 6) and a single very worn tooth (Figure 7). The latter, belonging to a sheep (G Avery pers. comm.) probably dates to recent times as the land is generally used for agricultural purposes. Although the edges of the cobble were smooth and rounded, no actual polished surfaces or grooves were observed. No evidence of flaked stone, bone, shell, pottery or vitrified dung was noted.

Figures 5 and 6: Pit 104 – heap of stones in the gully; rounded granite cobble. The ruler is about 15 cm in length.

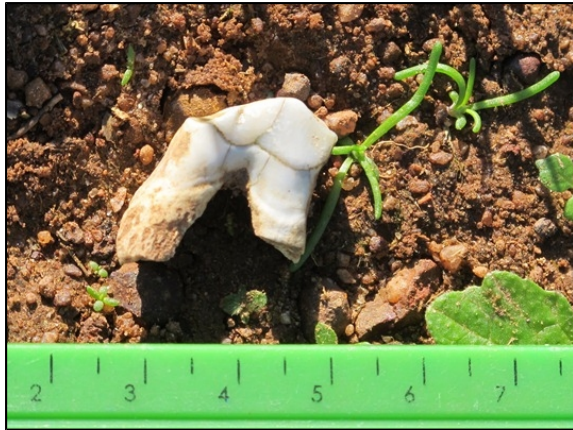
Figure 7: Pit 104 – worn tooth. The scale is in cm.

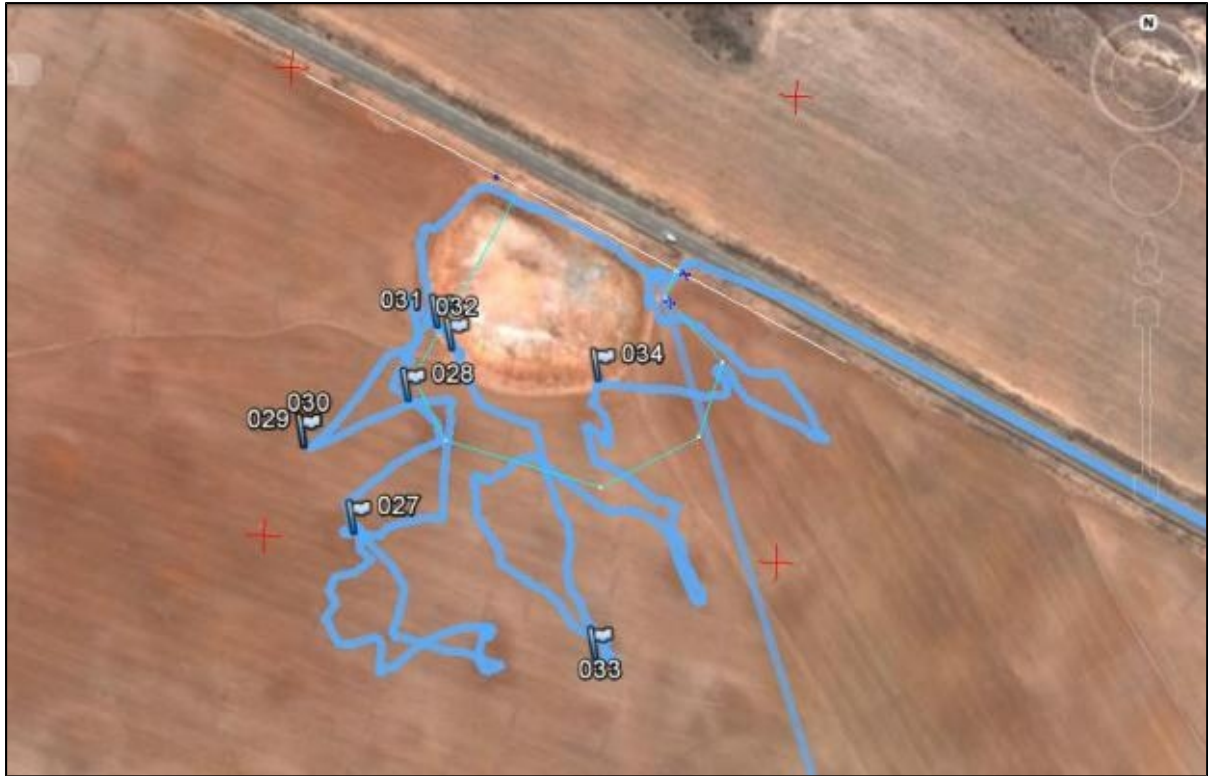
Figure 8: Google earth image showing the proposed extension of the existing borrow pit 105, tracks and waypoints of the field survey. Please note that the straight blue lines do not indicate survey tracks.

Environment: The existing pit and proposed extension lie in ploughed land adjoining the MR0240 (Figure 8). The proposed extension would be in an easterly, southerly and westerly direction from the present quarry. Except for the road and the western edge of the quarry, there are no clear boundaries for the proposed extension so a wider area than the affected polygon was surveyed. The ground slopes gently uphill to the south-east. The faint brown circles visible in the satellite image and on the ground indicate the presence of termite mounds ('heuweltjies'). Colluvially transported, ferruginised gravelly silty sand mostly overlies gravelly, silty sandy ferricrete. The gravel consists of fine to medium nodular ferricrete and ferruginised sand grains that are weakly to moderately cemented. The sand and gravel overlie completely weathered coarse-grained granite, partly calcretised and ferruginised. Some calcrete gravel occurs 0.4 m below the surface in some areas. Archaeological visibility was good as the terrain was only covered by patchy grass and sparse, dried wheat stalks.

Waypoint	South	East	Description of material found
027	S32 53 04.1	E17 57 33.1	Sheep's tooth, probably recent
028	S32 53 02.1	E17 57 33.9	Rounded cobble
029	S32 53 02.9	E17 57 32.1	Snapped quartz flake/blade
030	S32 53 02.9	E17 57 32.1	Milky quartz, possible LSA core
031	S32 53 01.0	E17 57 34.4	Coarse-grained silcrete flake
032	S32 53 01.3	E17 57 34.7	Quartz chunk and flake, calcrete flake
033	S32 53 05.9	E17 57 37.5	Lower grindstone fragment
034	S32 53 01.7	E17 57 37.4	Coarse-grained silcrete artefact, possible adze

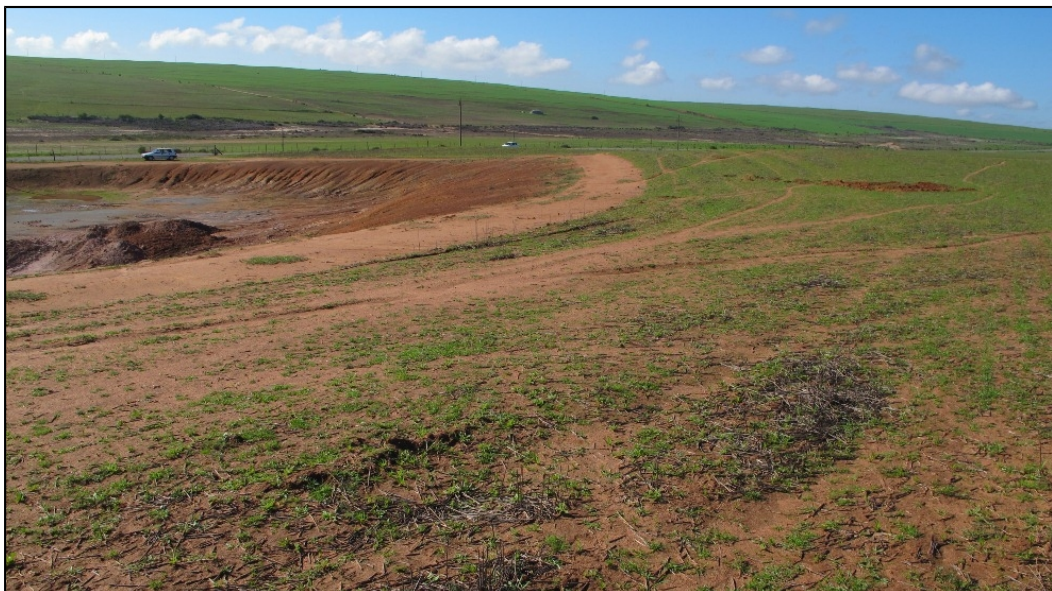
Figure 9: Pit 105 – view towards the east, the area where Pit 104 lies. The existing quarry is evident on the left.

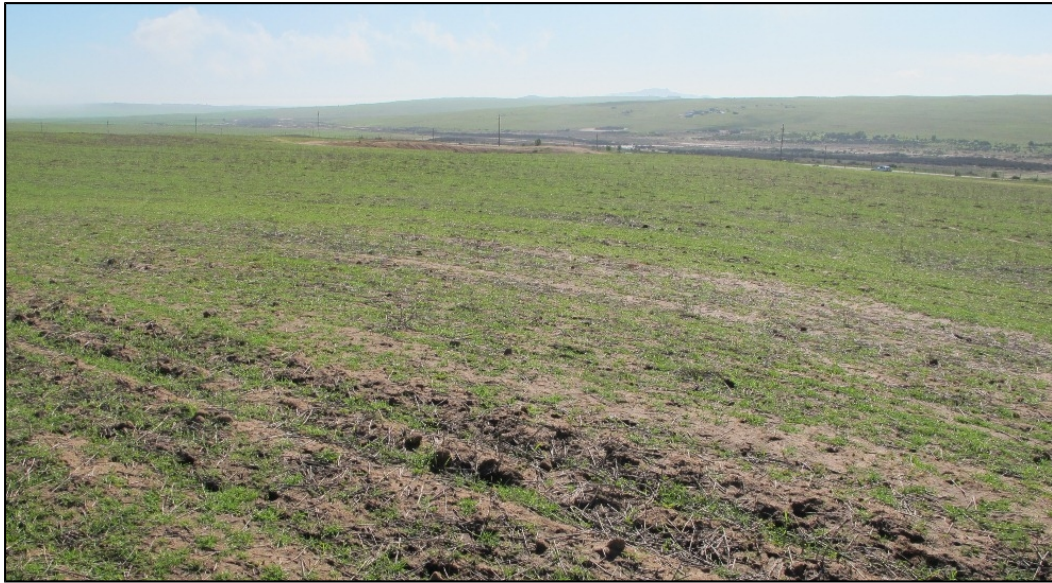
Figure 10: Pit 105 – view towards the north taken from a spot outside the southern boundary of the affected area. The existing pit and road lie in the middle distance and Kasteelberg is very faintly visible on the horizon.

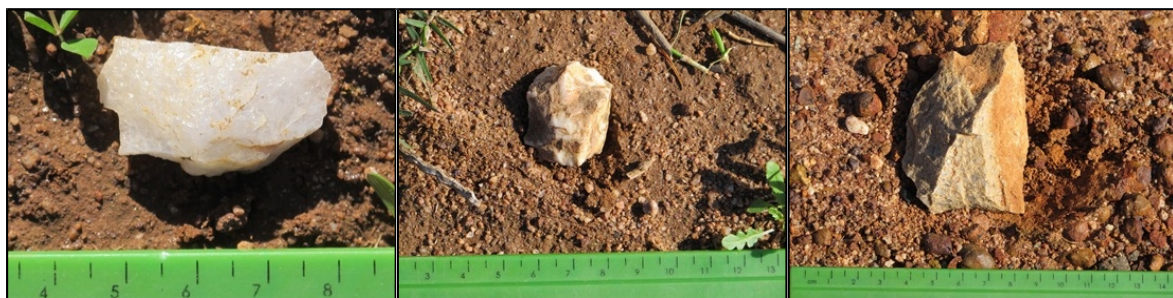
Results of the survey: A few scattered artefacts of quartz, coarse-grained silcrete and calcrete were observed (Table 2 in the Appendix, Figures 11 to 14, 16). Part of a sandstone or quartzite lower grindstone with polish on both surfaces was noted (Figure 15), as was a rounded granite cobble (Figure 17). No polished surfaces, grooves or hammer marks were observed. One of the silcrete artefacts (Figure 16) appeared to have backing along one edge and could perhaps be an adze. The artefacts mostly appear to be of indeterminate age, although the possible quartz core would belong to the LSA. The carcasses of a couple of dead sheep lay in the field so the few bone fragments observed were not recorded as way points. The only exception was a tooth (Figure 14) which has been identified as belonging to a sheep (G. Avery, pers.comm.). No other material of archaeological interest such as shell, pottery or vitrified dung were observed.

Figures 11 to 13: Pit 105 – snapped quartz flake; quartz core; coarse-grained silcrete flake. The scale is in cm.

The sparse, scattered archaeological material observed was found in a disturbed, secondary context and is therefore considered to be of low heritage significance. No significant impact on such resources is expected if the proposed extensions of the existing borrow pits are developed. No further archaeological studies or mitigation are recommended.

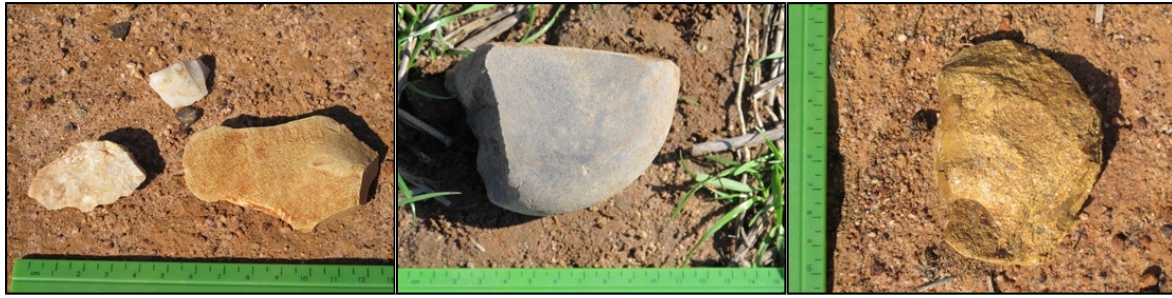
Figures 14 to 16: Pit 105 – quartz and calcrete flakes; part of lower grindstone; coarse-grained silcrete artefact. The scale is in cm.

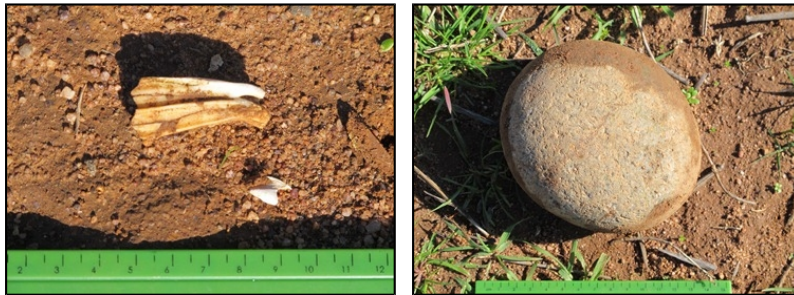
Figures 17 a: Pit 105 – sheep tooth; rounded granite cobble. The ruler is about 15 cm in length.
