HERITAGE IMPACT ASSESSMENT

submitted in terms of section 38(8) of the National Heritage Resources Act

prepared for
AURECON South Africa (Pty) Ltd
27 June 2012

Divisional Road 01223 Bredasdorp
Bredasdorp - Overberg District Municipality, Western Cape

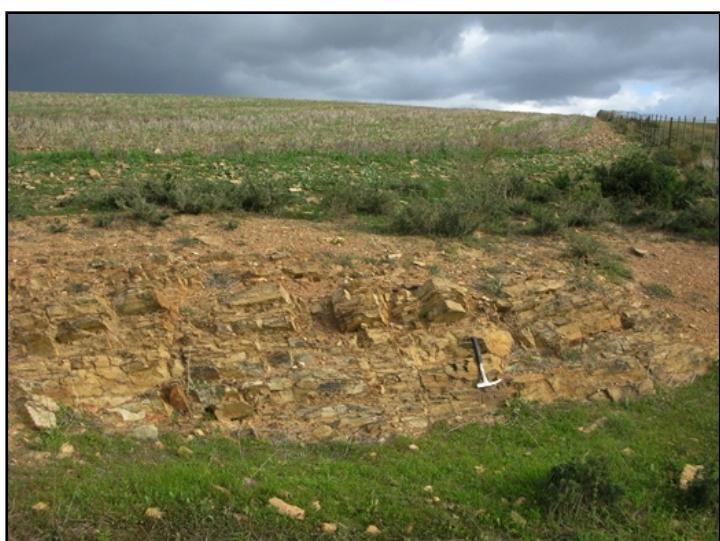
Figure 2: Low exposure of well-bedded Bokkeveld Group wackes trending NW-SE across southern edge of proposed borrow pit area (Almond 2012: 4)

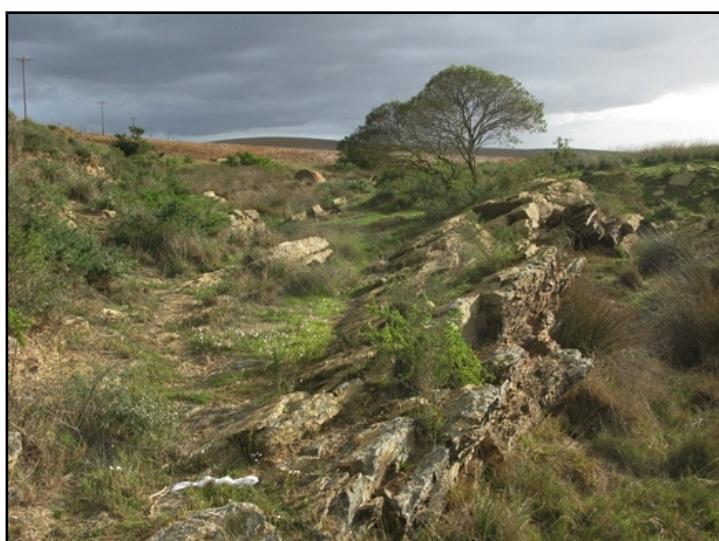
Figure 3: Prominent NW-SE trending ridge of cleaved wackes and siltstones of the Lower Bokkeveld Group exposed along a small stream just north of the study area (Almond 2012: 4)

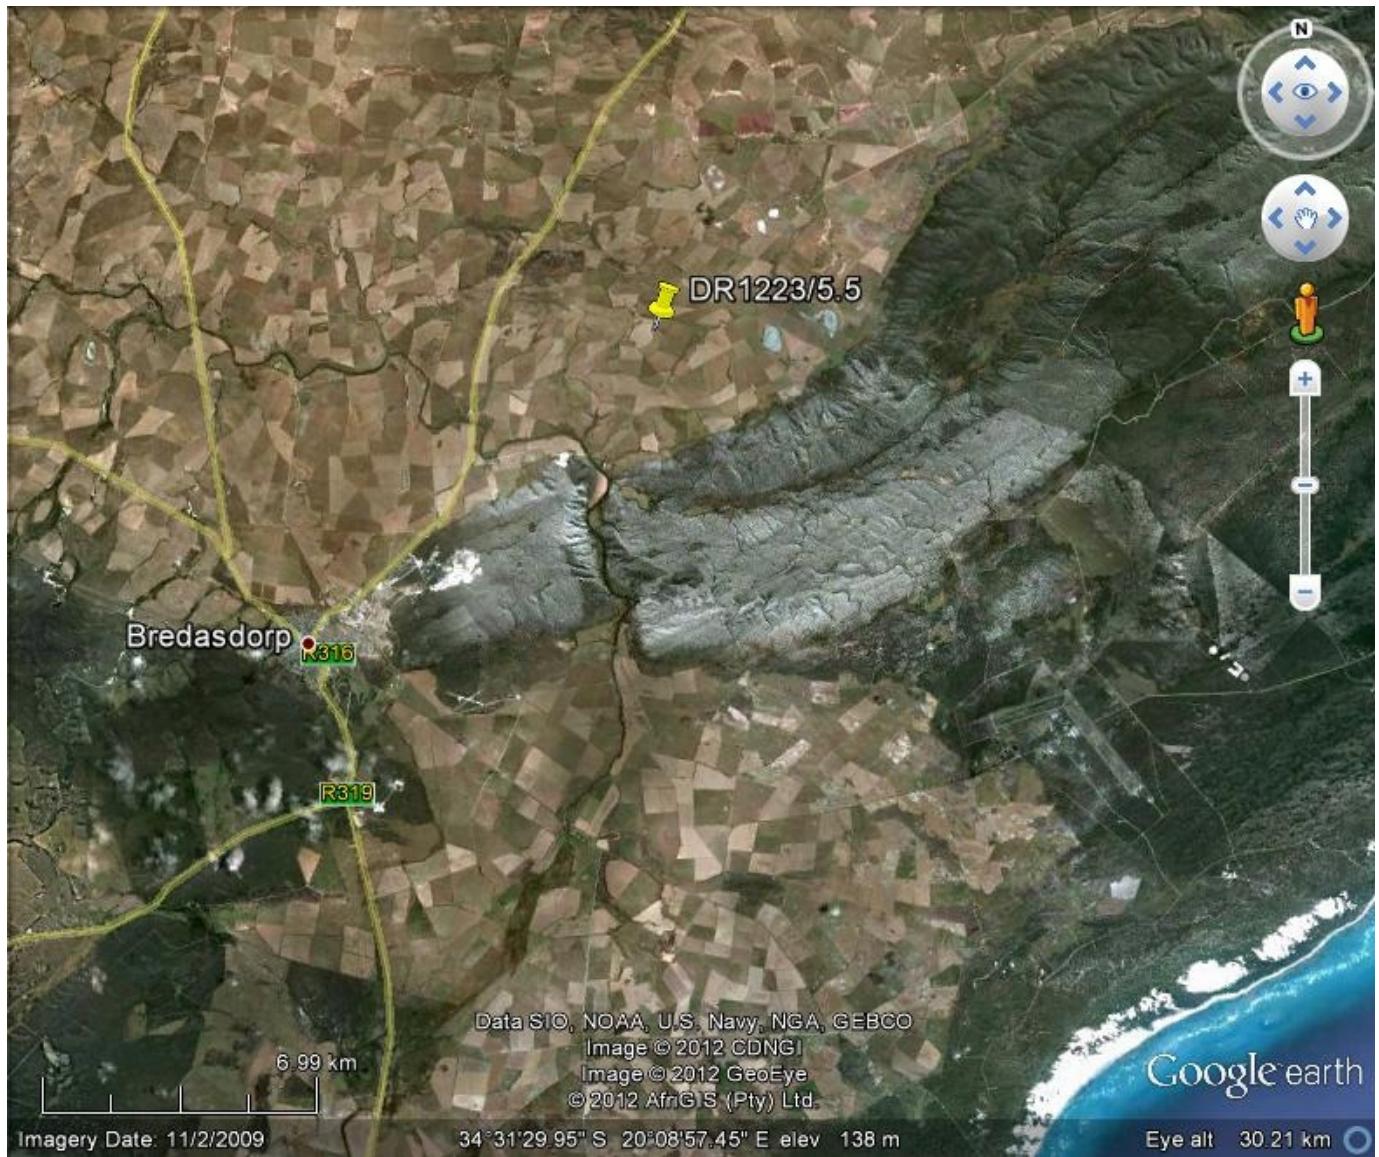
Figure 3: Aerial view of proposed borrow pit location (Google earth image, June 2012)

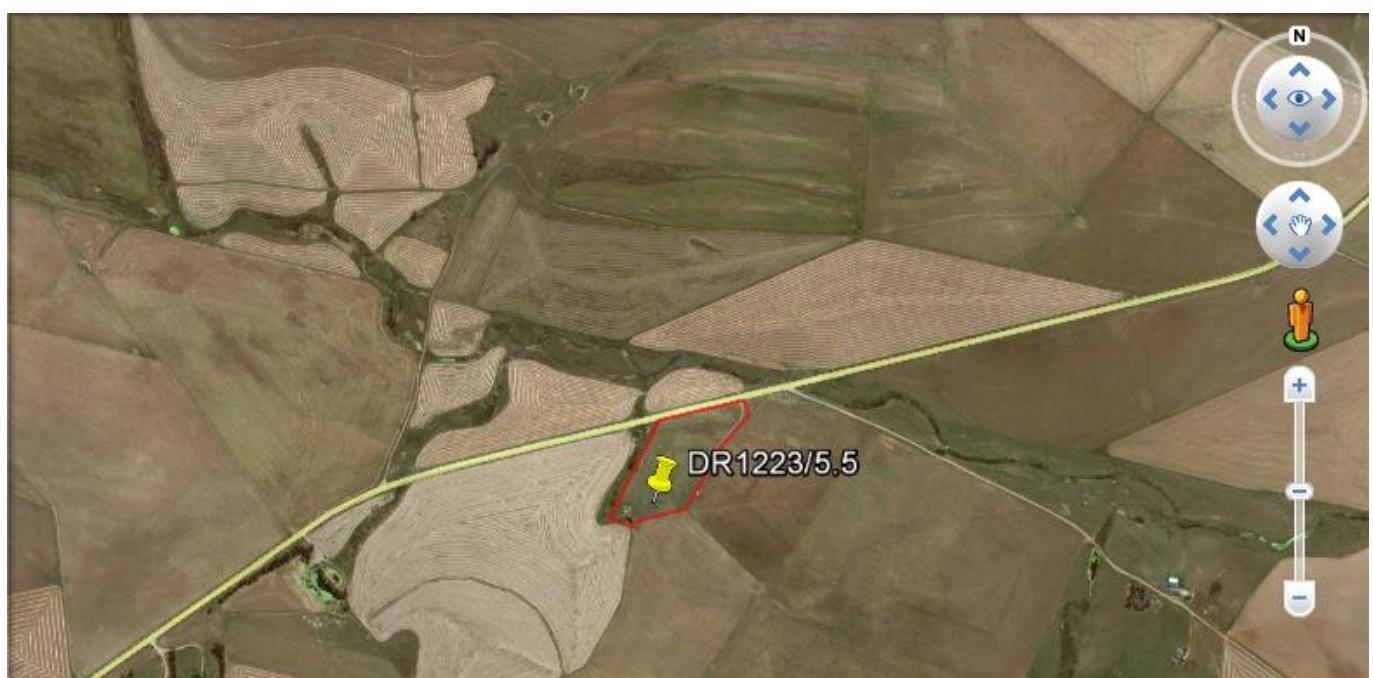
Figure 4: Aerial view of proposed borrow pit location and expropriation area (Google earth image, June 2012)
