HERITAGE IMPACT ASSESSMENT

DR 2196 West Coast

Clanwilliam – West Coast District Municipality, Western Cape

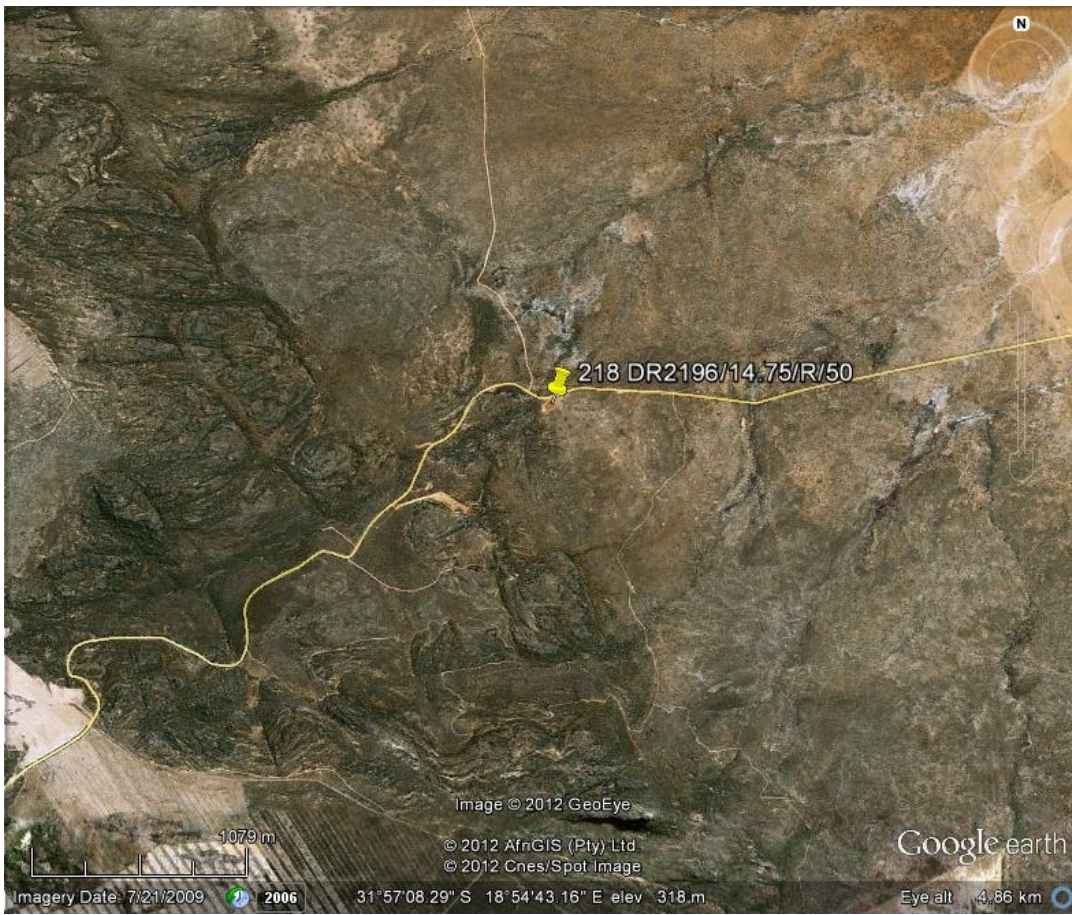
Figure 3: Site context and existing borrow pit location (Google earth, September 2012)

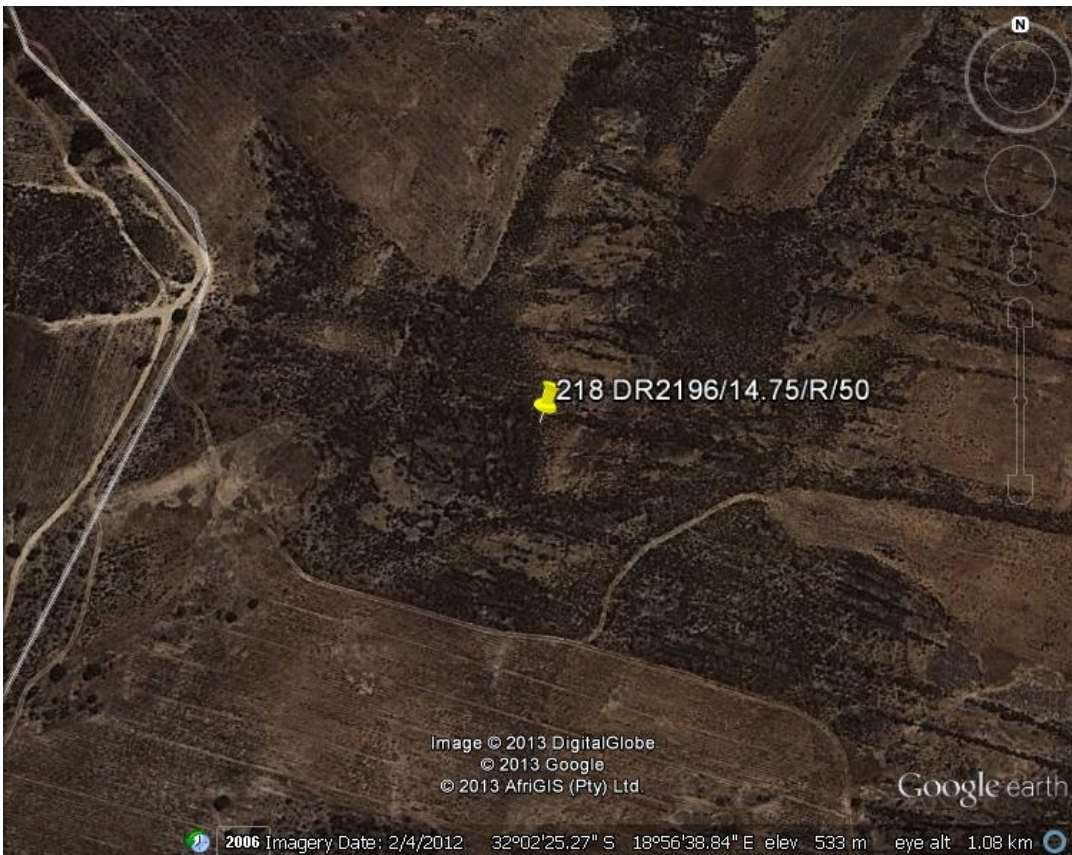
Figure 4: Aerial view of existing borrow pit and expropriation area (Google earth, June 2013)
