**ARCHAEOLOGICAL IMPACT ASSESSMENT
OF THE PROPOSED EXTENSION OF A BORROW PIT
ON PORTION 1, FARM NO. 643, CLANWILLIAM AREA,
WEST COAST DISTRICT MUNICIPALITY, WESTERN CAPE**

(Assessment conducted under Section 38 (8) of the National Heritage Resources Act as part
of a Heritage Impact Assessment)

JUNE 2013

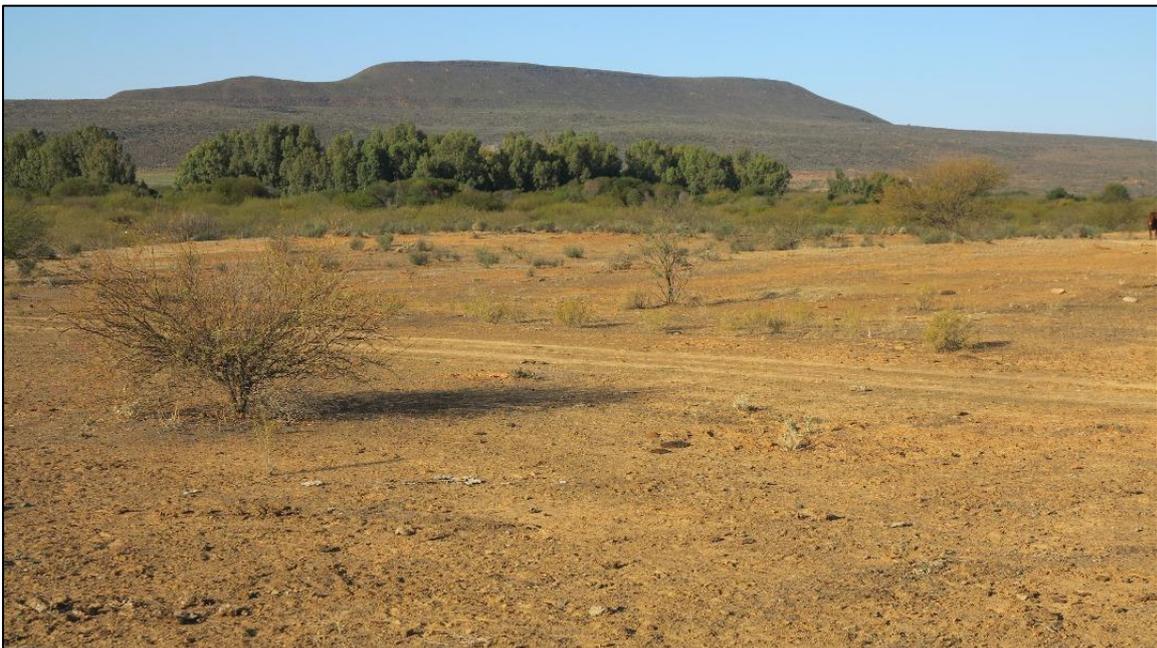
Figure 4: View towards the east with the tall blue gum trees indicating the position of the Brandewyn River. The mudrock gravel is visible in the foreground, whereas sandy alluvium covers the area closer to the river.

Environment: The existing quarry and proposed extension are situated on fairly flat-lying land over 400m to the west of the Brandewyn River (Figures 2, 4, 5 and 6). The DR2196 forms the western boundary of the polygon. The affected area, as well as the terrain between the polygon and the river, has been highly disturbed by previous agricultural activities, quarrying, animal burrowing and trampling by cattle. It has subsequently been invaded by alien *Proposis* sp. trees, a few bushes and sparse grass (Figures 3 to 7). The polygon is covered by clayey, silty sand with sub-angular mudrock gravel with occasional clasts of sandstone and quartzite (Figures 3, 4 and 5). Sandy alluvium occurs in the slightly lower-lying area between the polygon and the river (Figures 6 and 7). Calcrete nodules occur in one area to the south of the polygon. A track, dry canal and very dense alien vegetation separate the whole area from the Brandewyn River (Figures 2 and 8).

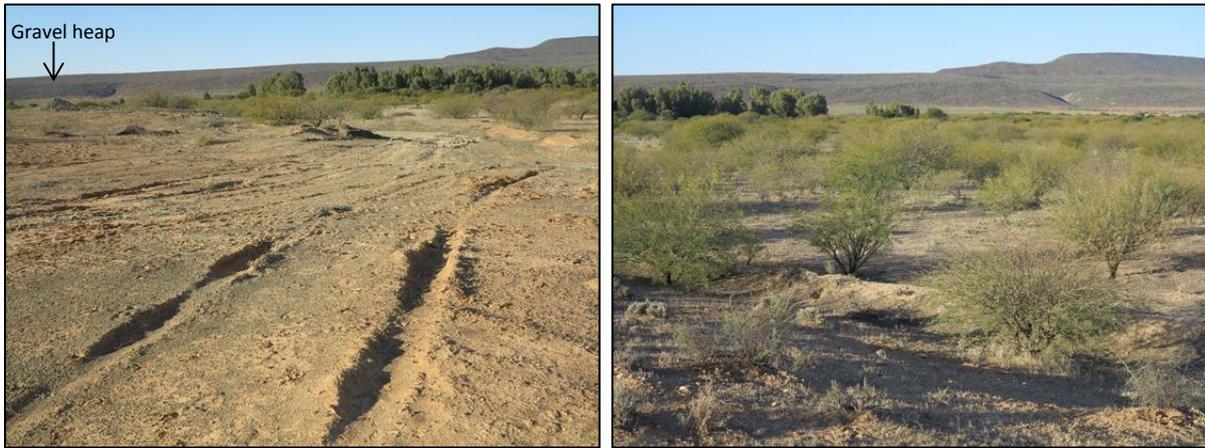
Figures 5 and 6: View towards the northeast with the existing quarry in the foreground and the trees indicating the Brandewyn River in the background; view towards the northeast of the slightly lower-lying area between the polygon and the river which has been invaded by *Prosopis* sp.

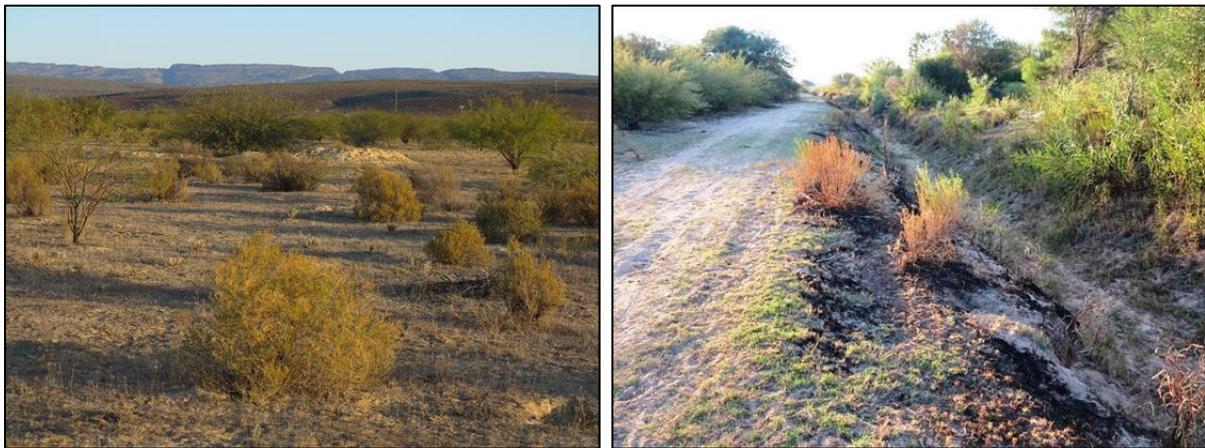
Figures 7 and 8: View towards the southwest with the Pakhuis Mountains in the background; view towards the northwest showing the track and dry canal to the west of the Brandewyn River.
