**ARCHAEOLOGICAL IMPACT ASSESSMENT
OF THE PROPOSED EXTENSION OF TWO BORROW PITS
ON PTN. 7 OF FREDERICKS DAL 60 & PTN. 10 OF
ELIZABETHFONTEIN 59, CEDERBERG,
CLANWILLIAM DISTRICT, WESTERN CAPE**

(Assessment conducted under Section 38 (8) of the National Heritage Resources Act as part
of a Heritage Impact Assessment)

AUGUST 2012

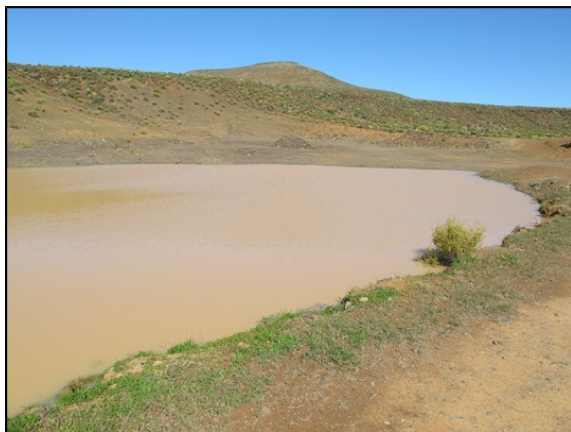
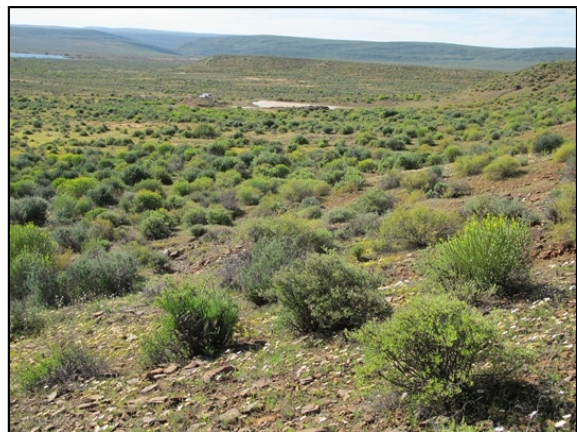
Figures 3 and 4: Pit 125 – view towards the southeast showing the existing pit and the plateau; view of the affected area towards the north. The water-filled existing pit is visible in the middle ground.

Results of the survey: No archaeological remains were observed.

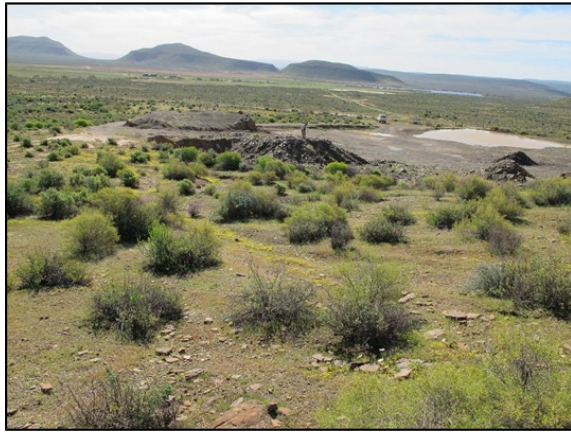
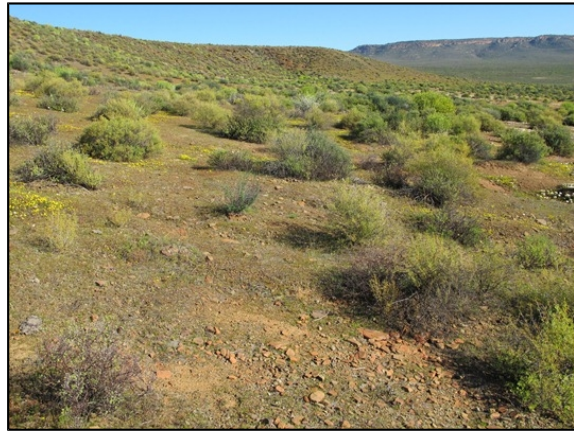
Figures 5 and 6: Pit 125 – view towards the northwest of the existing pit with heaps of mudstone; photo taken from the northeast corner of the affected area towards the southwest. The edge of the plateau of the adjacent hill is visible on the left.

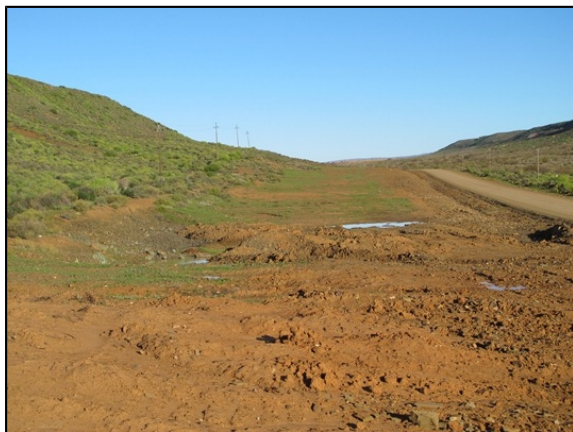
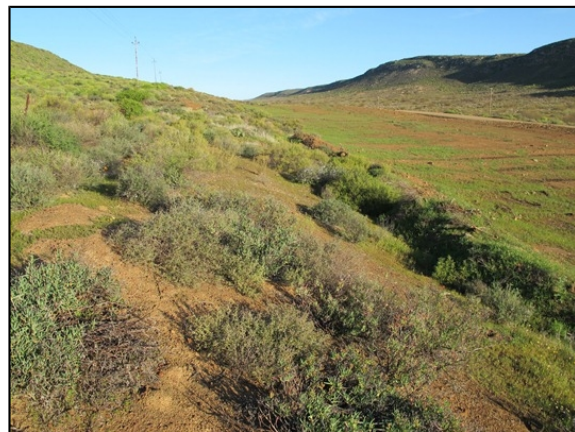
Figures 8 and 9: Pit 126 – view towards the southeast with the original borrow pit filled with water; view towards the south showing the less disturbed area along the fence.

Results of the survey: No archaeological remains were observed in either the undisturbed or rehabilitated areas.

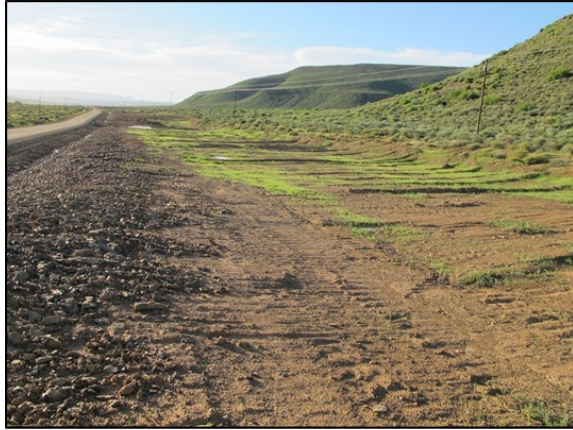
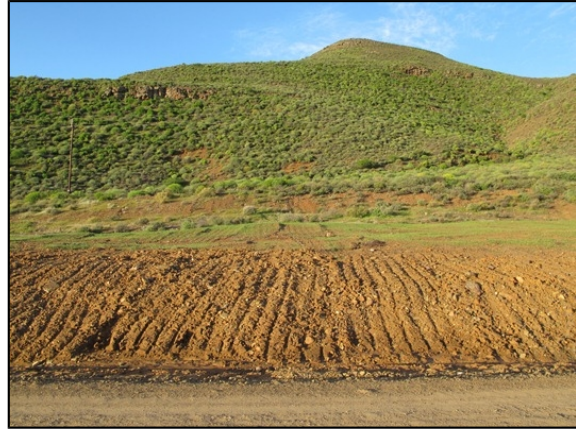
Figures 10 and 11: Pit 126 – view across the affected area towards the northwest with grass planted on the rehabilitated area; another view (towards the east) showing rehabilitation of the southern pit area.
