**ARCHAEOLOGICAL IMPACT ASSESSMENT
OF THE PROPOSED EXTENSION OF AN EXISTING
BORROW PIT AND THE DEVELOPMENT OF A NEW
BORROW PIT NEAR RHEENENDAL, KNYSNA AREA,
EDEN DISTRICT MUNICIPALITY, WESTERN CAPE**

(Assessment conducted under Section 38 (8) of the National Heritage Resources Act as part
of a Heritage Impact Assessment)

OCTOBER 2012

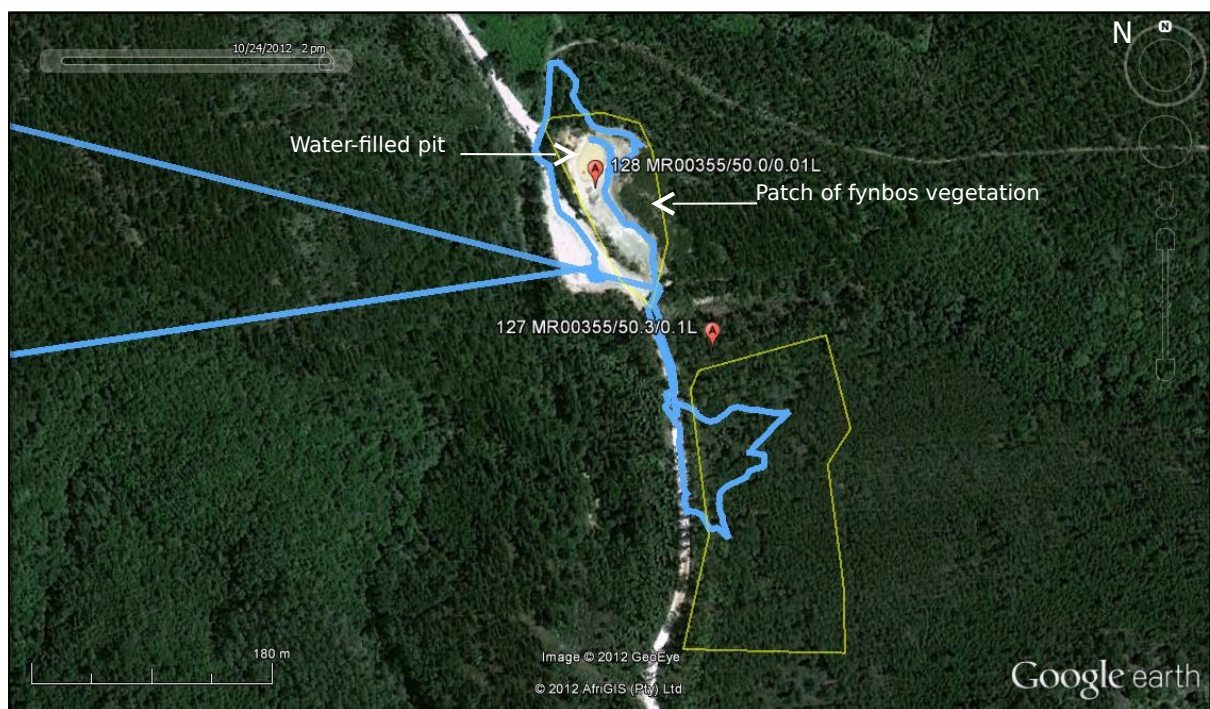
Figure 2: Google earth image showing the polygons indicating the proposed extension of Pit 128 and the proposed Pit127 with the tracks of the field survey. Except for the small patch of fynbos vegetation indicated, the rest of the vegetation consists of plantations with alien pine, black wattle and blue gum trees. Please note that the straight blue lines do not indicate survey tracks.

Fieldwork for the proposed pit and extension were undertaken by the author and two assistants on 23 October 2012. Site plans and polygons indicating the affected areas were provided by Aurecon for the Phase 1 survey. Each area was covered on foot and tracks were recorded by a Garmin GPSMAP 62s set on the WGS84 datum (Figure 2). Both sites were extensively photographed.

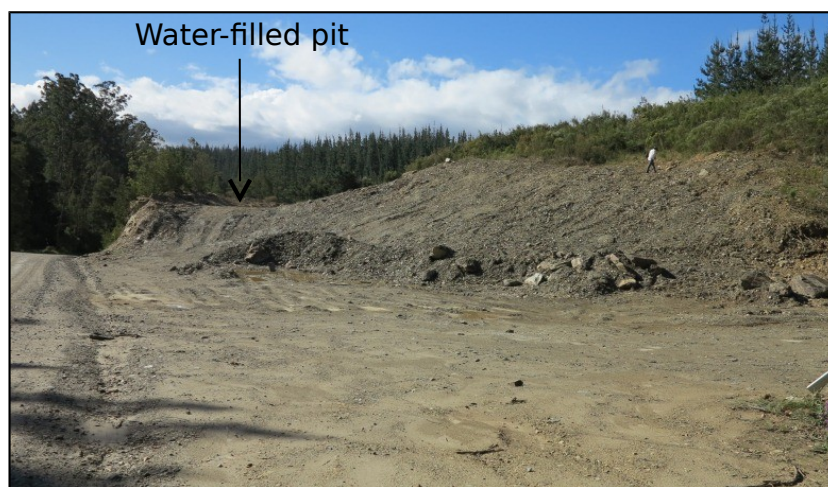
Figure 3: Pit 128 – View towards the northeast showing the southern part of the existing quarry with dense fynbos vegetation above the working face. The northern part with the water-filled pit lies at the foot of the trees in the background.

The existing pit lies on a west-facing slope and consists of a water-filled depression at the northern end (Figures 4 and 6) and exposed working faces along the north-eastern and eastern parts of the site (Figures 3 and 6). Previously excavated topsoil has been heaped up around the north-eastern margins of the pit (Figure 6) and blocks off the pine plantation to the north (Figure 7). Visibility of archaeological material on the ground was poor in this latter area. The small patch of fynbos at the top of the eastern slope is so dense that it was impossible to move through it (Figures 3 and 5). Visibility was however good in the disturbed major part of the site and it was possible to look for sections where gravel surfaces with stone artefacts might be exposed.

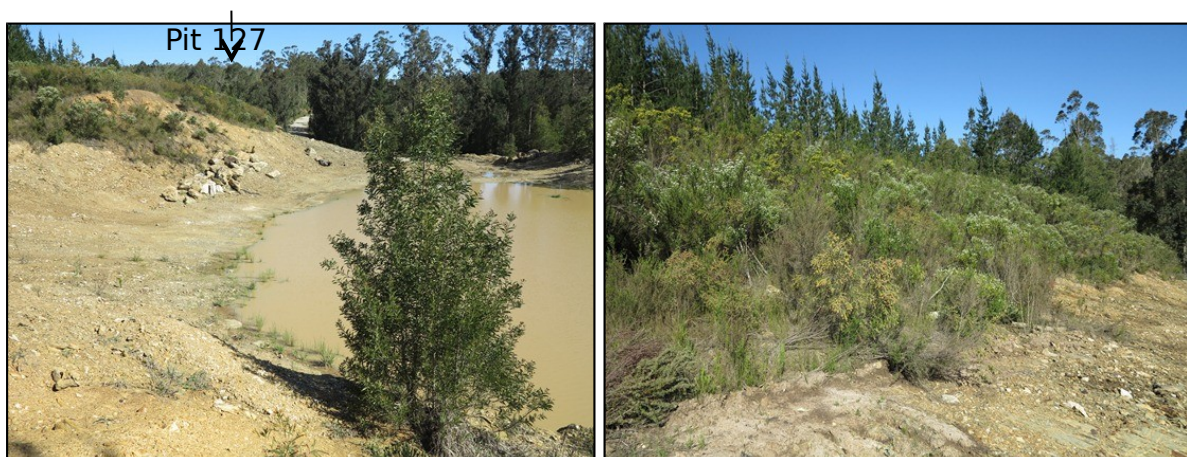
Figures 4 and 5: Pit 128 – view towards the south showing the water-filled pit, the slope with fynbos vegetation and the location of proposed pit 127; view towards the south of the dense fynbos vegetation in the south-eastern part of the affected area.

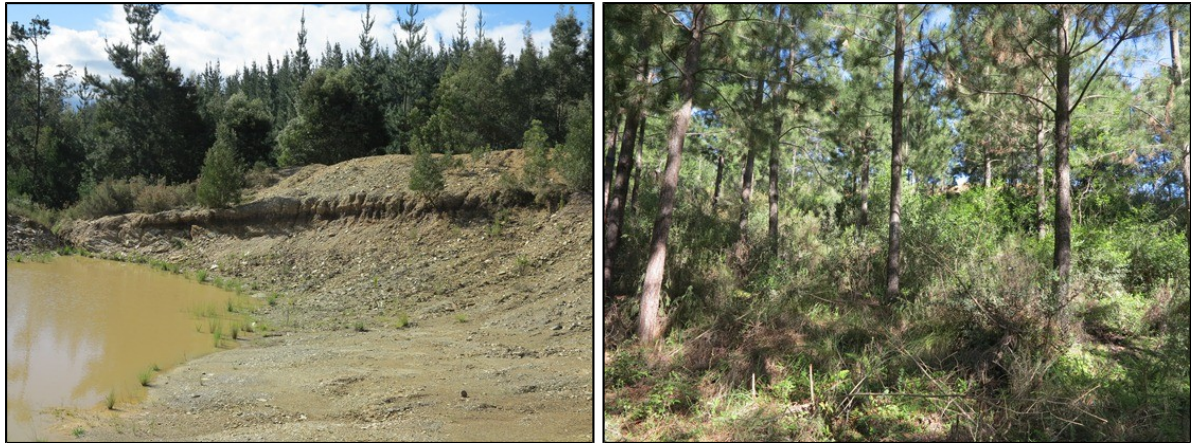
Figures 6 and 7: Pit 128 – view towards the north showing part of the water-filled pit and the heaps of soil on top of the original land surface on the northern edge of the pit; view towards the south of the pine plantation to the north of the pit.

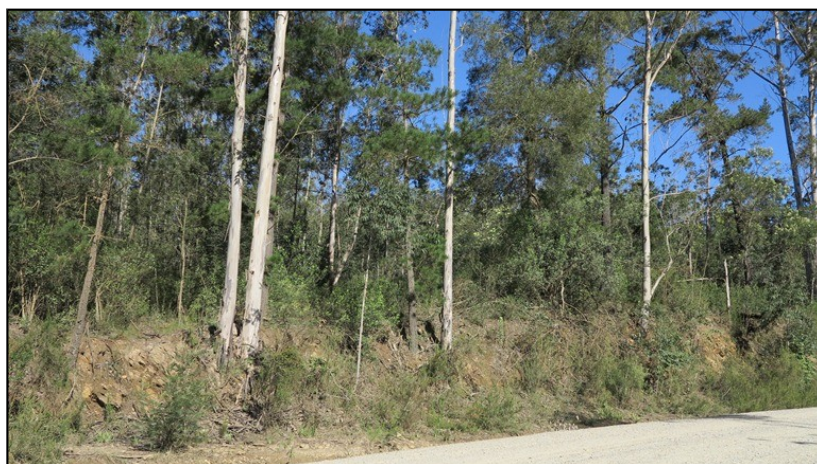
Figure 8: Pit 127 – view towards the southeast with the road cutting along the MR00355 evident below the forested surface.

The proposed pit area is presently covered by dense vegetation - black wattle and blue gum trees, with an understorey of indigenous bushes such as *Metalasia* sp., *Halleria lucida* and *Agathosma* sp. A thick layer of branch, leaf and bark litter obscures the surface of the ground throughout the entire area and results in very poor visibility of any archaeological material which may be present (Figures 9, 10 and 11). The only area where visibility is good is the road-cutting adjacent to the MR00355 (Figures 8 and 12).

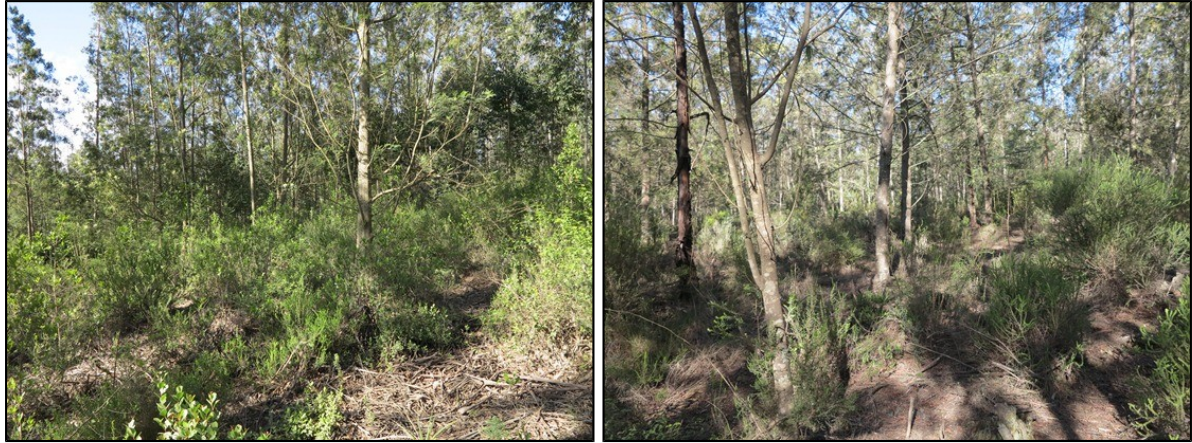
Figures 9 and 10: Pit 127 – views towards the northeast and east respectively showing the understorey of indigenous bushes with branch, leaf and bark litter amongst the black wattles.

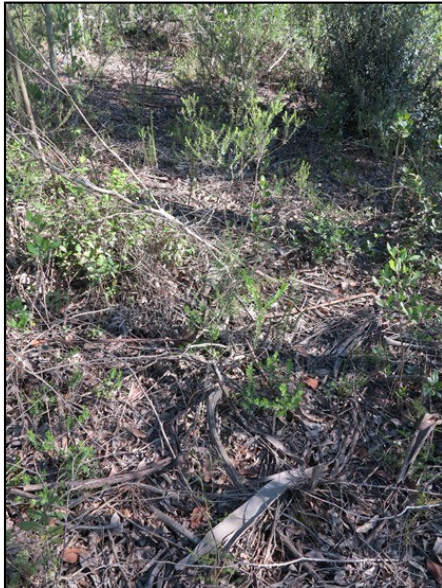
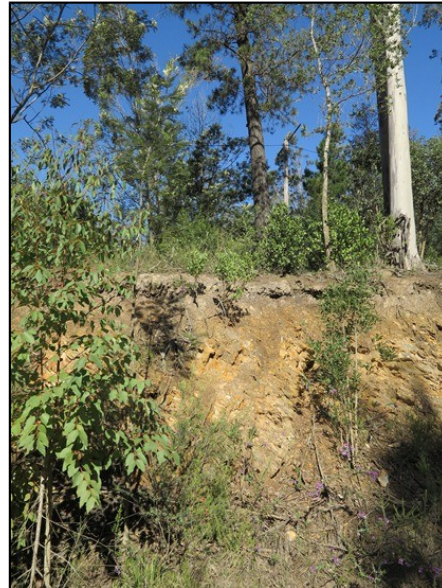
Figures 11 and 12: Pit 127 – detail of the litter obscuring the surface of the affected area; view towards the east of part of the road cutting.

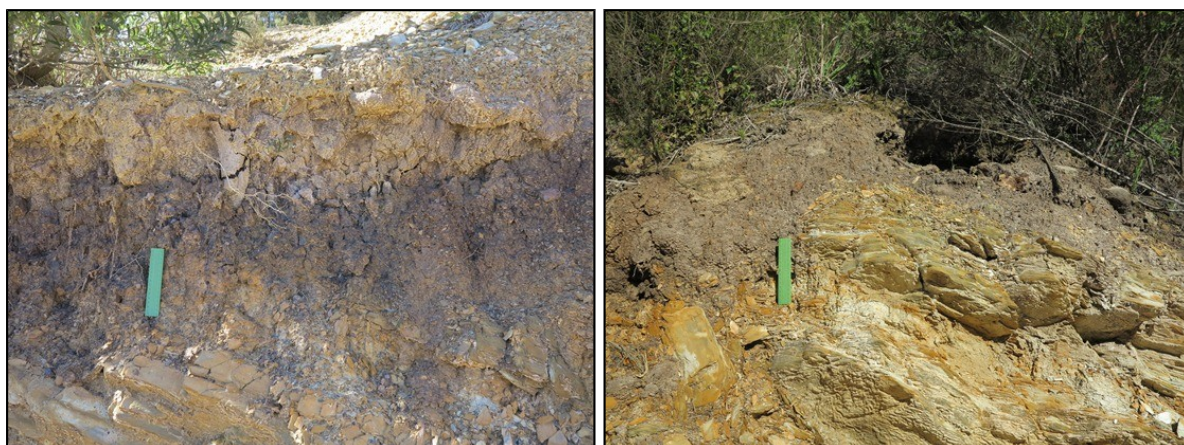
Special attention was paid to areas such as slopes and road cuttings where there were exposures of the underlying geology and it might be possible to observe any horizons which might contain Stone Age material, such as that noted in the study by Hart & Halkett (2003). There was no such layer evident in the case of existing pit 128 where the colluvium appears to lie directly on the underlying phyllite.

Figures 13 and 14: Pit 128 – sections showing the reddish-brown colluvium overlying phyllite of the Kaaimans Group along the northern and eastern slopes of the existing pit respectively. The upper brown soil in the photo on the left is from the dump. The ruler is about 15cm in length.

The absence of any archaeological material indicates that the affected areas are of low archaeological heritage significance. No significant impact on such resources is expected if the proposed pit and extension of the existing borrow pit are developed. No further archaeological studies or mitigation are recommended.

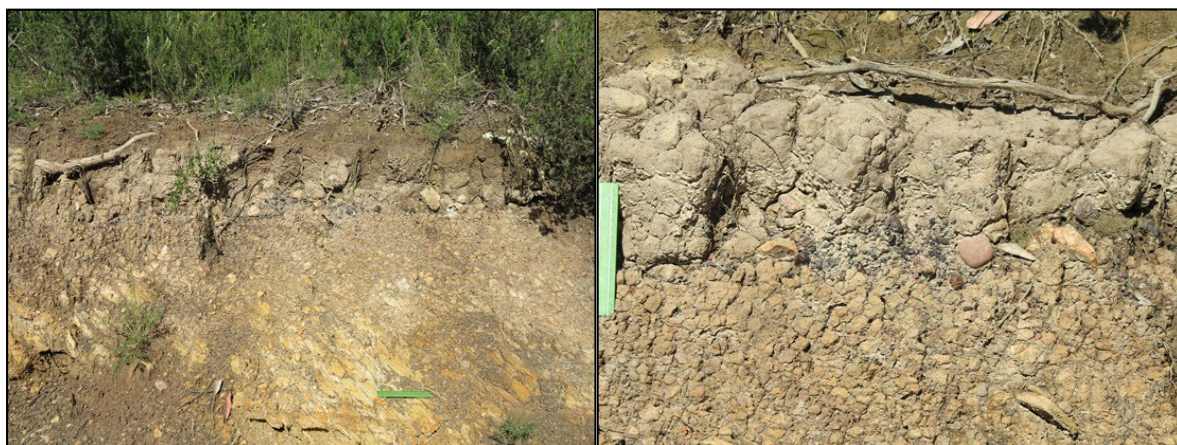
The road-cutting along the western border of proposed pit 127 (Figures 8 and 12) revealed an intermittent layer with ferruginised pebbles, quartz fragments and the occasional quartzite/sandstone pebble (Figures 15 and 16). None of these appeared to be flaked. No other pebbles or cobbles were observed on the surface of the affected area

Figures 15 and 16: Pit 127 – detail of sections of the road cutting showing the layer with ferruginised pebbles, quartz fragments and the occasional quartzite pebble lying between the reddish-brown colluvium and weathered phyllite.
