**ARCHAEOLOGICAL IMPACT ASSESSMENT  
OF THE PROPOSED EXTENSION OF A BORROW PIT ON  
VOORBRUG OUTSPAN 258 NEAR GREAT BRAK RIVER,  
GEORGE DISTRICT, WESTERN CAPE**

(Assessment conducted under Section 38 (8) of the National Heritage Resources Act as part  
of a Heritage Impact Assessment)

**OCTOBER 2012**

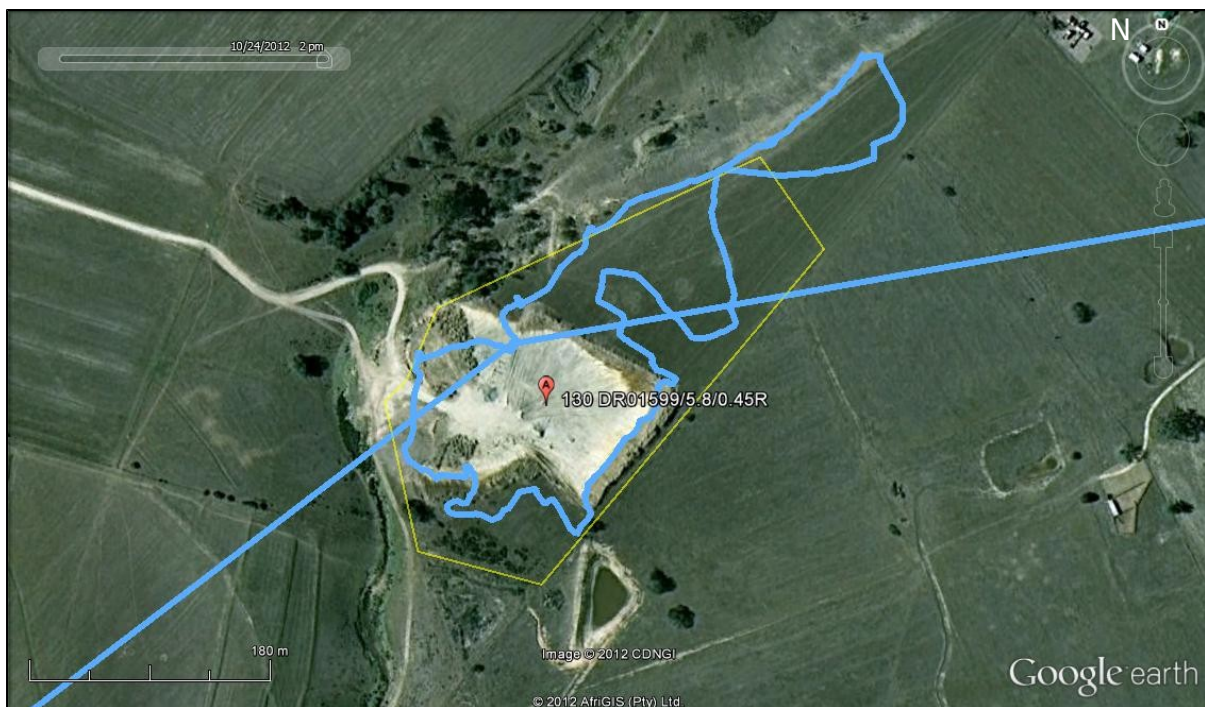
Figure 2: Google earth image showing the proposed extension to borrow pit 130 and the tracks of the field survey. Please note that the straight blue lines do not indicate survey tracks.

Fieldwork for the proposed pit extension was undertaken on 23 October 2012. A site plan indicating the affected area was provided by Aurecon for the Phase 1 survey. The area was covered on foot and the tracks were recorded by a Garmin GPSMAP 62s set on the WGS84 datum (Figure 2). The site was extensively photographed.

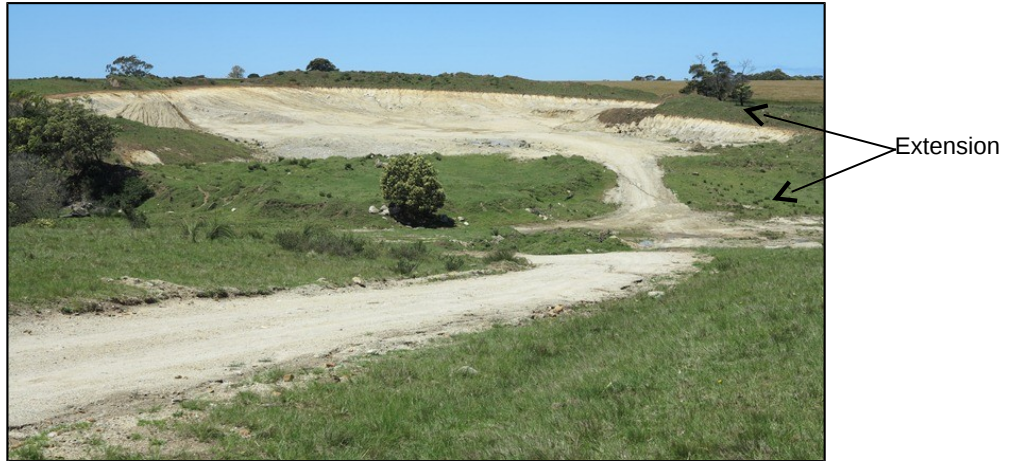
Figure 3: View towards the east showing the existing pit and part of the proposed southern extension.

**Environment:** The existing borrow pit lies in hilly agricultural land currently used for cattle grazing. The pit has been excavated into a north-west facing slope of a hill located to the southeast of a shallow valley. It is proposed to extend the pit to the south (Figures 2, 3 and 5) and the northeast (Figures 4, 6 and 10). A small, semi-permanent stream curves around the pit and flows southwards (Figure 2). It lies outside the western border of the proposed extension. A fence indicates the south-western and eastern boundaries, whereas the north-western border is indicated by the sloping edge of the otherwise flat-lying north-eastern extension. The north-eastern limit of the site is not clear on the ground. The area around the existing pit is highly disturbed and surrounded by heaps of previously-quarried material which has been dumped (Figures 5, 8 and 10). Fine, gravelly, silty sand overlies weathered granite of the Rooiklip Facies of the George Granite Pluton. Short grass covers most of the proposed extension area, as well as some of the heaps of dumped soil.

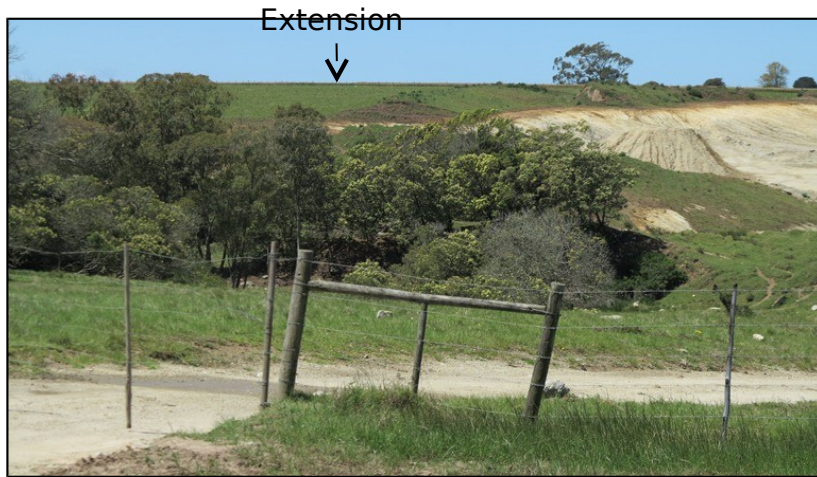
Figure 4: View towards the northeast showing the area of the proposed north-eastern extension.

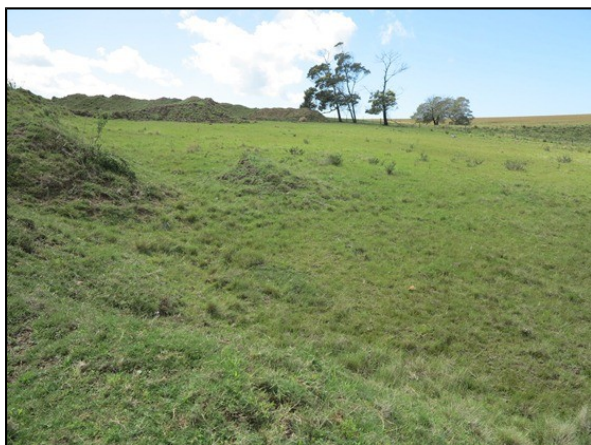
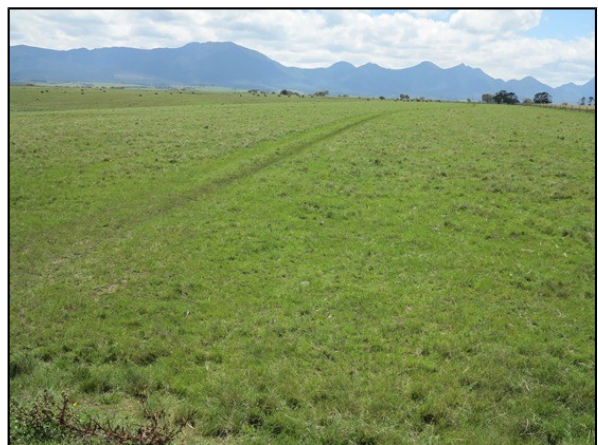
Figures 5 and 6: View towards the east showing the area of the proposed south-eastern extension and several heaps of previously-quarried material; view towards the northeast of the proposed north-eastern extension

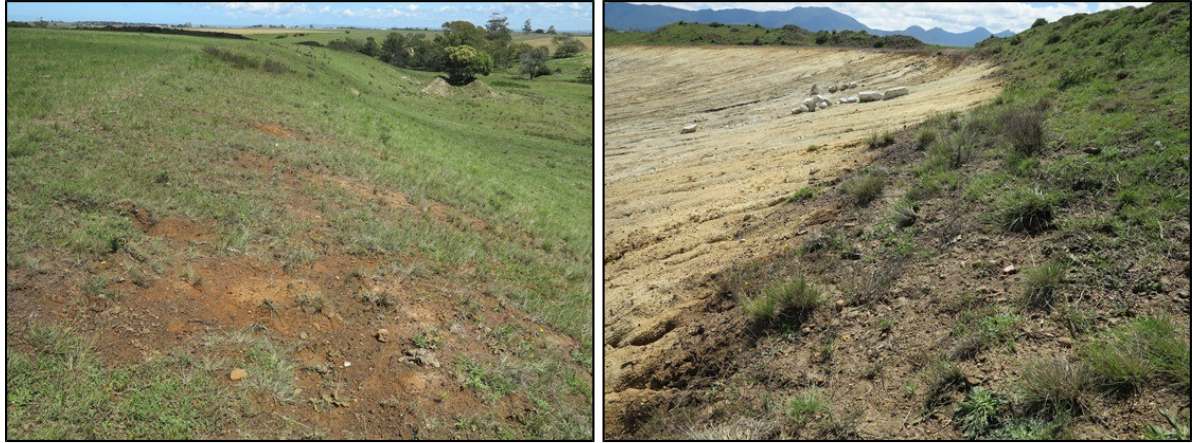
Figure 7 and 8: View towards the southwest of the slope where there is exposure of the underlying ground; view towards the northeast with the ferruginised gravel layer visible in the foreground.

As it was expected that there could be sub-surface archaeological material, attention was given to areas where the underlying soil and rock were exposed, namely the worked slopes of the existing quarry (Figures 8 and 10) as well as open patches along the north-western edge of the polygon - where it slopes down towards the stream (Figure 7). In some areas, a layer of medium to coarse, ferruginised sandstone gravel and small cobbles was evident between the base of the topsoil and the weathered granite bedrock (Figures 8 to 10). It could be observed *in situ* at the edges of the worked slopes (Figures 8 and 9). It had been partly removed from some surfaces and dumped, together with the topsoil, in heaps close by (Figure 10). Chunks of naturally-occurring vein quartz were evident on the gravel surface and in the heaps. It seems likely that this gravel layer would be the horizon containing archaeological material.

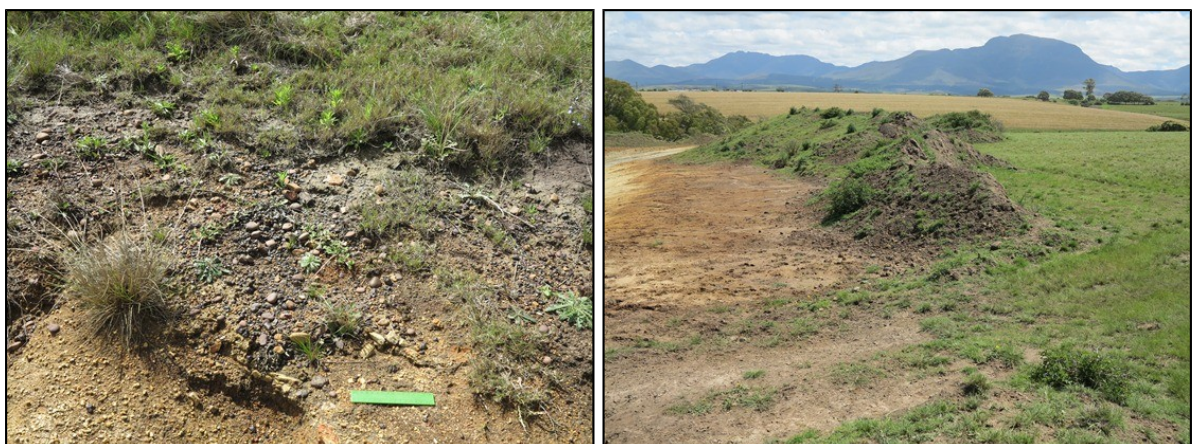
Figures 9 and 10: Detail of the ferruginised gravel layer situated between the topsoil and the weathered granite bedrock; view towards the north showing the scraped gravel layer, heaps of previously dumped material and part of the flat-lying proposed extension area. The ruler is about 15cm in length.

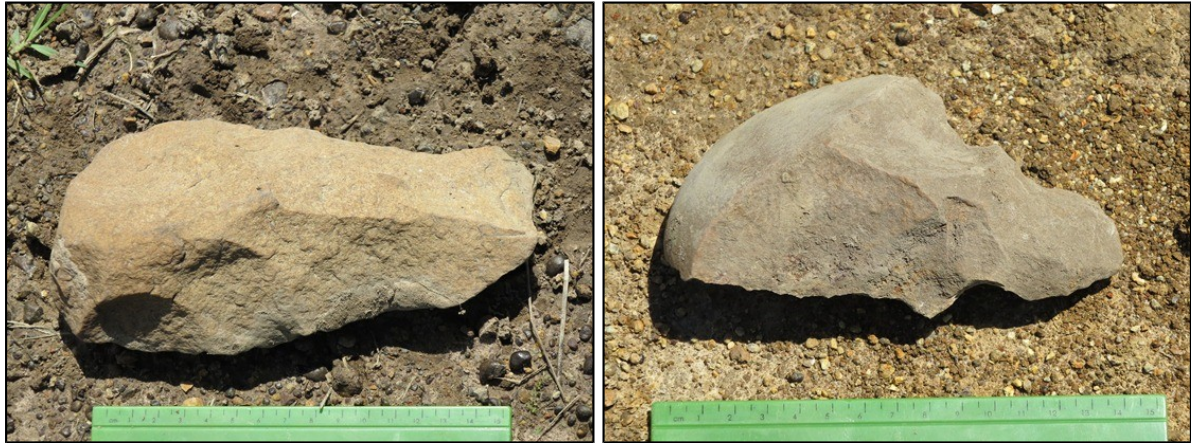
Twelve Stone Age artefacts were seen in association with the gravel and in the heaps throughout the affected area. Although cobbles were noted in the heaps of soil, they were not abundant. The archaeological material mostly consists of quartzite artefacts, some clearly ESA (Figures 11 and 12) or MSA (Figures 15 and 16), whereas others are likely to be ESA and/or MSA in origin (Figures 13 and 14). Only the MSA point (Figure 16) was noted along the north-western edge of the affected area. Except for a possible core (Figure 16), no convincing artefactual flaking of quartz was observed. All the material was in a disturbed, secondary context due to quarrying activities.

Figures 11 and 12: Examples of ESA artefacts. The scale is in cm.

The presence of Stone Age material indicates that there may be more archaeological remains below the surface of the proposed extension. However, if previous mining had disturbed a rich ESA or MSA site, it seems likely that a high proportion of the observed cobbles would have been flaked. The scarcity of artefacts observed would suggest that the proposed extension is of low archaeological heritage significance. No significant impact on such resources is expected if the proposed extension is developed. No further archaeological studies or mitigation are recommended.

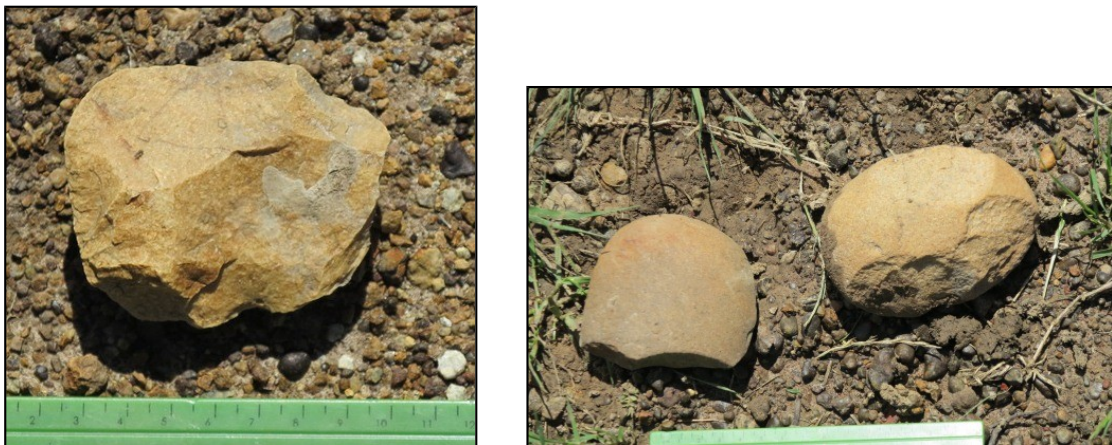
Figures 13 and 14: ESA/MSA artefacts – core and flaked cobbles. The scale is in cm.

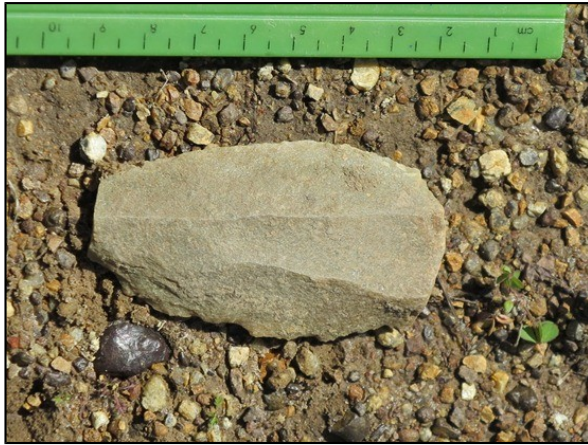
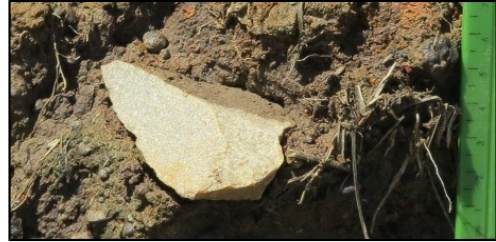
Figures 15 and 16: MSA blade and point. The scale is in cm.

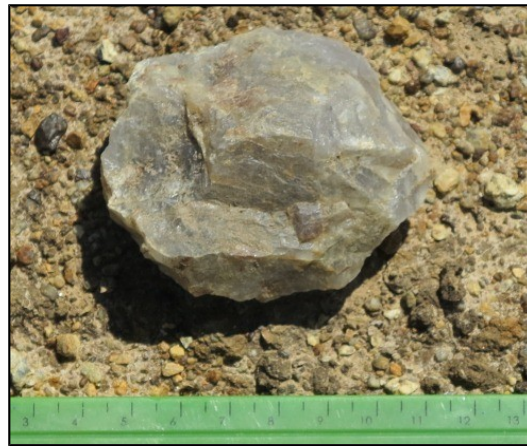
Figure 16: Possible quartz core. The scale is in cm.
