**ARCHAEOLOGICAL IMPACT ASSESSMENT  
PROPOSED DEVELOPMENT OF AGRICULTURAL LAND  
AND CONSTRUCTION OF AN OFF-CHANNEL STORAGE  
DAM ON PORTION 18 OF THE FARM UITNOORD NO. 129  
ROBERTSON**

**FEBRUARY  
2011**

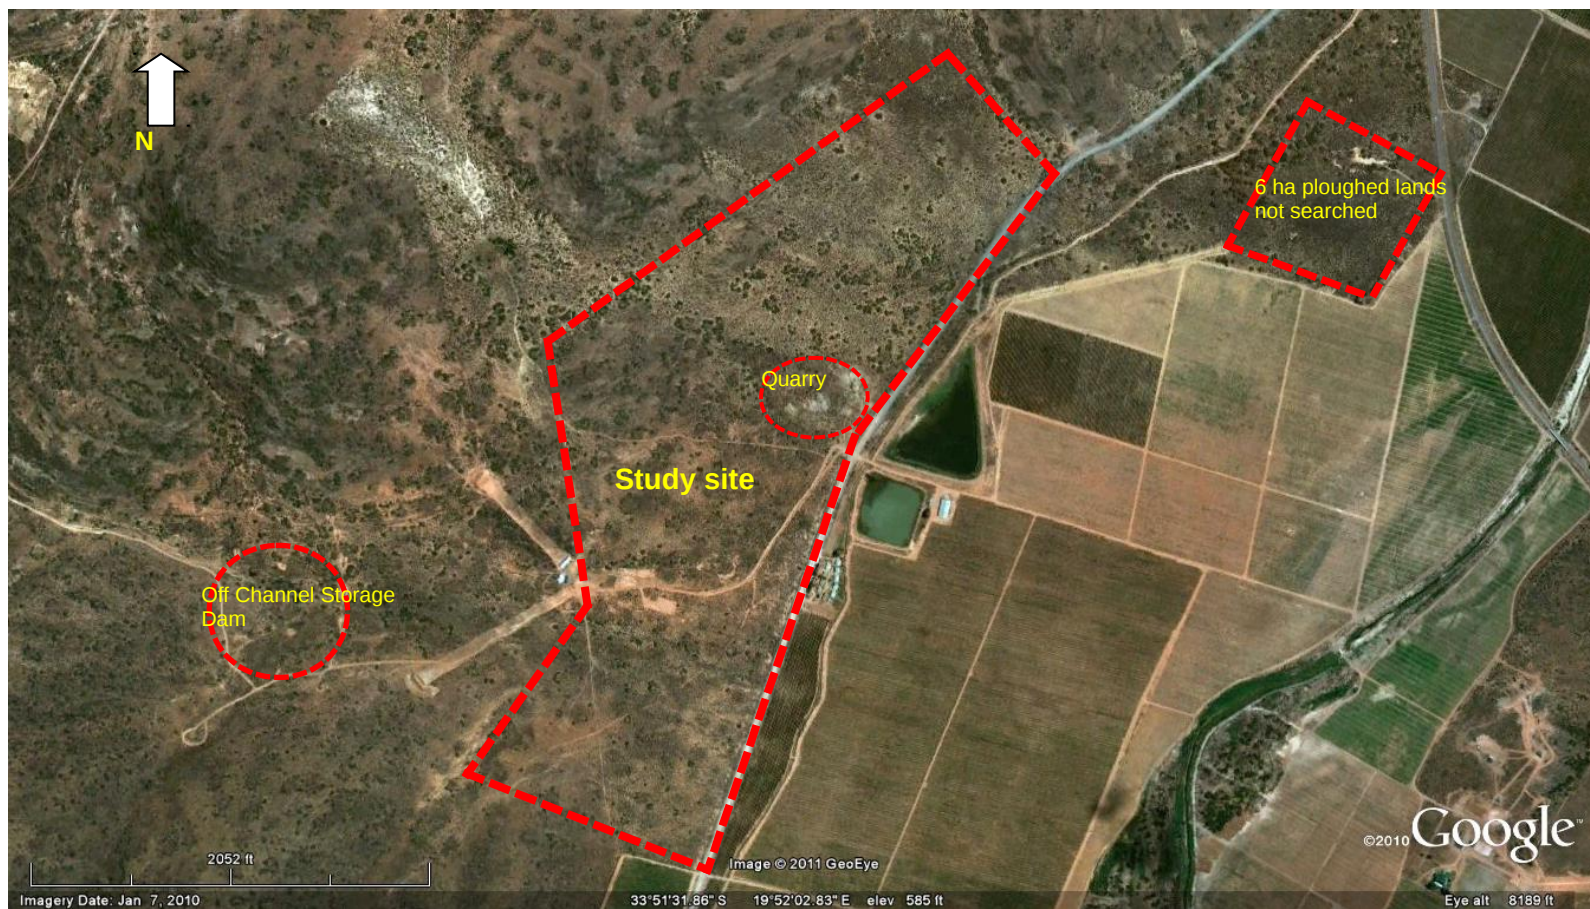
Figure 3. Close up aerial photograph of the proposed study site

An aerial photograph of the study site is illustrated in Figures 2 and 3. The farm known as Uitnoord is located about 6 kms south of Robertson and about 3 kms west of the road between Robertson and McGregor. Access to the property is via the Koringrivier turnoff, on a gravel road.

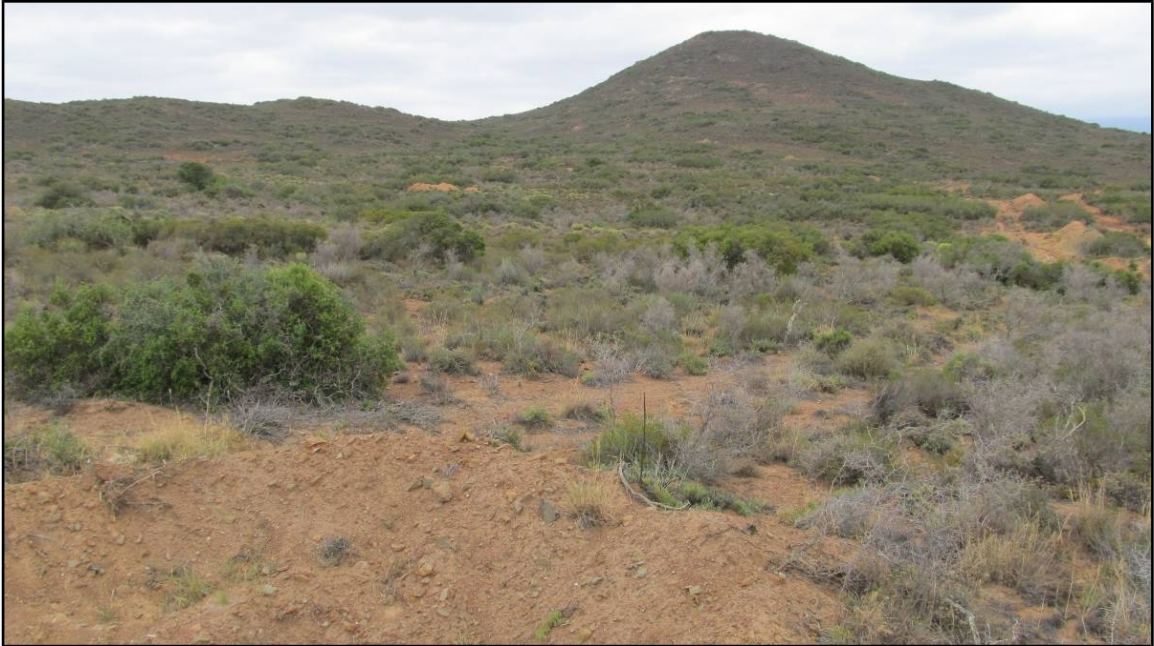
Figure 4. View of the proposed dam site facing north east

About 14 deep test pits have already been excavated on the proposed site for the off-channel storage dam, which is located a few hundred metres to the north west of an existing pistol shooting range, with the estimated centre of the dam wall at the co-ordinates S 33° 51'.40" E 19° 51' 33" (on map datum WGS85). The ± 5 m deep test pits comprise homogenous clays, with some dispersed gravel (quartzite and quartz) inclusions. At full supply, the dam will inundate an area of about 6.85 ha. The wall height will be about 15 m and will comprise a clay core. A pipeline will be laid from the proposed dam to an existing dam alongside the road, where water will be pumped to the new dam which will be used to irrigate the fields. The affected lands are set within a natural catchment area surrounded by hills and kopjes. The proposed site is covered by dense bush, scrubs, Euphorbia, with sporadic trees occurring in places. There is a natural drainage channel/small eroded stream running more or less through the centre of the property. Some sheet wash and several deep dongas occur on the proposed site (Figures 4 & 5).

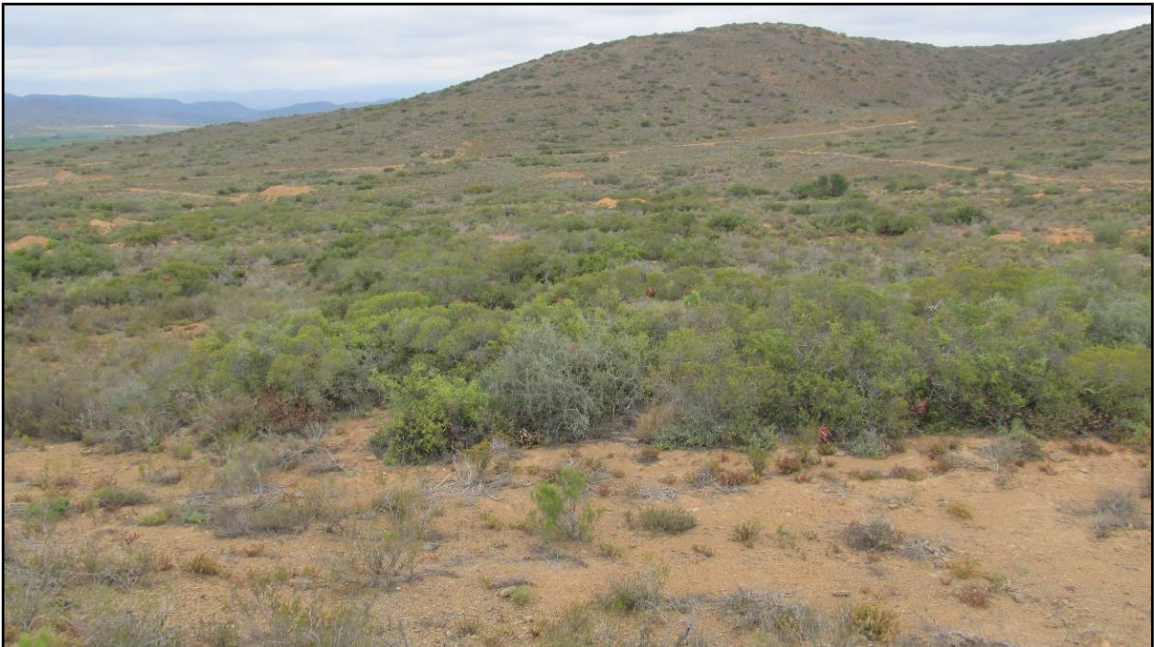
Figure 5. View of the proposed dam site facing south west

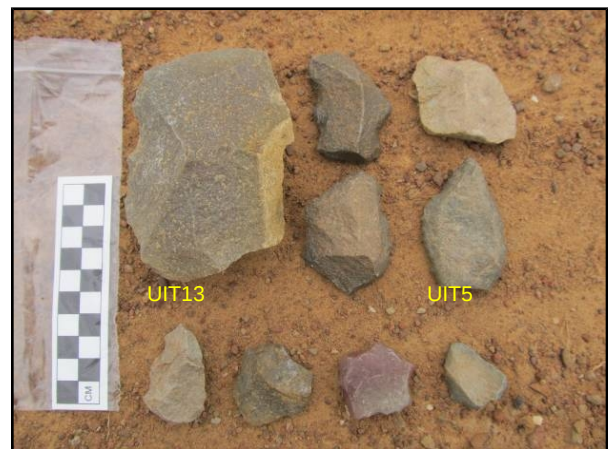
Figure 13. Collection of tools from the proposed off-channel storage dam. Scale is in cm

Ten archaeological occurrences (UIT4-UIT13), numbering 14 stone implements were documented on the proposed site for the off-channel storage dam (Figure 13). The tools occur fairly randomly over the landscape, and comprise MSA flake tools and chunks, including a large flake (UIT13) and one double-sided retouched flake/point (UIT5). Most of the implements occur in a disturbed context, on a sheet washed slope near the top of the dam wall, in the natural stream channel and alongside an erosion donga. There is very little surface stone covering the site which is overlain by wind blown sands.

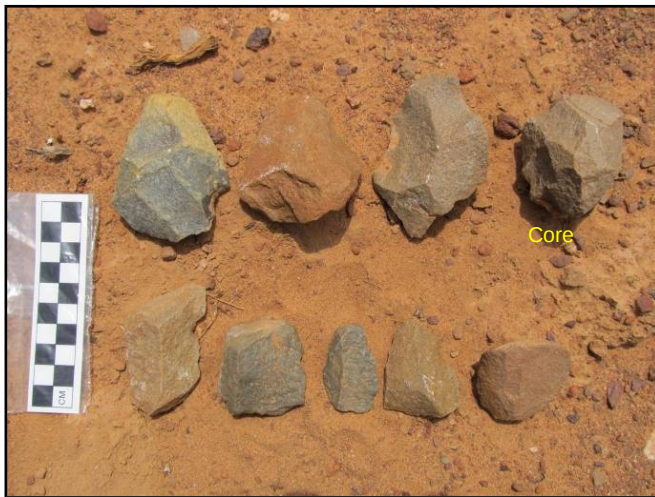
Figure 14. Collection of tools from the agricultural lands. Scale is in cm

A collection of the tools and the context in which some of them were found are illustrated in Figures 14-19.

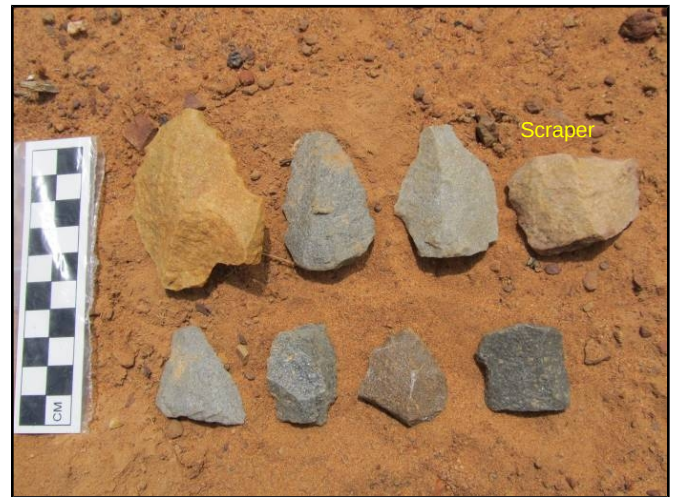
Figure 15. Collection of tools from the agricultural lands. Scale is in cm

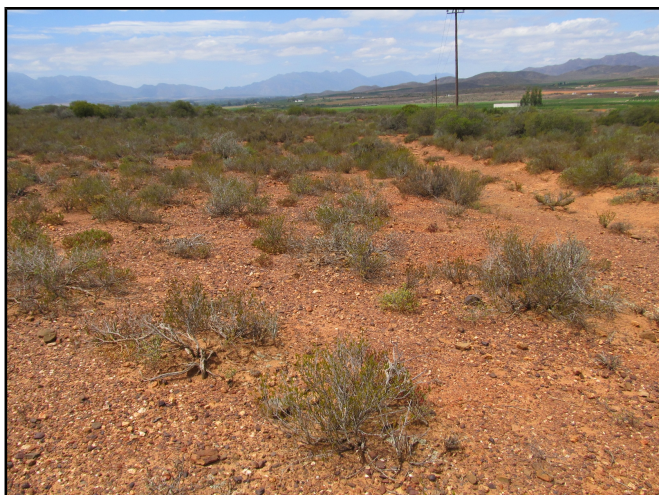
Figure 16. Sheet washed slopes in the north east. Note the Telkom servitude to the right of the plate

While most of the tools are spread quite thinly and randomly over the surrounding landscape, larger numbers appear to occur in the north east, on extensive sheet washed slopes, or in the Telkom servitude. One small silcrete chunk (UIT63) was found in a sandy footpath in the northern portion of the property. No tools were noted in the large worked out quarry, but a few tools were found nearby or close to the edge. Apart from the silcrete chunk and one quartz flake (UIT83) found near the pistol shooting range, all the tools are in readily available, rough quartzite.

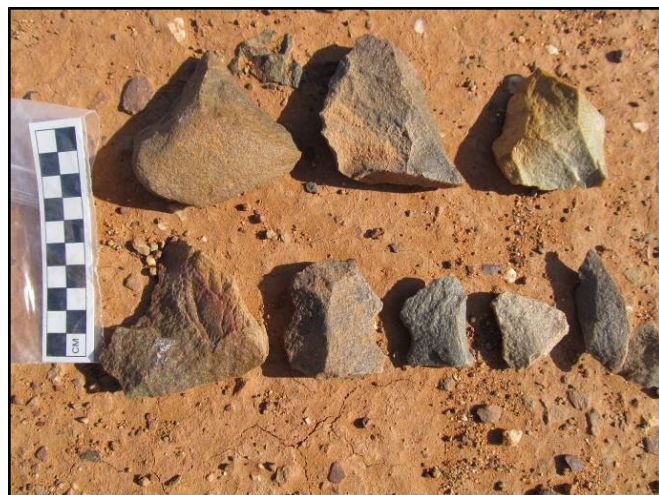
Figure 18 Collection of tools from the agricultural lands. Scale is in cm

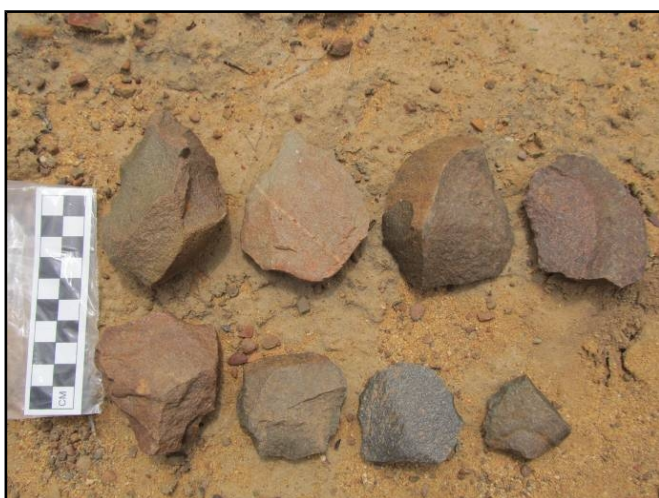
Figure 17. Collection of tools from the agricultural lands. Scale is in cm

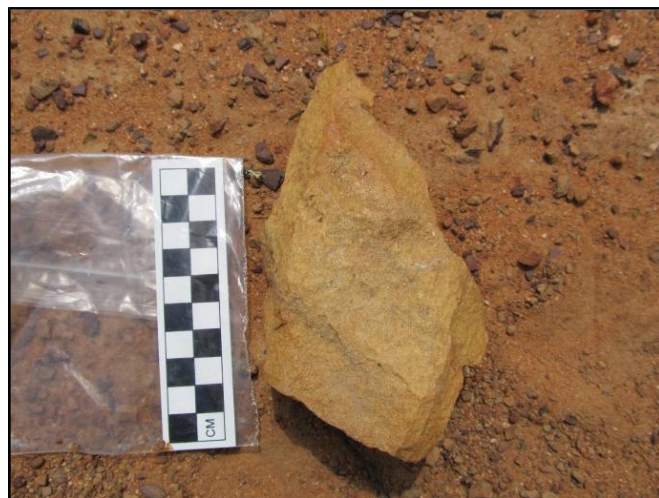
Figure 19. Possible Handaxe (UIT61) Scale is in cm

More than 99% of the implements found comprise Middle Stone Age flakes tools, a few flake blades, chunks and several round cores. One formal convex scraper was also found. One possible Early Stone Age handaxe was documented near the edge of the

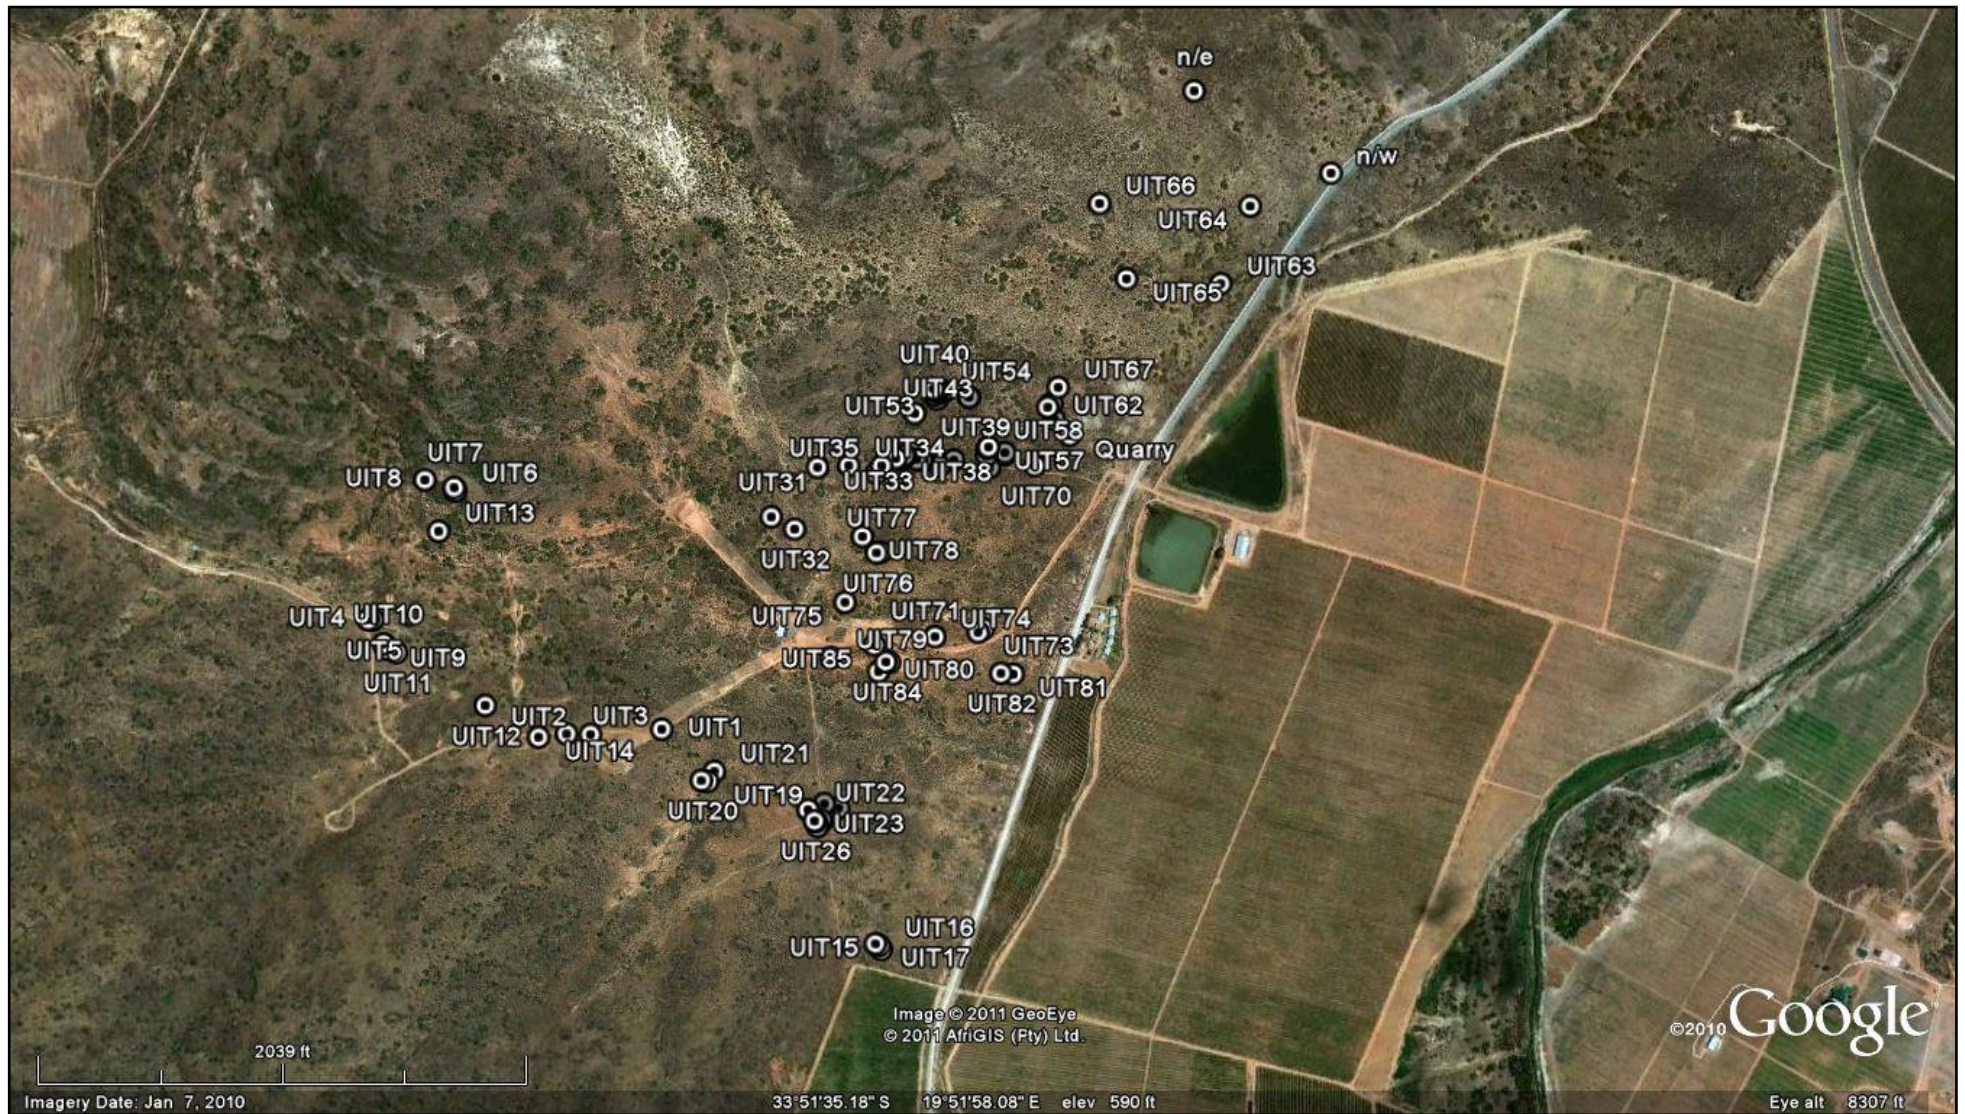
Figure A. Aerial photograph of the study site and Illustration of waypoints

Eighty-five archaeological occurrences were documented during the baseline study (refer to Table 1 and Figure A in Appendix).

85 archaeological occurrences, numbering nearly 100 stone implements, were documented during the Archaeological Impact Assessment of Portion 18 of the Farm Uitnoord No. 129. All the tools found were point plotted with a hand-held GPS (refer to Figure A in the Appendix). More than 99% of the tools are assigned to the Middle Stone Age, with only two ESA tools found, including one possible handaxe. No evidence of any factory or workshop site, or the result of any human settlement was identified. Most of the finds are spread quite thinly and unevenly over the surrounding landscape, and occur where some kind of physical disturbance or alteration of the landscape has already taken place. Most of the finds occur below the sandy overburden and are probably not in-situ, and have been displaced, or moved around in one way or the other.
