**ARCHAEOLOGICAL IMPACT ASSESSMENT
OF THE PROPOSED EXTENSION OF A BORROW PIT ON
PORTION 12 SCHERPENHEUVEL 481 (KENMOOR),
BREEDE VALLEY DISTRICT, WESTERN CAPE**

(Assessment conducted under Section 38 (8) of the National Heritage Resources Act as part
of a Heritage Impact Assessment)

AUGUST 2012

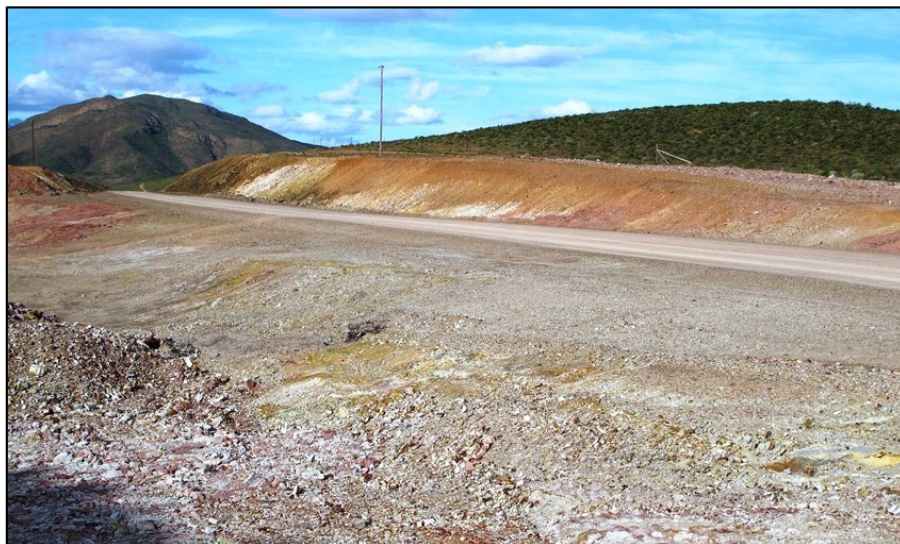
Figure 3: View from the existing quarry towards the western part of the affected area on the southern side of the DR1380. View towards the southeast.

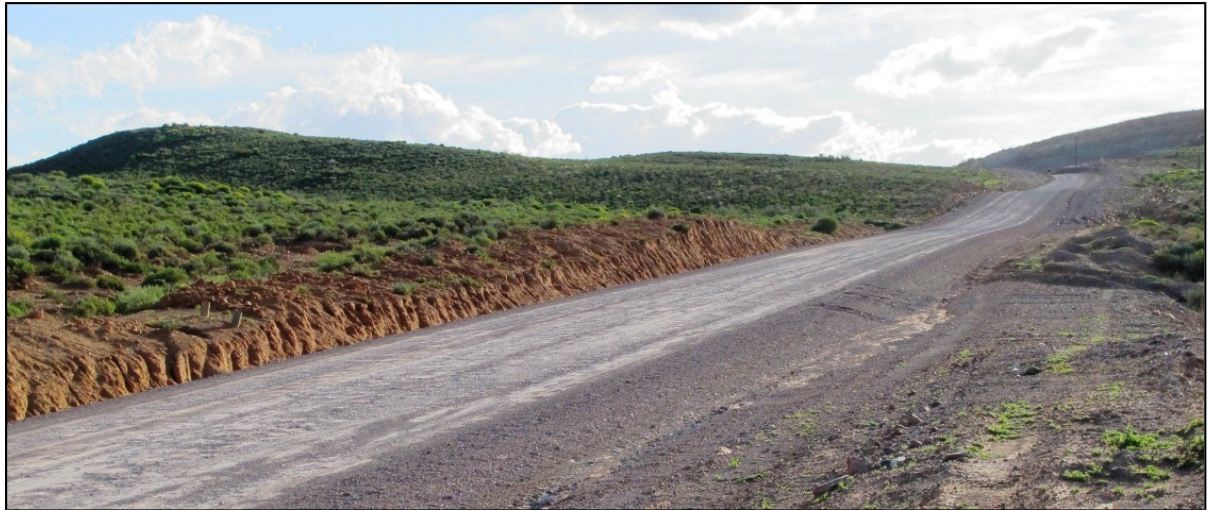
Figure 4: View towards the west showing the affected strip along the southern side of the DR 1380. The slope on the left side of the photo is the eastern portion where a few, isolated artefacts were observed. The existing quarry lies beyond the rise in the road, in the top right corner of the image.

Environment: The affected area consists of the existing, large hillside quarry and the strip of land adjacent to the road on the southern side of the DR1380 which runs in a roughly east-west direction (Figure 2). A fence which is parallel to the road marks the southern extent of the proposed extension along most of the affected area. The present quarry has been used for many years and is well known for its palaeontological interest. Fossils of insects, *Mesosaurus* and *Notocaris* have been observed in the very weathered, laminated mudrocks of the Whitehill Formation of the Ecca Group (J. Almond, pers. comm.). The underlying Prince Albert Formation crops out on the southern side of the road and is overlain by gravelly colluvium. Although the Breede River is not far away, the terrain of the proposed pit extension lies elevated above the alluvial flood plain. It appears that extensive excavating of gravel has already taken place along a portion of the road as most of the area was disturbed and some of it partly rehabilitated (Figures 3, 5 & 6). Only a narrow strip of vegetation was left in some areas along the fence (Figure 6) and at the eastern end of the affected area where the hill-slope has not been fenced off (Figures 4 & 7). The remaining vegetation consists of small karoo bushes and euphorbias.

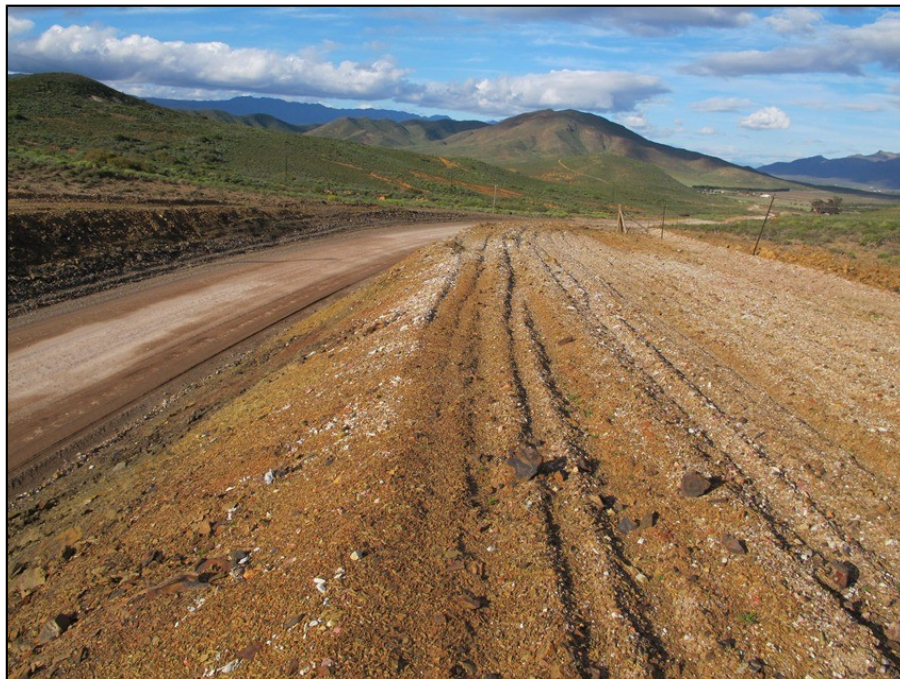
Figure 5: View along the partly-rehabilitated affected area towards the east. The unfenced slope at the eastern end lies beyond the bend in the road.

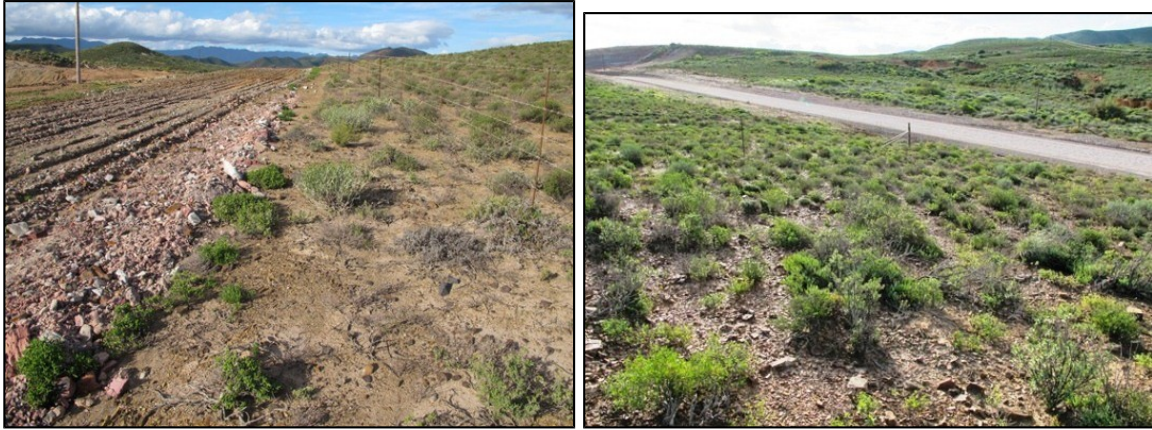
Figures 6 and 7: View towards the east showing the undisturbed strip between the fence and the partly-rehabilitated area; view towards the northwest with the existing quarry in the top left corner of the photo. This last photo was taken from the unfenced slope in the eastern part of the affected area.

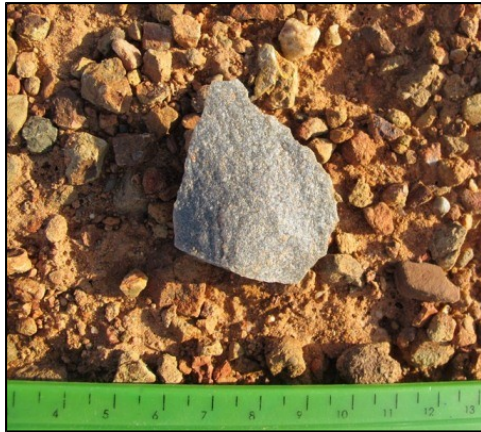
Figure 10: Single quartzite flake. The scale is in cm.

The disturbed, slope-wash context of the stone artefacts at the proposed site for Pit 123 indicates that the material is in a secondary context and is therefore of low archaeological heritage significance. No significant impact on such resources is expected if the proposed extension is developed further. No further archaeological studies or mitigation are recommended.
