# HERITAGE IMPACT ASSESSMENT

29 August 2012

DR01380 Cape Winelands

Worcester – Cape Winelands District Municipality, Western Cape

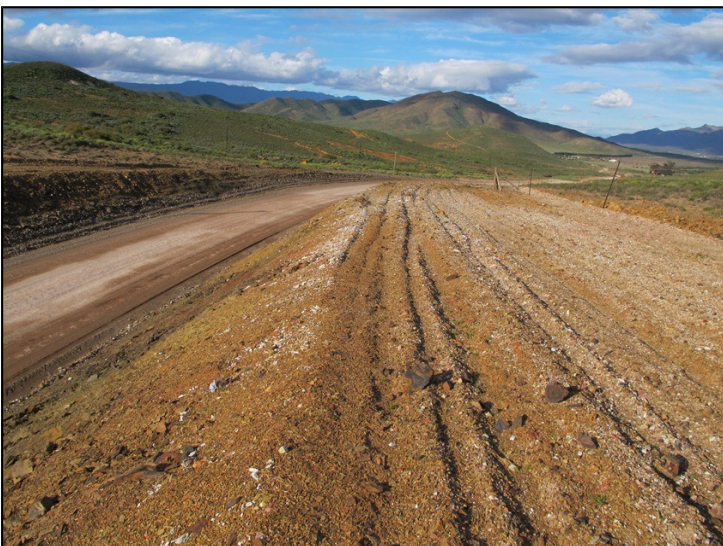
Figure 2: View along the partly-rehabilitated affected area towards the east. The unfenced slope at the eastern end lies beyond the bend in the road. (Tusenius 2012: 8)

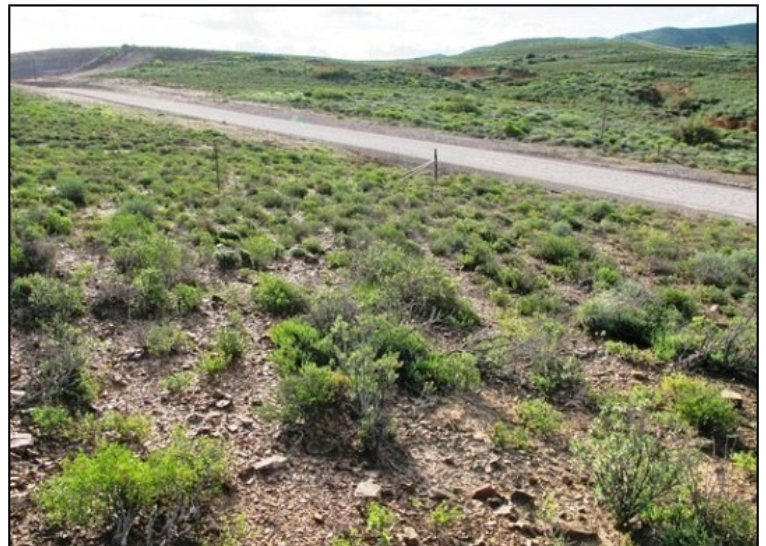
Figure 3: view towards the northwest with the existing quarry (Tusenius 2012: 9)

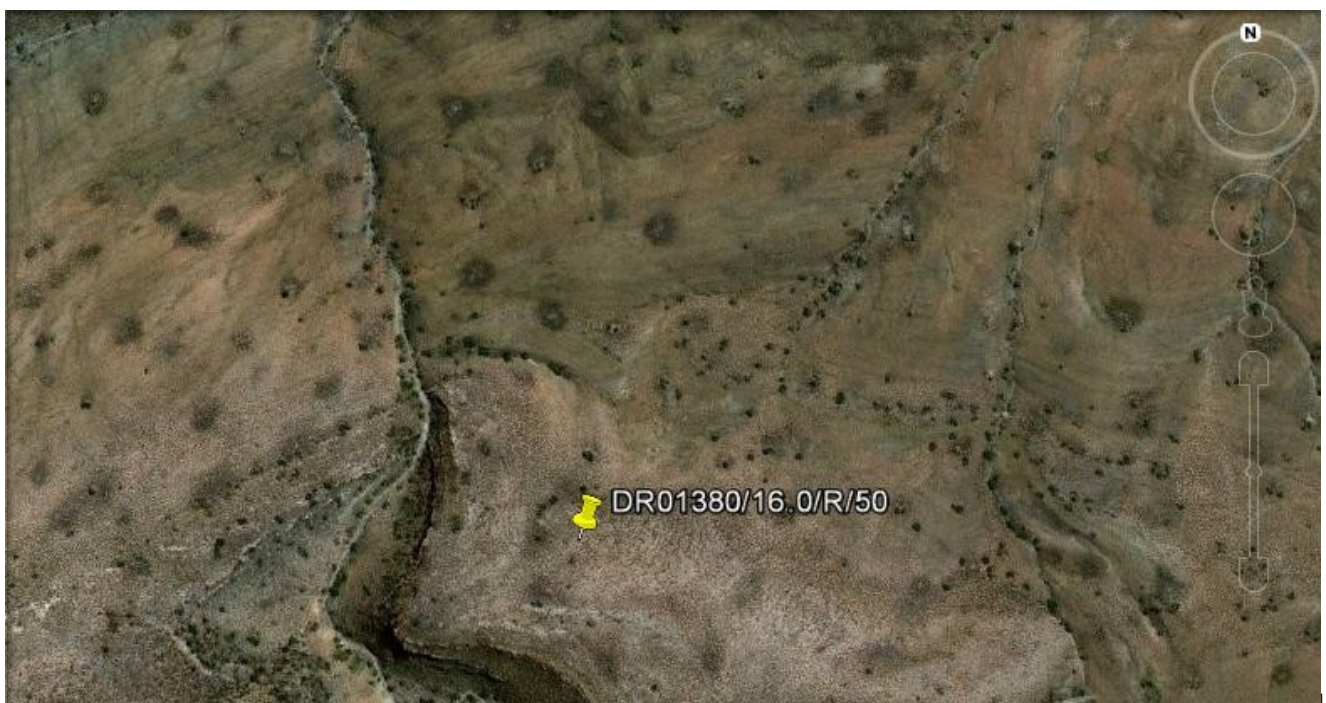
Figure 5: Aerial view of existing borrow pit (Google Earth image, August 2012)
