# **AN ASSESSMENT OF THE IMPACTS ON HERITAGE OF THE PROPOSED 66Kv OVERHEAD POWERLINE BETWEEN THE TOWNS OF CLANWILLIAM AND GROENWATER**

**Magisterial District: Clanwilliam**

June 2009

**Archaeology Contracts Office**

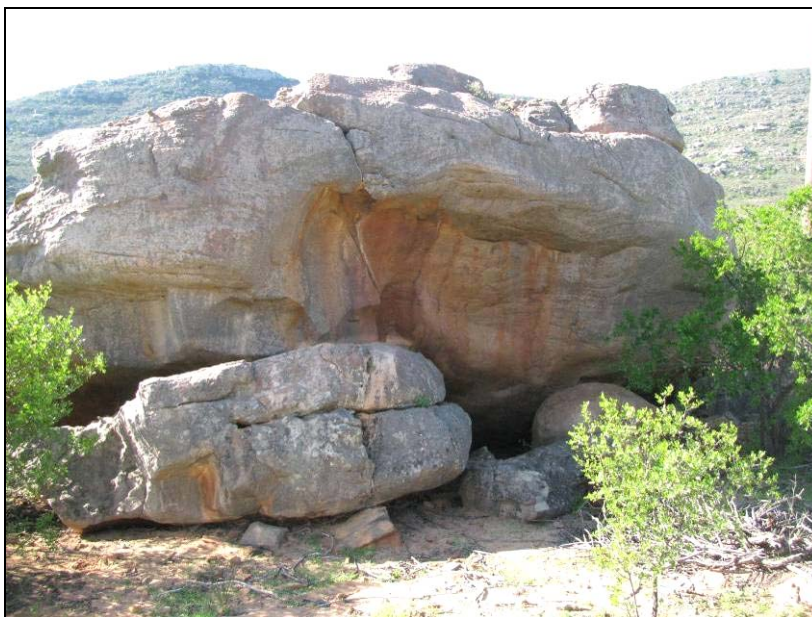
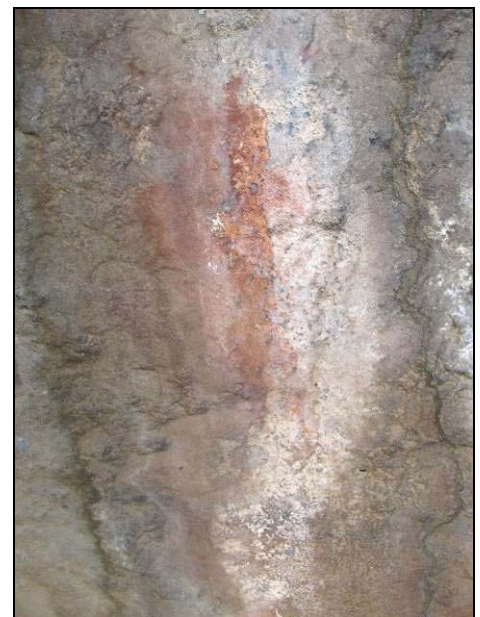
**TL:** Looking nw into PLR 14 **TR:** One of the more visible painted human figures at the site

On this section of the route, three sites lie on/close to the proposed route (PLR 8, 13 and 14). PLR 13 and 14 are sites with rock paintings and artefact scatters, while PLR 8 is an old farm werf. A farm road runs through the midst of these sites and as a result some impact may occur during the construction phase. Other sites are of very low significance and as long as no poles are placed directly on them, no further mitigation is required. None of the previously recorded database sites (CB 1-4) were found to be on the proposed route and therefore do not require mitigation. The old road PLR 10 is also of low significance and does not require any mitigation. At present, both o/h telephone and power lines run alongside the R364.

Poles should be located to the nw of these sites and construction crews should avoid using the existing upper track. No poles should be placed within a polygon defined by the following lat/lon positions.

In addition, as it is not realistic to place the area off limits to construction crew, the foreman must instruct his team as to the protocol to be observed in respect to these sites. In terms of the rock paintings, look but don't touch, and do not throw any liquids onto the paintings, no graffiti, no fires, no collecting of any items.

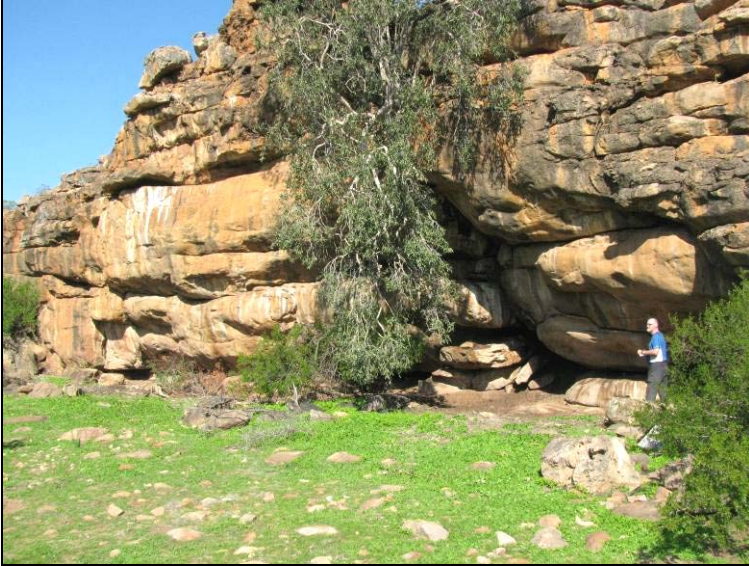
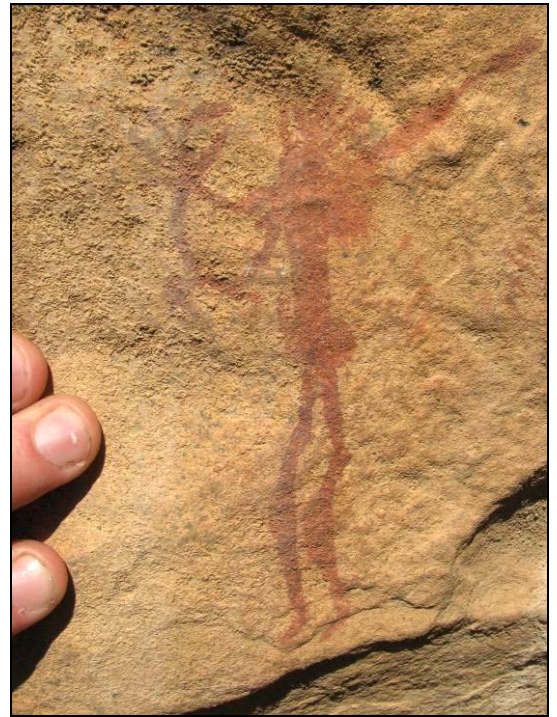
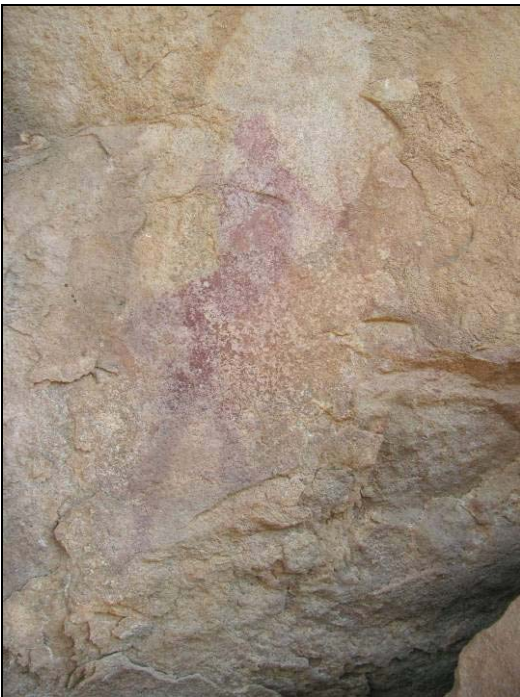
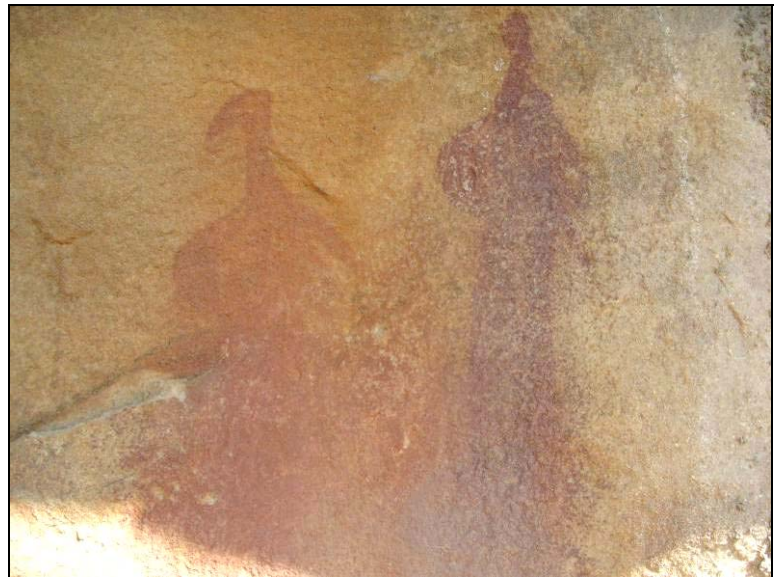
**TL:** PLR 13 showing the extensive rock wall and level talus **TR, BL, BR:** Some of the distinctive human figures at the site.

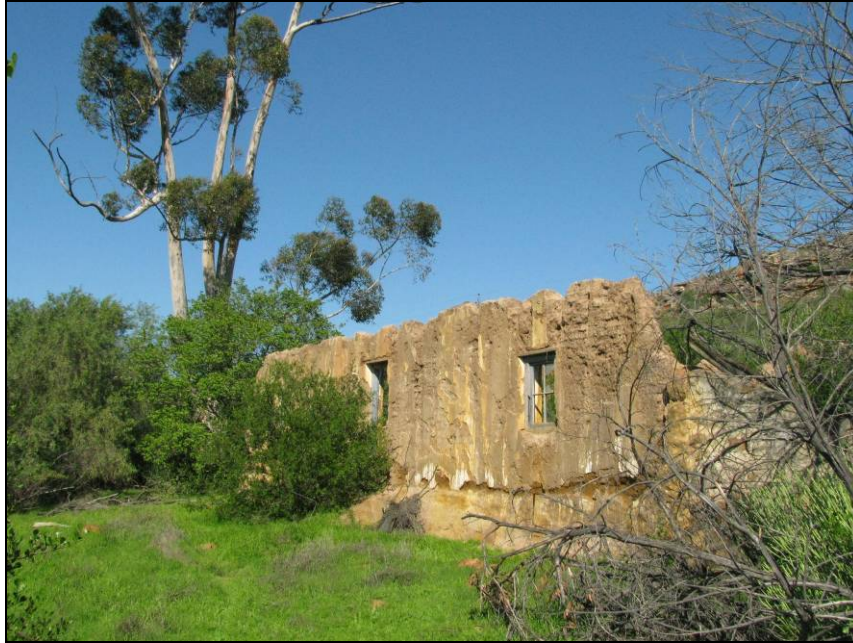
**T:** PLR 8 showing the ruined dwelling which is one of several structural elements on the old *werf*

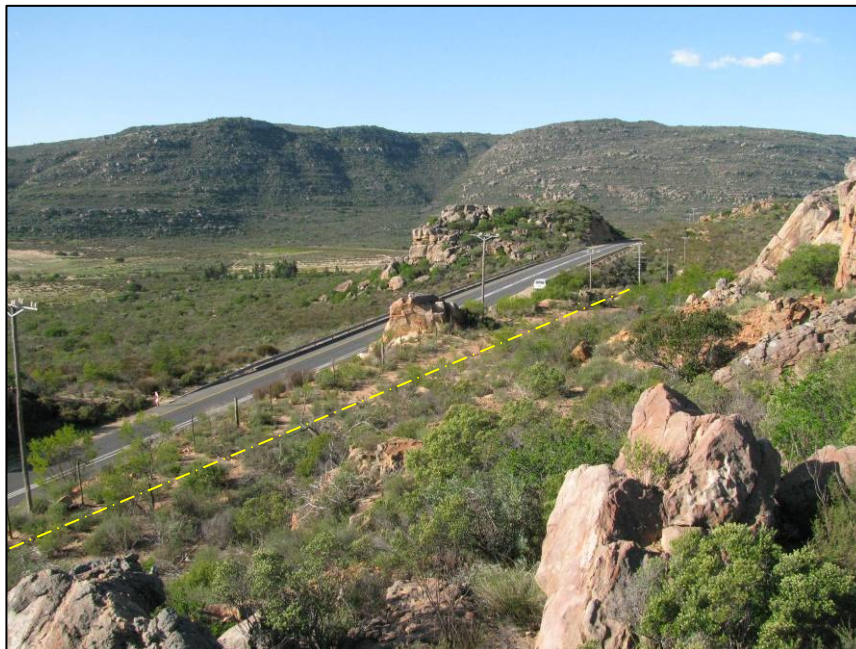
**B:** PLR 10, the old road (dotted line) can be seen in places and dry stone embankments are quite distinct. No impacts are likely to occur to this feature. The powerline will be in the valley to the left of the road.

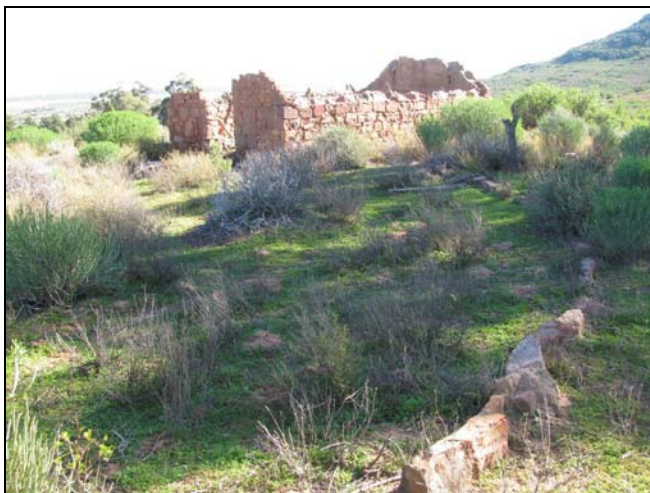
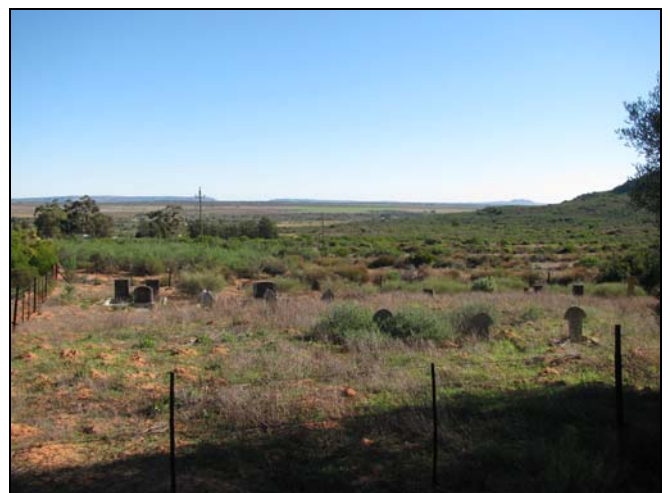
**TL:** Ruin and threshing floor at PLR 1 **TR:** Cemetery at PLR 2

Similar to the Cartensberg Pass option, this section of the proposed route is characterised by stone age sites in the form of artefacts and rock paintings, and more recent historical occurrences in the form of an old farm werf PLR 1 and features 1a, and associated cemetery PLR 2. Sites PLR 3-6 and UK 2, while close to the proposed route, are of low significance and no particular mitigation is required. PLR 7 is an isolated boulder with distinct rock paintings but is relatively far from the line and is unlikely to be in any danger. The most significant site in the kloof is UK 1. While it does not lie on the immediate route and will not be directly impacted, it could suffer indirect impacts from human intervention. The type of painting that is found at UK 1 is best described as polychrome human figures. It should be noted that there is an existing 22Kv o/h line in the kloof and no impacts resulted from that installation.

The cemetery PLR 2 should obviously be avoided and as the route now stands, the line would run between the old werf and the cemetery. No items should be collected from either. In the unlikely event of encountering human remains outside of the cemetery, such an occurrence must be reported and the pole position shifted. As with the Carstenberg Pass rock art sites, the foreman must instruct workers as to the protocol to observe in respect of any rock paintings. UK 1 is away from the route and unless people specifically search for it, it will probably remain undetected. The same applies to PLR 7, PLR 11 and 12 are also not directly impacted by the line. Access by vehicles must avoid the immediate area to prevent any impact.

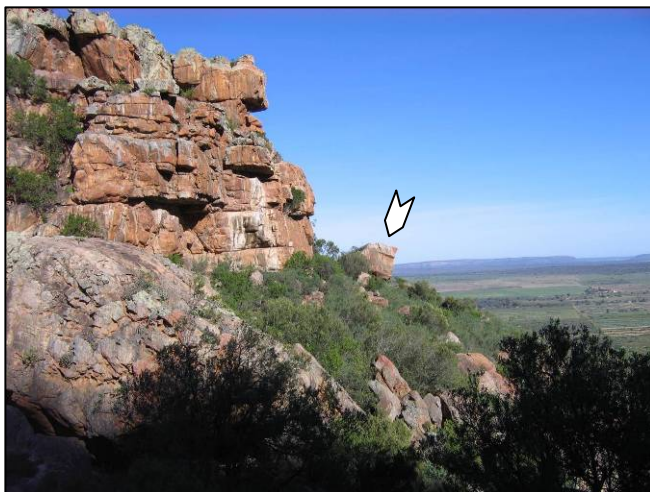
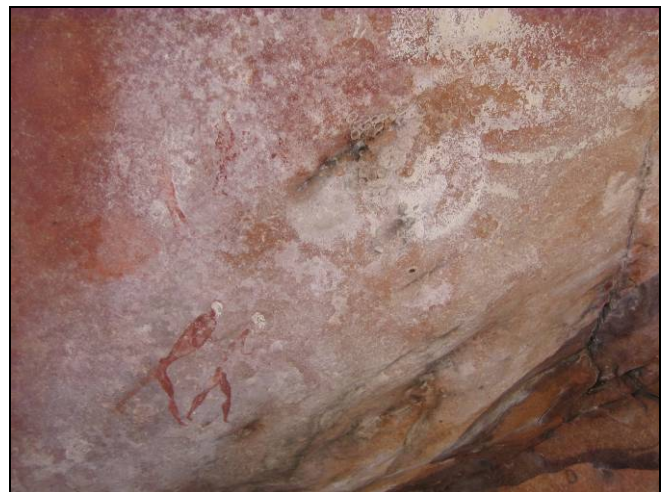
**BL:** UK 1 is below a boulder at the edge of a cliff **BR:** The main r/a panel faces the entrance

In considering the routes in terms of both impacts on archaeological sites and visual environment, we believe that the route following Alternative 2 would be the better option. Although the painted site UK 1 lies on the route, we believe that it is far enough removed not to be an issue.

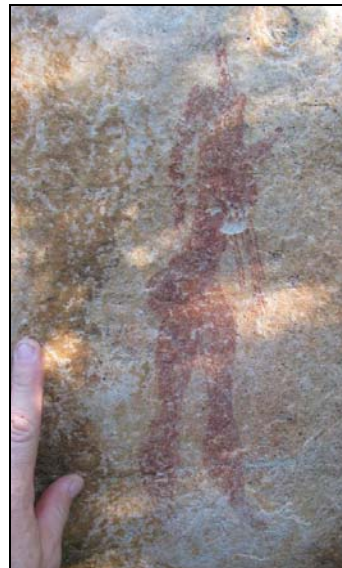
**TL:** Detail of polychrome hookheads at UK 1

**TR(3):** An exceptional polychrome figure with white and black detail at UK 1

**BL:** The isolated outcrop at PLR 7

**BR:** A distinct human figure with tasselled frontal bag, a recurring theme in this study

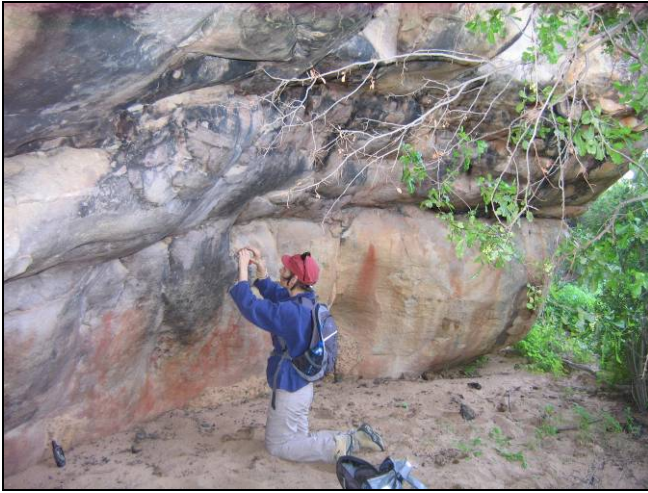
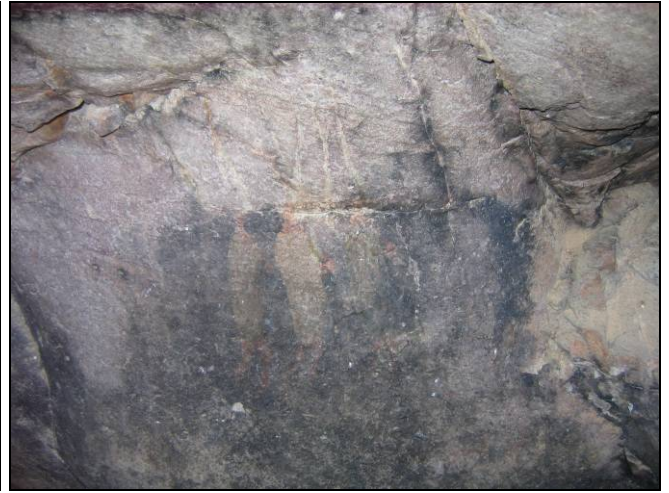
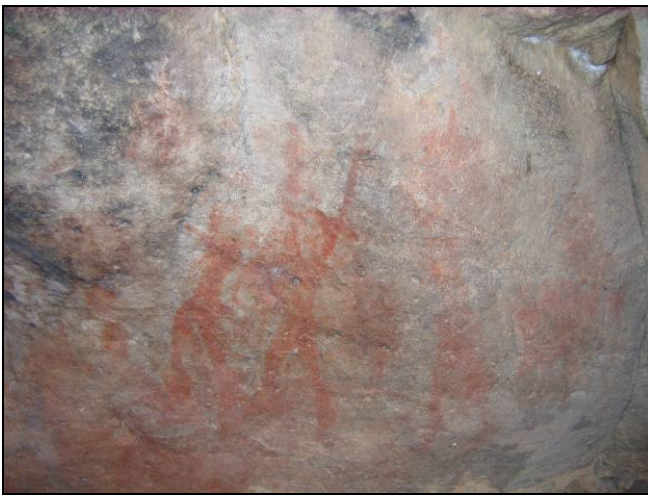
**TL:** The inside of the shelter at MG 2. The sandy floor comes almost to the level of the lowest paintings suggesting that the shelter may have filled with soil since the painting was done.

**TR:** Three kaross-clad figures visible amongst black staining.

**L:** Large human figures predominate the central panel of r/a

Two sites were found close to the line. The site MG 2 was previously recorded on the SARU database. It will not experience direct impact from the line itself but as it is within 20 meters of the farm track that will be used for access, it may be subject to indirect impact by human intervention. There are several human figures some with tasselled bags and most distinctly, three small figures with karosses. No artefacts were observed. An existing 22Kv o/h line is present close to the site and no damage resulted during that project. A small graveyard consisting of 9 informal graves, MG1, is located close to/on the route.

The foreman must instruct workers as to the protocol to observe in respect of any rock paintings.

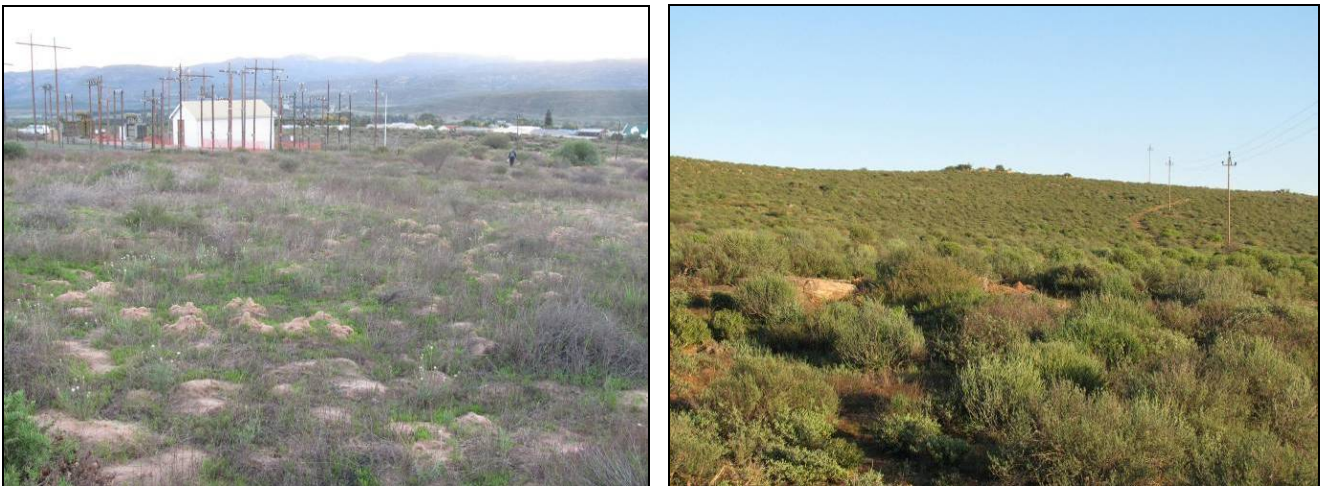
Moderate increase of visual impact from Clanwilliam moderated by the fact that electric lines tend to be “lost against the background of Ramskop. Impact is mostly limited to the point where it crosses the skyline.

**TL:** Existing Clanwilliam sub-station. **TR:** Existing powerline on the north side of Ramskop at Clanwilliam

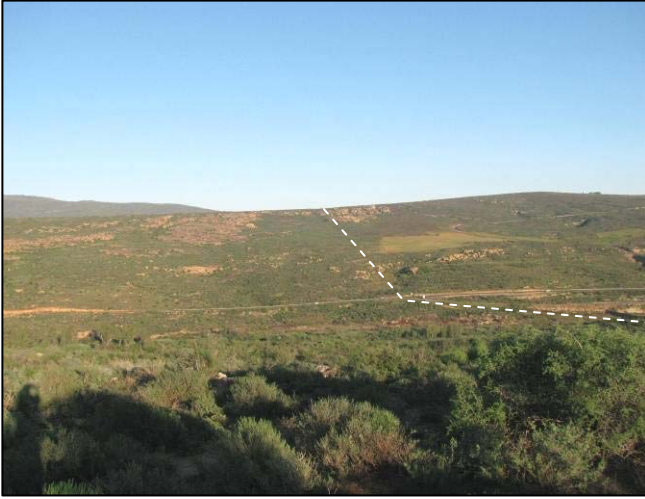
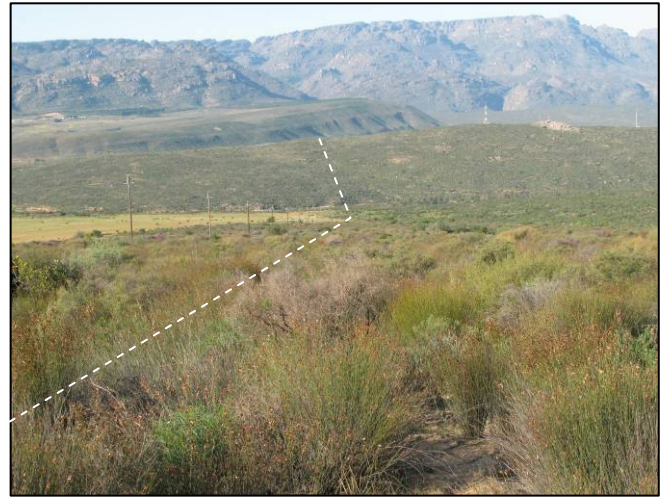
The point at which the line crosses the ridge at Malgashoek is some distance from the N7 and since at right angles to the Olifants River valley, will tend to have a limited visual signature. The line is some distance from the R364 where it crosses Malgashoek and lies below eye level, or is shielded by road cutting embankments. Beyond Malgashoek towards Uitkomsberg, the line remains quite distant from the R364 and is lost against the agricultural background.

**BL:** Looking south from Top of Ramskop showing approximate route of powerline (dotted) over Malgashoek farm, N7 in bottom of valley. **BR:** Looking from Malgashoek back towards Clanwilliam.

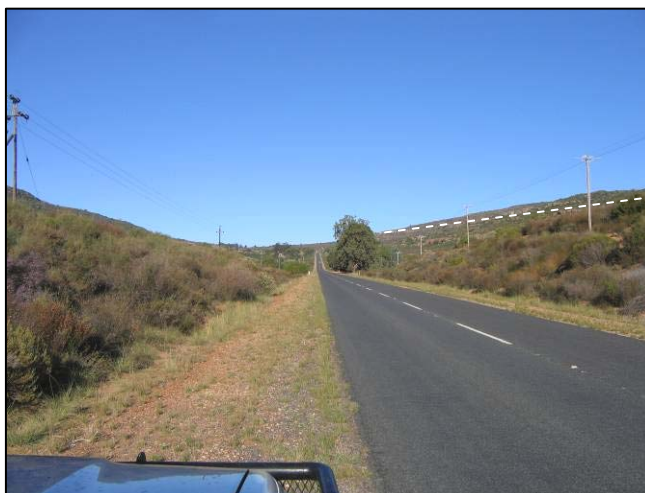
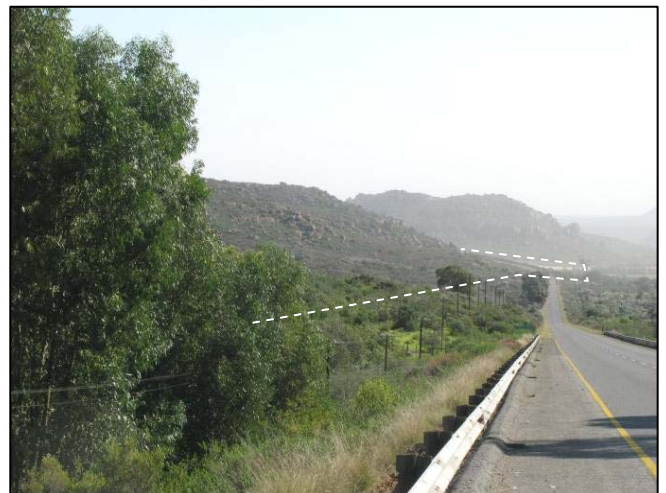
**TL:** Looking se along the R364 direction Clanwilliam at Carstenbergs Pass. **TR:** Looking nw down the R364 direction Graafwater at Carstenbergs Pass (proposed route shown approximately by white dotted line)

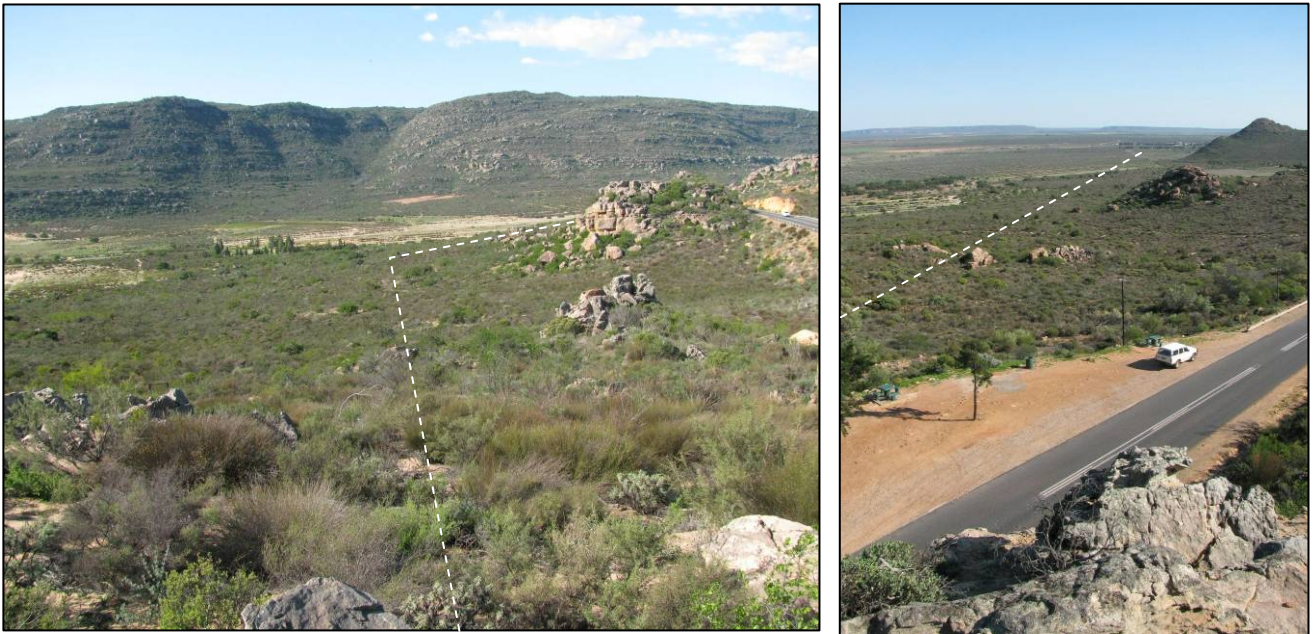
Route alternative 2 diverges from Alternative 1 on the northern side of the Uitkomsberg. The route following Cartstenbergs Pass runs parallel to the mountains and then cutting diagonally until it comes close to the R364. Although lying close to the road, it tends to be lost against the background. A moderate signature will be created where it crosses from one side of the R364 to the other at Melkboomfontein. From that point the line runs in the valley alongside the pass. No lines exist here at present. Some visual signature will be created where the lines cross back over the R364 but this is at a point between two high road cuttings. From there it cuts diagonally across veld to a point adjacent to the R364, where it runs for a short distance before cutting diagonally inland across agricultural land to link up with the Graafwater sub-station.

**BL:** The valley to the west of Carstenbergs Pass, visible at rhs. **BR:** The powerline crosses back over the R364 and cuts across veld to rejoin the road for a short distance towards Graafwater after which it heads back to the sw to link with route alternative 2 just short of the sub-station.

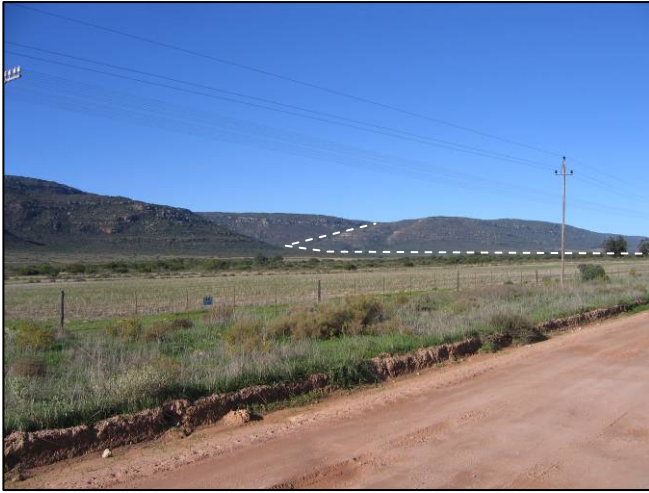
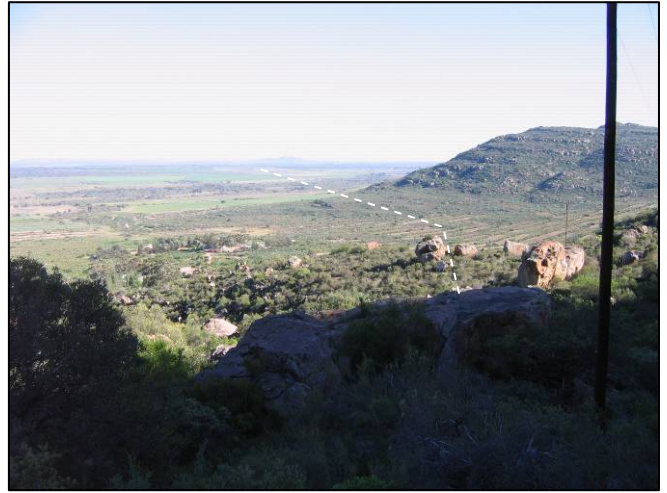
This section is far removed from any major public roads and is confined to a kloof. Residents of Uitkoms farm will experience a moderately increased visual signature in addition to the existing line. On leaving the mountains, the line runs across agricultural land alongside the existing installation until linking with the existing sub-station.

**TL:** Looking nw towards Uitkomsberg showing the kloof. **TR:** Looking towards the nw from the Uitkomsberg kloof

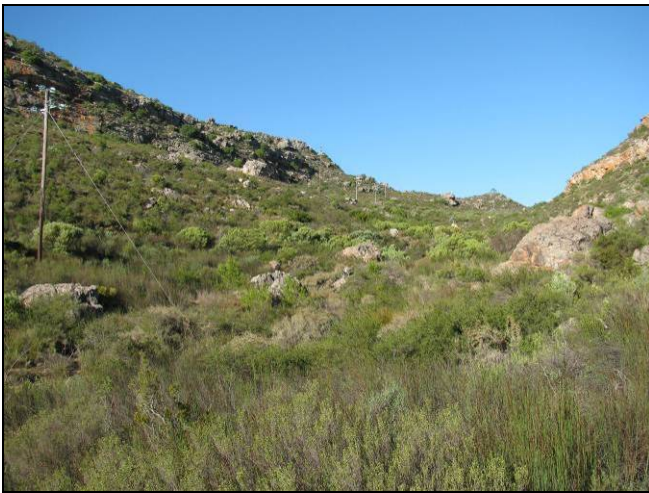
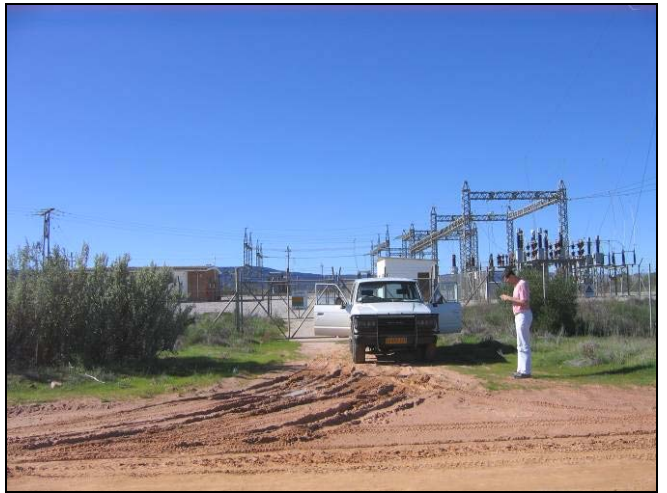
**BL:** Looking nw up the kloof showing existing powerline. **BR:** The existing Graafwater sub-station on the road linking the R365 and R364.
