ARCHAEOLOGICAL SPECIALIST STUDY

The Improvement Of National Route R63 Sections 15 And 16 From Bhisho (km 5.8) To The N6 Bridge Intersection (km 1.0)

CTS HERITAGE

April 2018

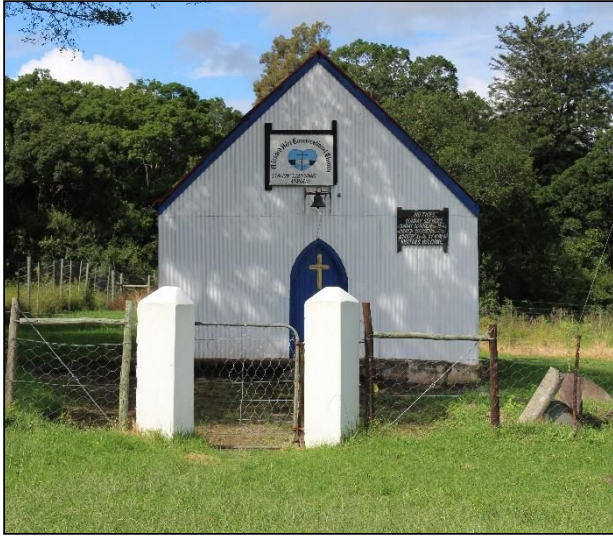
Site R63-15-S1 comprises the Colonial Period Richard Brit Congregational Church. The site is older than 60 years of age, and reasonably inferred to pre-date 100 years, based on corrugated iron having been used as building material. The site is protected by the NHRA 1999. The site is still in use. Current conservation measures comprise a permanent fence with access gate, with these conservation measures complying with SAHRA / EC PHRA minimum standards for heritage site conservation. The site is situated approximately 60-70m from the relevant road alignment.

Plate 1: General view of Site R63-15-S1, the Colonial Period Richard Brit Congregational Church

- **Site Significance and Recommendations:** Site R63-15-S1 receives automatic SAHRA / EC PHRA protection as a site of low local significance (Grade IIIC). Current conservation measures comply with SAHRA / EC PHRA minimum standards for heritage site conservation. It is not necessary for the developer to take additional measures to ensure conservation of the site during the construction phase.

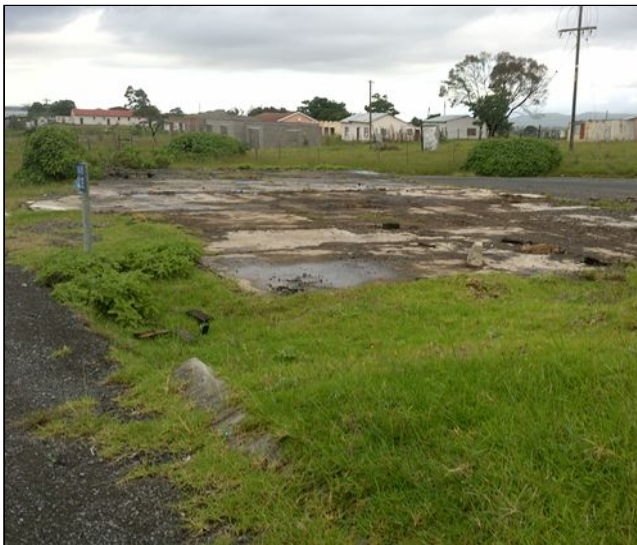
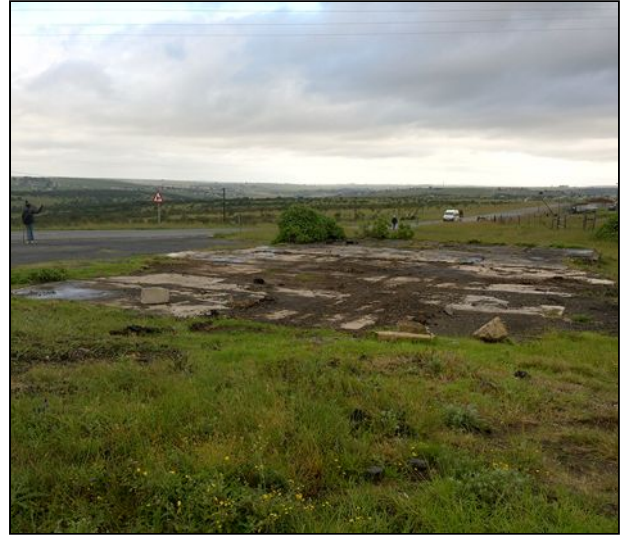
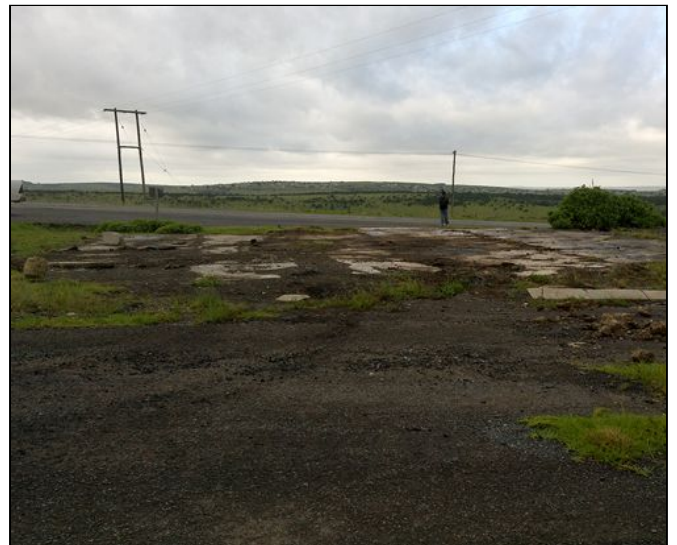
Site R63-15-S2 comprise the Contemporary Period remains of the Old Ciskei – South African border post. The Ciskei was the fourth homeland to become independent in 1981, when the border post was constructed. The site is at present demolished to cement floor level. Structure remains are younger than 60 years of age and not protected by the NHRA 1999. However, the remains are of heritage significance. The site will be directly, albeit perhaps only partially impacted by development. Realignment of the road for purposes of site conservation is not recommended.

Plate 3: General view of Site R63-15-S2, the Contemporary Ciskei Border Post [2]

Plate 2: General view of Site R63-15-S2, the Contemporary Ciskei Border Post [1]

Plate 4: General view of Site R63-15-S2, the Contemporary Ciskei Border Post [3]

- **Site Significance and Recommendations:** Site R63-15-S2 does not receive protection under the NHRA 1999. The site is however of heritage sensitivity. Development will directly, albeit perhaps only partially impact on the site remains. Impact on the border post remains are not subject to an EC PHRA Built Environment Permit. It is however recommended that the developer ensures that a plinth be erected with the wording 'Border Post' as close as possible to the original site locale upon completion of road works in the vicinity of the site.

having to comply with additional heritage compliance requirements. It is recommended that the developer constructs a plinth with the wording 'Border Post' as close to the original locale of site to the road as permitted within road legislation and regulations and with cognizance to visibility and safe road usage.

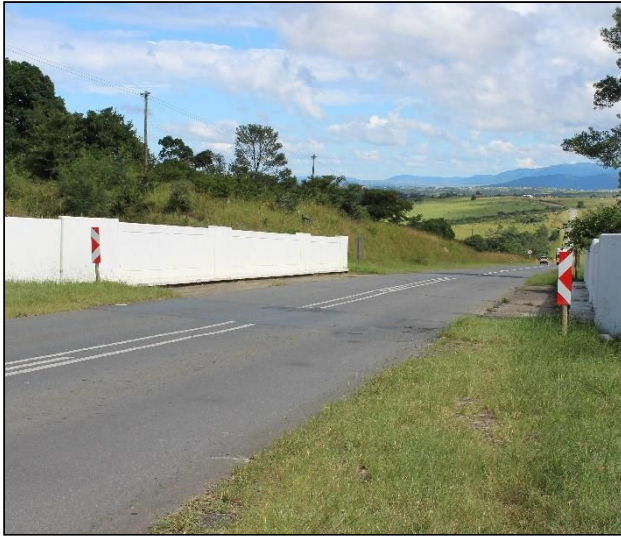
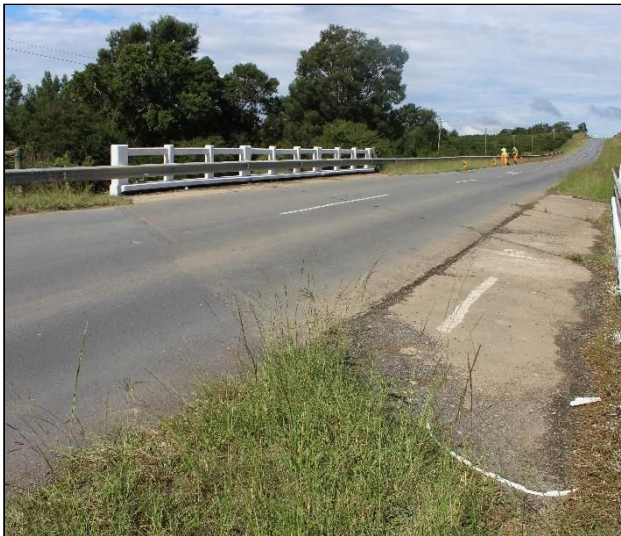
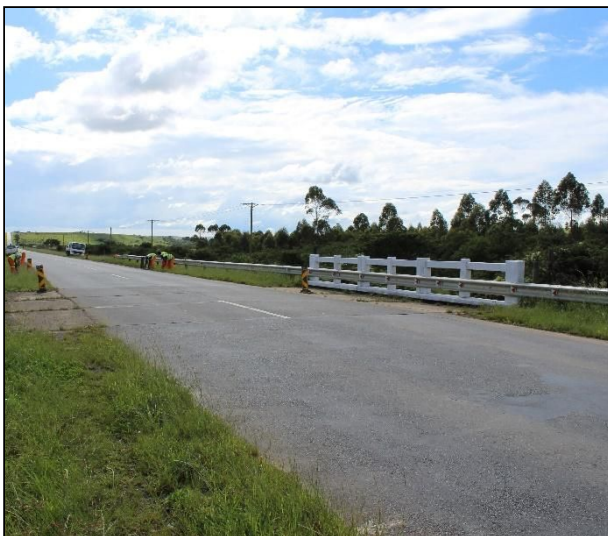
Proposed upgrade of the said road alignment includes related work to 6 bridges. None of the bridges are of archaeological or cultural heritage significance, as defined and protected by the NHRA 1999. Similar to impact on culverts and drainage channels, bridge reconstruction and upgrades can proceed without the developer having to comply with additional heritage compliance requirements.

Plate 11: Selected bridges along the road alignment (rail bridge)

Plate 12: Selected bridges along the road alignment [1]

Plate 13: Selected bridges along the road alignment [1]

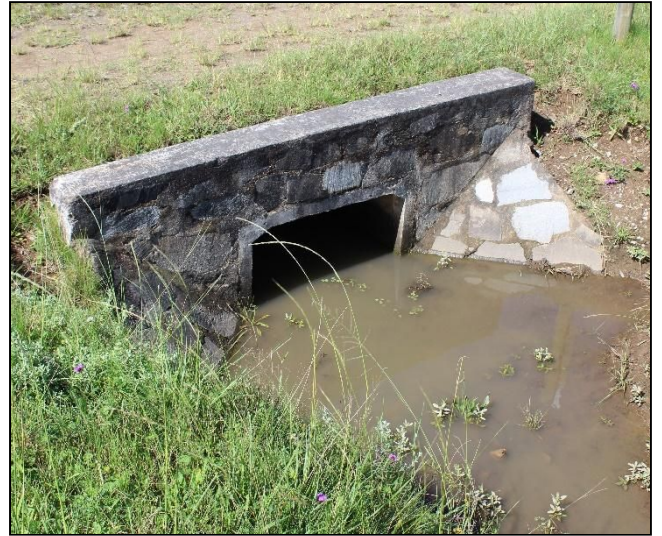
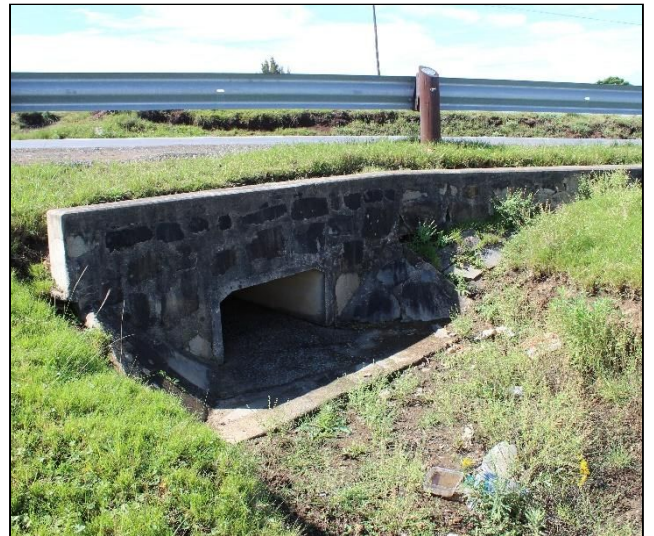
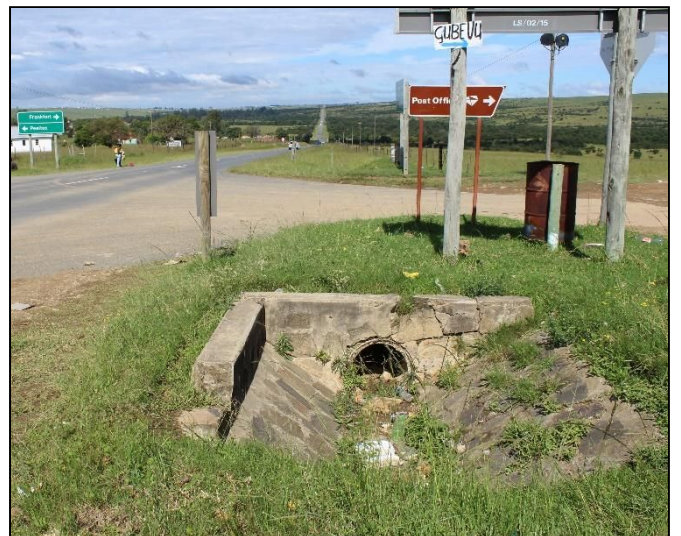
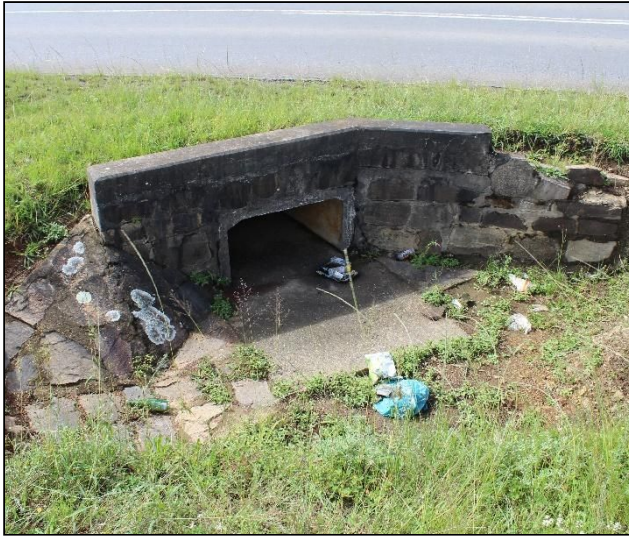
Culverts and storm water drainage channels are more than often stone lined, with approximately 90 culverts identified along the length of the line route, thus very similar to findings of the R63 N6 bridge to the N2 intersection east of Komga, immediately adjoining the study site to the east where 140 such culverts and associated drainage channels were identified (Van Ryneveld 2017¹). Although the exact date of construction of these features are not known, the abundance thereof does not suggest heritage significance while evidence of sequential upgrade and maintenance thereto throughout the years have lessened any possible heritage significance. Fair interpretation is vested in the use of stone as local construction material, thus an earlier environmental solution to the construction industry, rather than a reference to heritage with the early use of stone as primary or significant building material.

Plate 14: Culverts [1]

Plate 15: Culverts [2]

Plate 16: Culverts [3]

Plate 17: Culverts [4]

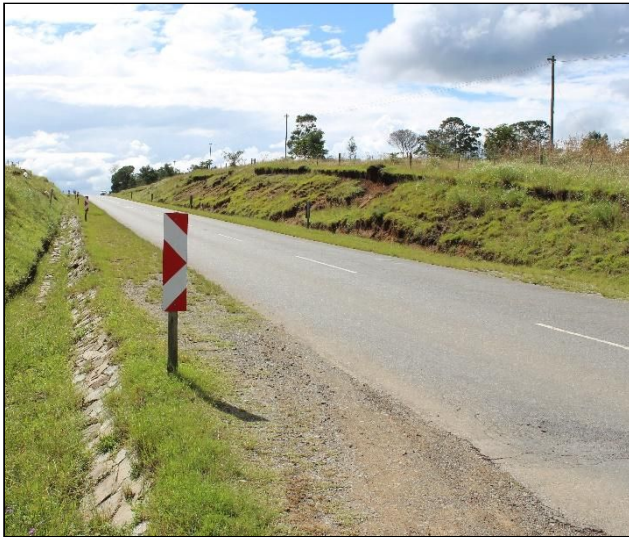
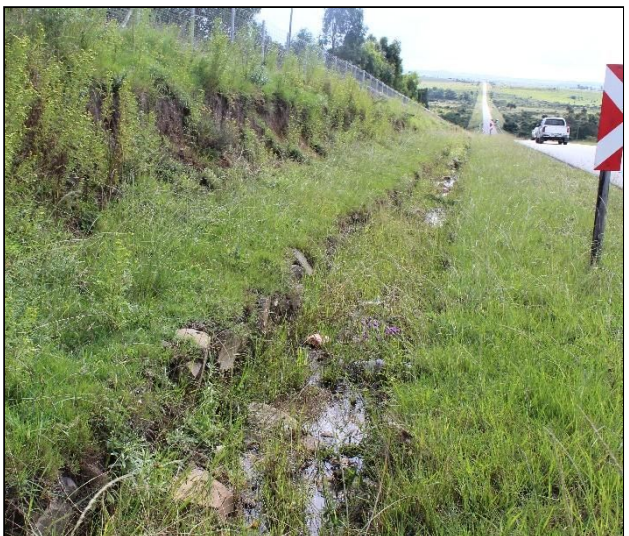
Plate 18: Storm water drainage channels [1]

Plate 19: Storm water drainage channels [2]

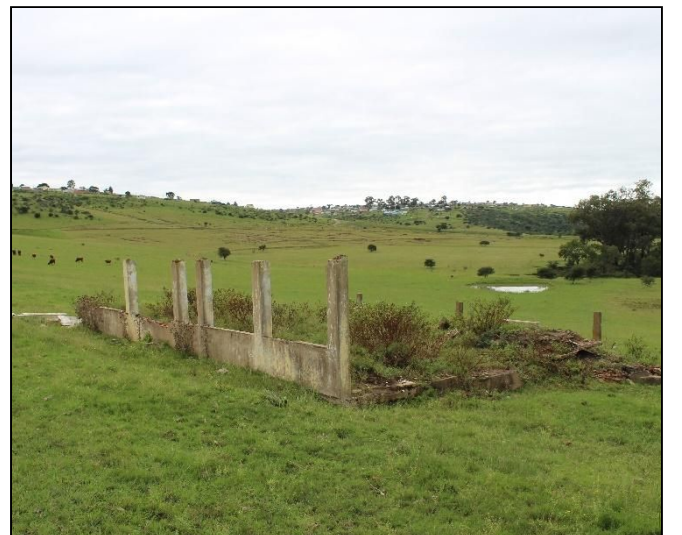
Site R63-15-S3 comprises the Colonial Period remains of a farmstead. The main residence, currently in ruins with only partial walling still standing is situated at the site co-ordinate S32°46'19.3"; E27°23'52.5", approximately 90m from the boundary of proposed Quarry 15, while remnants of related period farming infrastructure (R63-15-S3.1) is visible at S32°46'19.7"; E27°23'49.9", approximately 25m from the proposed Quarry 15 boundary. Structure remains are

reasonably inferred to pre-date 60 years of age and are protected by the NHRA 1999. No conservation measures are in place.

- **Site Significance and Recommendations:** The Site R63-S15-S3 structure remains receives automatic SAHRA / EC PHRA protection as a site of low local significance (Grade IIIC). No conservation measures are in place.

Plate 34: View of the Site R63-15-S3 Colonial Period structure remains

- o It is recommended that the developer ensures that temporary conservation measures, including a temporary fence, of construction netting or a similar visually clear demarcation be erected around these features for the duration of use of Quarry 15. Temporary signage indicating these features as 'No Entry – Heritage Site' should be attached at intervals along the conservation fences. All temporary conservation measures should be removed upon closure of the quarry. OR

- o Based on the period of use of the quarry the developer may opt for permanent conservation of the features, including that features be permanently fenced with an access gate. The developer should allow for an approximate 5m conservation buffer between the features and the conservation fence.

- The Site R63-15-S3 (S32°46'19.3"; E27°23'52.5") situated in close proximity to Quarry 15 comprise Colonial Period farmstead remains including structure and infrastructural remains. No conservation measures are in place. It is recommended that conservation measures, either temporary or permanent, as will be most practical with reference to the duration of use of Quarry 15 be implemented prior to use of the quarry.

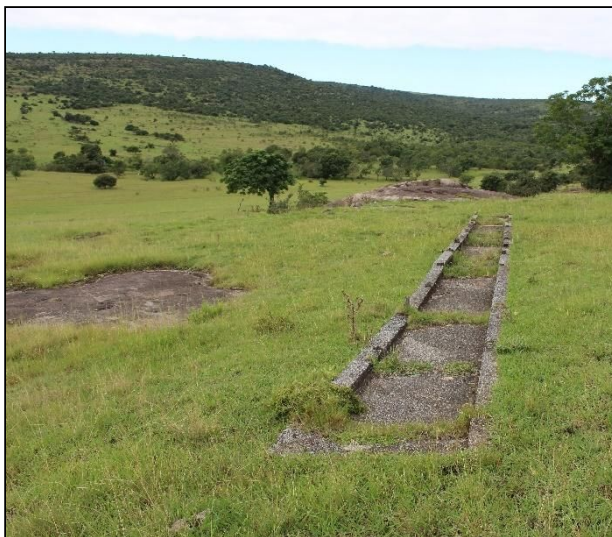
Plate 35: View of the Site R63-15-S3.1 Colonial Period farming infrastructure

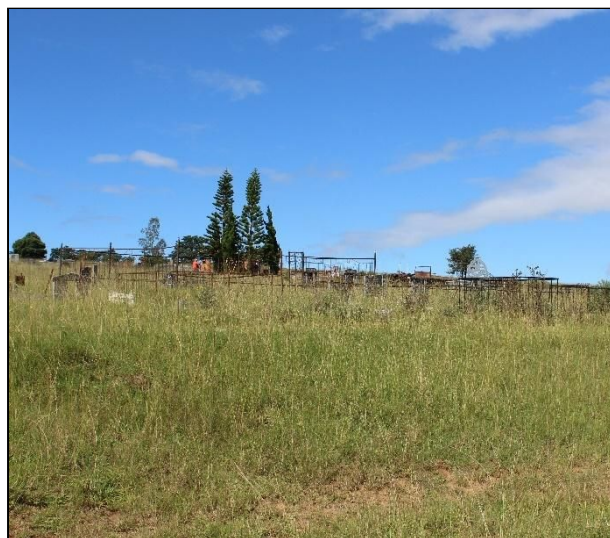
Site R63-15-S4 comprises an informal Later Iron Age cemetery, situated along the access road to be used for Borrow Pit 16 (and other study sites). The cemetery boundary is within 25m from the access road to be used. The informal cemetery is formally protected by the NHRA 1999. No formal conservation measures are in place. The cemetery houses 500+ graves of varying grave style including modern style graves, often individually fenced as well as traditional style earth mound, stone outlined, stone cairn and headstone demarcated graves.

- **Site Significance and Recommendations:** The Site R63-S15-S4 cemetery comprises a burial site formally protected by the NHRA 1999. The cemetery boundary is situated within 25m from the proposed access road. The site is graded as having high local significance (Grade IIIA). No conservation measures are in place. The site is ascribed a SAHRA / EC PHRA High / Medium Significance (Grade IIIA).
 - o It is recommended that the developer ensures permanent heritage conservation measures, including a permanent fence with access gate to be in place ensuring compliance with SAHRA / EC PHRA minimum standards for heritage site conservation prior to commencement of construction.

Plate 39: View of the Site R63-15-S4 Later Iron Age cemetery

- Site R63-15-S4 (S32°47'19.0"; E27°29'23.5") comprises an informal Later Iron Age cemetery, situated on route to Borrow Pit 16. No conservation measures are in place. It is recommended that the site be permanently fenced with an access gate prior to the start of construction, thereby ensuring that heritage conservation measures meet SAHRA / EC PHRA minimum standards for heritage site conservation.

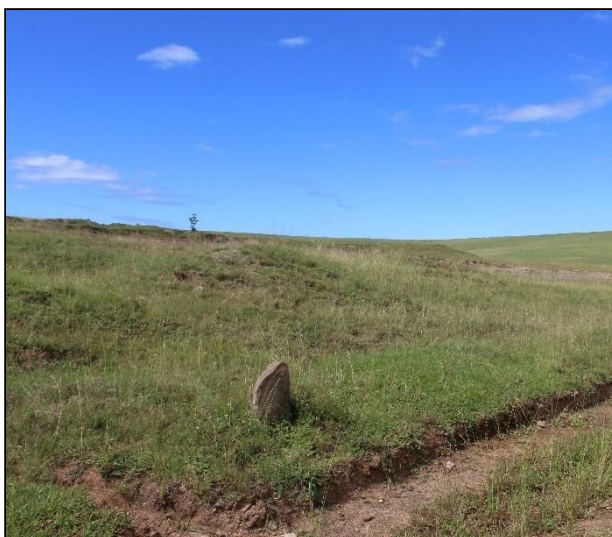
No archaeological or cultural heritage resources were identified on the surface of the study site or within exposed former borrowing sub-surface sections. A single monolithic stone along the access road to Borrow Pit 16 is a terrain marker and not a grave. Site R63-15-S4, an informal Later Iron Age cemetery is situated along the access road to Borrow Pit 16. No conservation measures are in place. It is recommended that the cemetery be permanently fenced prior to the start of construction. [Site R63-15-S4 is described under 4.2 Archaeological Resources Identified].

Plate 37: Borrow Pit 16 with a single monolithic stone, being a terrain marker

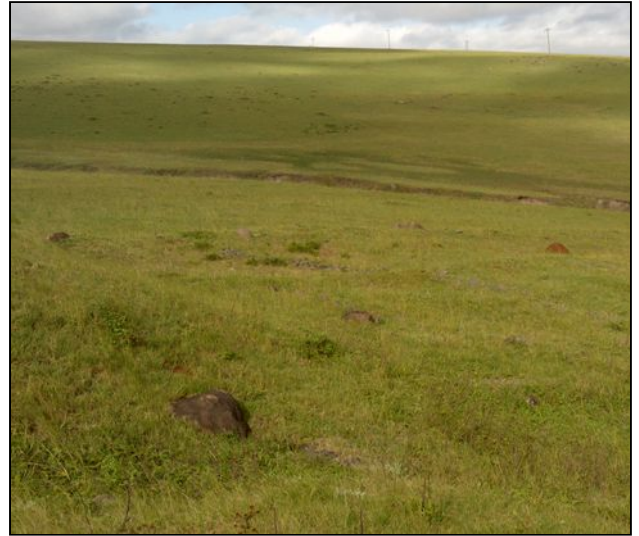
Site R63-15-S5 comprises Contemporary low-keyed structure foundation remains associated with former use of Quarry 3 and in character similar to the former quarry boundary fence remains. These stone outline remains are not formally protected under the NHRA 1999. Impact thereon or proximity thereof to the study site does threaten heritage as defined by the NHRA 1999.

- **Site Significance and Recommendations:** The Site R63-S15-S5 Contemporary stone foundation features are not protected by the NHRA 1999. Proximity to the study site or impact thereon are not subject to heritage compliance requirements.

Plate 44: View of the Site R63-15-S5 Contemporary structure foundation remains

- Site R63-15-S5 (S32°47'55.9"; E27°29'28.3") comprises contemporary structure foundation remains associated with former use of Quarry 3. Foundation remains are not protected by the NHRA 1999. Impact thereon by development or proximity thereof to development does not trigger any heritage compliance requirements.

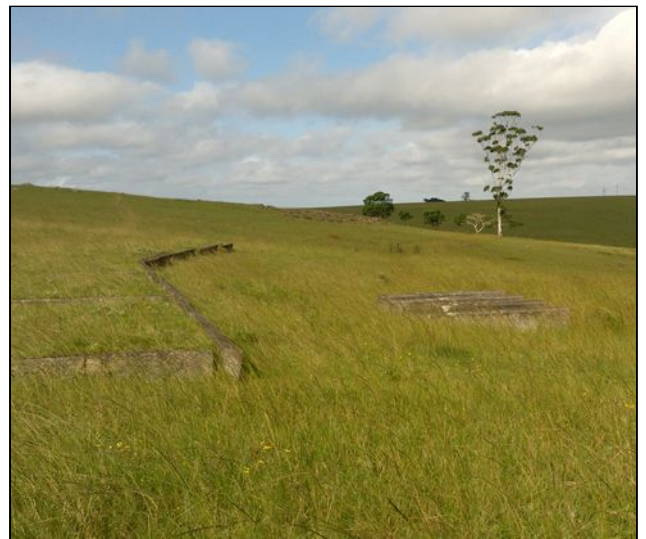
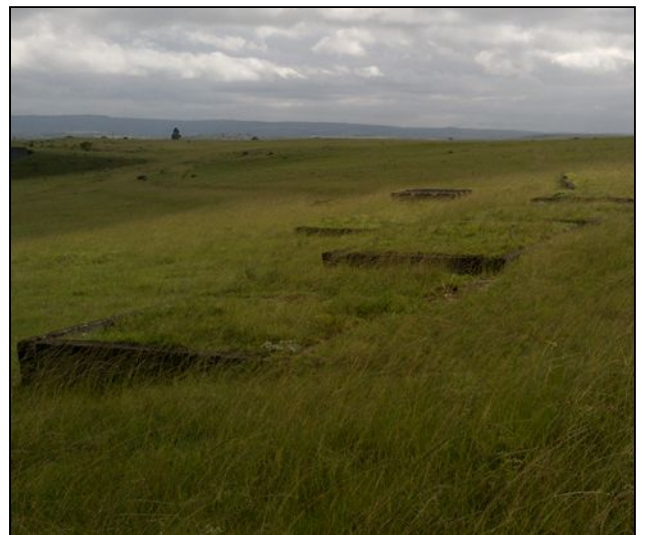
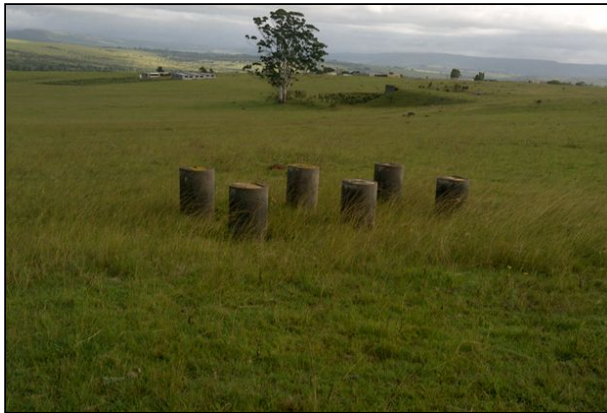
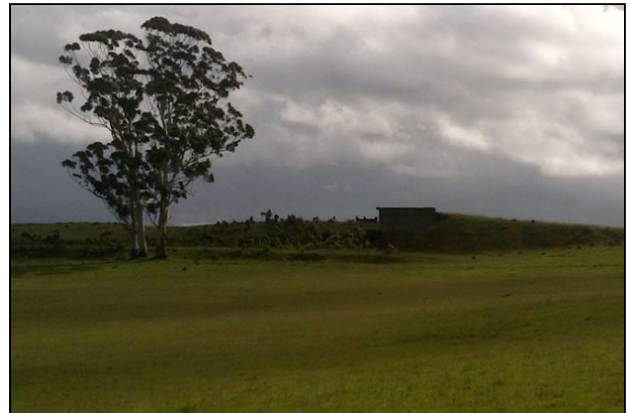
Site R63-15-S6 comprises the remains of a Colonial Period Railway Platform. The old railway track has been removed in totality with only cement foundations remains of the original platform still visible (situated at the site co-ordinate S32°47'57.3"; E27°29'42.5"). In close proximity are a collection of columns, structural remains directly associated with the railway platform (Site R63-15-S6.1 – S32°47'51.1"; E27°29'44.2"), whilst further associated remains are situated further from the Quarry 3 study site, approximately 200m north thereof (Site R63-15-S6.2 – S32°47'51.3"; E27°29'36.5"). Railway remains pre-date 100 years of age and are protected by the NHRA 1999. The Quarry 3 site will directly impact on the platform remains and the collection of structural columns, situated at S32°47'57.3"; E27°29'42.5" and S32°47'51.3"; E27°29'36.5".

- **Site Significance and Recommendations:** The Site R63-S15-S6 Colonial Period railway platform remains receives automatic SAHRA / EC PHRA protection as a site of low local significance (Grade IIIC). No conservation measures are in place. Quarry 3 will directly impact on selected of the remains including the platform remains and the collection of foundational columns.

Plate 45: View of the Site R63-15-S6 Colonial Period Railway platform remains [1]

Plate 46: View of the Site R63-15-S6 Colonial Period Railway platform remains [2]

Plate 47: View of the Site R63-15-S6.1 Colonial Period
Railway platform remains

Plate 48: View of the Site R63-15-S6.2 Colonial Period
Railway remains from Quarry 3

- It is recommended that the developer applies for an EC PHRA Built Environment site destruction permit prior to use of Quarry 3 as currently proposed. Upon the issue of a destruction permit development may legally proceed and the affected heritage structures destroyed. OR

- The developer should ensure that the heritage structures be formally conserved within the development layout implying a reduction in size of proposed Quarry 3. Heritage structures should be permanently fenced with an access gate. The heritage conservation fence should allow for an approximate 15m conservation buffer between the heritage sites and the Quarry development. Permanent signage indicating the area as a 'heritage Site' should be affixed to the conservation fence.
