ARCHAEOLOGICAL SPECIALIST STUDY

Proposed development of the Taaibosch Puts Renewable Energy Facility Cluster and associated Electrical Grid Infrastructure near Postmasburg, Northern Cape

November 2021

Updated June 2022

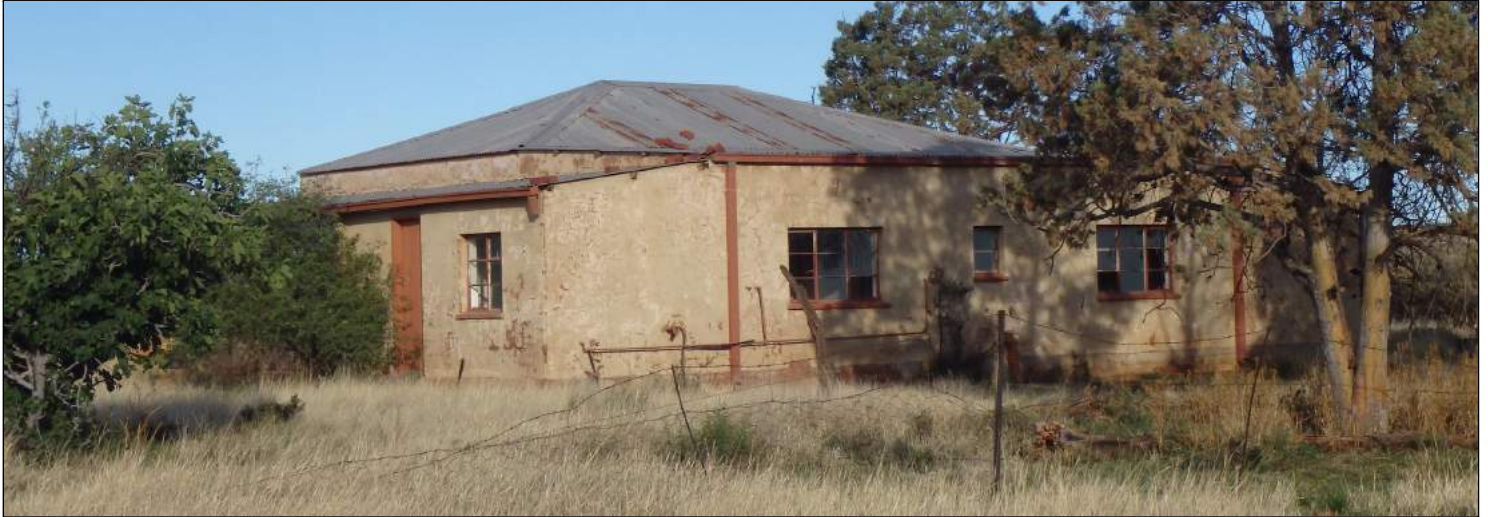
Figure 7.11 Site No. 114

The older Klein Fairview farmhouse is located within this development layout (Site No. 114). This site is located along an existing road and within a proposed grid alignment. While no direct impact from the proposed development is anticipated, the nearest turbine to this heritage resource is Turbine 34 located only 450m away. It is recommended that this turbine be removed from the layout in order to conserve the context of this heritage resource.

3. A minimum no-go development area of 20m must be implemented around Sites 114 and 161 to ensure that no impact to these structures takes place (Figure 9.3 and Figure 9.4)

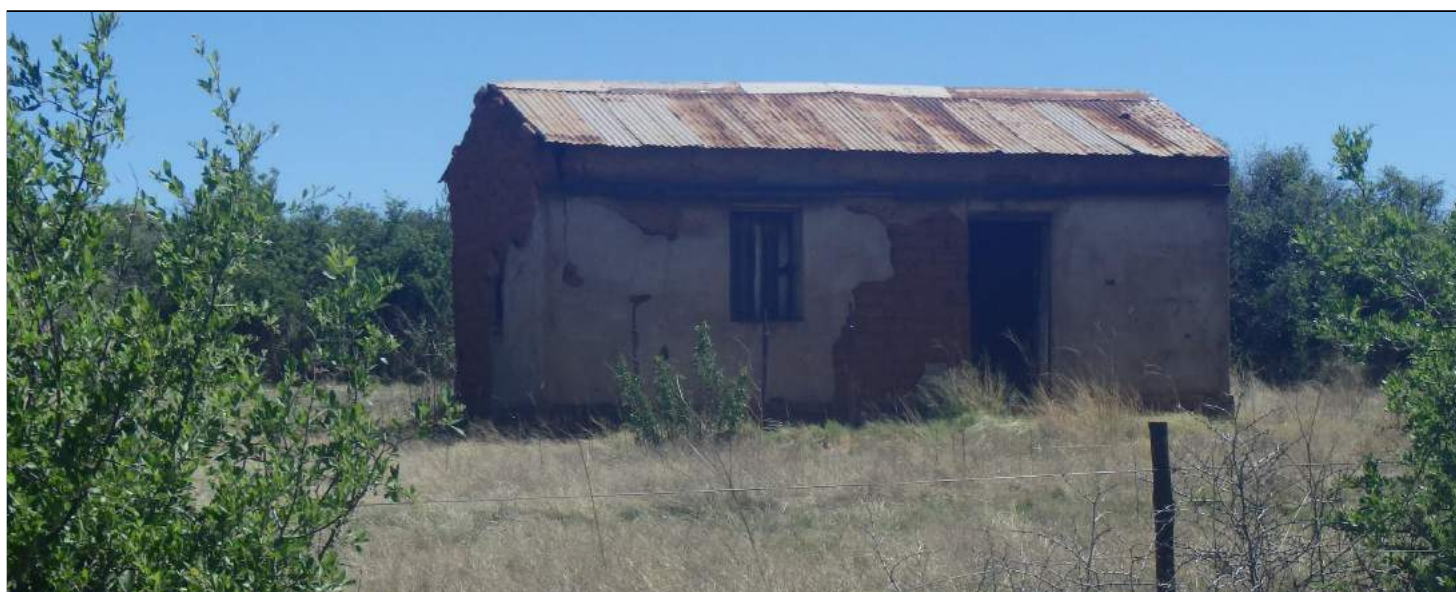
Figure 7.15 Site No. 161

An older clay cottage (Site No. 161) is located along the southern grid connection. This site is located along an existing road and within a proposed grid alignment. While no direct impact from the proposed development is anticipated, it is important that no pylons are placed within 20m of the structure and as such, a 20m no development buffer is recommended around this site.

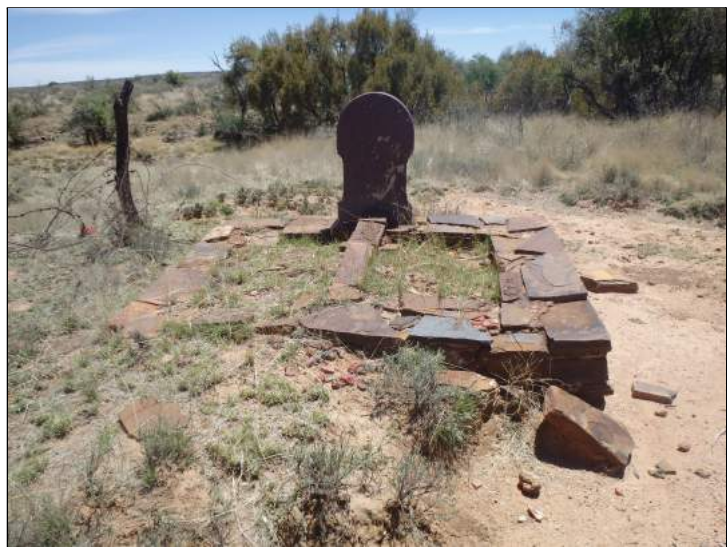
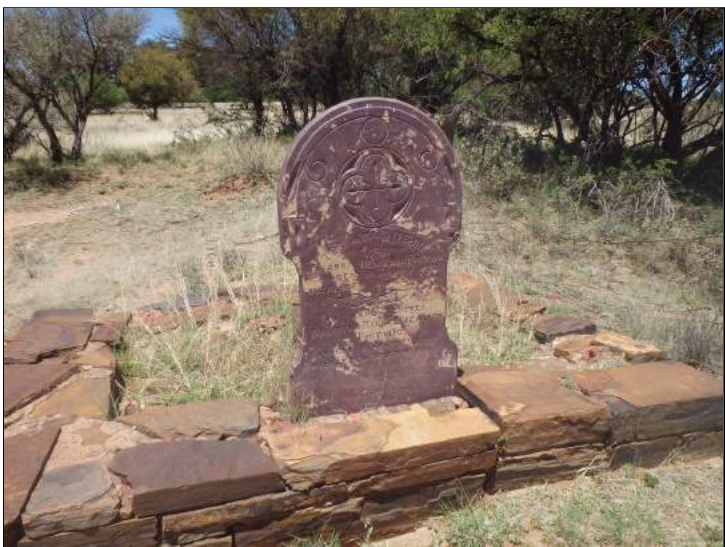
Figure 7.21 Site No. 230

The Springvalley Farm Complex (Site No. 276) and a burial (Site No. 230) are located within the Koraqua PV. In the layout that has been provided these sites are located within the PV area however it is recommended that no impact to

these sites is permitted. A no development buffer of 200m around each site is recommended to ensure that no impact occurs.

2. A minimum no-go development area of 200m must be implemented around Sites 175, 230 and 276 to ensure the conservation of the broader context of these resources (Figure 9.2)
