HERITAGE IMPACT ASSESSMENT

Proposed development of the San Solar PV Facility and Associated Infrastructure, Northern Cape Province

Prepared by CTS Heritage

April 2022

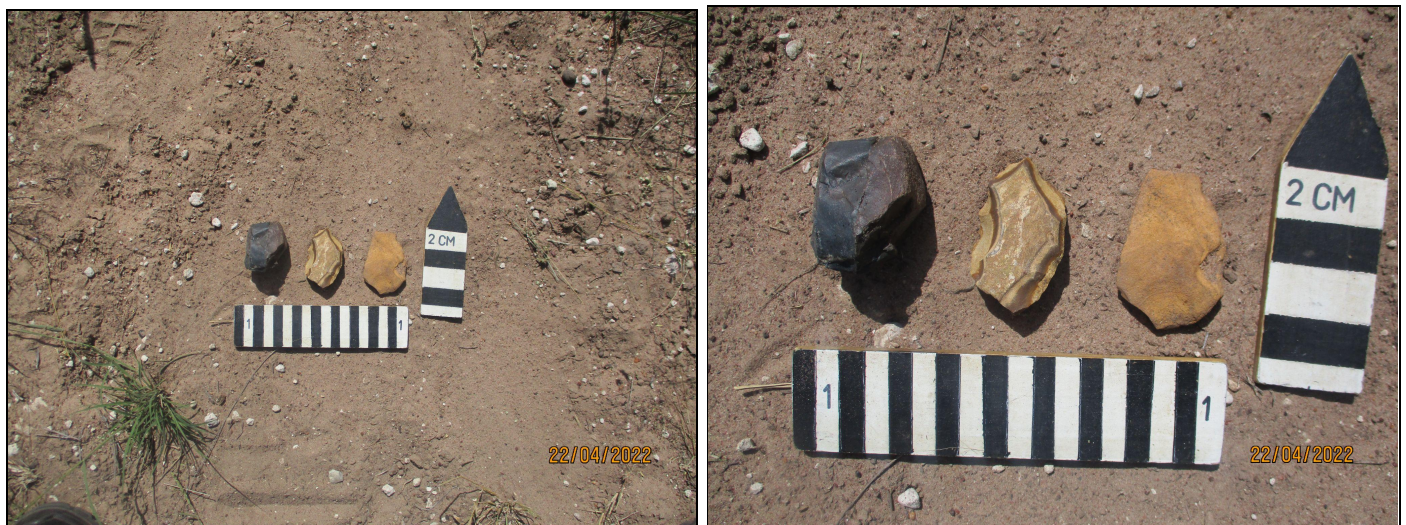
Figure 5a: Observation 004

Point ID & Site #	Photo #	Description	Period	Location	Field rating/ Significance/ Recommended Mitigation	
004	29-31	Type lithic/s	MSA/ Early LSA	27° 34' 04.6" S 22° 57' 04.9" E	Field Rating Iii B Medium significance Resource must be retained where possible where not possible it must be fully investigated and/or mitigated.	
		Raw material				Scraper, core and chunk CCS and BIF
		N in m ² .				3/10m ²
		Context				Scattered
		Additional				Located on edge of wetland area
005	32-36	Type lithic/s	MSA/ Early LSA	27° 34' 02.3" S 22° 57' 08.9" E	Field Rating Iii B Medium significance Resource must be retained where possible where not possible it must be fully investigated and/or mitigated.	
		Raw material				Scraper, chips and chunks CCS and BIF
		N in m ² .				6/10m ²
		Context				Scattered
		Additional				Located on edge of wetland area
006	37-41	Type lithic/s	MSA/ Early LSA	27° 34' 06.3" S 22° 57' 06.1" E	Field Rating Iii B Medium significance Resource must be retained where possible where not possible it must be fully investigated

Stone Age finds
We recommend the following mitigation: The identified wetland should be a no-go zone with a conservation bufferzone around the wetland of not less than 200m. This feature is archaeologically sensitive.
Iron Age/ Agri-pastoralist Early Farming communities finds
No mitigation. Project can proceed.
Historical finds
No mitigation, but developers should take cognisance of the sensitivity of the old ruin for possible future developments. Project can proceed.
Identified graves
No graves identified, located or recorded. Take note of above specialist comments on graves.
Intangible Heritage/ Cultural Landscape
We recommend the following mitigation: A 20m concervation bufferzone should be implemented around the crosses until such time it is removed by either the family or road authorities.
Other
Due to the dense vegetation, we rccommend that an additional Heritage survey should be done after ground clearance, to ensure an accurate heritage survey and recording.

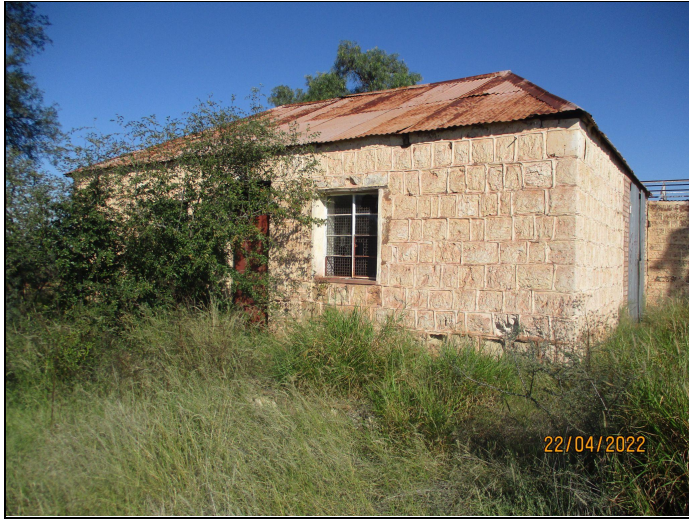
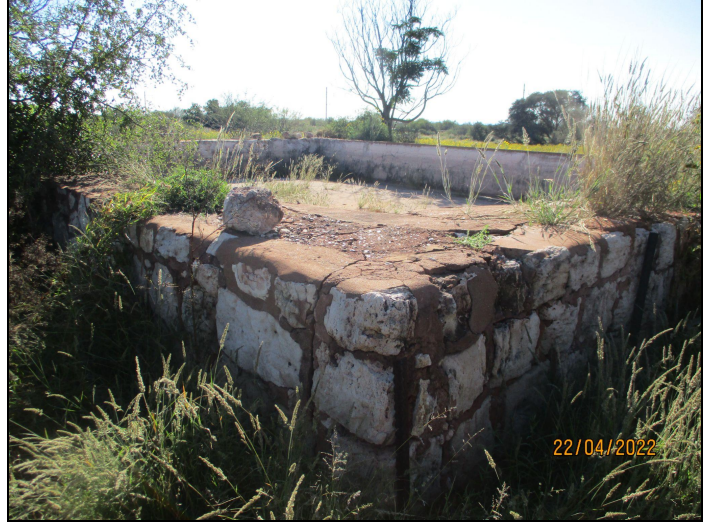
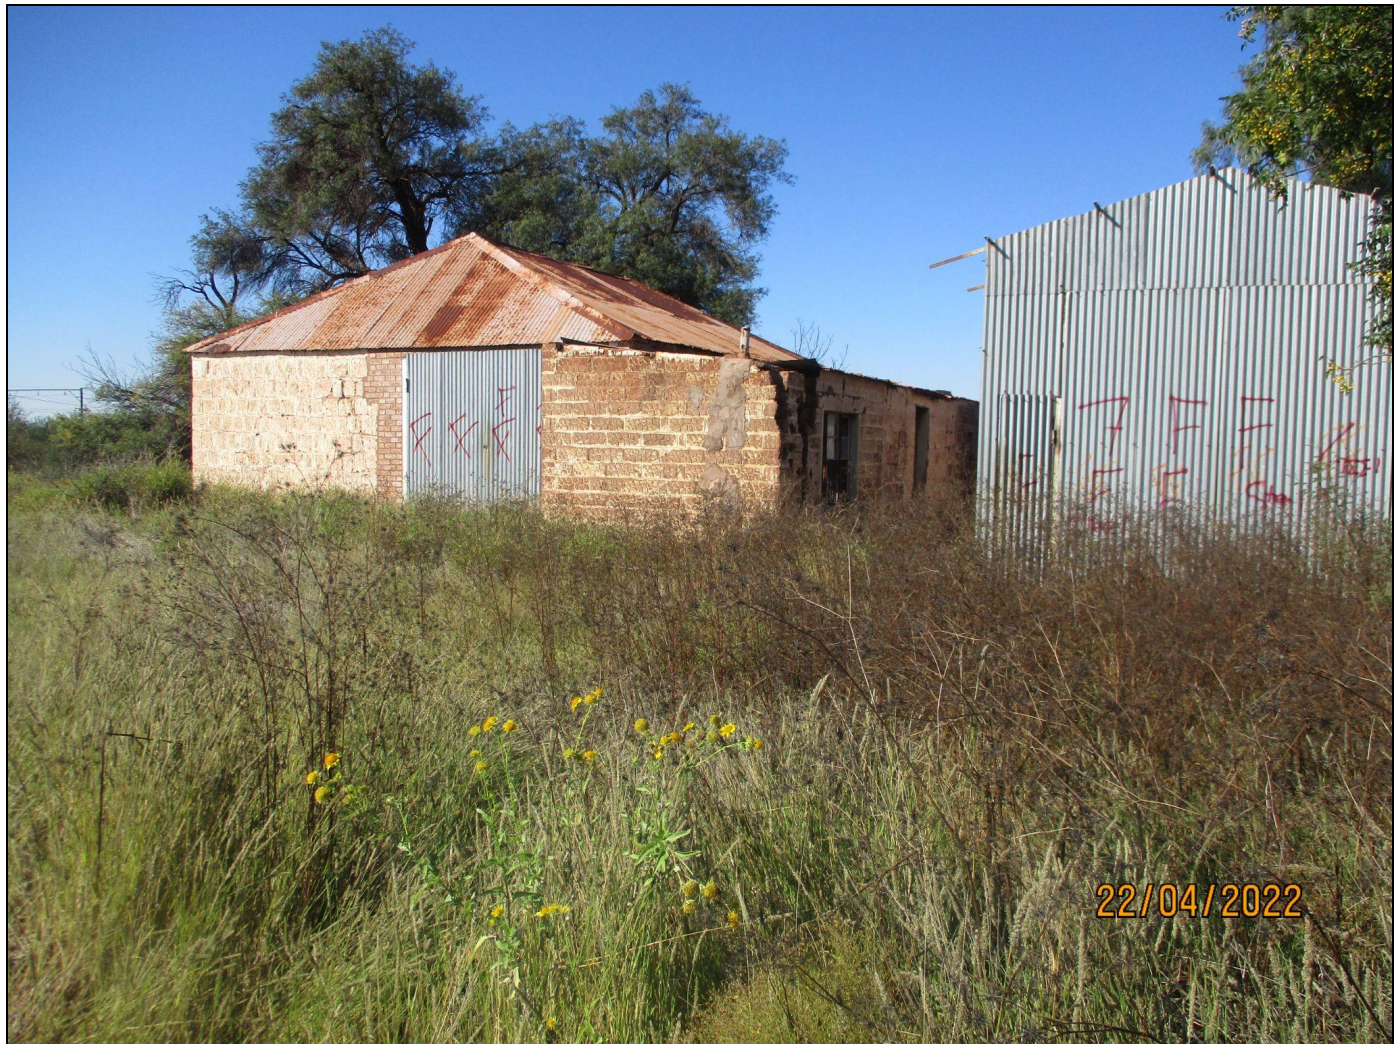
Figure 5d: Observation 002

Way Point ID & Site #	Photo #	Description	Period	Location	Field rating/ Significance/ Recommended Mitigation	
Way-Point 002	18-24	Type of feature	Old building ruin	Modern ca 1950s-1970s	27° 34' 39.10" S 22° 56' 20.40" E	Field Rating III C Low significance. Building outside the development site. No Mitigation Required
		Material	N/A			
		N in m ² .	N/A			
		Context	In context with farming infrastructure and an abandoned railway siding on the eastern side of the railway line bordering the old farm settlement.			
		Additional	Building material mostly vernacular with some modern additions. Karoo cottage style architecture. Building material seems like dolomite blocks.

Additional observations were made (ruined structure and memorial) however these observations were determined to be not conservation-worthy in terms of the definitions of cultural significance included in the NHRA and as such, no further recommendations are made in this regard.

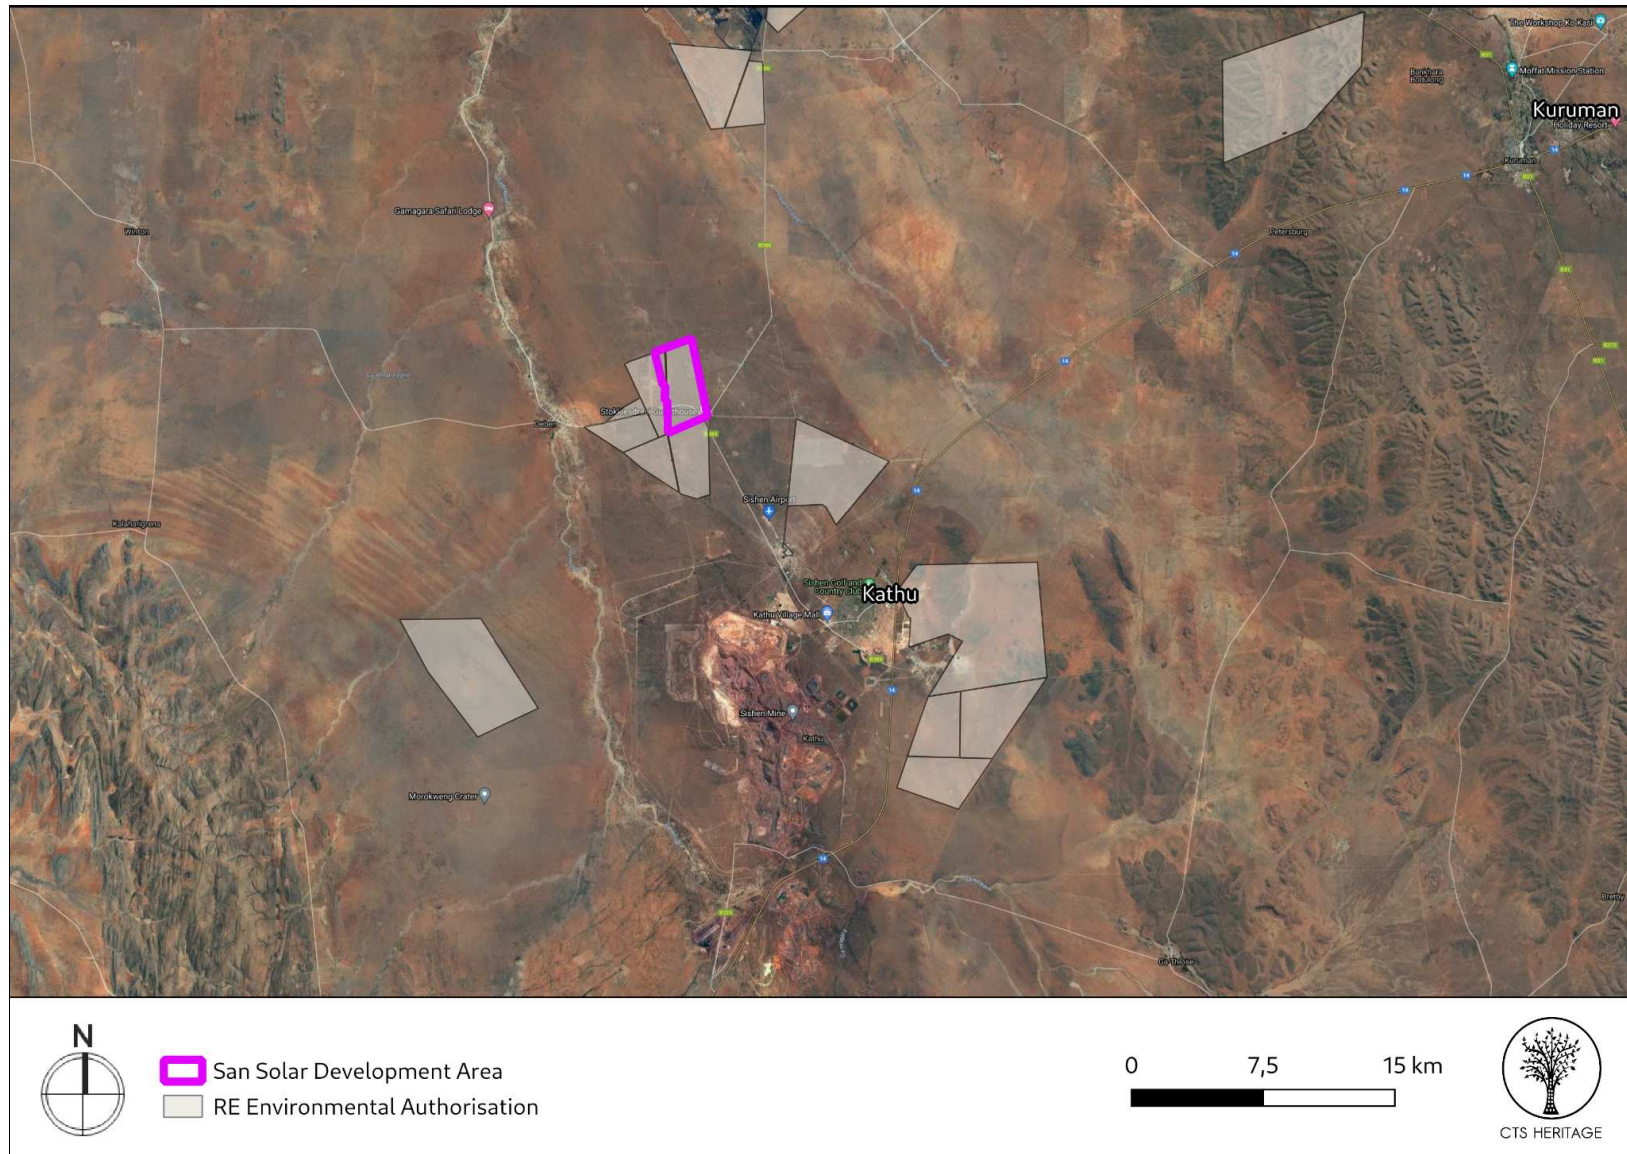
Map 7: Map indicating the location of authorised renewable energy facilities in proximity to the proposed development

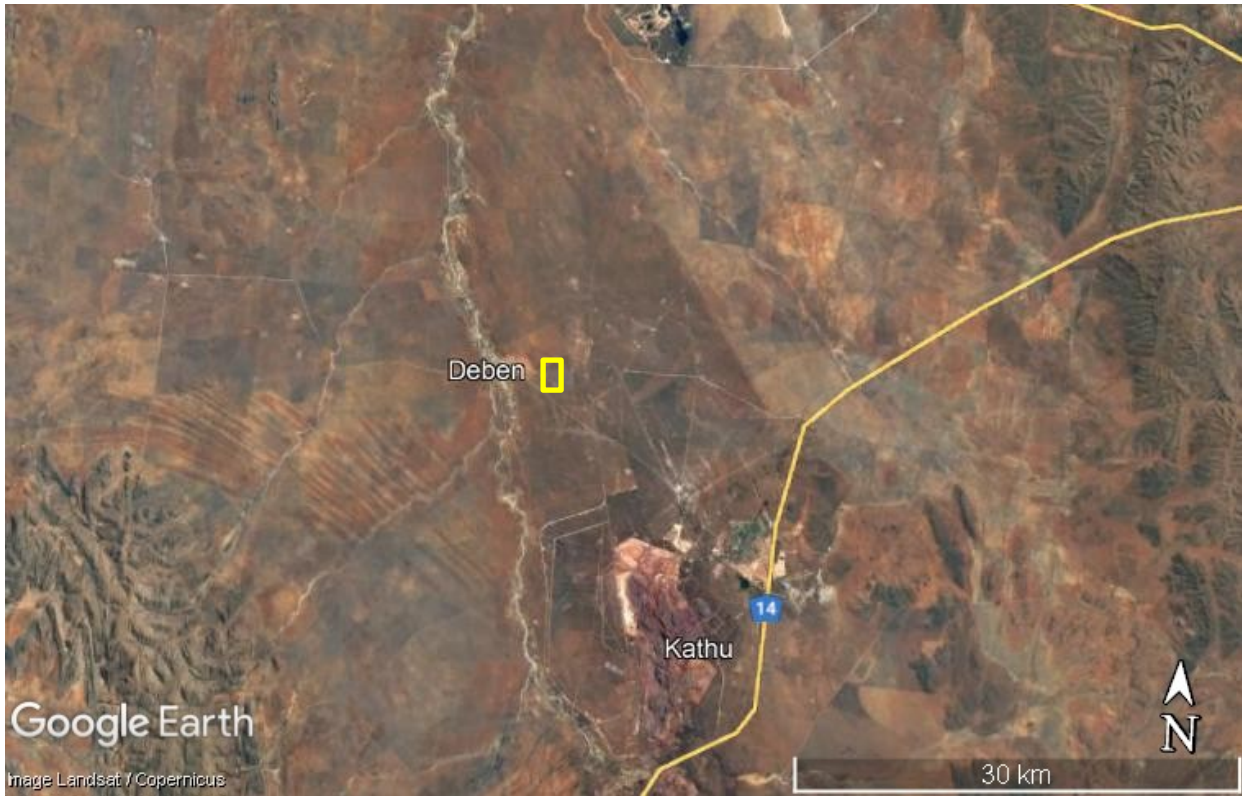
Figure 1: Google Earth map of the proposed development of the San Solar Facility northwest of Kathu with the site shown by the yellow outline.

A Palaeontological Impact Assessment was requested for the proposed development of the San Solar PV Facility near Kathu in the Northern Cape. This is immediately to the east of and existing solar facility. The proposed site is about 10 km northwest of Kathu on the Remainder of Farm Wincanton 472 in the Gamagara Local Municipality, John Taolo Gaetsewe District (Figures 1 and 2).

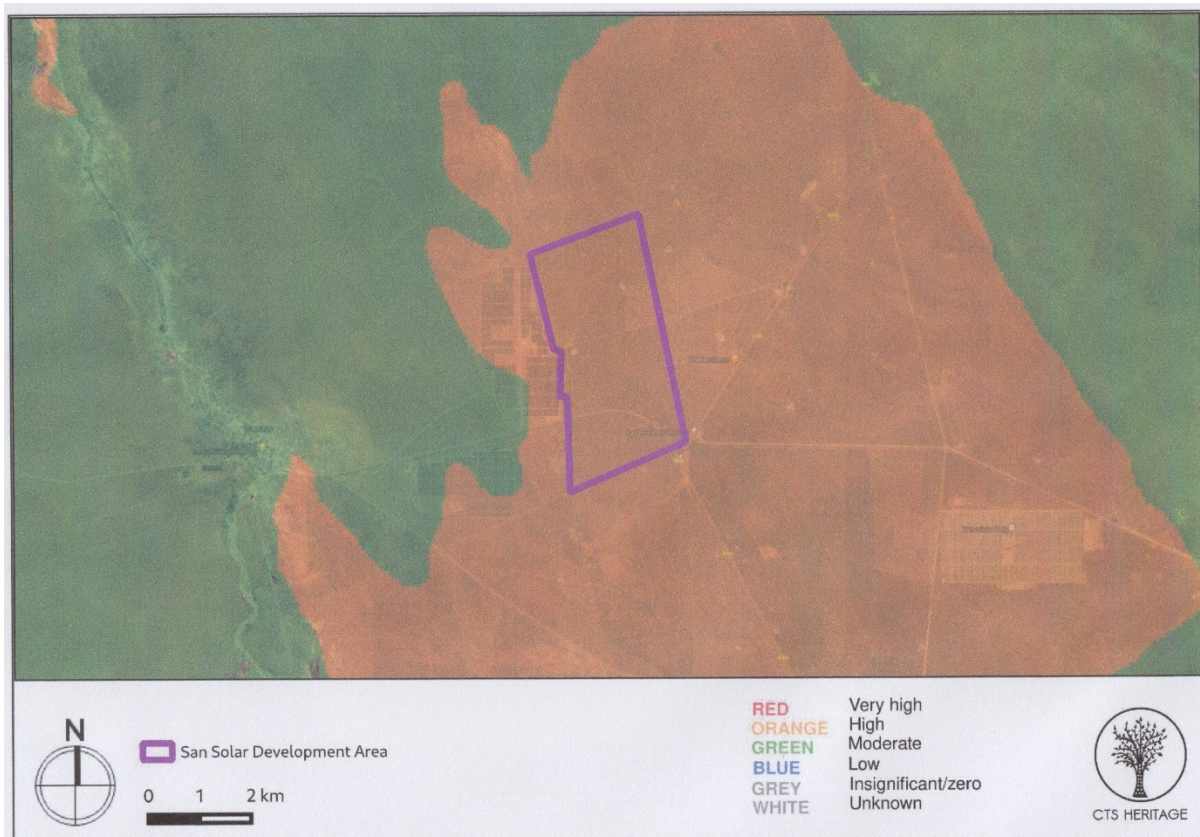
Figure 4: SAHRIS palaeosensitivity map for the site for the proposed San Solar Facility on the Remainder of Farm Wincanton 472 shown within the purple rectangle. Background colours indicate the following degrees of sensitivity: red = very highly sensitive; orange/yellow = high; green = moderate; blue = low; grey = insignificant/zero.

The Tertiary calcretes can trap fossils and artefacts when associated with palaeo-pans or palaeo-springs (Partridge et al., 2006). Where deflation has occurred, for example along the west coast of South Africa, any trapped materials in the different levels can be concentrated in the depo-centre of the pan or dune and thus it can be challenging to interpret the deposit (Felix-Henningsen et al., 2003). A well-known example of a limestone tufa deposit is at the Buxton-Norlim Limeworks about 15m southwest of Taung, on the margin of the Ghaap Plateau. Fauna and the Taung child cranium were excavated from here but it should be noted that the topography of this fossiliferous site is very diverse and includes a now roofless cave complex (Hopley et al., 2013). In contrast, the limestones north of Kathu are generally more or less flat.

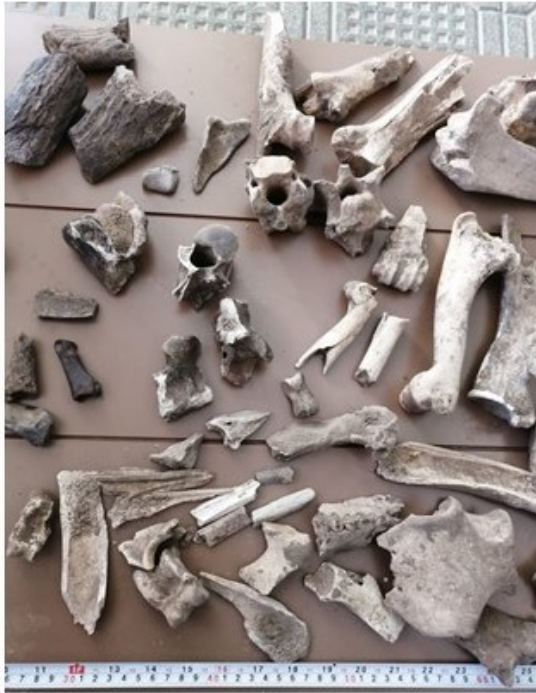
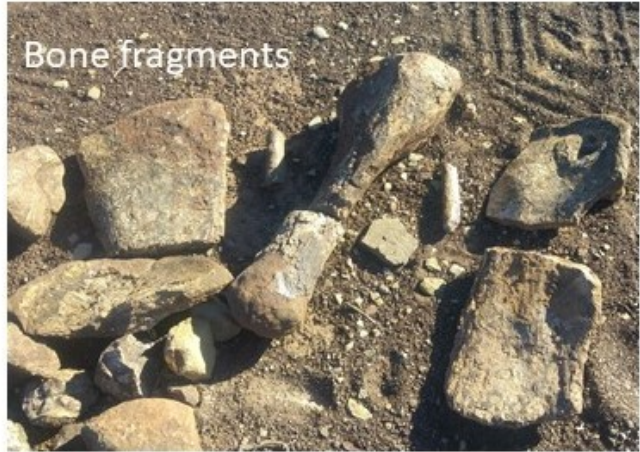
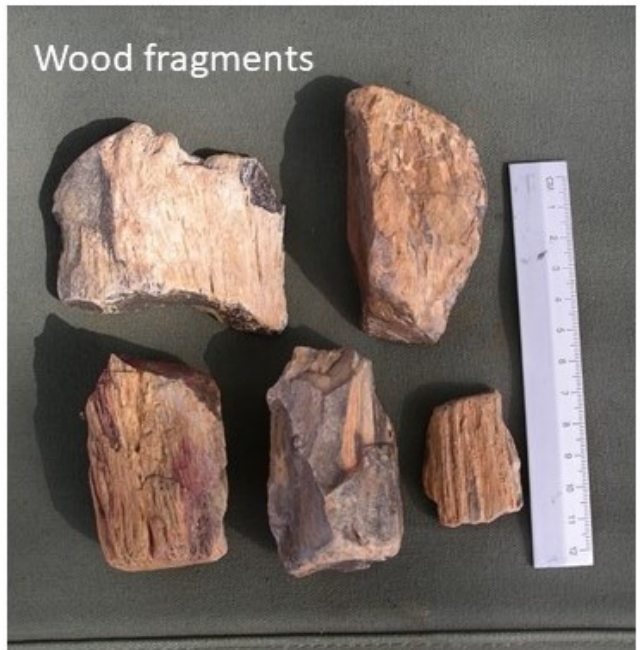
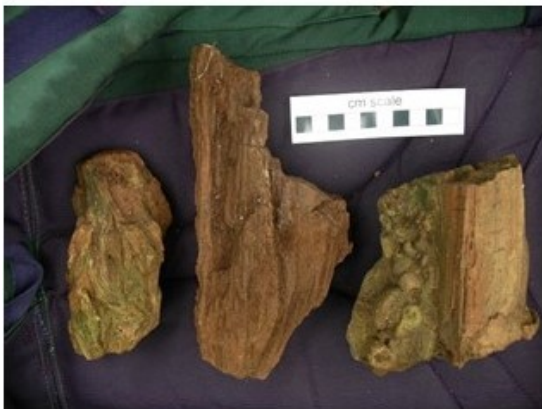
Figure 5: Fragmented and robust fossils from fluvial and pan deposits.
