# ARCHAEOLOGICAL SPECIALIST STUDY

## **Proposed Development of the Vetlaagte infrastructure associated with the authorised PV Facilities near De Aar**

CTS HERITAGE

November 2021

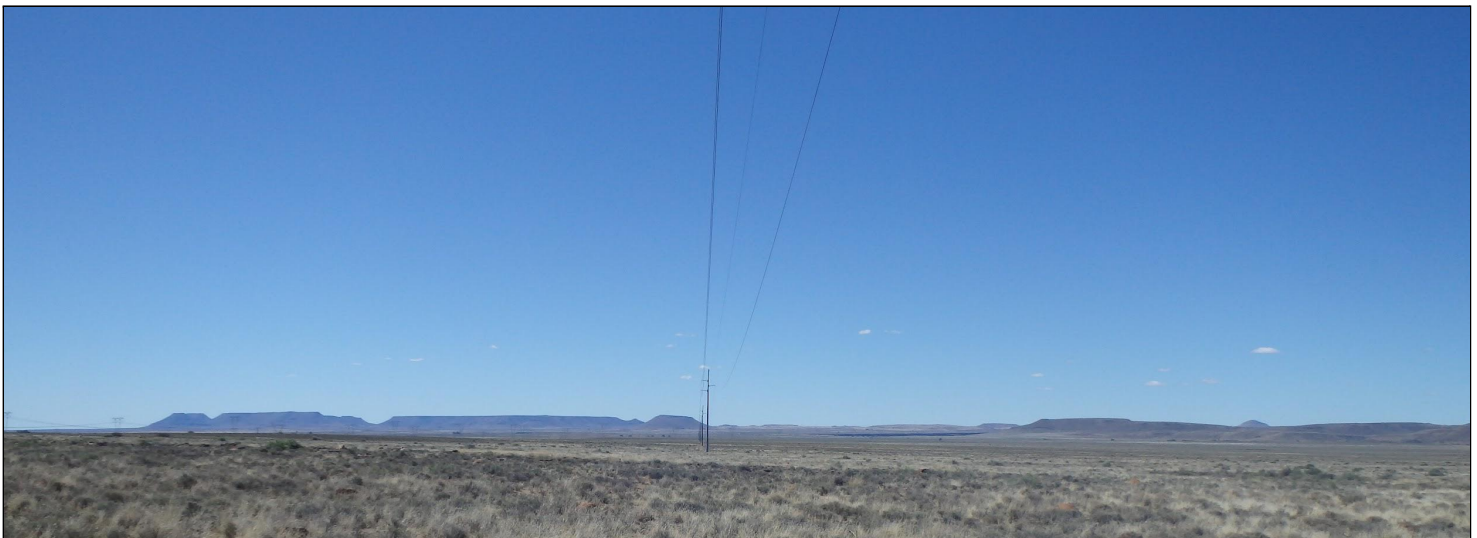
Figure 4.4: Contextual Images with existing electrical infrastructure

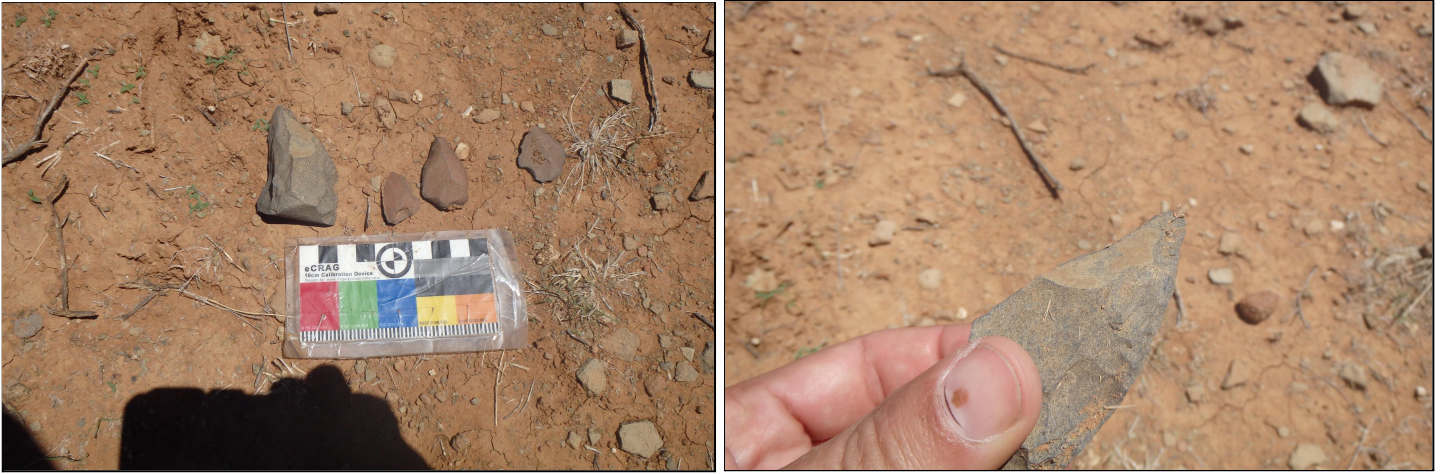
Figure 7.1: Observation Vetlaagte 026

Site No.	Site Name	Description	Density m <sup>2</sup>	Period	Co-ordinates		Grading	Mitigation
026	Vetlaagte 026	Next to old dam wall. Hornfels points and flakes, siltstone flake worth adze wear, possibly scraping	0-5	MSA	-30.68727	24.10714	NCW	NA
027	Vetlaagte 027	Patinated hornfels flake blade with flakes removed from ventral side	0-5	MSA	-30.68745	24.10386	NCW	NA
028	Vetlaagte 028	Small hornfels point with hafted platform retouch	0-5	MSA	-30.68891	24.10134	NCW	NA
029	Vetlaagte 029	Two heavily patinated hornfels flakes near low dolerite outcrop	0-5	MSA	-30.68995	24.10013	NCW	NA
030	Vetlaagte 030	Hornfels flake, heavily weathered	0-5	MSA	-30.69168	24.09962	NCW	NA
031	Vetlaagte 031	Heavily weathered hornfels flakes	0-5	MSA	-30.69228	24.0979	NCW	NA
032	Vetlaagte 032	Hornfels points, flakes, some fresher, others still heavily patinated	5-10	MSA	-30.69075	24.09674	NCW	NA
033	Vetlaagte 033	Hornfels flake with very finely struck secondary scars on dorsal	0-5	MSA	-30.68823	24.09485	NCW	NA

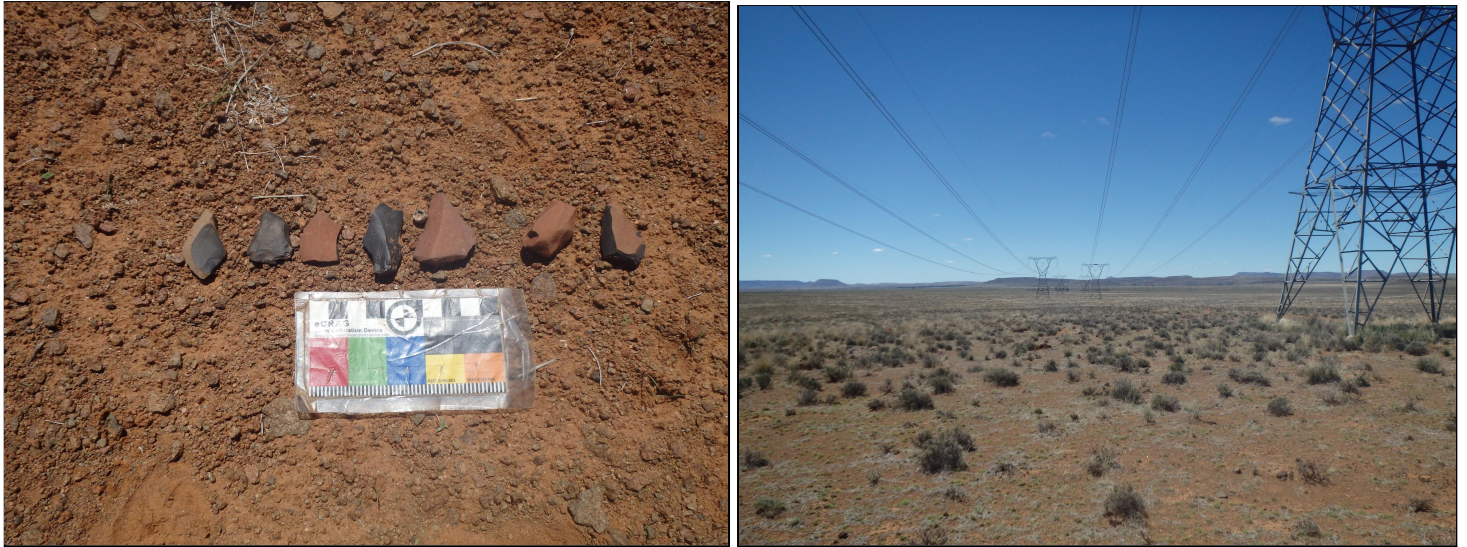
Figure 7.4: Observation Vetlaagte 032 adjacent to existing electrical infrastructure

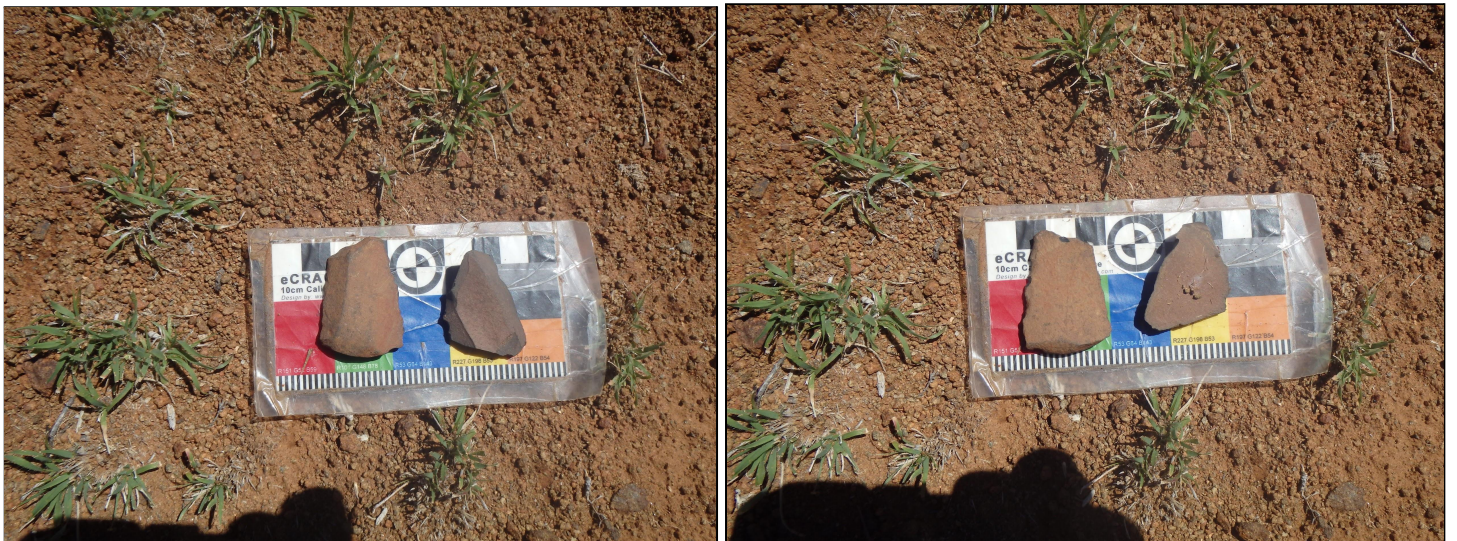
Figure 7.5: Observation Vetlaagte 035

034	Vetlaagte 034	Hornfels chunk, debitage	0-5	LSA	-30.68937	24.09264	NCW	NA
035	Vetlaagte 035	Two hornfels flakes in amongst dolerite outcrops	0-5	MSA	-30.68906	24.09129	NCW	NA
036	Vetlaagte 036	Hornfels microlith	0-5	LSA	-30.69	24.08837	NCW	NA
037	Vetlaagte 037	Hornfels flakes, segment	0-5	MSA	-30.69021	24.09002	NCW	NA
038	Vetlaagte 038	Hornfels flake	0-5	MSA	-30.69028	24.09267	NCW	NA
039	Vetlaagte 039	Hornfels flakes, one retouched all around, triangular point	0-5	MSA	-30.69163	24.09172	NCW	NA
040	Vetlaagte 040	Hornfels flakes	0-5	LSA	-30.69188	24.08705	NCW	NA
041	Vetlaagte 041	Hornfels flake, prepared platform	0-5	MSA	-30.69166	24.08503	NCW	NA
042	Vetlaagte 042	Heavily weathered hornfels flakes	0-5	MSA	-30.68811	24.08625	NCW	NA
043	Vetlaagte 043	Hornfels flake	0-5	MSA	-30.68584	24.08541	NCW	NA
044	Vetlaagte 044	Hornfels flakes with views onto de Aar (west) and already built solar farm (north)	0-5	MSA	-30.68473	24.08571	NCW	NA

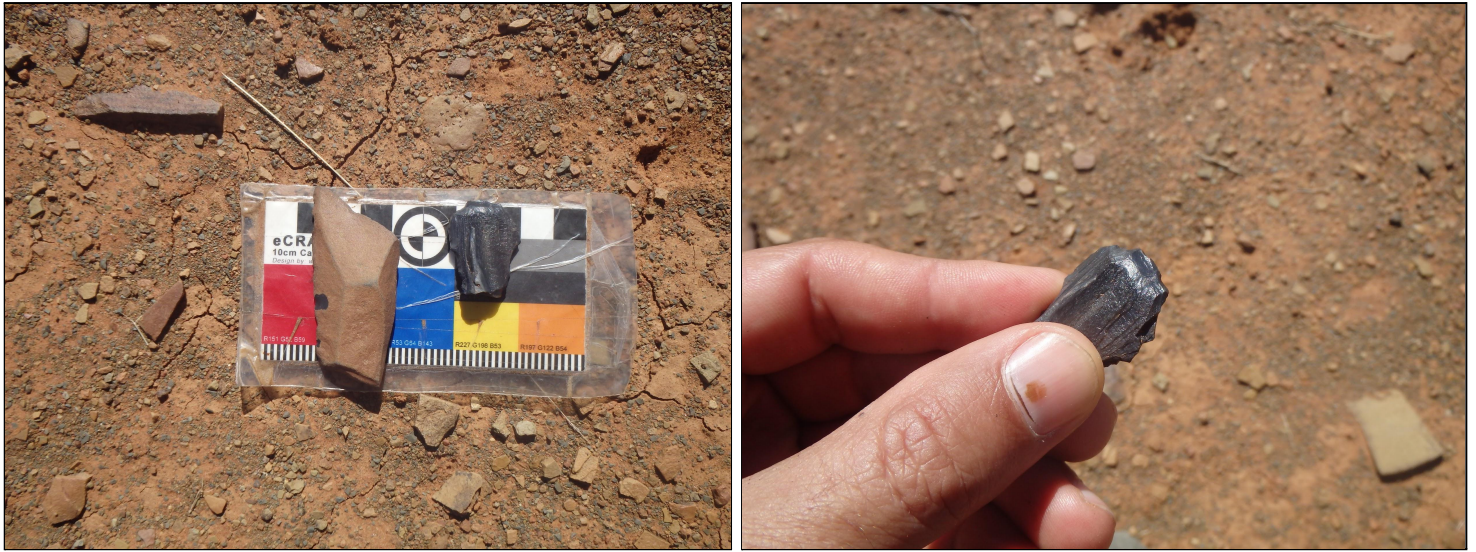
Figure 7.7: Observation Vetlaagte 054

045	Vetlaagte 045	Hornfels flakes, point	0-5	MSA	-30.68571	24.0871	NCW	NA
046	Vetlaagte 046	Hornfels core	0-5	MSA	-30.68706	24.08877	NCW	NA
047	Vetlaagte 047	Hornfels flakes in jeep track	0-5	MSA	-30.68724	24.09022	NCW	NA
048	Vetlaagte 048	Heavily weathered hornfels flakes	0-5	MSA	-30.68164	24.09155	NCW	NA
049	Vetlaagte 049	Heavily weathered hornfels flakes	0-5	MSA	-30.67917	24.09155	NCW	NA
050	Vetlaagte 050	Hornfels retouched flake blade	0-5	MSA	-30.67774	24.09149	NCW	NA
051	Vetlaagte 051	Hornfels flake	0-5	MSA	-30.67396	24.09136	NCW	NA
052	Vetlaagte 052	Hornfels flakes	0-5	LSA	-30.66739	24.09051	NCW	NA
053	Vetlaagte 053	Unifacially retouched hornfels flake on dorsal surface	0-5	MSA	-30.66513	24.09031	NCW	NA
054	Vetlaagte 054	Ccs flake edge retouched end scraper, hornfels blade lateral retouch	0-5	MSA, LSA	-30.66287	24.09025	NCW	NA
055	Vetlaagte 055	Hornfels flakes, one blade	0-5	MSA	-30.65858	24.08986	NCW	NA

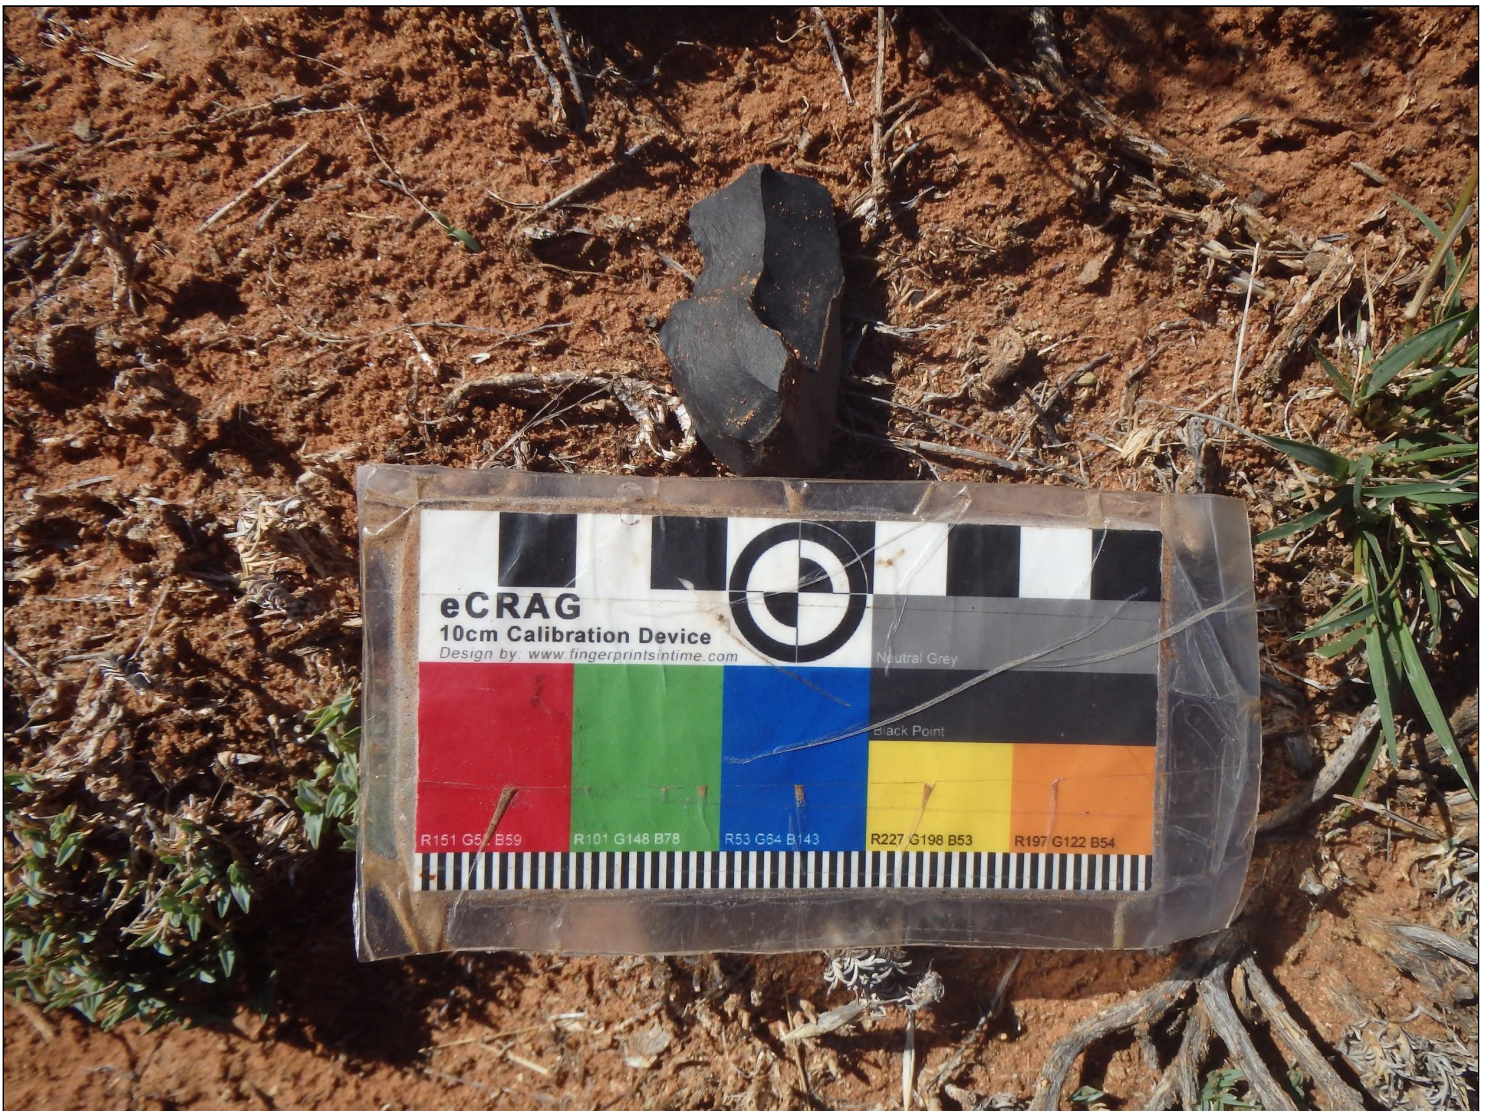
Figure 7.8: Observation Vetlaagte 058

056	Vetlaagte 056	Hornfels flake, triangular, notched	0-5	MSA	-30.68495	24.11804	NCW	NA
057	Vetlaagte 057	Hornfels bladelet and flake	0-5	LSA	-30.68727	24.11874	NCW	NA
058	Vetlaagte 058	Hornfels core flake	0-5	LSA	-30.68672	24.12147	NCW	NA
