**PROPOSED CALEDON SEWER PIPELINE PROJECT,
COMPENSATION, KWADUKUZA MUNICIPALITY,
KWAZULU-NATAL**

Phase 1 Heritage Impact Assessment

December 2021

AUTHOR: JLB Consulting

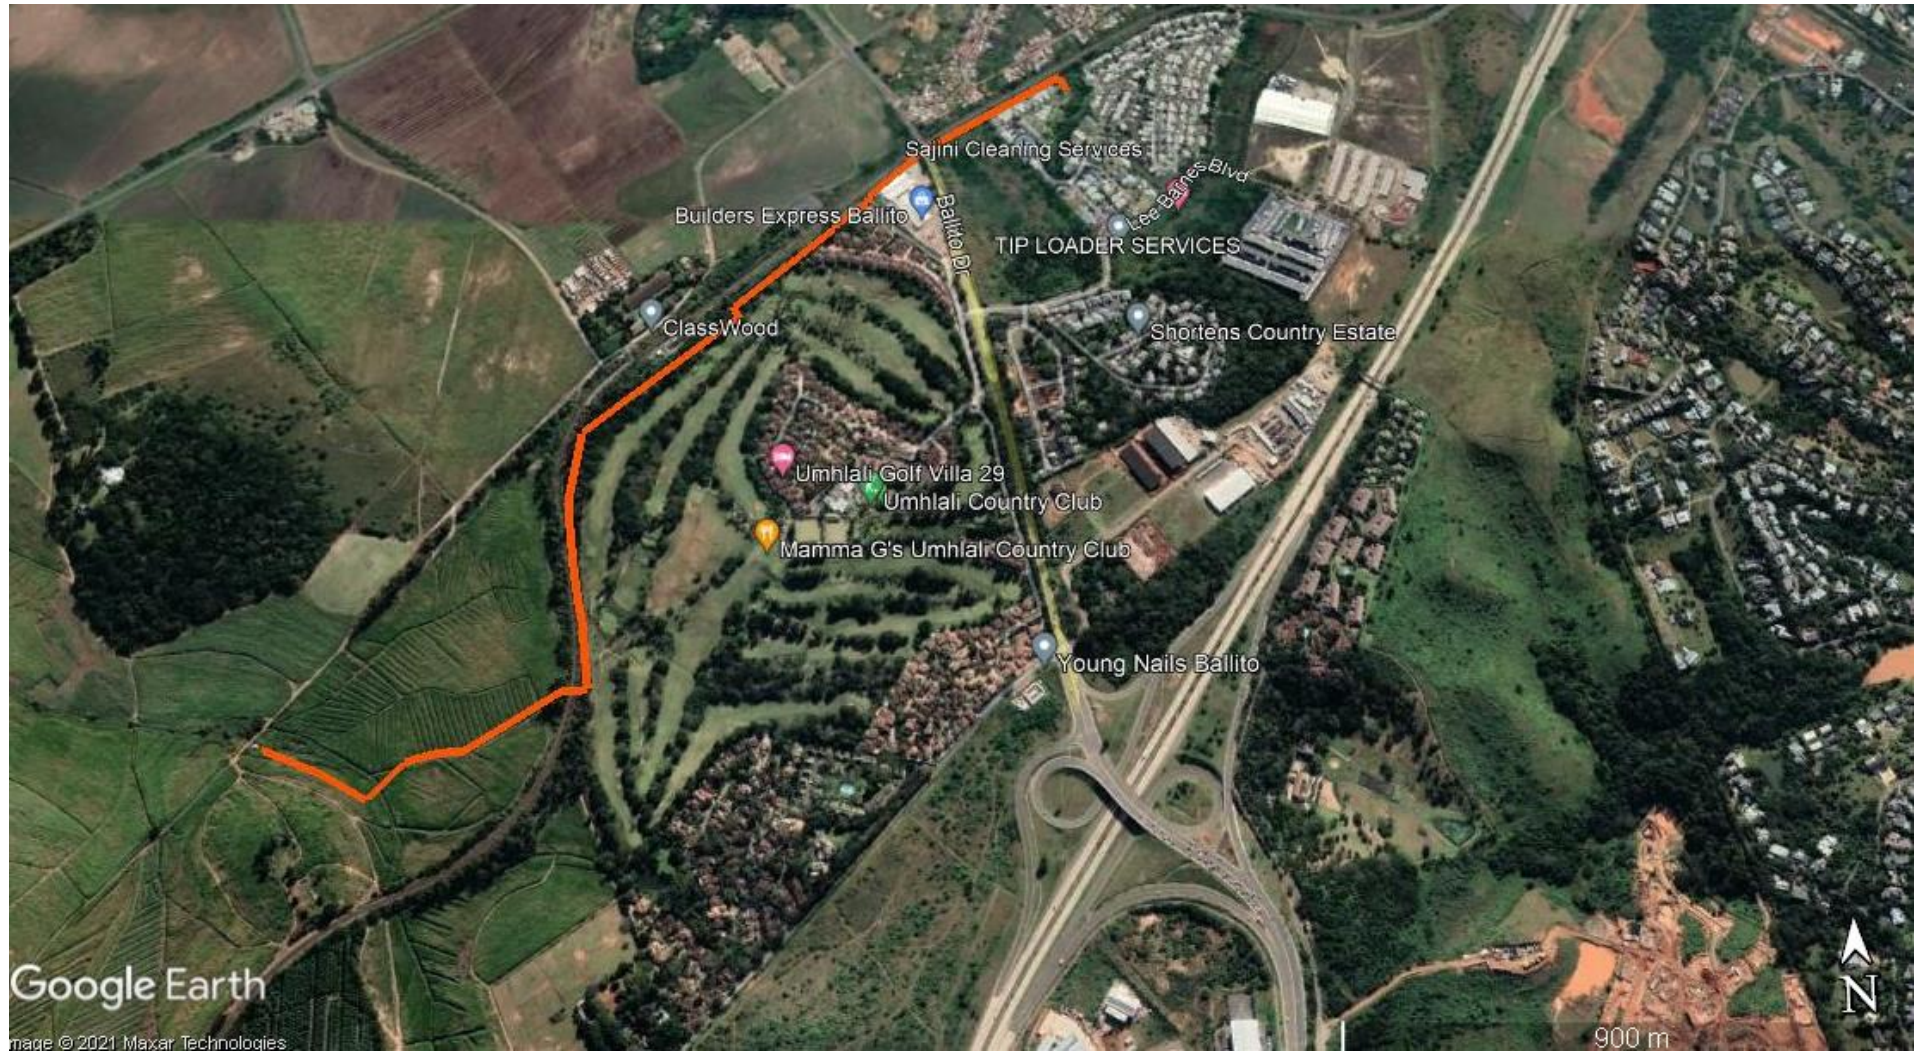
The project area is located west of the N2 highway and a large section runs along / parallel to the north-western boundary of the uMhlali Country Club in Ballito (**Figure 1**) The pipeline is located between the Caledon Residential Estate in the north and the existing Compensation pump station further south.

Figure 1: Project location with pipeline route indicated in orange

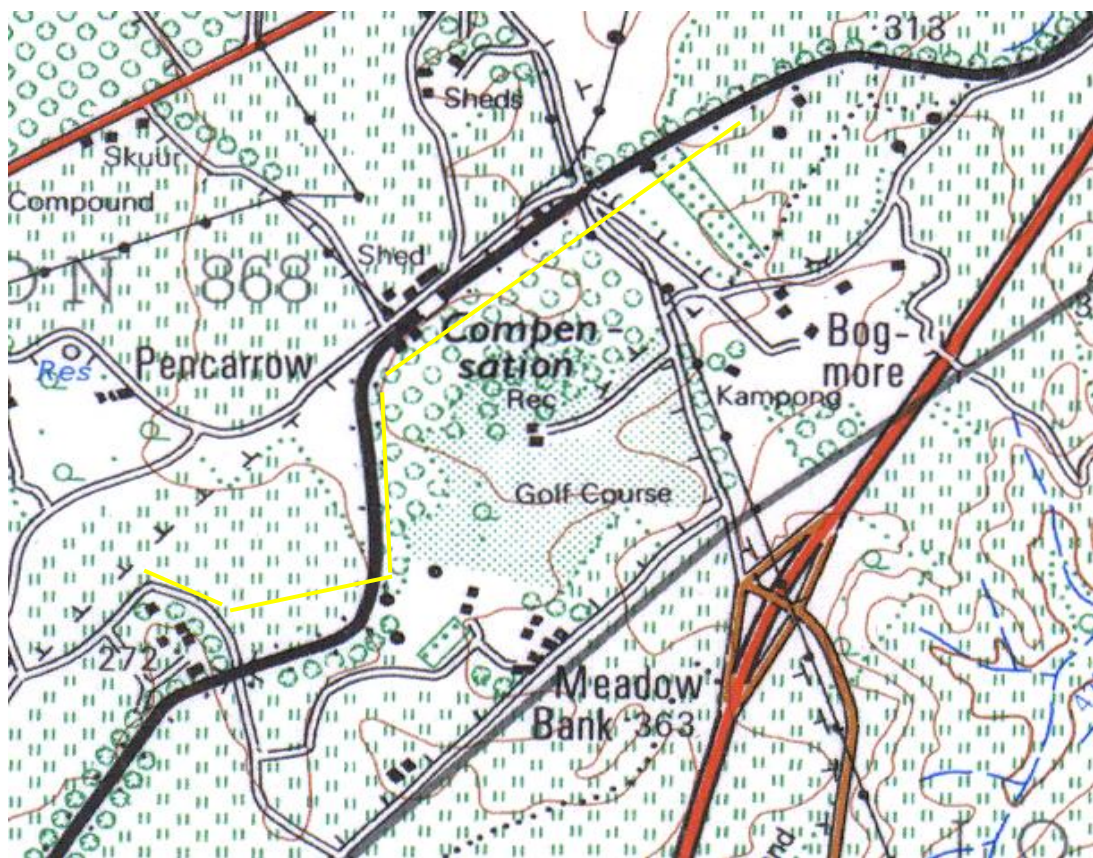
In the 1969 topographical map, the homesteads mentioned above have disappeared and have been replaced with cultivated land. A golf course, the uMhlali Country Club which was established in 1961, is visible as well as the N2 highway.

Figure 3: 1969 topographic map with pipeline indicated in yellow

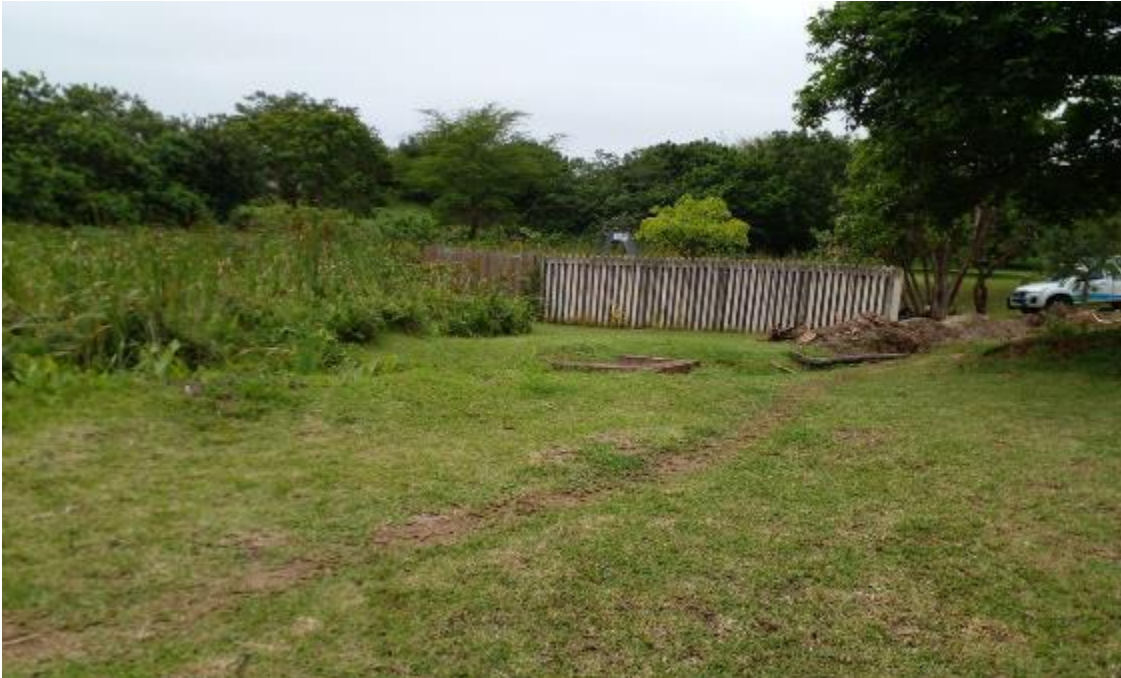
The inspection started at the Caledon Estate pump station. The area surrounding the pump station is manicured as it is located within a residential estate. The proposed sewer pipeline will exit the pump station from its western side and then turn southwards once outside the Estate. This section of pipeline is located between the Estate boundary fence and a railway line hence the area is disturbed and overgrown with vegetation. No heritage sites were found here.

Figure 4: Area between fenced pump station and boundary of Caledon Estate

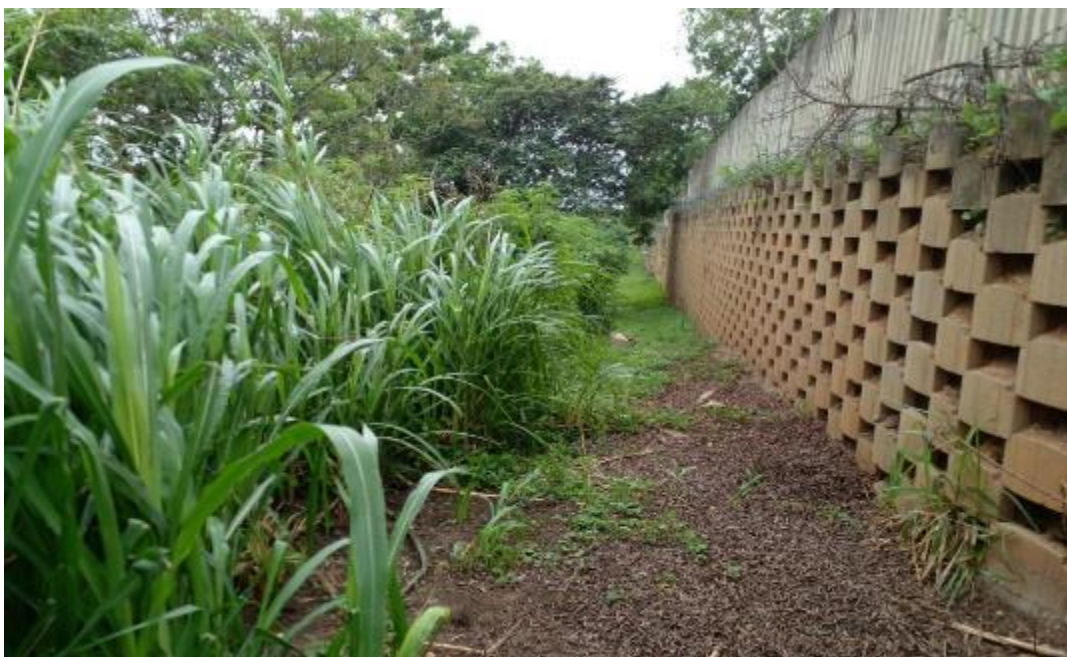
Figure 5: Pipeline route west of Estate boundary wall

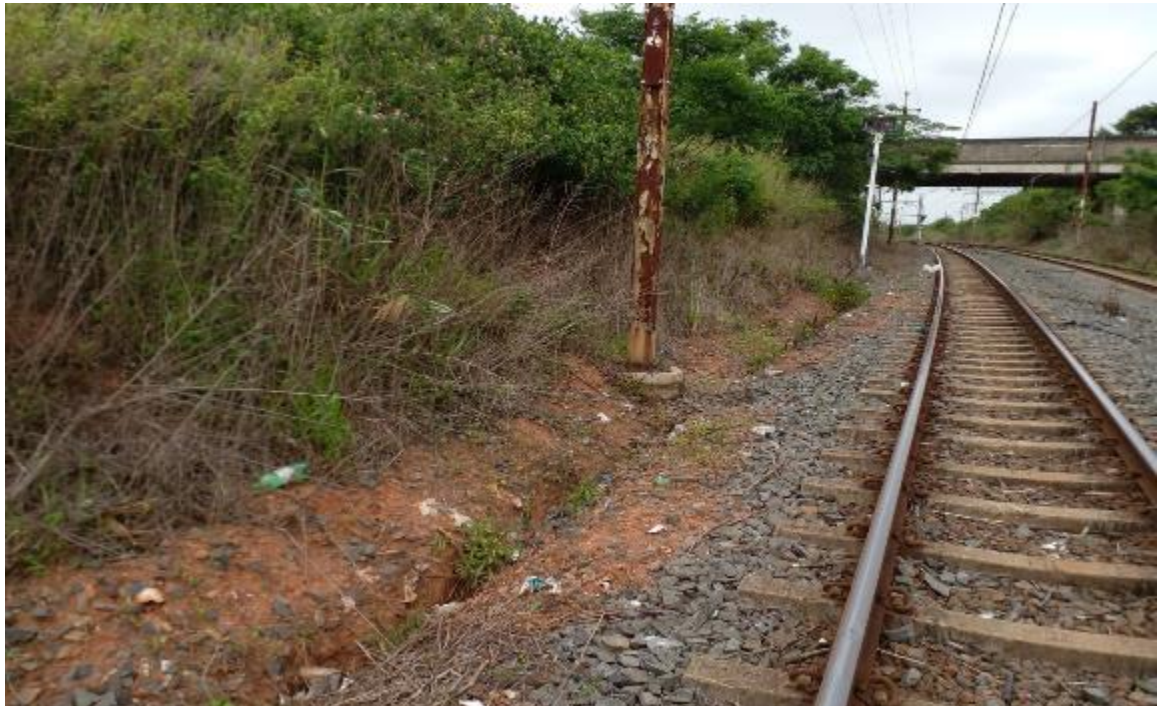
The route runs alongside and immediately east of the railway line and is located between the railway line and some buildings including the Builder's Express. No heritage sites were found along this section of the pipeline route.

Figure 6: Pipeline route is situated close to railway line

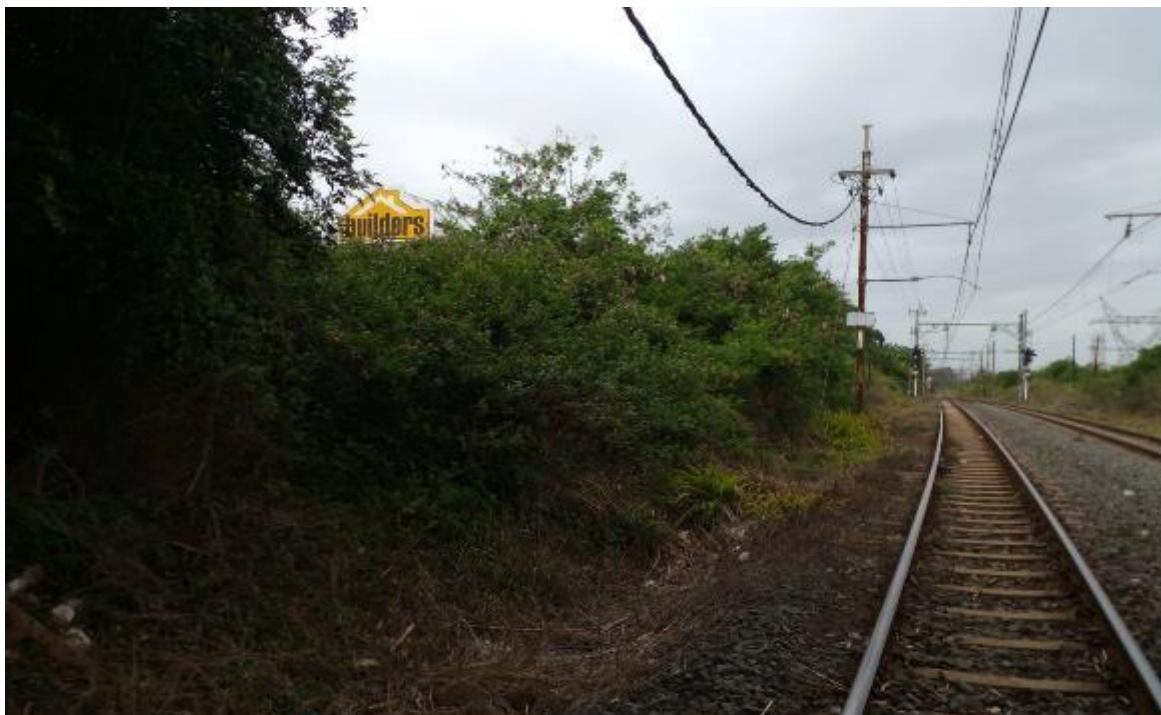
Figure 7: Pipeline route located between railway line and Builders Express

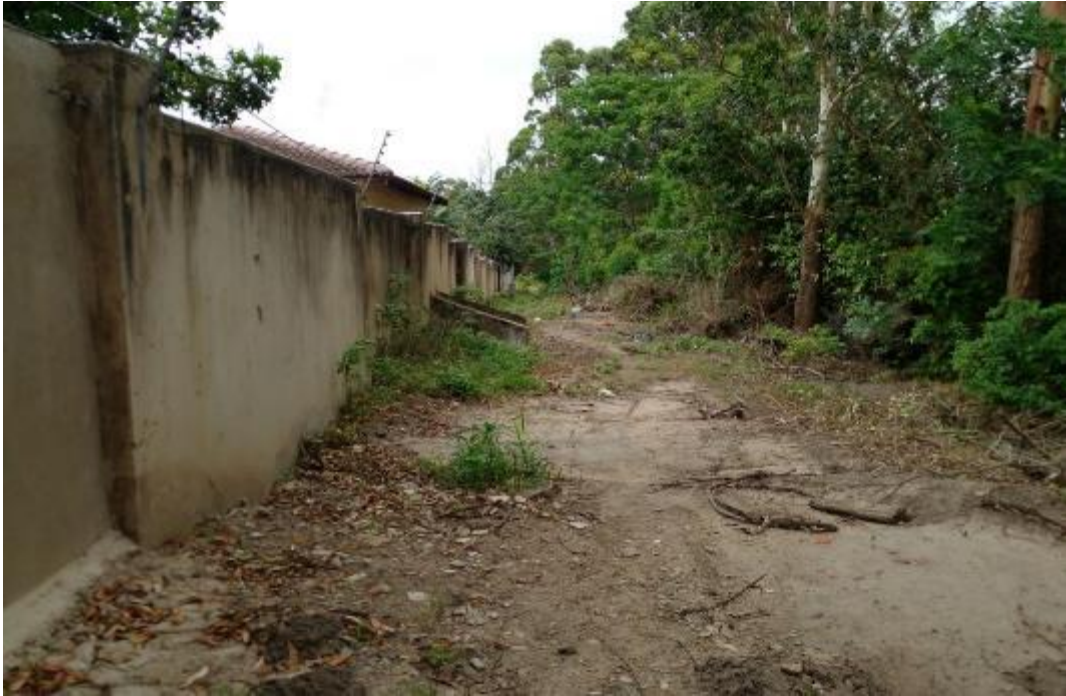
cross the railway line. The area between the Country Club and railway line is disturbed by an existing road and previous building activity. The area is also overgrown with vegetation and there is existing sewer infrastructure in the area with several manholes and a visible pipeline. The pipeline is located just over 20m east of the Compensation Railway Station.

Figure 8: Boundary wall of Country Club and adjacent area

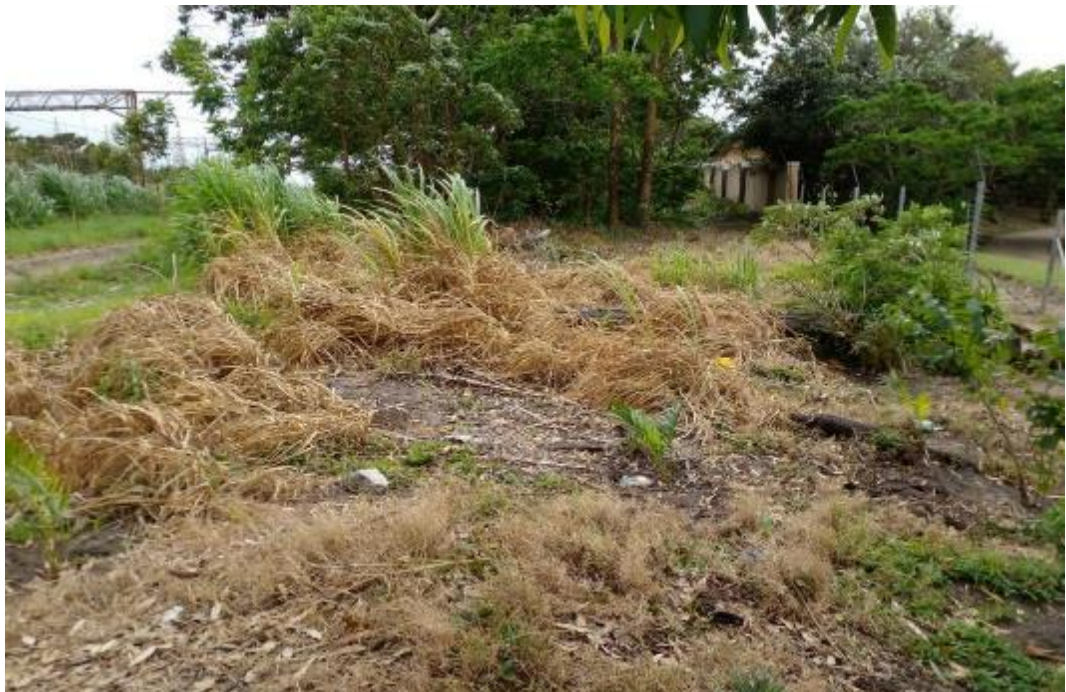
Figure 9: Project area between Country Club and railway line

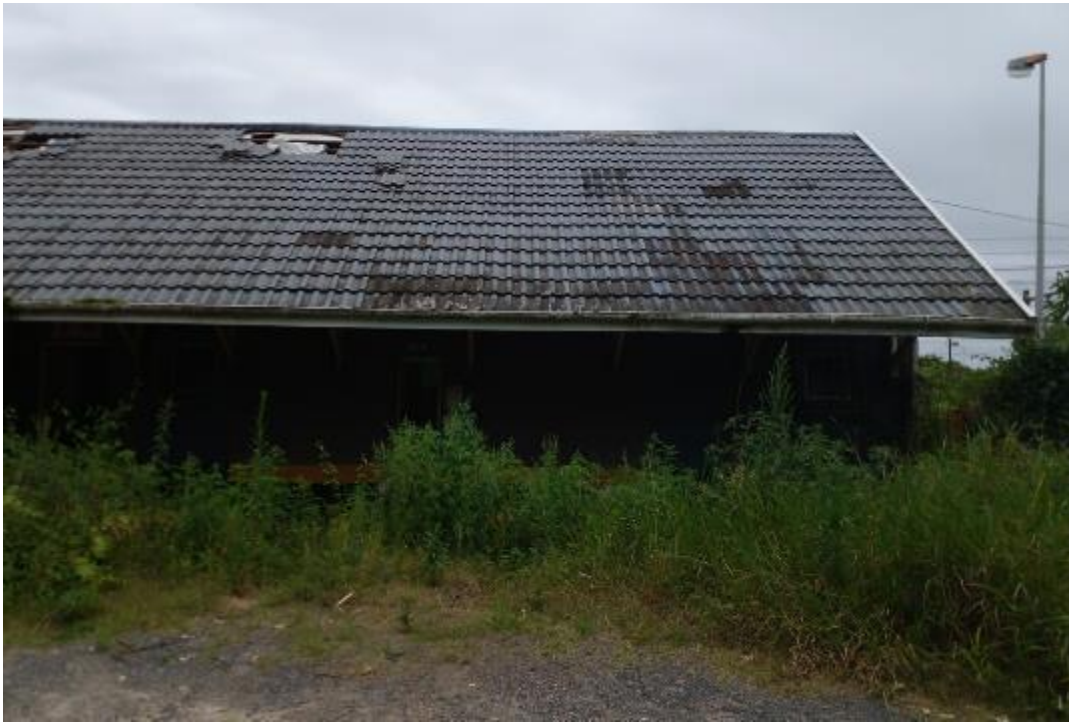
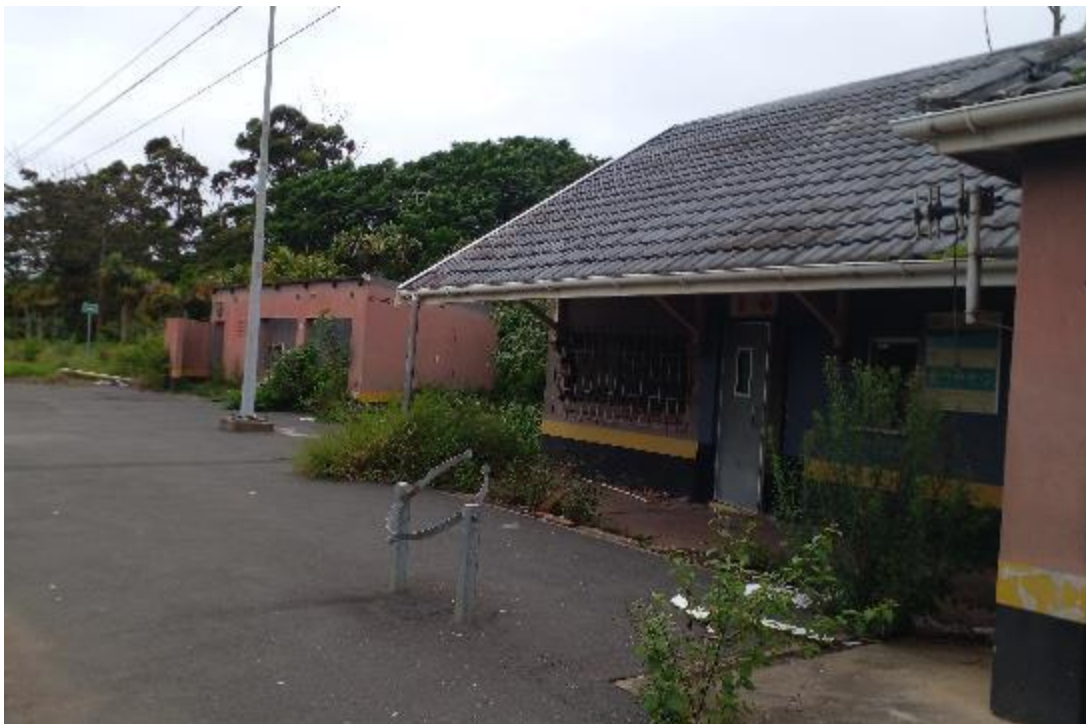
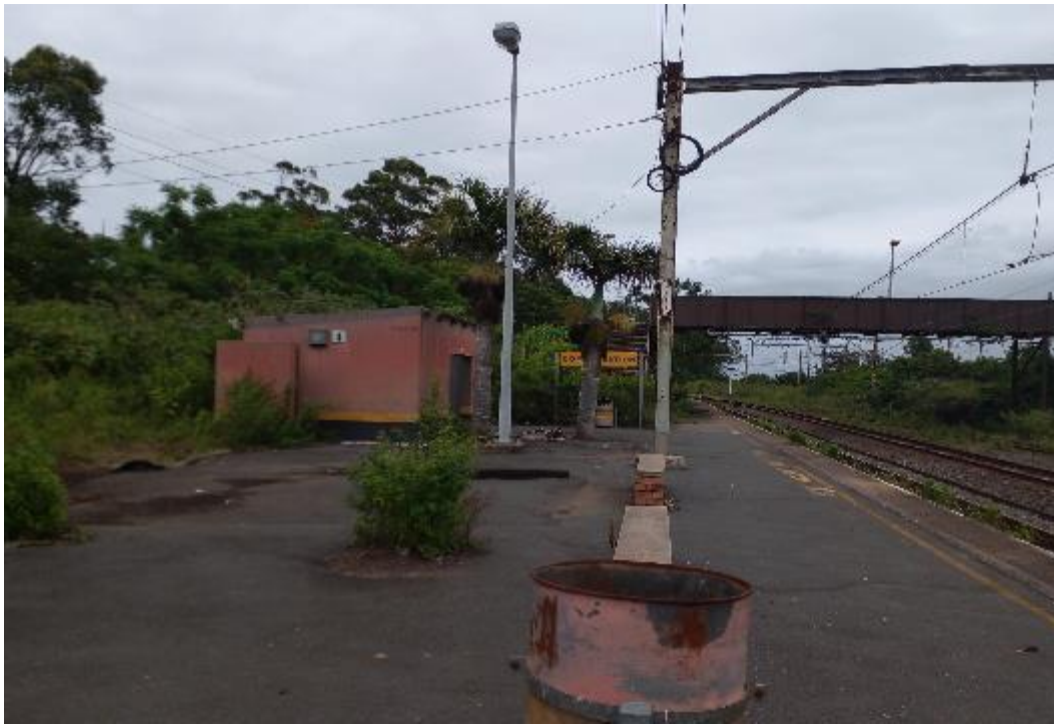
The railway station and associated buildings appear in the 1942 topographic map. Due to their age, they are protected by section 37 (1)(a) of the KwaZulu-Natal Amafa and Research Institute Act, 2018, which refers to the protection of structures that are or that may reasonably be expected to be older than 60 years. The railway station is no longer in use and the buildings are abandoned.

Figure 10: External view of section of railway station

Figure 11: View of buildings and platform

Figure 12: Railway line, platform and associated building

During the site inspection, structures were found that are protected by section 37 (1)(a) of the KwaZulu-Natal Amafa and Research Institute Act, 2018, which refers to the protection of structures that are or that may reasonably be expected to be older than 60 years. The Compensation railway station and associated buildings are protected by this section; however, the buildings are abandoned and not in a good condition hence the low heritage significance ascribed to them. The installation of the pipeline should not impact the structures and they should be left *in-situ*.

However, if the structures are to be impacted, then application must be made to the Institute in terms of the process described in section 3 of the draft KwaZulu-Natal & Research Institute Regulations, 2021 or section 2 of the KwaZulu-Natal Heritage Regulations 2012 if the 2021 regulations have not been officially promulgated by the time an application is made. This section refers to an application to the Institute for the demolition, alteration or addition to a structure which is, or which may reasonably be expected to be older than 60 years.

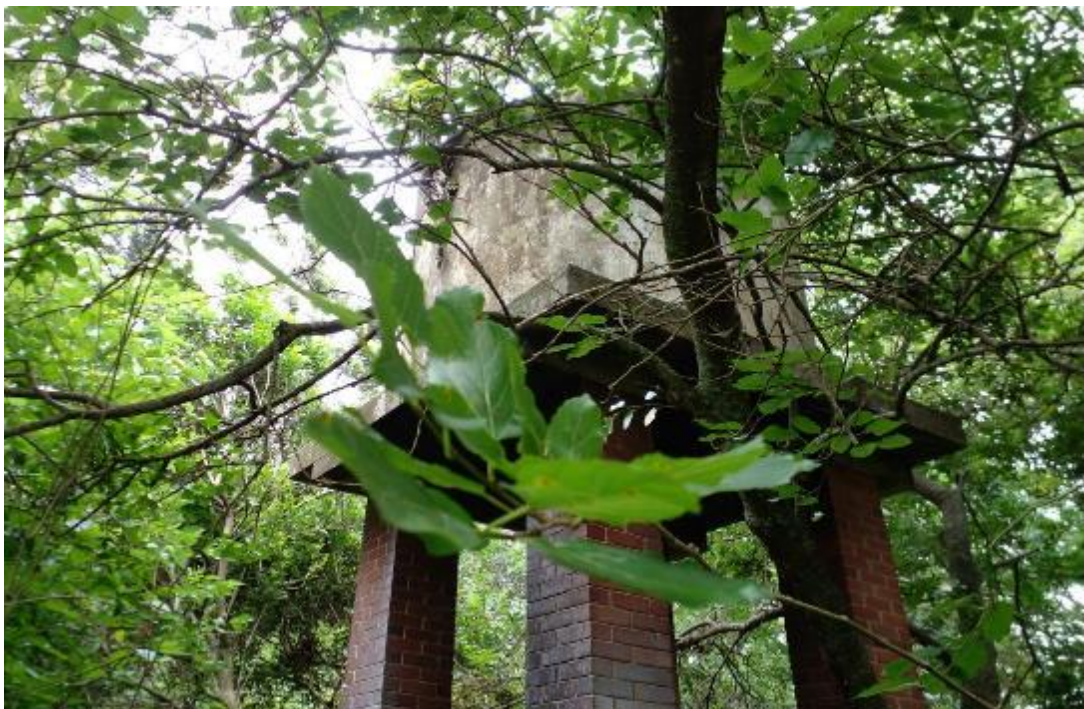
During the inspection a water tank on a platform was discovered further south of the railway station. It does not appear to be used any longer and its age could not be determined.

Figure 13: Elevated water tank on platform

The age of the elevated water tower could not be determined. It is situated very close to the proposed pipeline and could therefore be impacted. A built heritage specialist will need to be consulted if this structure is to be demolished, altered or damaged by the installation of the pipeline. It is recommended that the structure be left *in-situ* and be cordoned off with danger tape to avoid damage by the activities associated with the installation of the pipeline.

However, if the structure is to be impacted in any way and it is determined that the structure is older than 60 years, then application must be made to the Institute in terms of the process described in section 3 of the draft KwaZulu-Natal & Research Institute Regulations, 2021 or section 2 of the KwaZulu-Natal Heritage Regulations 2012 if the 2021 regulations have not been officially promulgated by the time an application is made.

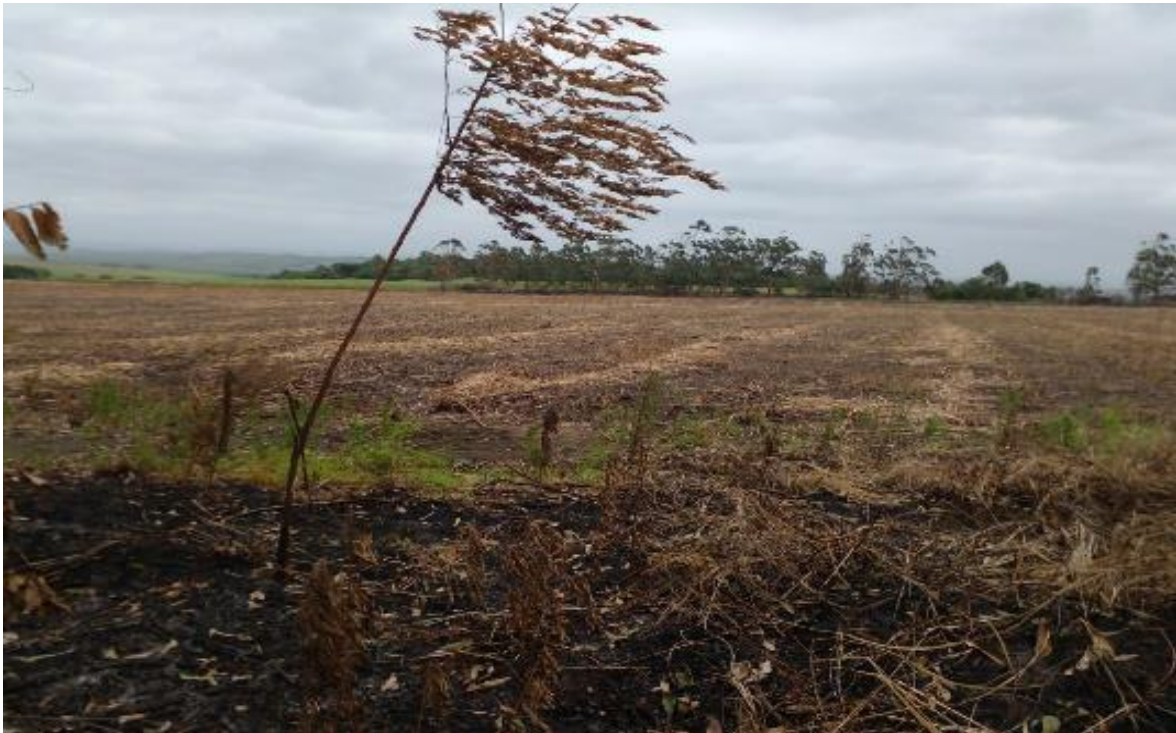
The proposed pipeline route west of the railway line goes through sugar cane fields and alongside a small watercourse before it reaches the Compensation pump station. Manholes are evidence of existing infrastructure along the pipeline route. The sugar cane had recently been cut hence visibility was good. No heritage sites were found during the site inspection.

Figure 14: Project area west of railway line

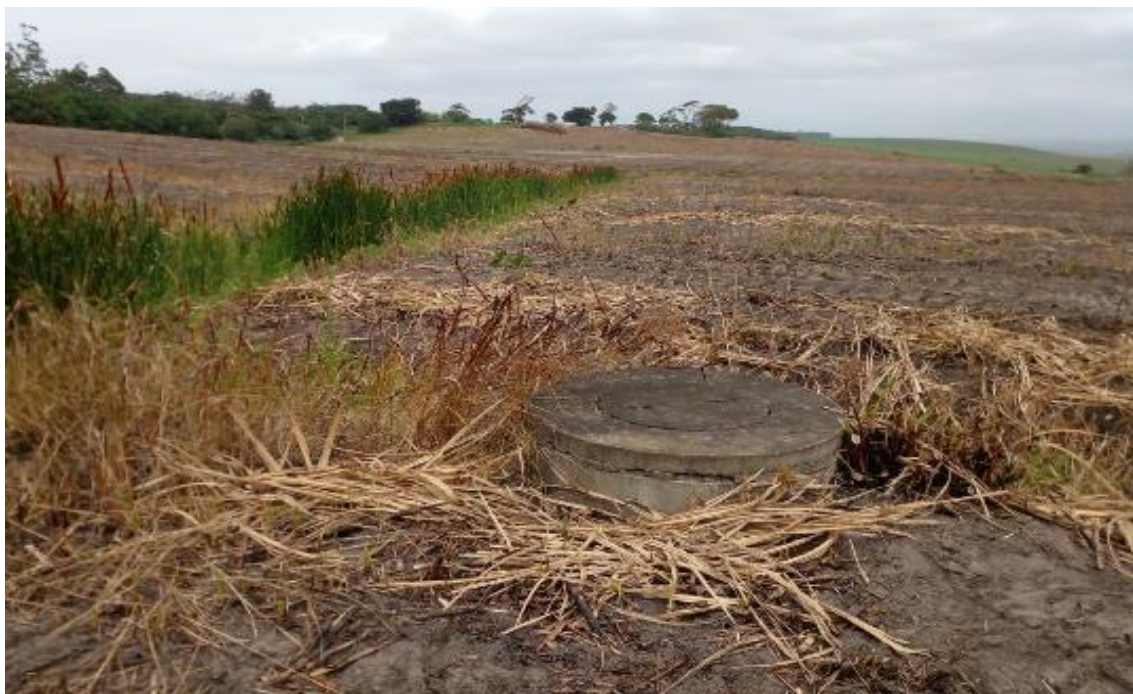
Figure 15: Pipeline route adjacent to watercourse

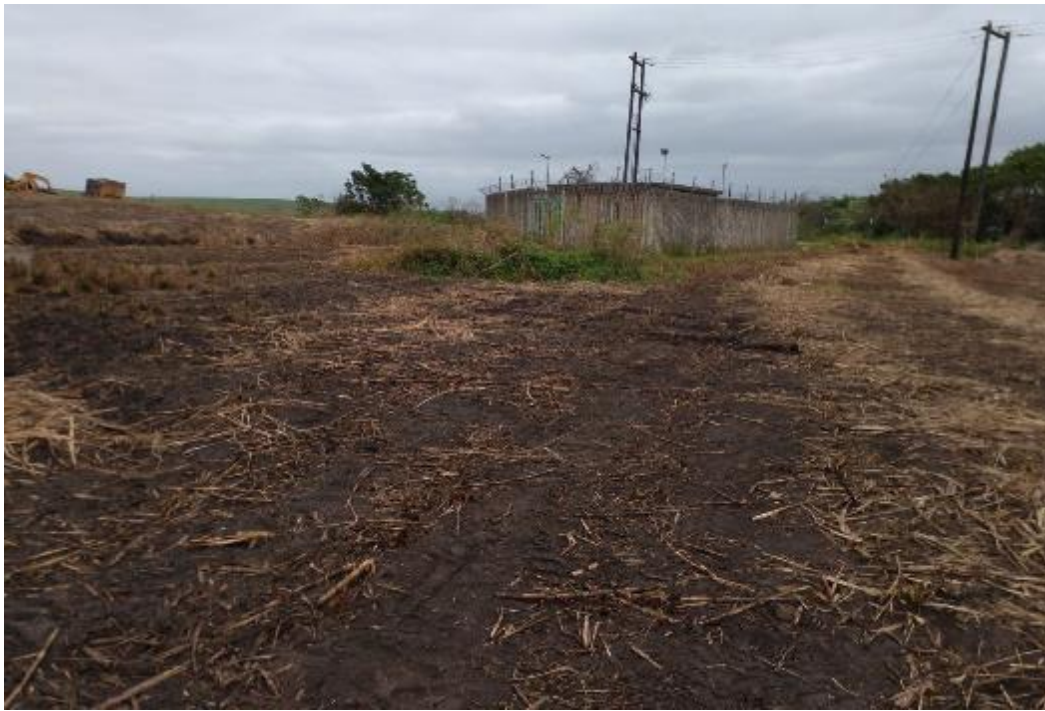
Figure 16: Compensation pump station
