**ARCHAEOLOGICAL IMPACT ASSESSMENT  
OF THE PROPOSED EXTENSION OF A BORROW PIT  
ON FARM NO. 581 (KEURBOS), CLANWILLIAM DISTRICT,  
WESTERN CAPE**

(Assessment conducted under Section 38 (8) of the National Heritage Resources Act as part  
of a Heritage Impact Assessment)

**AUGUST 2012**

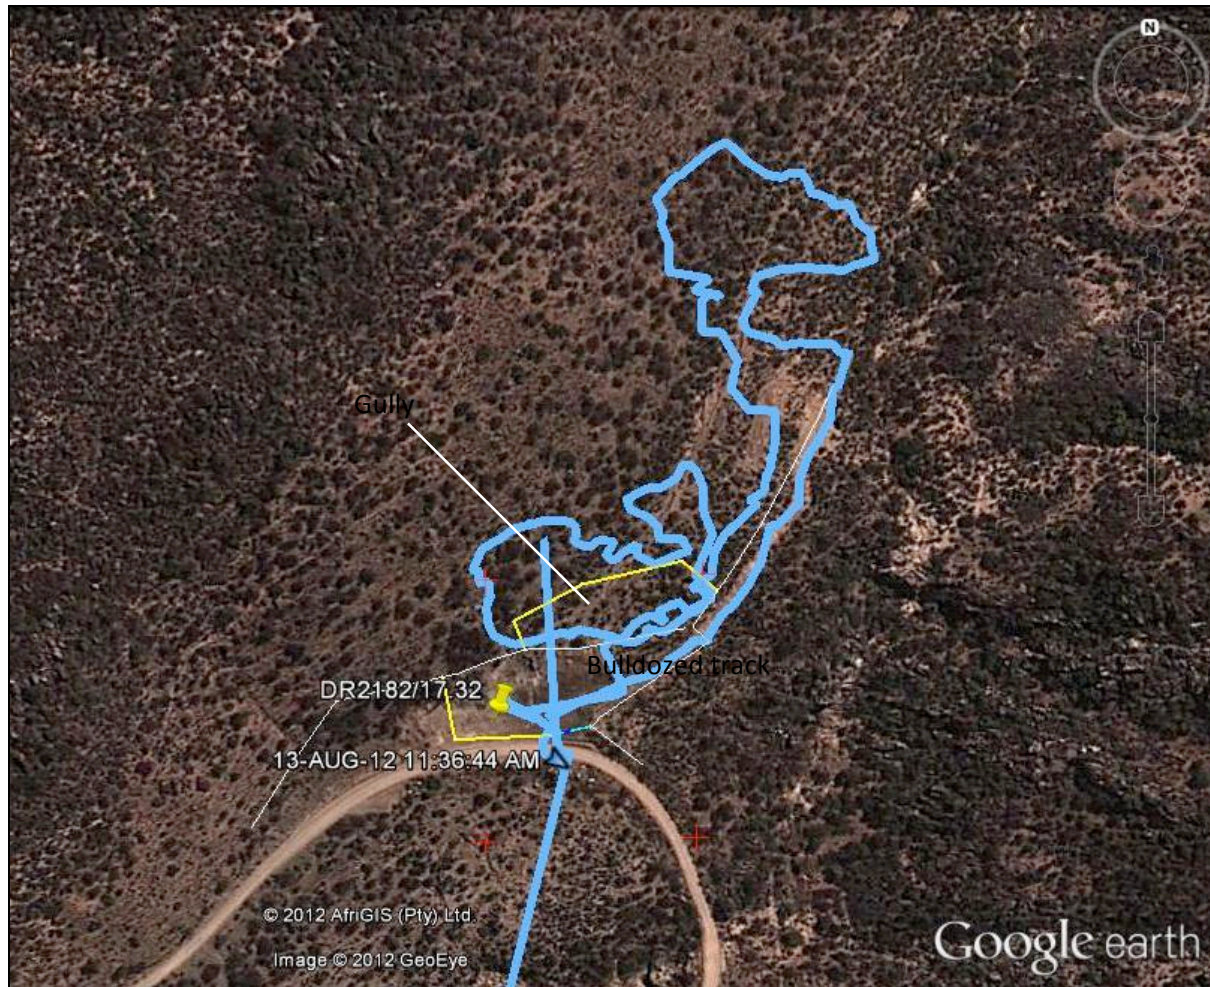
Figure 2: Google earth image showing the proposed extension of the existing borrow pit 106 and the tracks recorded during the field survey. The yellow lines mark most of the outer boundaries of the proposed extension according to the site plans. Please note that the straight blue lines do not indicate survey tracks and that the vegetation on the ground in winter is thicker than it appears in this image.

A new track has been bulldozed along the south-eastern boundary of the affected area and part of the northwest limit lies close to a gully (Figure 6), but the other boundaries of the polygon are not clear on the ground. A larger area than the affected polygon was thus surveyed (Figure 2). Colluvially transported bouldery, gravelly silty sand overlies thinly laminated mudrocks of the Soom Member, which in turn overlie sandy Pakhuis Formation tillite with sparse pebbles (J. Almond, pers. comm.). The surface colluvial gravel is partially ferruginised. Boulders and smaller blocks of sandstone are scattered on the slope. Apart from the cutting and the bulldozed road, the site is covered by fynbos vegetation. The visibility of archaeological material on the ground was limited in the dense patches of shrubs such as *Rhus*, *Wiborgia*, *renosterbos* (*Elytropappus*) and other Asteraceae which occur

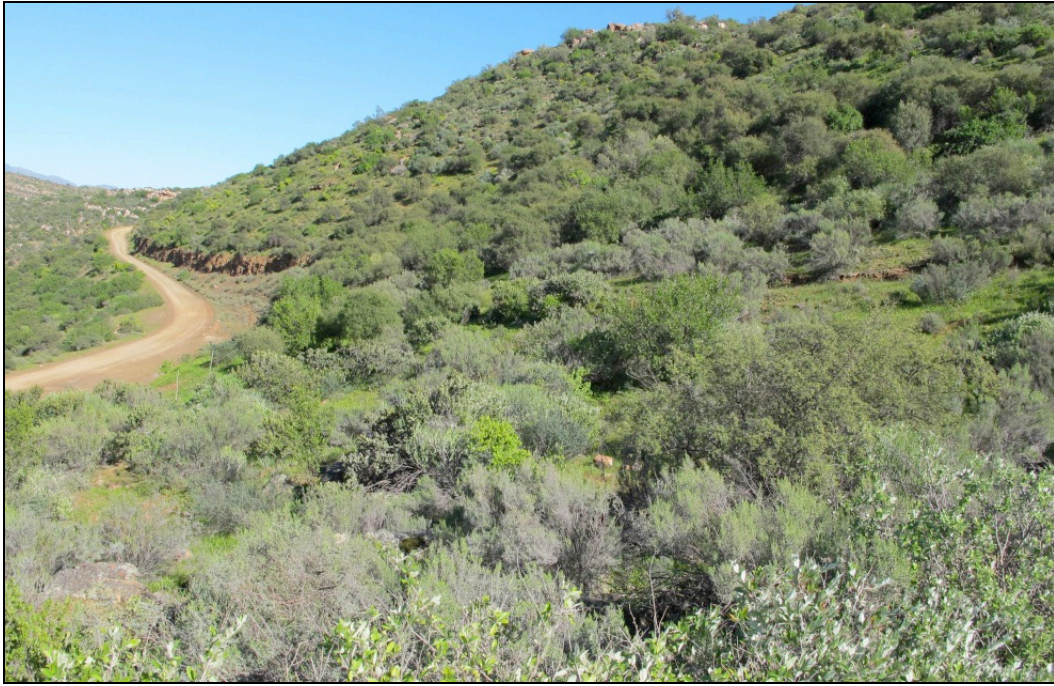
Figure 3: View towards the west of the existing roadside-cutting borrow pit and the proposed extension in the foreground. The photo was taken from the bulldozed track which forms the south-eastern boundary of the affected area.

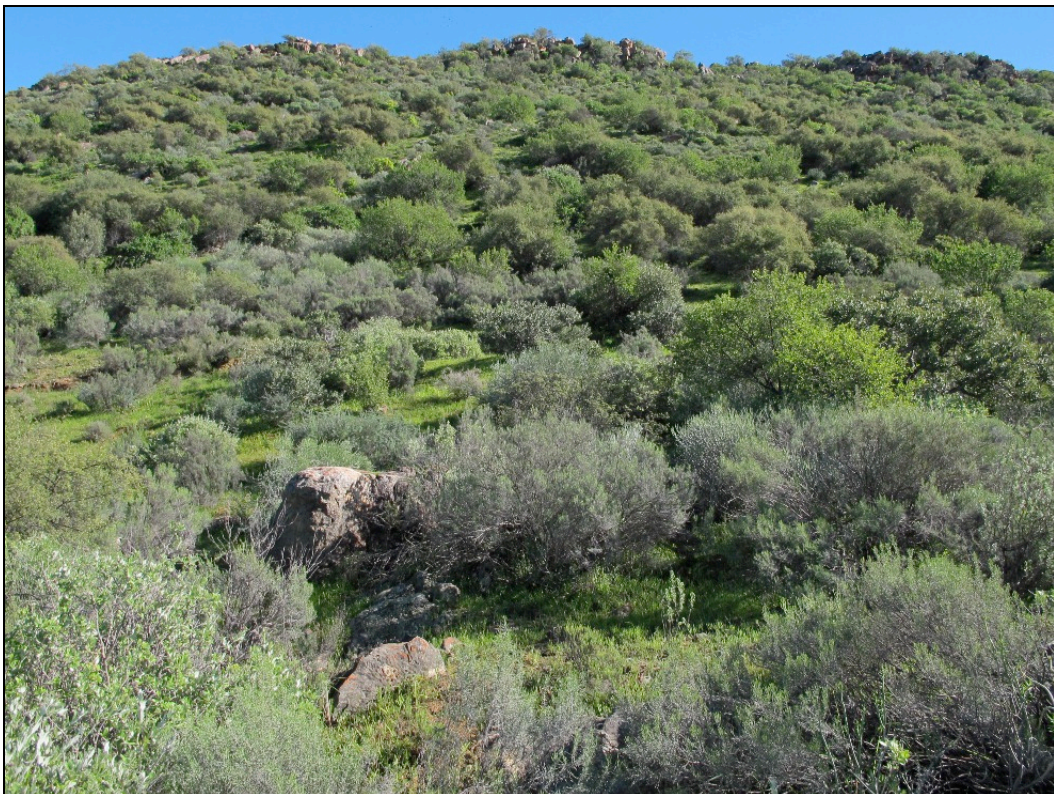
Figure 4: View of the affected area at the base of the steep south-east facing slope. The rocky outcrops at the crest of the ridge lie outside the area. Patches of dense shrubs and grass are visible, as well as the large sandstone boulder examined for rock art.

**Results of the survey:** No archaeological remains were observed within the affected area. One large sandstone boulder with potential surfaces for rock paintings was examined (Figure 4) but none was noted. One likely-looking piece of quartzite found outside the polygon was naturally fractured - there were no artefactual flake scars.

The absence of any archaeological remains in the affected area indicates that the proposed extension is of low archaeological heritage significance, although the surrounding area does obviously have sites of interest and research potential. No further archaeological studies or mitigation are however recommended for this particular pit as there will be no direct impact on archaeological heritage resources.

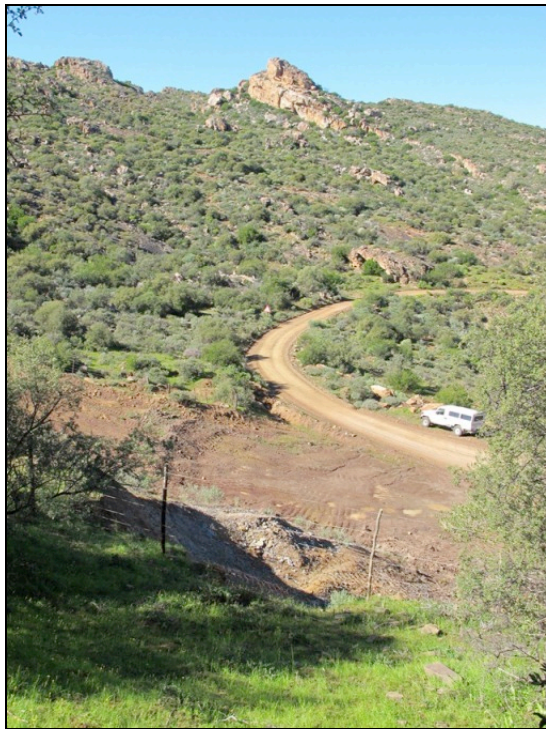
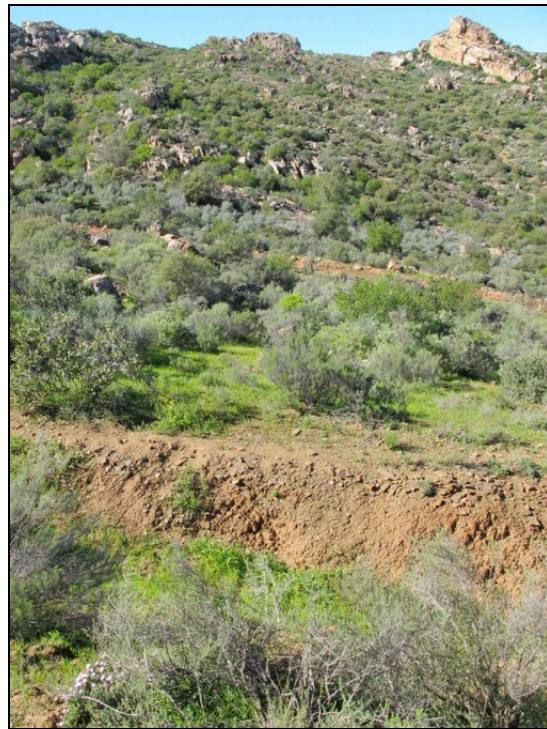
Figures 5 and 6: View of rocky outcrop, probably with rock art, towards the south-east of the affected area; closer view of the proposed extension area lying between the gully in the foreground and the bulldozed track in the middle ground of the photo.
