**ARCHAEOLOGICAL IMPACT ASSESSMENT
OF THE PROPOSED EXTENSION OF A BORROW PIT
ON FARM NO. 581 (KEURBOS), CLANWILLIAM DISTRICT,
WESTERN CAPE**

(Assessment conducted under Section 38 (8) of the National Heritage Resources Act as part
of a Heritage Impact Assessment)

5.2 Borrow pit DR2182/17.32/R/10/A (Vidamemoria pit no. 106)

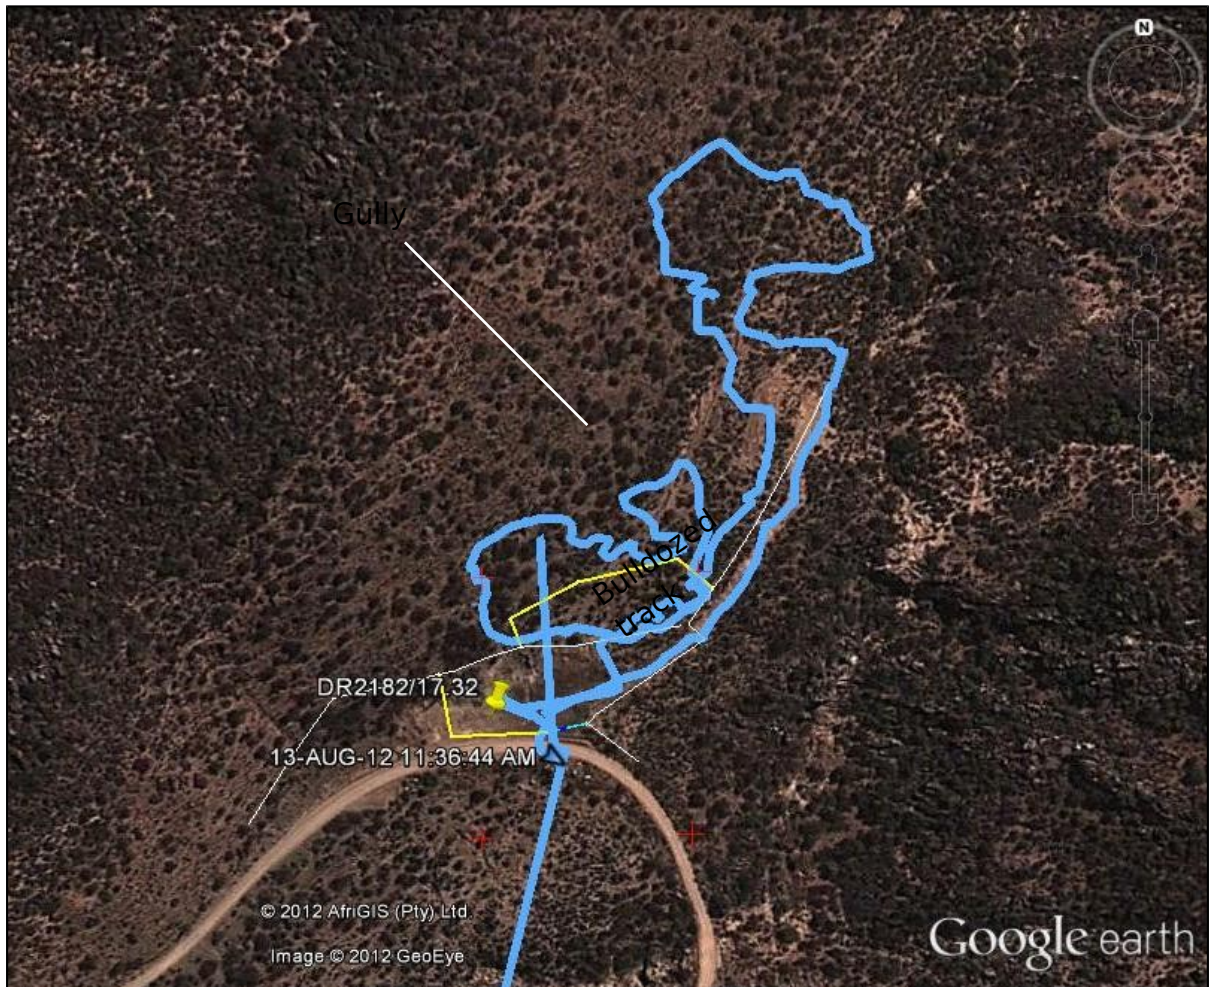
Figure 2: Google earth image showing the proposed extension of the existing borrow pit 106 and the tracks recorded during the field survey. The yellow lines mark most of the outer boundaries of the proposed extension according to the site plans. Please note that the straight blue lines do not indicate survey tracks and that the vegetation on the ground in winter is thicker than it appears in this image.

A new track has been bulldozed along the south-eastern boundary of the affected area and part of the northwest limit lies close to a gully (Figure 6), but the other boundaries of the polygon are not clear on the ground. A larger area than the affected polygon was thus surveyed (Figure 2). Colluvially transported bouldery, gravelly silty sand overlies thinly laminated mudrocks of the Soom Member, which in turn overlie sandy Pakhuis Formation tillite with sparse pebbles (J. Almond, pers. comm.). The surface colluvial gravel is partially ferruginised. Boulders and smaller blocks of sandstone are scattered on the slope. Apart from the cutting and the bulldozed road, the site is covered by fynbos vegetation. The visibility of archaeological material on the ground was limited in the dense patches of shrubs such as *Rhus*, *Wiborgia*, renosterbos (*Elytropappus*) and other Asteraceae which occur amongst the general scatter of isolated shrubs (Figures 3, 4, 6). The recent rains resulted in

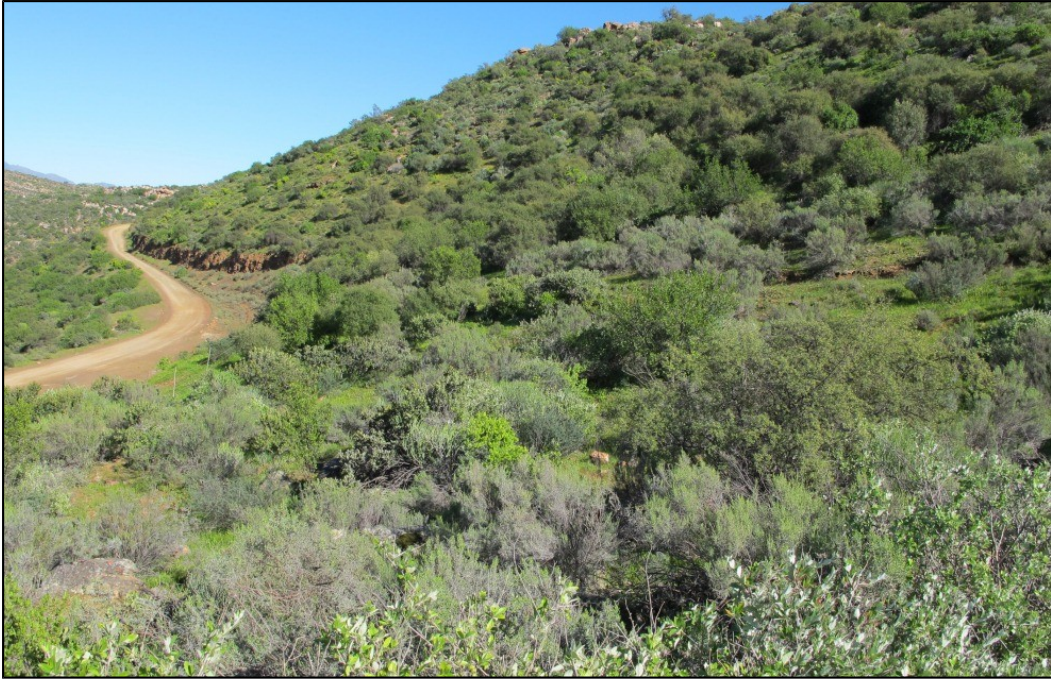
Figure 3: View towards the west of the existing roadside-cutting borrow pit and the proposed extension in the foreground. The photo was taken from the bulldozed track which forms the south-eastern boundary of the affected area.

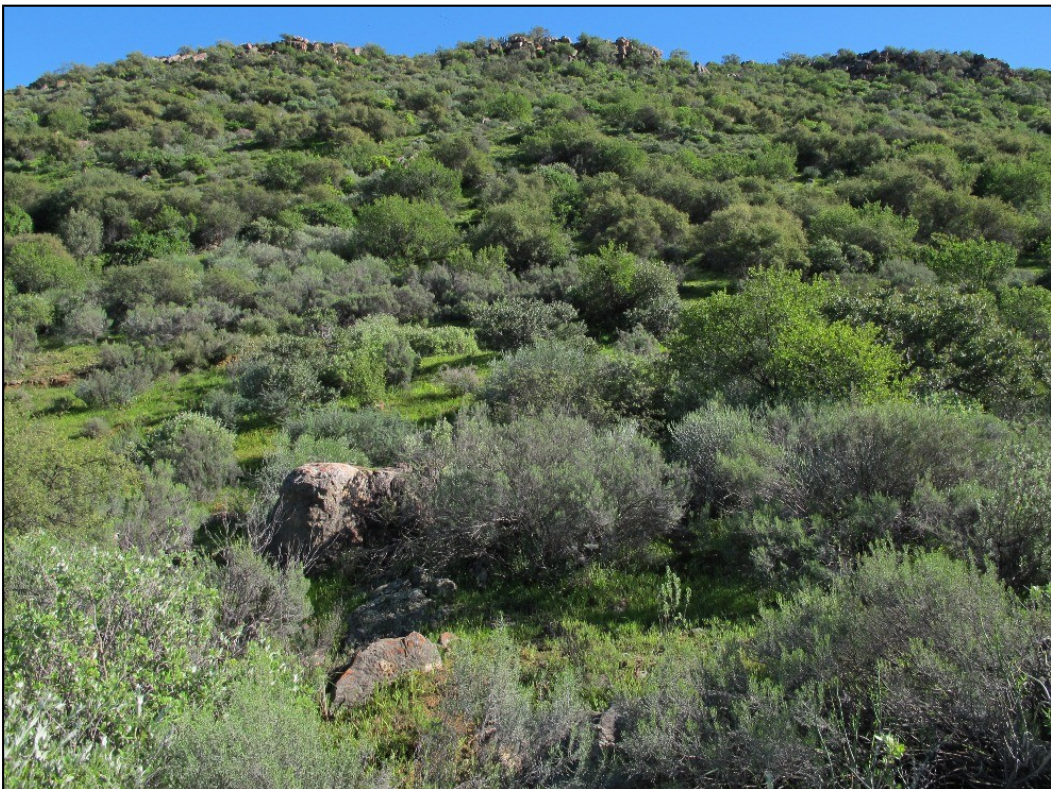
Figure 4: View of the affected area at the base of the steep south-east facing slope. The rocky outcrops at the crest of the ridge lie outside the area. Patches of dense shrubs and grass are visible, as well as the large sandstone boulder examined for rock art.

Results of the survey: No archaeological remains were observed within the affected area. One large sandstone boulder with potential surfaces for rock paintings was examined (Figure 4) but none was noted. One likely-looking piece of quartzite found outside the polygon was naturally fractured - there were no artefactual flake scars.

The absence of any archaeological remains in the affected area indicates that the proposed extension is of low archaeological heritage significance, although the surrounding area does obviously have sites of interest and research potential. No further archaeological studies or mitigation are however recommended for this particular pit as there will be no direct impact on archaeological heritage resources.

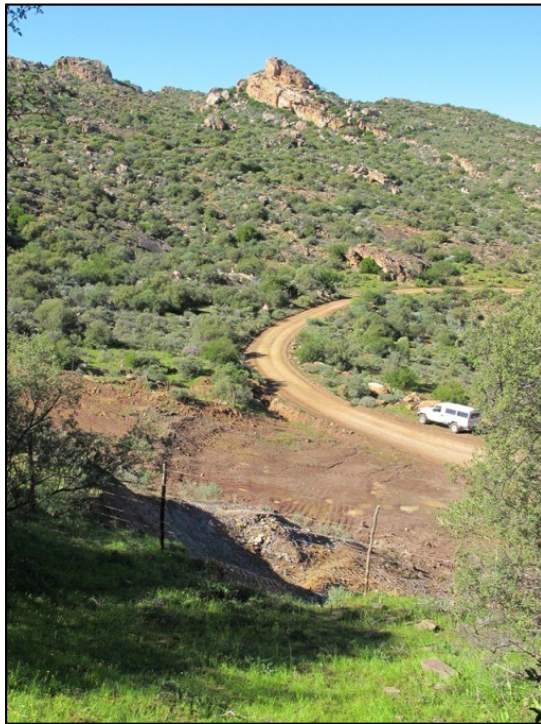
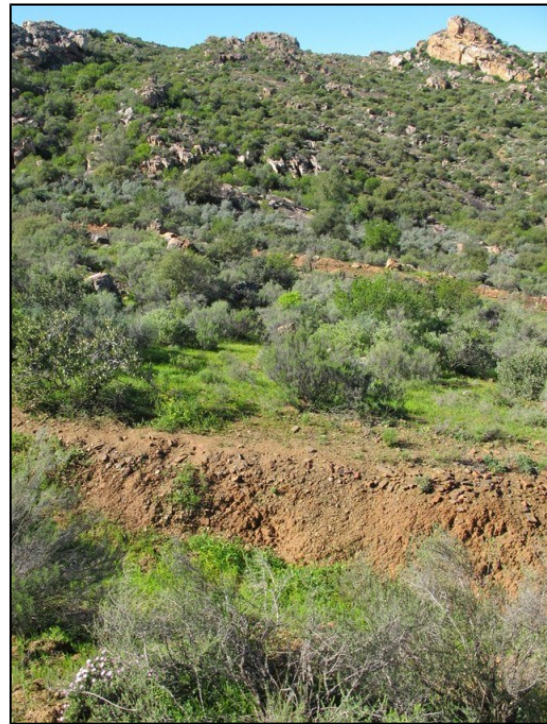
Figures 5 and 6: View of rocky outcrop, probably with rock art, towards the south-east of the affected area; closer view of the proposed extension area lying between the gully in the foreground and the bulldozed track in the middle ground of the photo.
