HERITAGE IMPACT ASSESSMENT

submitted in terms of section 38(8) of the National Heritage Resources Act

29 August 2012

DR 2262, Cederberg

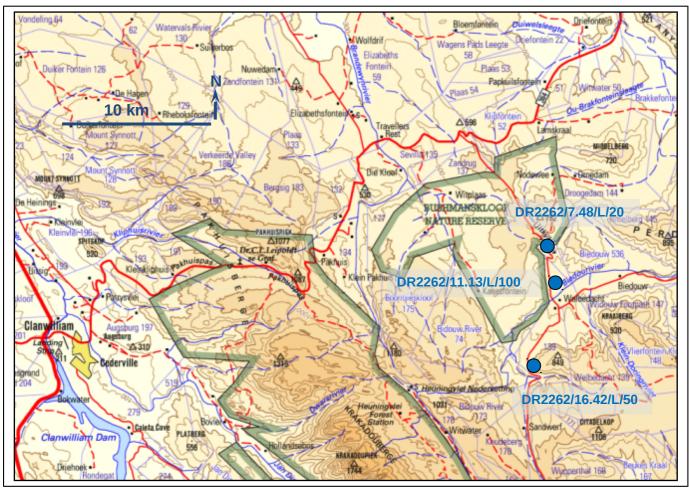
Figure 1: Extract from topographical sheet 3218 Clanwilliam (extracted Almond 2012: 2)

It is proposed to re-excavate and extend three existing borrow pits along the DR2262 between the R364 Pakhuis Pass to Botterkloof Pass road in the northern Cederberg region to the east of Clanwilliam, Western Cape. At km 16.42 borrow pit is located on the farm Mertenhof 586 on the east side of the road 3 km south south west of the Biedouw Valley. At km 11.13 borrow pit is located floor of the Biedouw Valley 2.3 km north of Mertenhof farmstead. At km 7.48 borrow pit is located within the road reserve on Farm Nodewee 141 overlooking the Biedouw Valley. Not much vegetation occurs in the existing borrow pit areas and land is not utilized for any specific purpose. At km 16.42 borrow pit co-ordinates are 32° 10' 36.1" S, 19° 10' 34.4" E, at km 11.3 are 32° 08' 16.8" S, 19° 11' 03.5" E and at km 7.48 are 32° 07' 04.0" S, 19° 10' 28.4" E.
