HERITAGE IMPACT ASSESSMENT

29 August 2012

DR 2262, Cederberg

Clanwilliam District – West Coast District Municipality, Western Cape

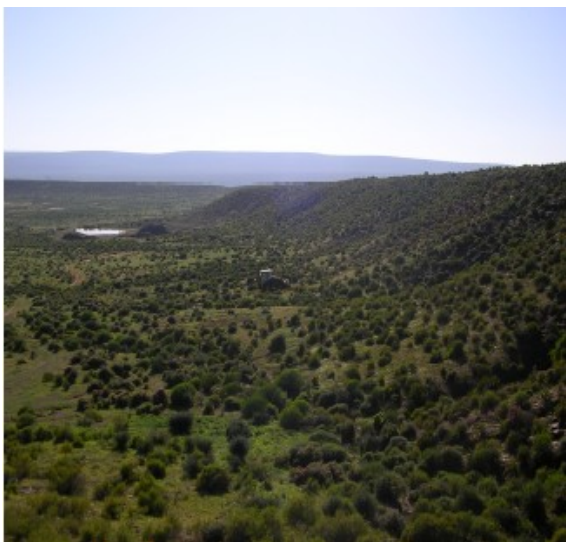
Pit DR2196/18.55/R/130 is located on the southern side of the unsealed road approximately 26.5 km north-northeast of Clanwilliam. This source of a wearing coarse gravel is located at an existing borrow pit at the base of a hill that forms a plateau further east. Not much vegetation occurs within the existing borrow pit area, while indigenous shrubs (fynbos) are found across the rest of the site. Apart from the old borrow pit that was once utilized for gravel, the land is not utilized for any specific purpose. The site on Farm Portion 7 of farm Frederiks Dal, No. 60 is in private ownership of Mr F de Milander. Co-ordinates are 31° 56' 44.9" S, 18° 57' 05.2" E.

Figure 2: At km 18.55 looking north-east over the site (July 2011)

Archaeological and palaeontological impact: No impact on archaeological resources would occur as a result of expansion. The site has been sufficiently recorded and requires no further recording before borrow pit activity occurs. However, at km 18.55 it is likely that newly-excavated mudrocks would yield diverse assemblages of well-preserved shelly fossils and it is therefore recommended that the developer should commission a professional palaeontologist to record and sample fossil material.

The palaeontological sensitivity of the site at km 28.5 is low and no further studies or mitigation of palaeontological heritage are recommended in this case. (Almond 2012: 14). However, palaeontological significance is considered as high at km 18.55 and it is therefore recommended that a professional palaeontologist be appointed to record and sample fossil material from the pit during the early stages of excavation when abundant fresh (*i.e.* unweathered) mudrock is available for examination, and before most material is employed for road construction (Almond 2012: 14).

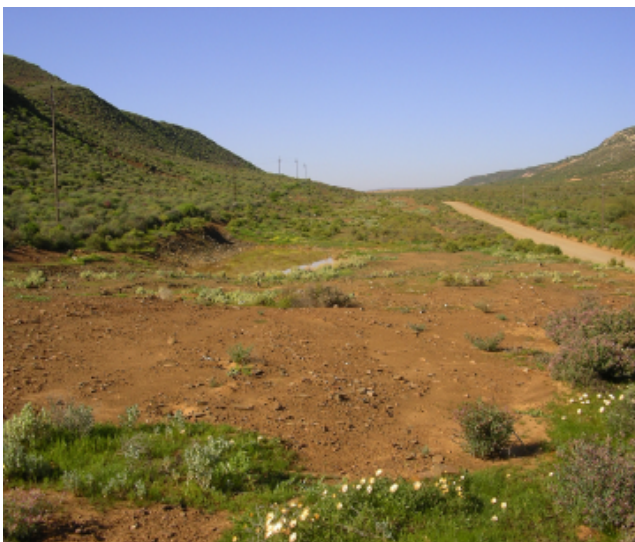
Pit DR2196/28.5/L/30 is situated approximately 22km northeast of Clanwilliam. This source of a wearing coarse gravel is located at within the road reserve at an existing borrow pit. The site lies at the base of a hillside adjacent to the road DR2196. Entrance to the site is directly from the DR2196 which forms the sites western boundary. Patches of vegetation, consisting of grasses and indigenous shrubs (fynbos) that have been rehabilitated in the area of the old borrow pit, are found across the site. Apart from the old borrow pit that was once utilized for gravel, the land is not utilized for any specific purpose. The site on Portion 10 of Farm Elizabethsfontein 59 is in private ownership of Mr K Strauss. Co-ordinates are 32° 00' 27.0" S, 19° 01' 11.3" E

Figure 5: At km 28.5 Looking south-east over site (July 2011)
