**ARCHAEOLOGICAL IMPACT ASSESSMENT  
OF THE PROPOSED EXTENSION OF TWO BORROW PITS  
ON PTN. 7 OF FREDERICKS DAL 60 & PTN. 10 OF  
ELIZABETHFONTEIN 59, CEDERBERG,  
CLANWILLIAM DISTRICT, WESTERN CAPE**

(Assessment conducted under Section 38 (8) of the National Heritage Resources Act as part  
of a Heritage Impact Assessment)

**AUGUST 2012**

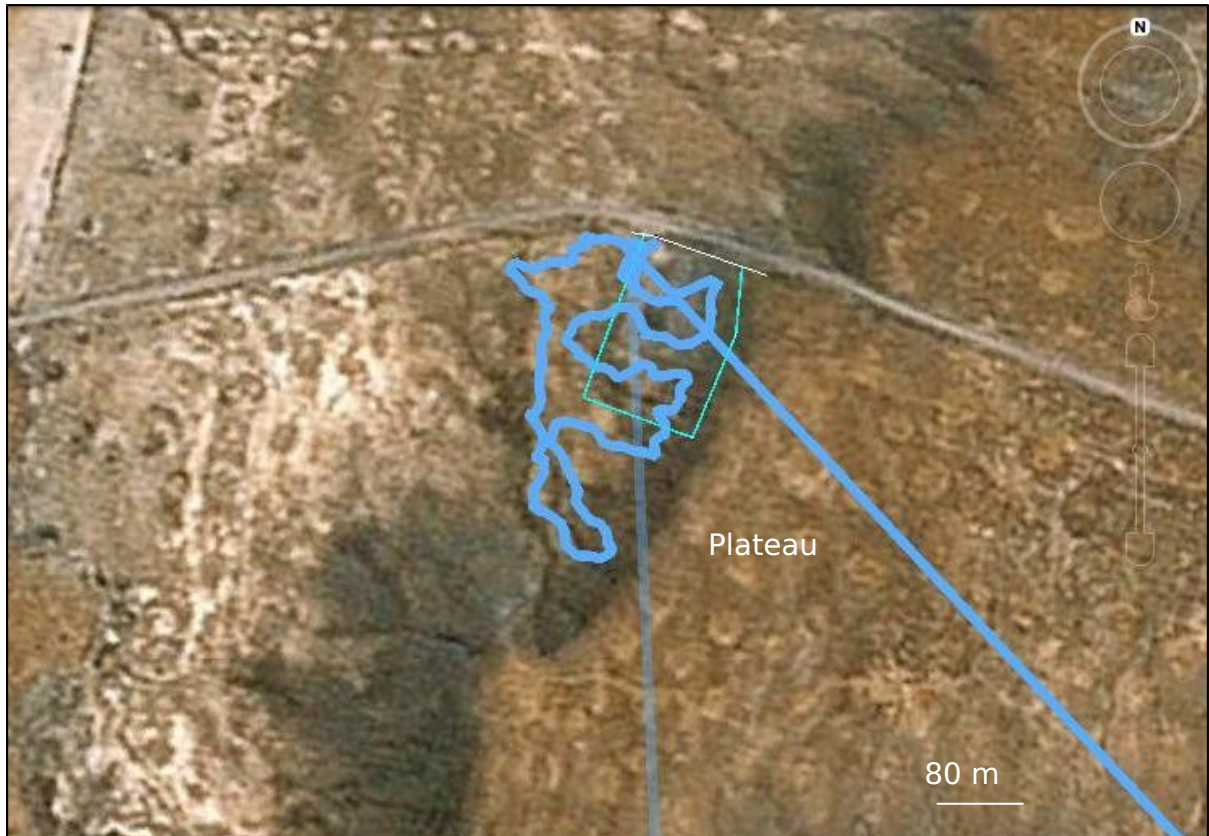
Figure 2: Google earth image showing the proposed extension of the existing borrow pit 125, the tracks of the field survey and the plateau to the southeast of the proposed extension. The relevant 1:50 000 topographical map is 3118DD Bulshoek. Please note that the straight blue lines do not indicate survey tracks. The Google earth image is unfortunately not sharp.

**Environment:** The proposed extension to an existing pit is situated at the base of a northwest-facing hill-slope in a bend of the DR2196. The affected area is bounded by the road to the north-east and the hill on the eastern side (Figure 2). The latter forms a plateau on its crest (Figures 3 and 6). As the western and southern limits of the affected polygon were not evident on the ground, a larger area than the polygon was surveyed. Bokkeveld mudrock of the Gydo Formation outcrops along the lower and steeper slopes of the hillside over most of the site. It is overlain by gravelly colluvium. There is evidence of sheet-wash and several small gullies drain water from the slope of the hill. The western part of the affected area is relatively flat-lying and the remains of 'heuweltjies' (fossil termitaria) are evident, also on the Google earth image (Figure 2). There is not much vegetation within the existing pit, partly filled with water at the time of the survey, while scattered euphorbias, asparagus plants, 'vygies' and kraalbos (*Galenia africana*) are found across the rest of the site. The good rains have resulted in patches of low grass, herbs and creeping daisies but the visibility of archaeological material on the ground has not been negatively affected. The land is not presently used for any specific purpose. The Brandewyn River lies approximately 2.5 km to the east of the affected area. Archaeological sites have been recorded along rocky slopes over 4 km to the south of the proposed pit (Manhire & Patrick, in Samie 2012), but no obvious rock shelters or overhangs where paintings may be found occur in the immediate area of the pit.

**Results of the survey:** No archaeological remains were observed.

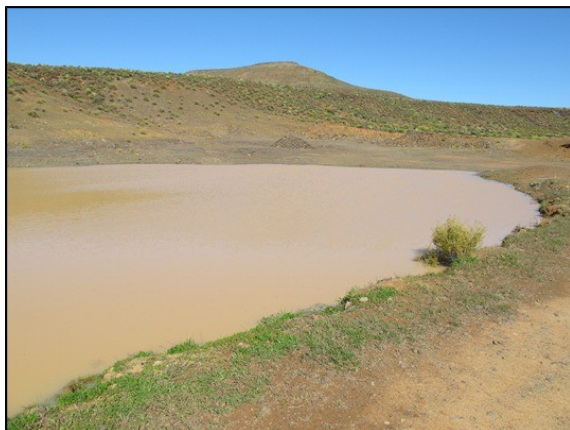
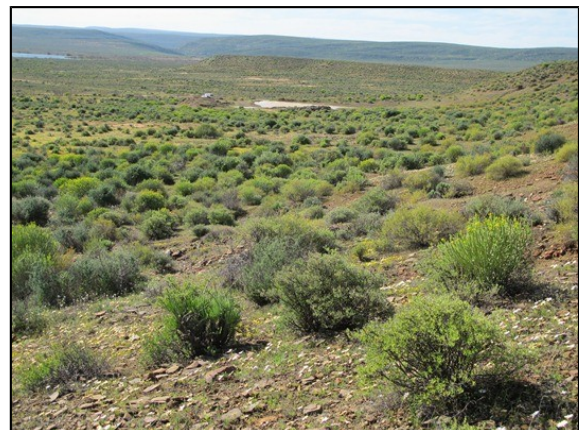
Figures 3 and 4: Pit 125 – view towards the southeast showing the existing pit and the plateau; view of the affected area towards the north. The water-filled existing pit is visible in the middle ground.

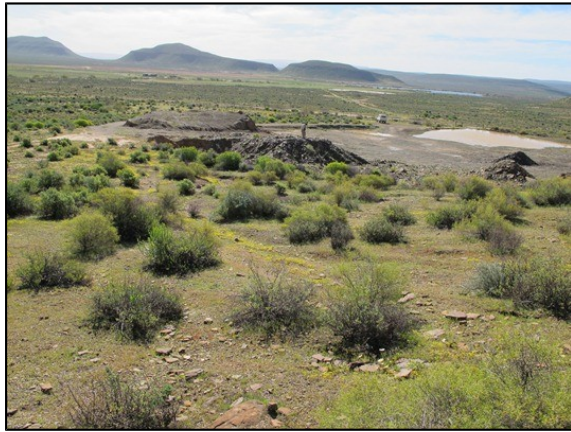
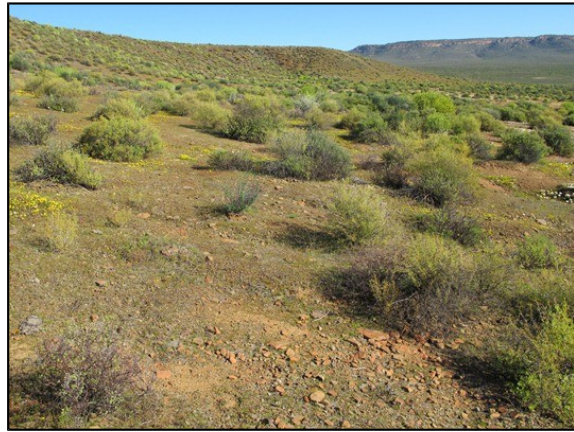
Figures 5 and 6: Pit 125 – view towards the northwest of the existing pit with heaps of mudstone; photo taken from the northeast corner of the affected area towards the southwest. The edge of the plateau of the adjacent hill is visible on the left.

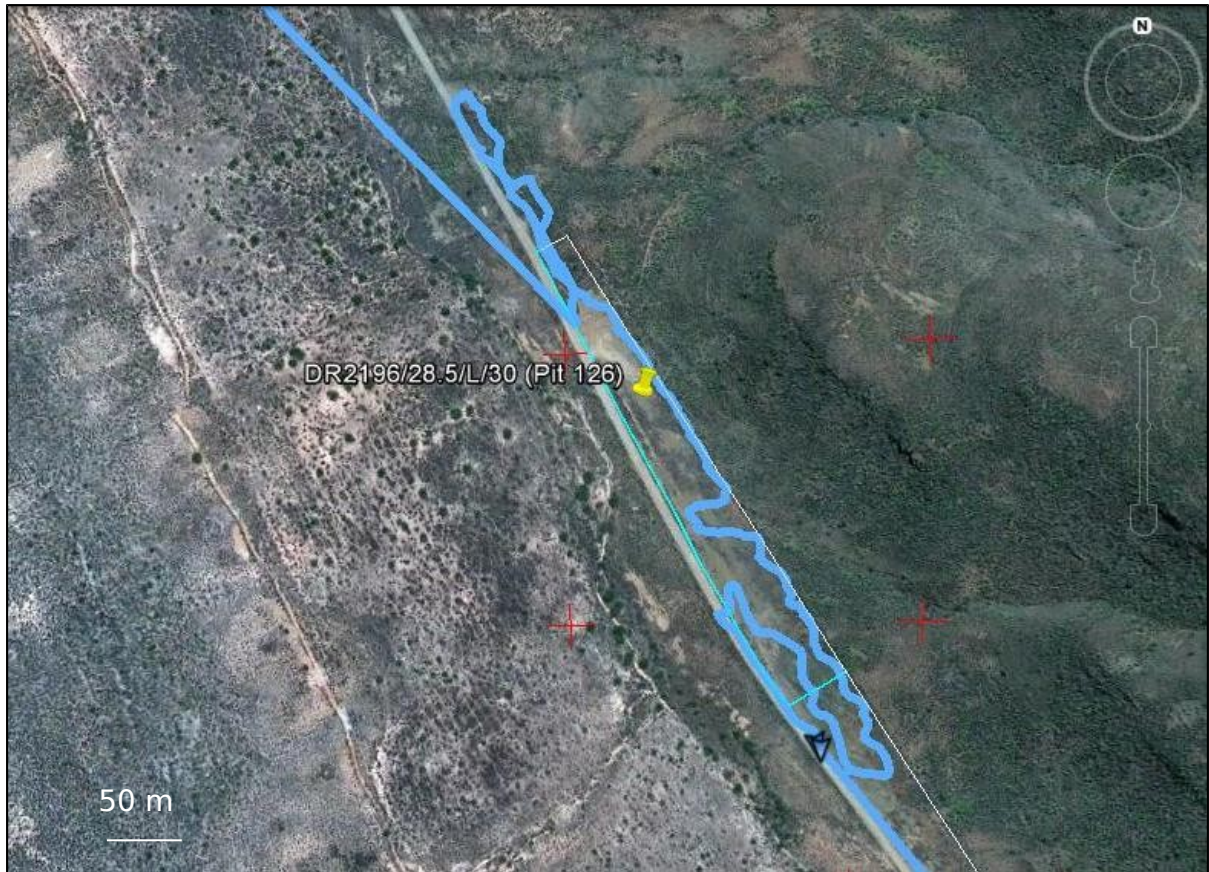
Figure 7: Google earth image showing the proposed extension of the existing borrow pit 126 and the tracks of the field survey. The relevant 1:50 000 topographical map is 3219AA Pakhuis. Please note that the straight blue lines do not indicate survey tracks.

**Environment:** The proposed extension to an existing borrow pit lies within the road reserve situated at the base of a hillside adjacent to the DR2196 (Figures 7, 8, 10). The affected area, which slopes down to the road, is bounded by the road to the southwest and a fence to the northeast. The existing pit lies in the northern section of the polygon but was not very obvious on the ground (Figure 8). It appears that a portion of the proposed extension may already have been quarried as a large part of the affected area has been dug up, rehabilitated and re-vegetated with grass (Figures 10, 11). The only area which has not been disturbed is the strip of land next to the fence where euphorbias, 'vygies' and shrubs such as *Galenia africana* and *Eriocephalus* occur (Figure 9). Weathered, thinly-laminated Bokkeveld Group mudrocks and sandstones are overlain by gravelly colluvium. The visibility of archaeological material on the ground was generally good. Archaeological sites have been recorded along the Brandewyn River to the east and on rocky slopes three or more km to the west and south of the affected area (Manhire & Patrick, in Samie 2012).

**Results of the survey:** No archaeological remains were observed in either the undisturbed or rehabilitated areas.

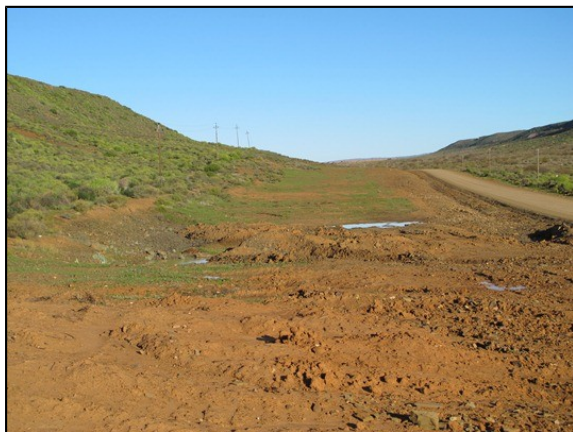
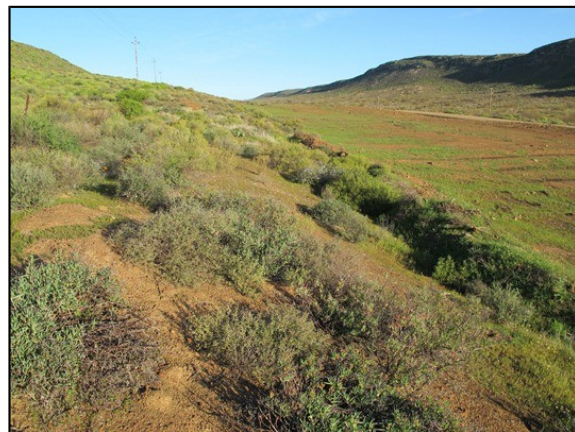
Figures 8 and 9: Pit 126 – view towards the southeast with the original borrow pit filled with water; view towards the south showing the less disturbed area along the fence.

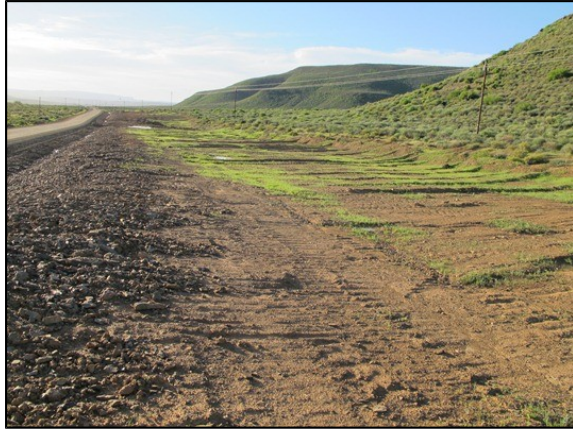
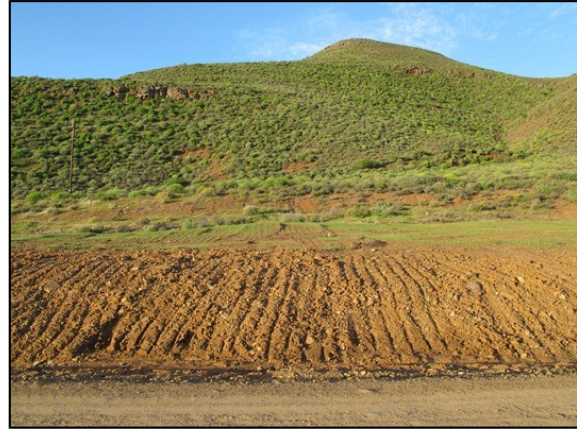
Figures 10 and 11: Pit 126 – view across the affected area towards the northwest with grass planted on the rehabilitated area; another view (towards the east) showing rehabilitation of the southern pit area.
