**ARCHAEOLOGICAL IMPACT ASSESSMENT
OF THE PROPOSED EXTENSION OF A BORROW PIT ON
WATERKLOOF 1092 NEAR MAMRE, WEST COAST
DISTRICT MUNICIPALITY, WESTERN CAPE**

(Assessment conducted under Section 38 (8) of the National Heritage Resources Act as part
of a Heritage Impact Assessment)

MARCH 2013

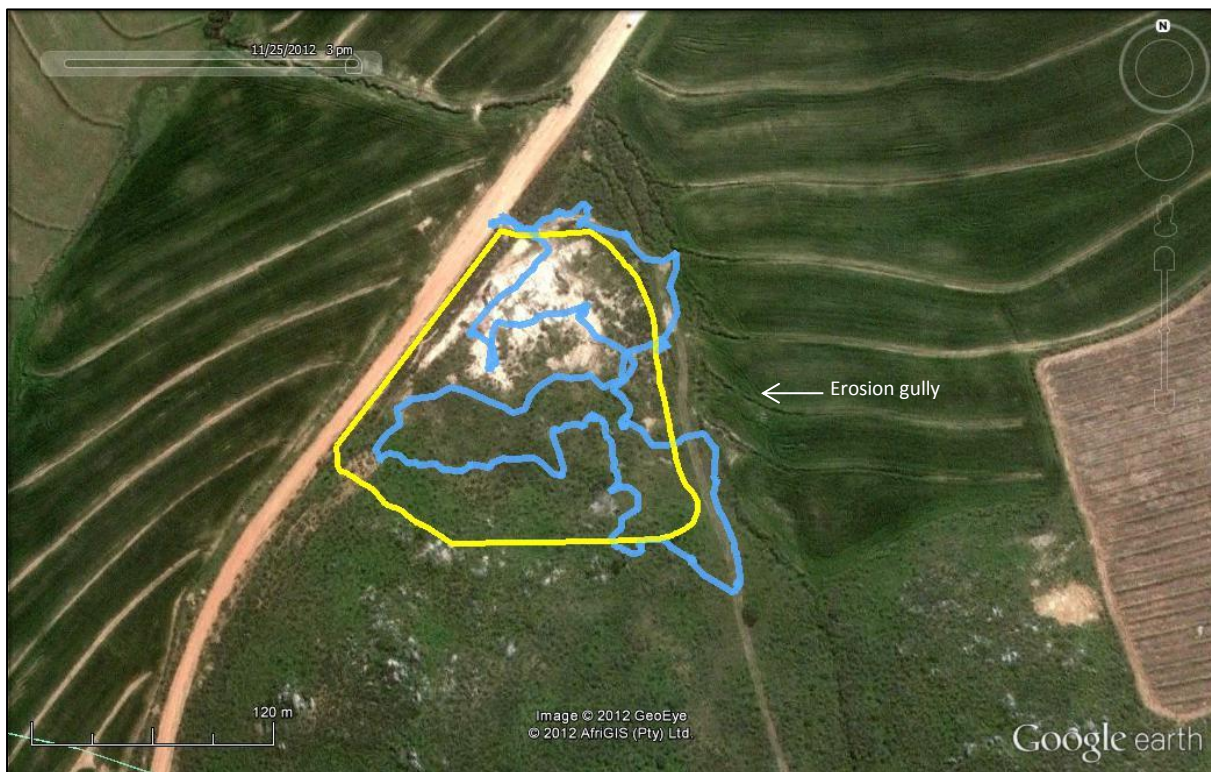
Fieldwork was undertaken on 24 November 2012. A site plan indicating the affected area was provided by Nadeson for the Phase 1 survey. The area was covered on foot by the author and two assistants and the author's tracks were recorded by a Garmin GPSMAP 62s set on the WGS84 datum (Figure 2). The site was extensively photographed.

Figure 2: Google earth image showing the polygon of the proposed extension, the author's tracks of the field survey and the granite boulders visible to the south of the polygon.

The stone artefacts appear to have been washed down the eastern part of the koppie which is adjacent to the erosion gully (Figure 2). If there had been a high density of material associated with the granite boulders on the crest of the hill, one would also expect to find archaeological material in the western half of the polygon. The area from which the artefacts derive may in fact be further away to the southeast. The artefacts observed at the proposed extension site are thus in a secondary context.

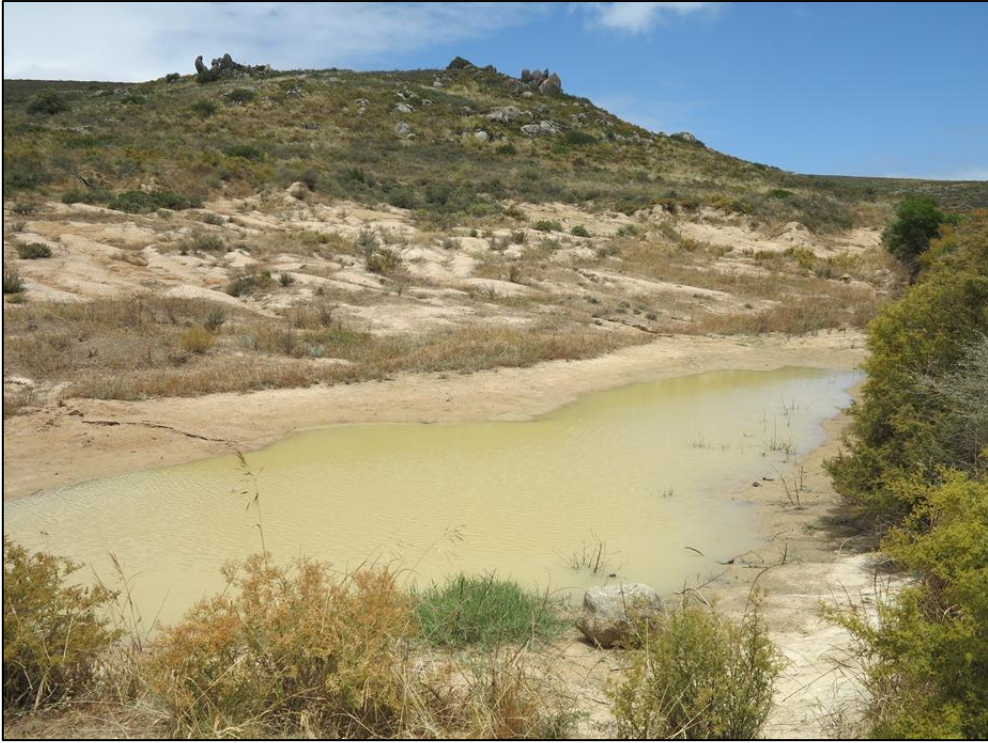
Figure 3: View towards the south showing the existing pit, the exposed lower slope of the kopie and the granite boulders outside the affected area.

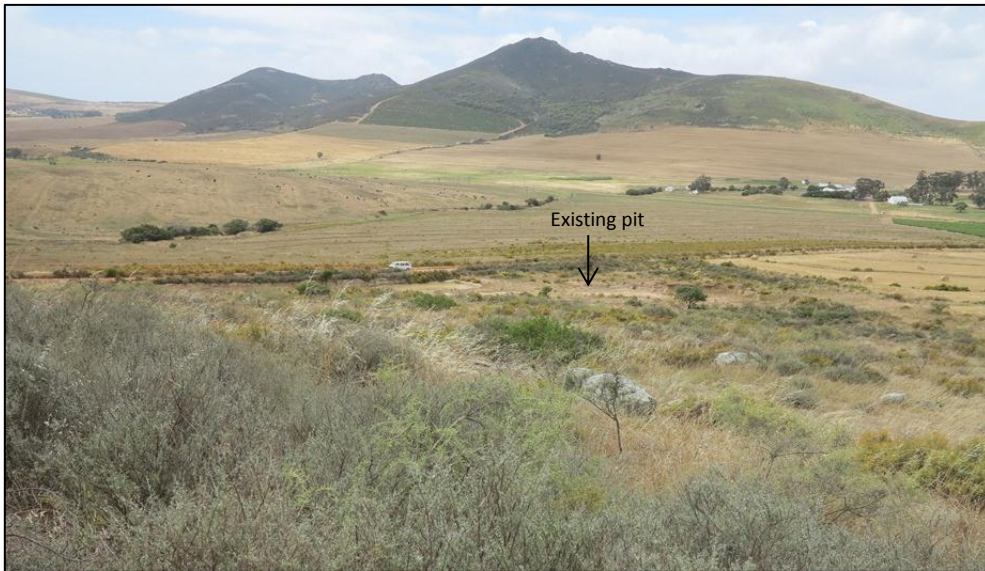
Figure 4: View towards the northwest with a dense patch of vegetation in the foreground and the existing pit in the middle ground. The parked vehicle indicates the position of the DR01145.

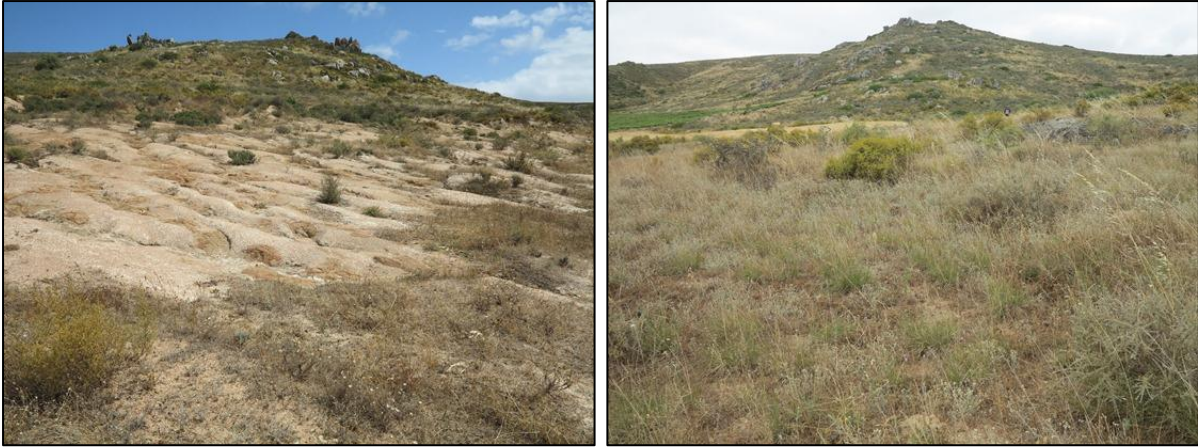
Figures 5 and 6: View towards the south with exposure of the sandy colluvium and highly weathered granite bedrock; view towards the east showing gaps between the dried grass and scattered bushes.

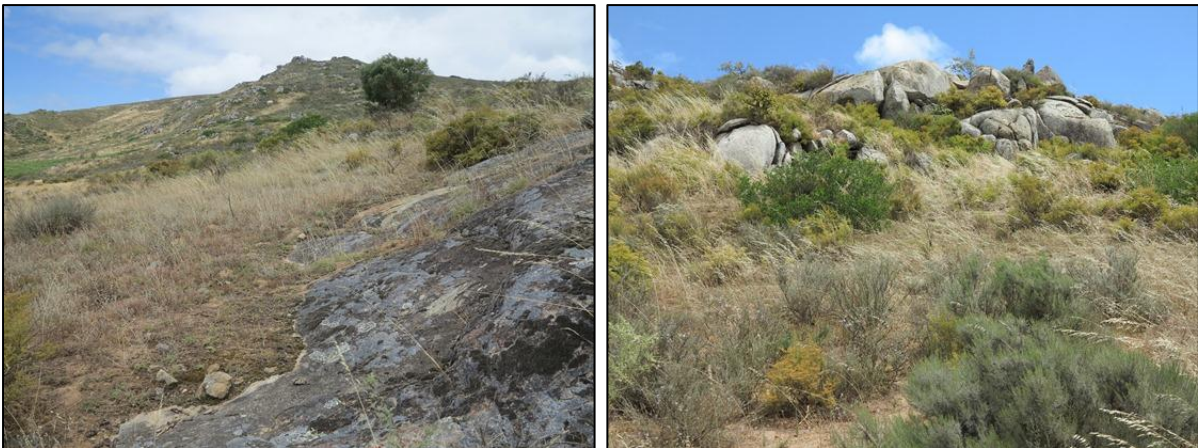
Figures 7 and 8: View towards the east showing granite outcrop; view towards the south of the granite boulders on the crest of the hill outside the polygon.

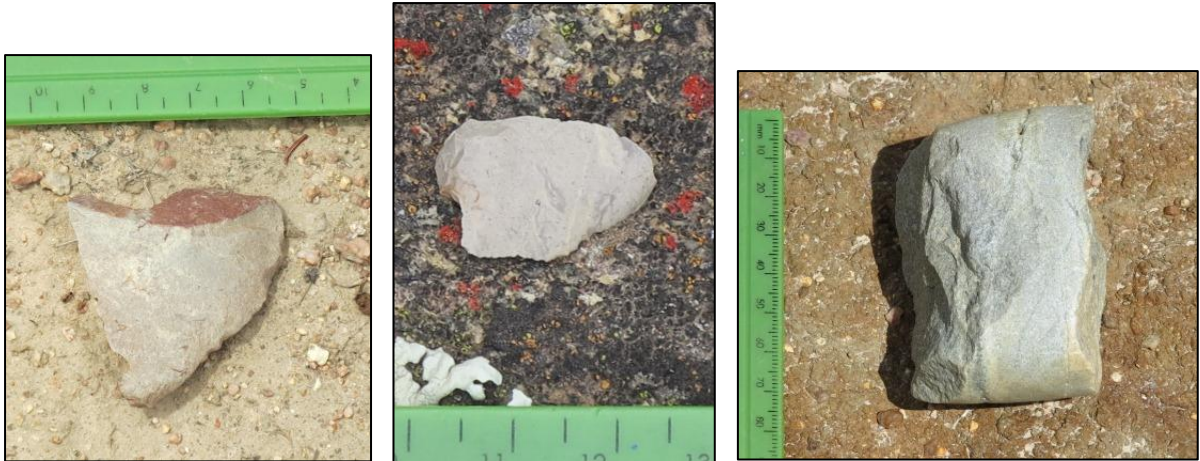
Fewer than 20 dispersed stone artefacts were observed in the eastern half of the affected area. Ten silcrete flakes (e.g. Figures 9, 10 and 13), one quartz flake (Figure 13), a possible quartz chunk, one quartzite flake and two flaked quartzite pebbles (Figures 11 and 12) were noted. Most of these artefacts are LSA but several are of indeterminate age. No other archaeological remains such as fragments of pre-colonial pottery which could indicate the presence of herders were noted.

Figure 9: Silcrete flake; Figure 10: silcrete flake; Figure 11: flaked quartzite pebble. The scale is in cm.

The low density scatter of archaeological remains in a secondary context in the eastern half of the polygon indicates that the site of the proposed extension is of low archaeological heritage significance. No further archaeological studies or mitigation are therefore recommended.

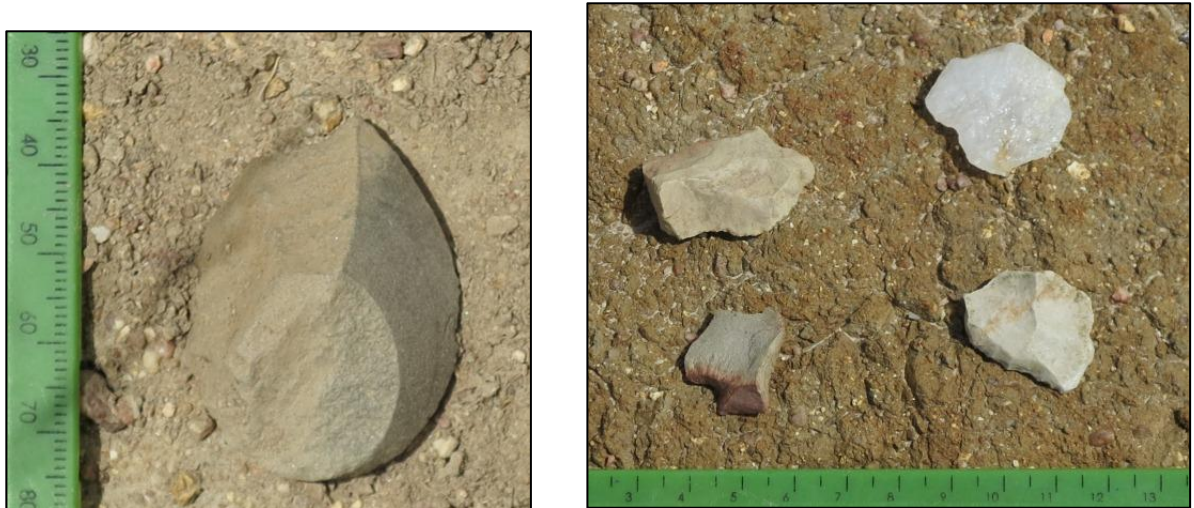
Figure 12: Flaked quartzite pebble; Figure 13: three silcrete flakes and one quartz flake. The scale is in cm.
