HERITAGE IMPACT ASSESSMENT PROPOSED CLANWILLIAM INTERSECTION UPGRADE ON NATIONAL ROUTE N7 SECTION 3 FROM APPROXIMATELY KM 127 TO KM 128

(Assessment conducted under Section 38 (8) of the
National Heritage Resources Act as part of an EIA.)

November 2012

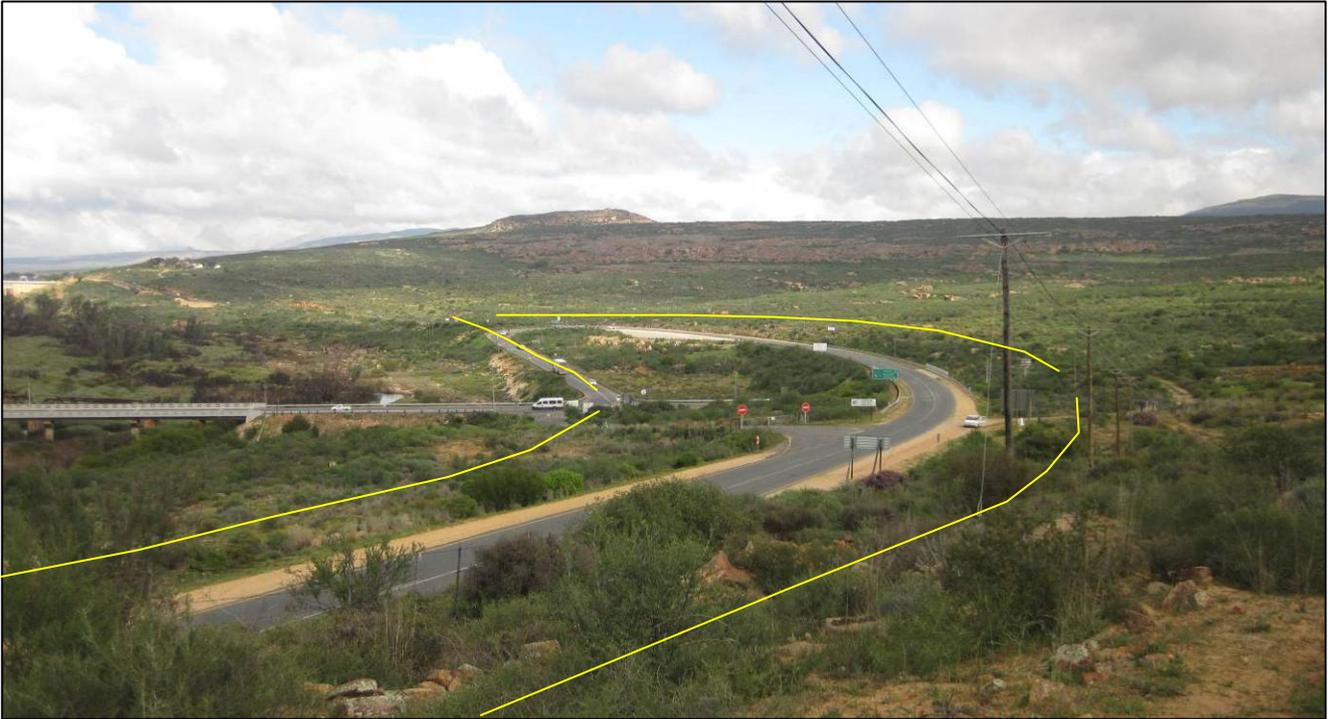
Plate 1: Approximate positions of on and off ramps linking to the existing R364 (Clanwilliam - Lamberts Bay Road) showing the receiving environment

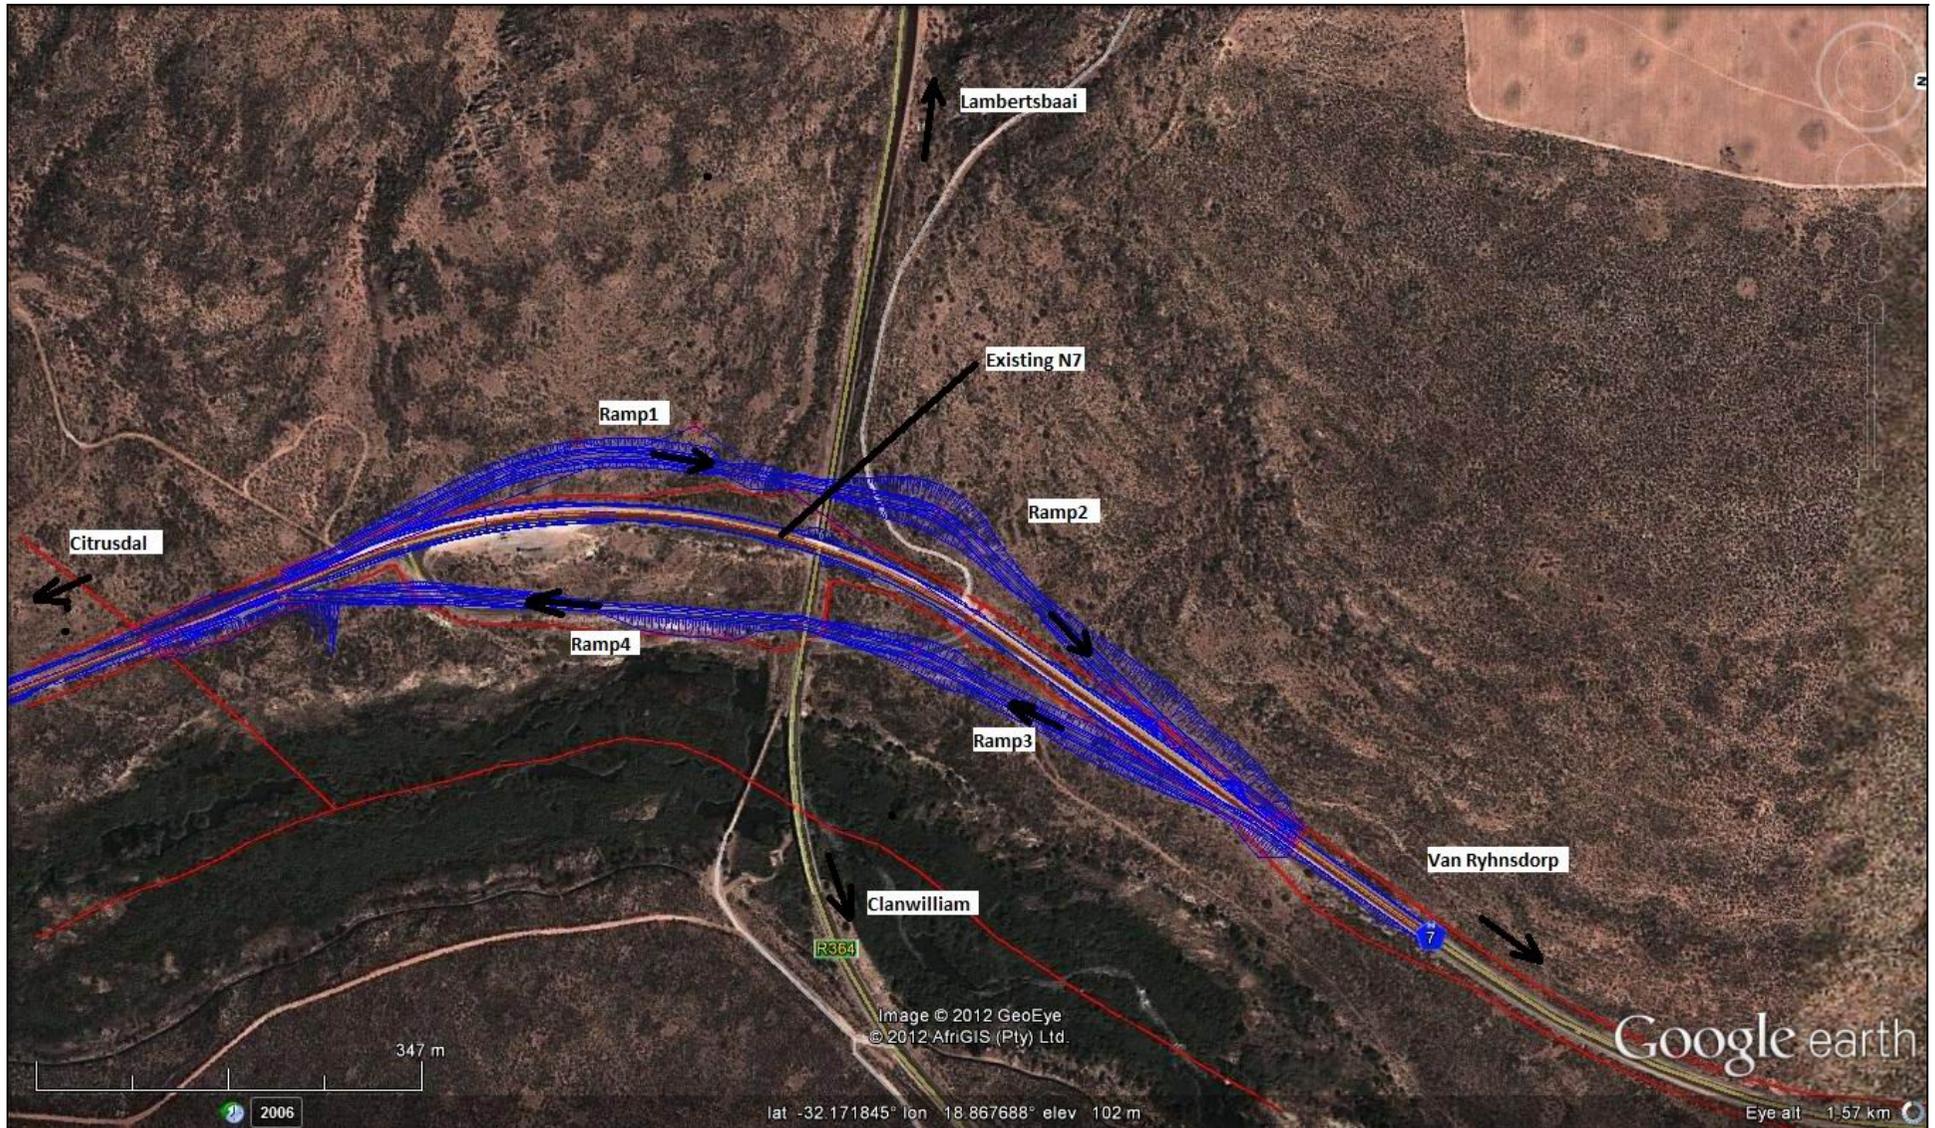
Figure 2: Detailed layouts of the proposed interchange (note north direction). Road reserves and farm boundaries in red.

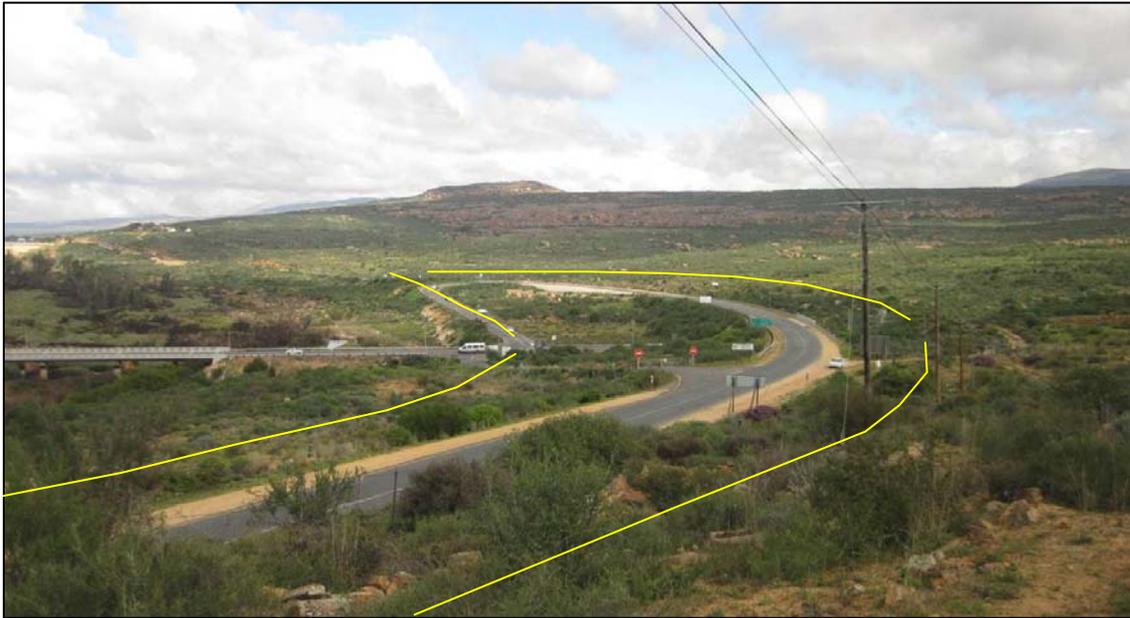
Plate 1: Approximate positions of on- and off- ramps linking to the existing R364 (Clanwilliam - Lamberts Bay Road) showing the receiving environment

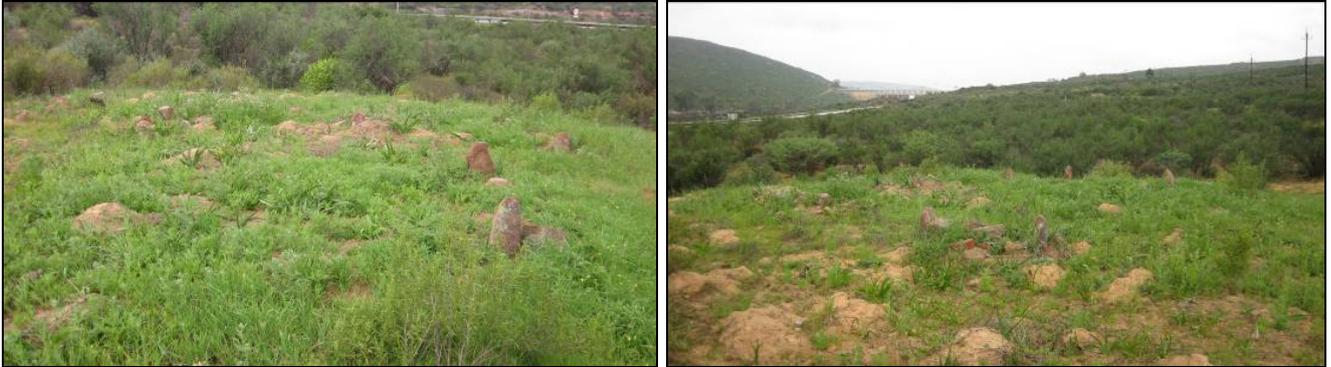
An **informal cemetery** (005 - 023) is sufficiently distant from the proposed offramp not to be impacted directly. It must still be identified and marked prior to commencement of the construction phase. It is not clear who is buried here, but it may have to do with the period of dam construction, or be associated with the small ruined dwelling elsewhere along the alignment and described below (Plates 2 - 3).

Plates 2 and 3: A small informal graveyard with sandstone head and footstones marking the graves, near the start of Ramp 1 must be identified and avoided during construction

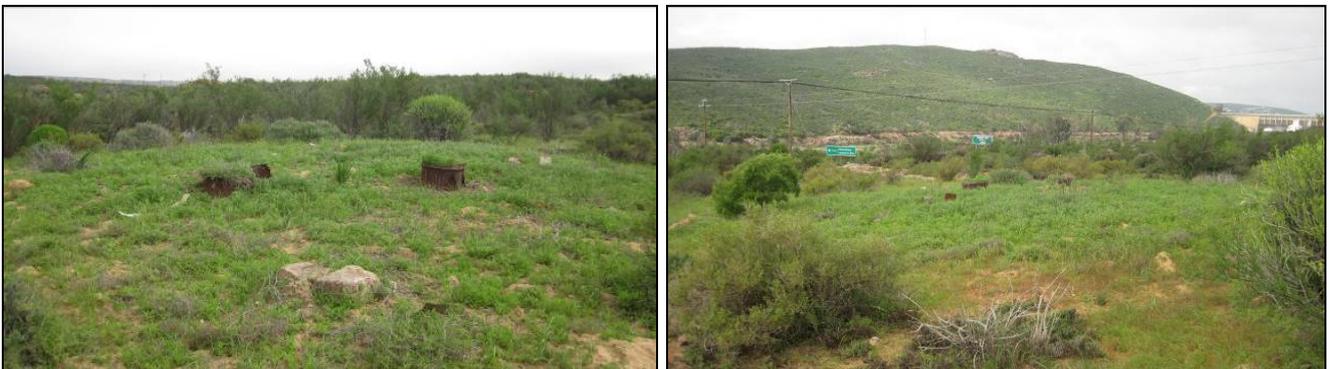
Of concern is a somewhat enigmatic observation (waypoints 026 - 047) further north along the alignment of Ramp 1. The **unknown feature** is similar in form to the known informal cemetery close by, yet lacks any burial mounds or grave markers. Two earth filled half-44 gallon drums seem to form an entrance to the area though there is no obvious signs of any fencing material today. Slightly mounded and devoid of the prevailing vegetation, it is probably an old termite hill (“heuweltjie”) that has disintegrated and been re-used (Plates 4 - 5). The engineers have determined that the site can be avoided by the proposed alignment. It must be identified and marked prior to commencement of the construction phase.

Plates 4 and 5: A small earth mound on the edge of which are placed two earth-filled half 44 gallon drums. It is reminiscent of the identified informal cemetery though lacks surface traces of graves? The site must be marked and avoided during the construction phase.

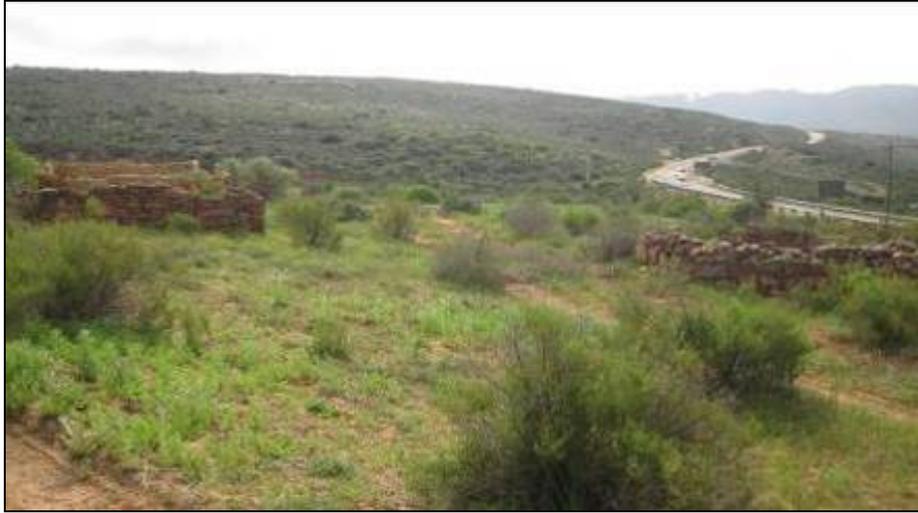
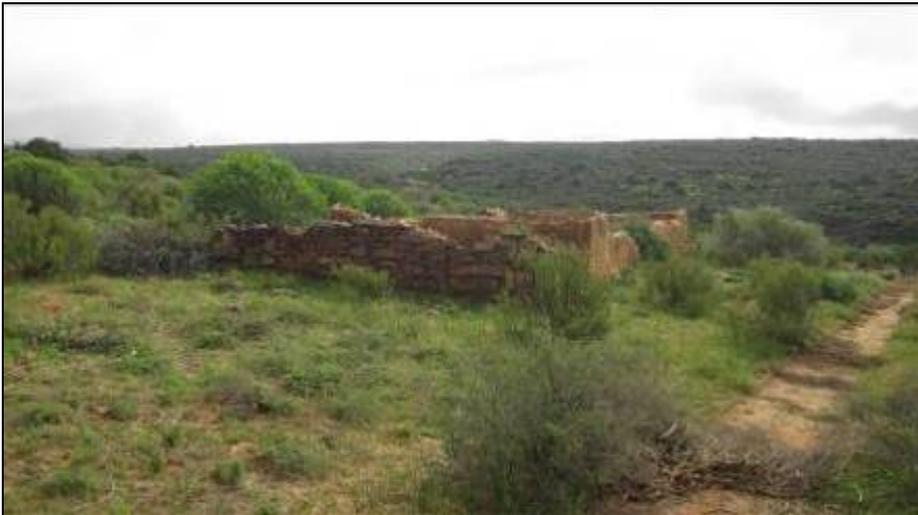
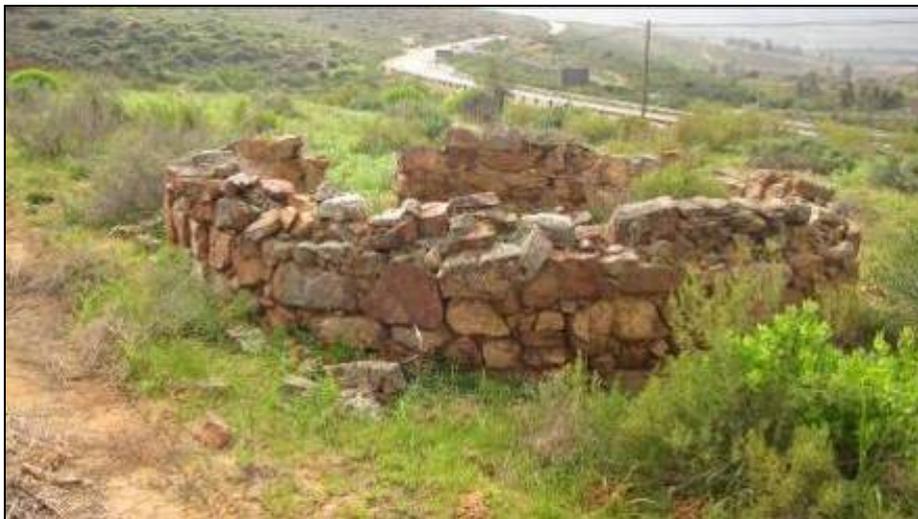
A **small ruined vernacular dwelling with associated stone kraal and possible bread oven** are also found along the alignment of Ramp 1. It is not unfortunately possible to re-align this section of the ramp to avoid the structures. The site probably dates to around the late 19th c judging by the occasional fragments of transfer printed refined earthenware, scattered about, and although of some moderate heritage interest, consent would probably be granted by HWC for demolition after some basic recording and mitigation has occurred (Plates 6 - 8). A blank permit application form is included (Appendix 4)

Plates 6-8: A small vernacular building ruin and associated kraal lie directly on the alignment of Ramp 1 and would be severely impacted by the development. These structures could be mitigated by recording and collection.

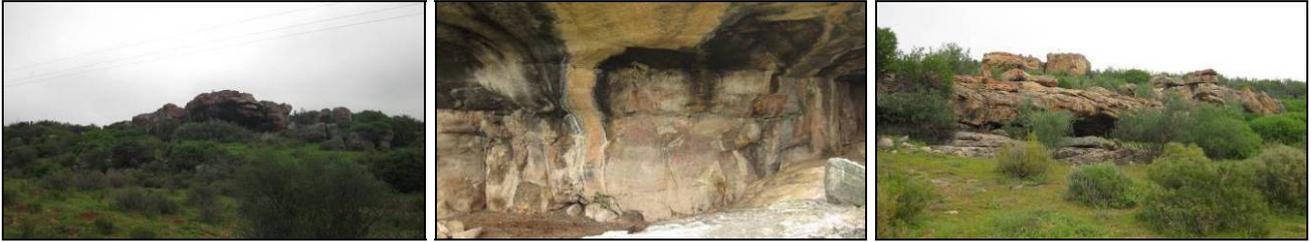
Two small rock shelters containing LSA artefacts and rock paintings occur some 180 meters from Ramp I and no direct impacts are anticipated from construction (Plates 9 - 11). Secondary impacts may result if the shelters are used by road workers during construction. The rock shelter containing the paintings (024) is already badly impacted by soot from fires and graffiti. The other shelter (025) is low and has no paintings so less impact is anticipated, if any.

Plates 9 - 11: A small rockshelter contains an ephemeral LSA deposit with artefacts and rock paintings. Another smaller low shelter has only a scatter of LSA artefacts on the talus.

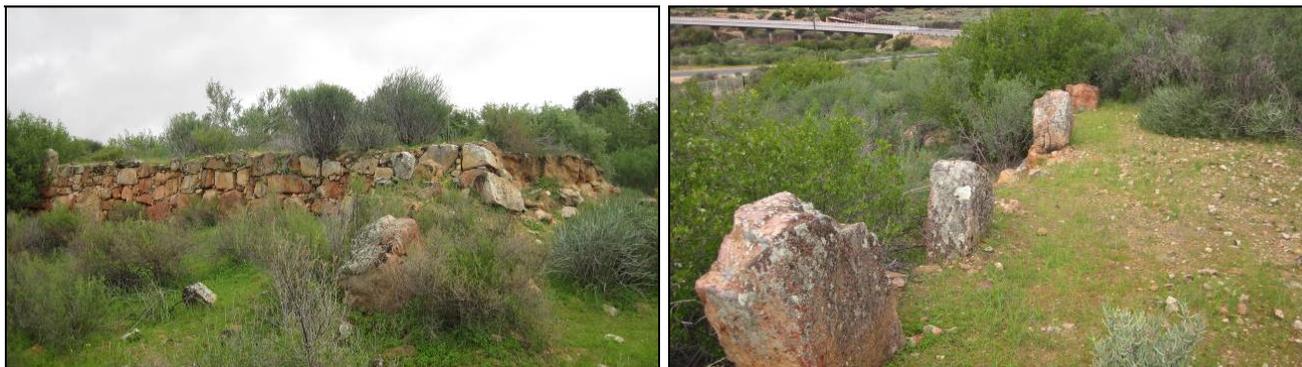
It is not clear who designed and built these roads, but the embankments with projecting stones along the top edges are reminiscent of both the 1860’s and 1930’s roads along the eastern side of the Clanwilliam Dam (Orton and Hart 2005, plates 26-35) (Plates 14 and 15). There was originally almost certain to have been a wagon track linking Clanwilliam to Graafwater and it is that that was probably

Plates 14 and 15: Historic road alignments with embankment walls and projecting edge stones

There is probably enough structural integrity for the remaining sections of old road to have some value from a tourism and local interest perspective. Some impacts to these features can be sustained as only relatively small sections would be affected by the ramp alignment.

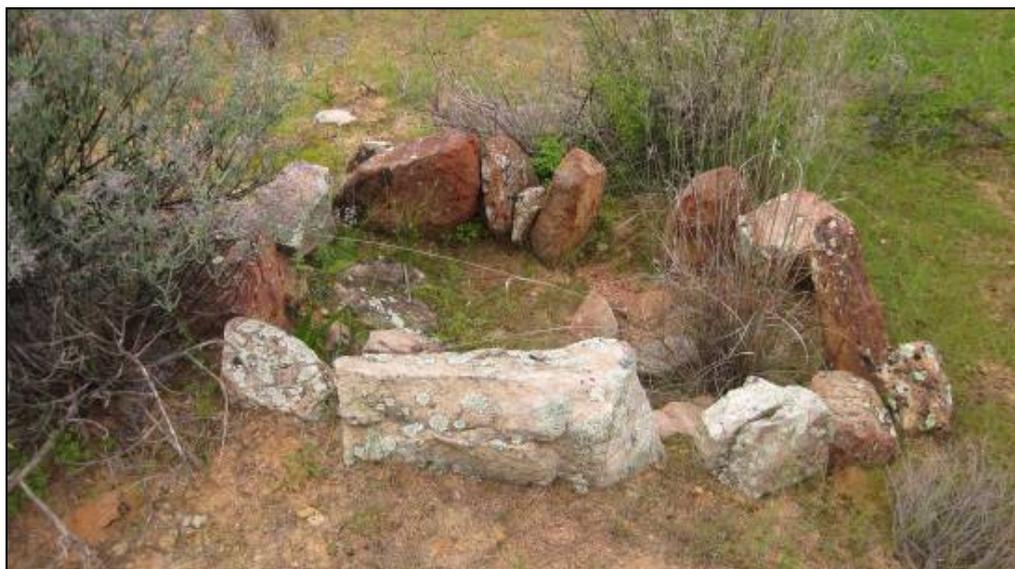
Another **enigmatic feature** (059) (Plate 16) might represent either a grave or something more mundane and associated with the old road. It lies close to the proposed ramp and according to the engineers, can be avoided by construction. It must be identified by the archaeologist and protected during the construction process.

Plate 16: A small enigmatic feature just off the alignment of ramp 2 may represent an informal grave. It must be identified and protected during the construction phase

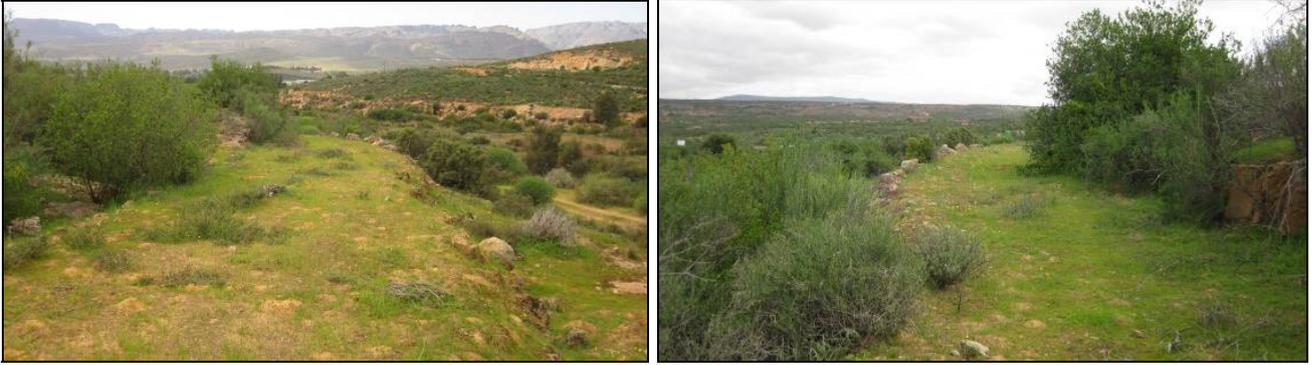
The area is already somewhat degraded due to the previous construction work for the N7. Being downslope of a road cutting, a fair amount of rubble has been placed here. Some areas are however unaffected. Two additional sections of **old road** (2) (described above) are found in this section and may have led down to a drift/or bridge across the Olifants River. Only a small section would be impacted by the ramp proposal (Plates 17 - 18). We have suggested some basic recording of road sections that would be impacted;

Plates 17 and 18: Old road alignments

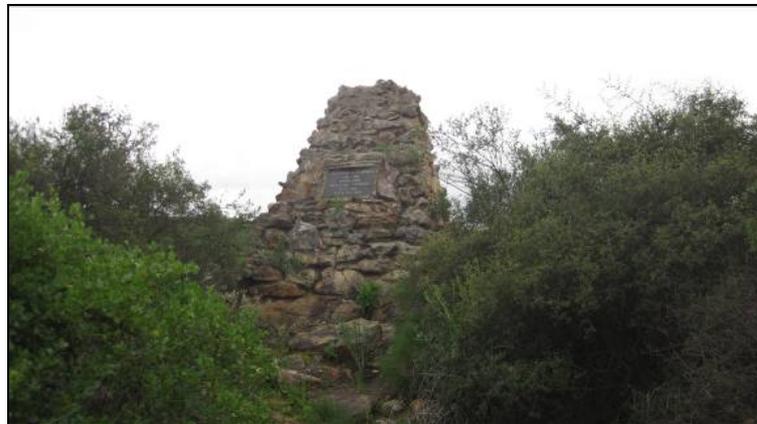
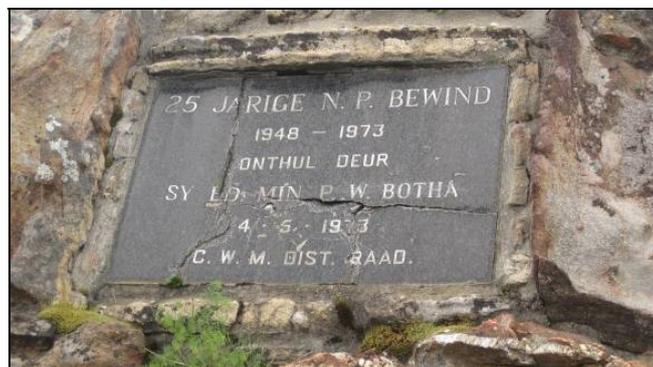
An attempt has already been made to destroy the polished granite plaque that is cemented into a rough sandstone block “obelisk” (Plates 19 - 20). The attempt at destruction is probably a form of protest.

Plates 19 and 20: Monument to “25 years of National Party rule...”

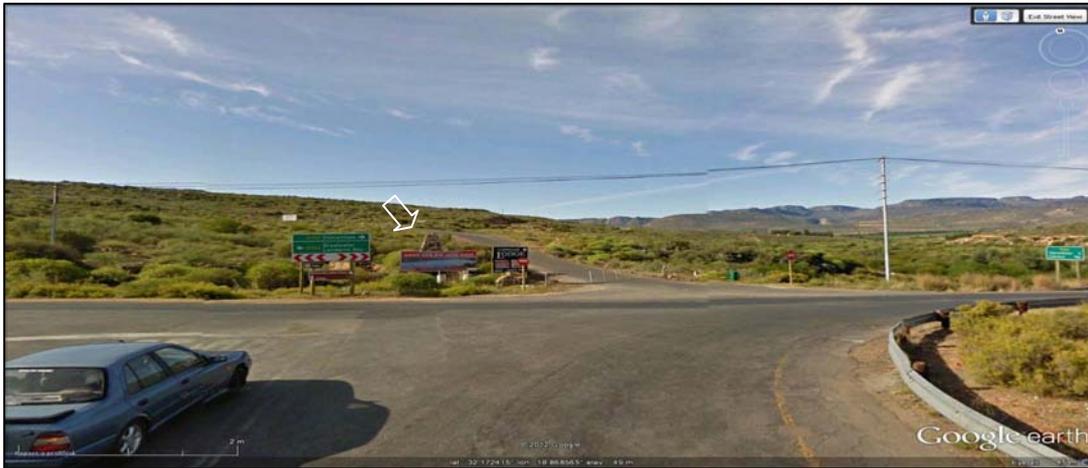
Once quite a prominent feature, lying directly in view of motorists entering the Clanwilliam intersection, the view is now largely obscured by various signage and billboards and would hardly be seen by the average motorist nowadays (Plate 21), although it would become more visible after construction of the new off ramp. We suspect that renewed acts of vandalism would occur. .

Plate 21: The monument (arrowed) is obscured by advertising boards and road signage.

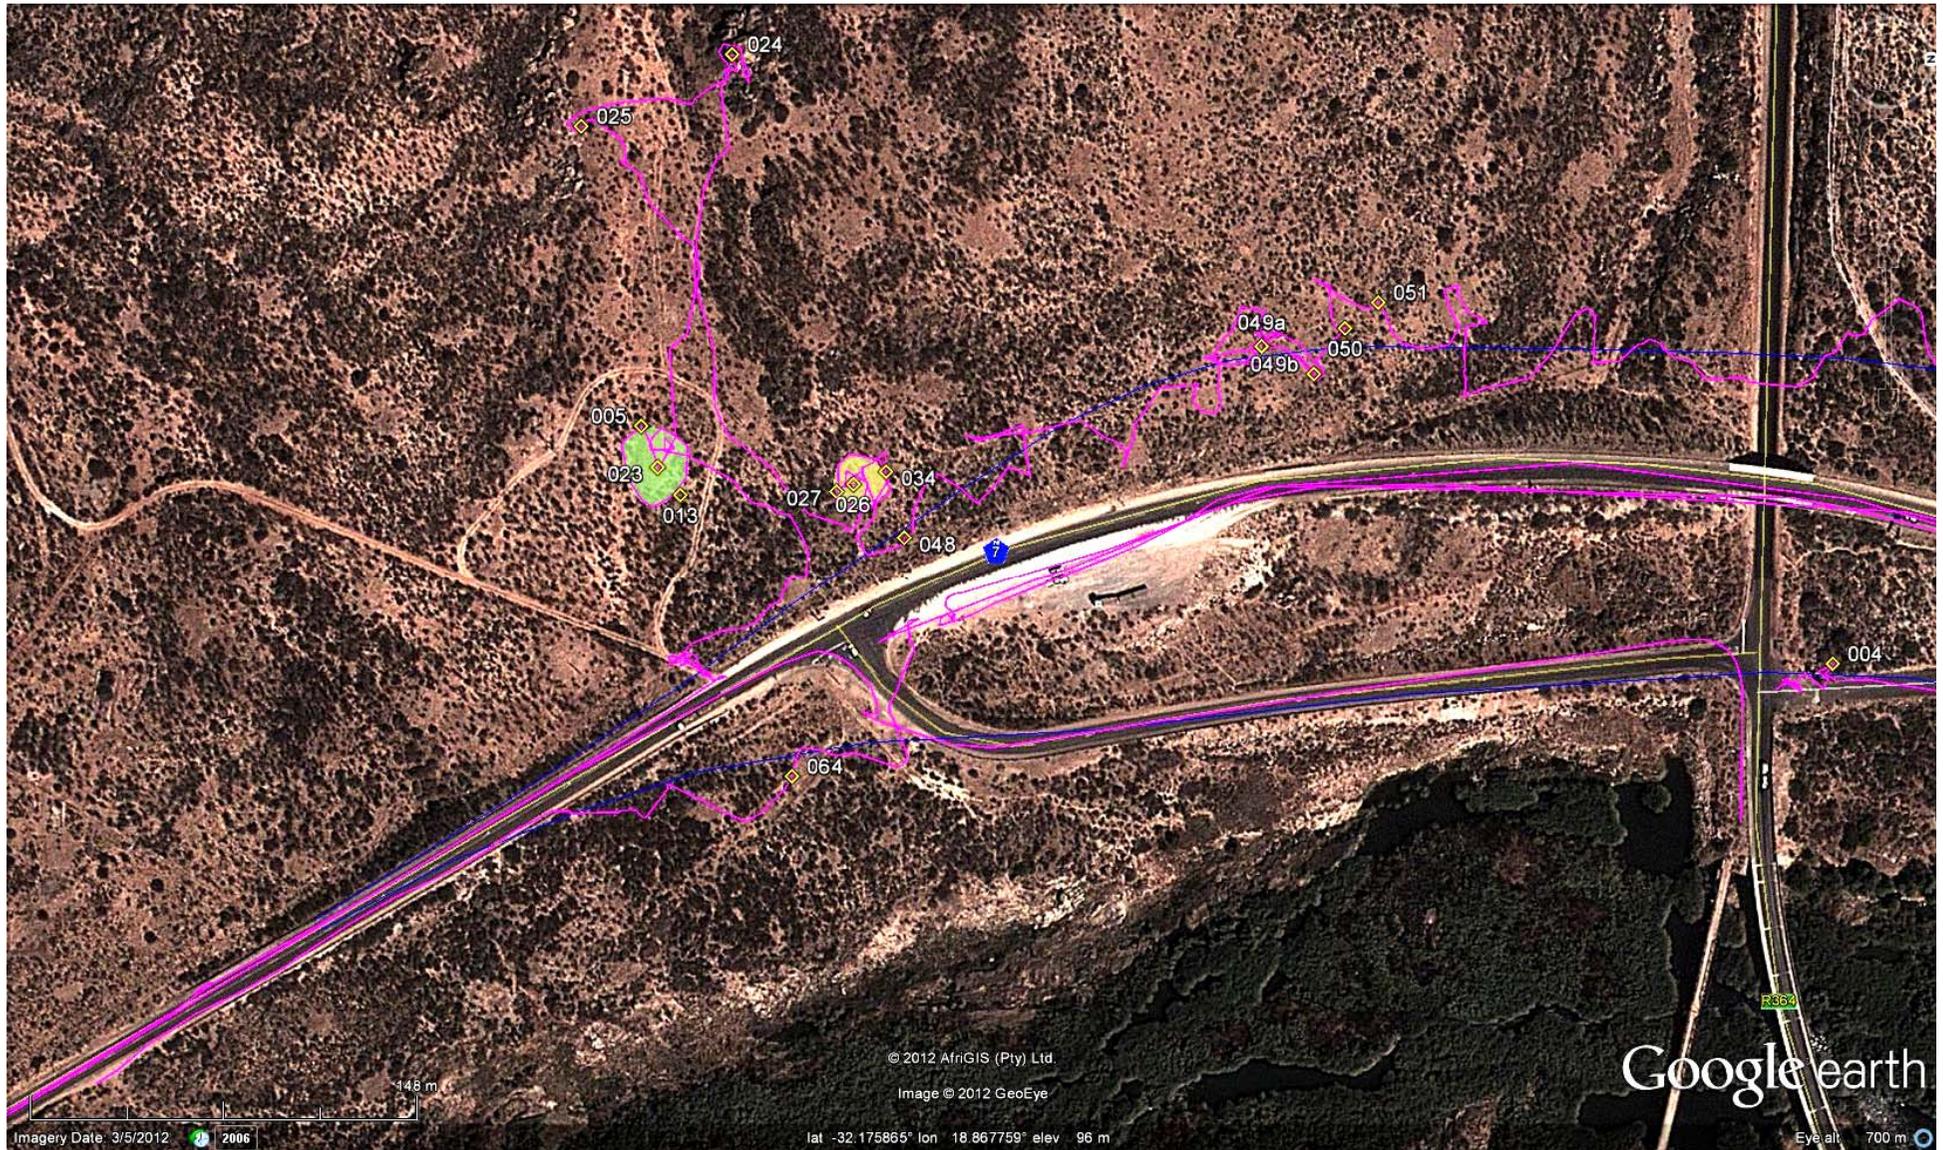
Figure 1: Detailed views of the ramp alignments 1(west) and 4 (east) (blue), Walk and drive paths (magenta), heritage sites (yellow diamonds), known informal cemetery (green shading), possible cemetery (yellow shading).

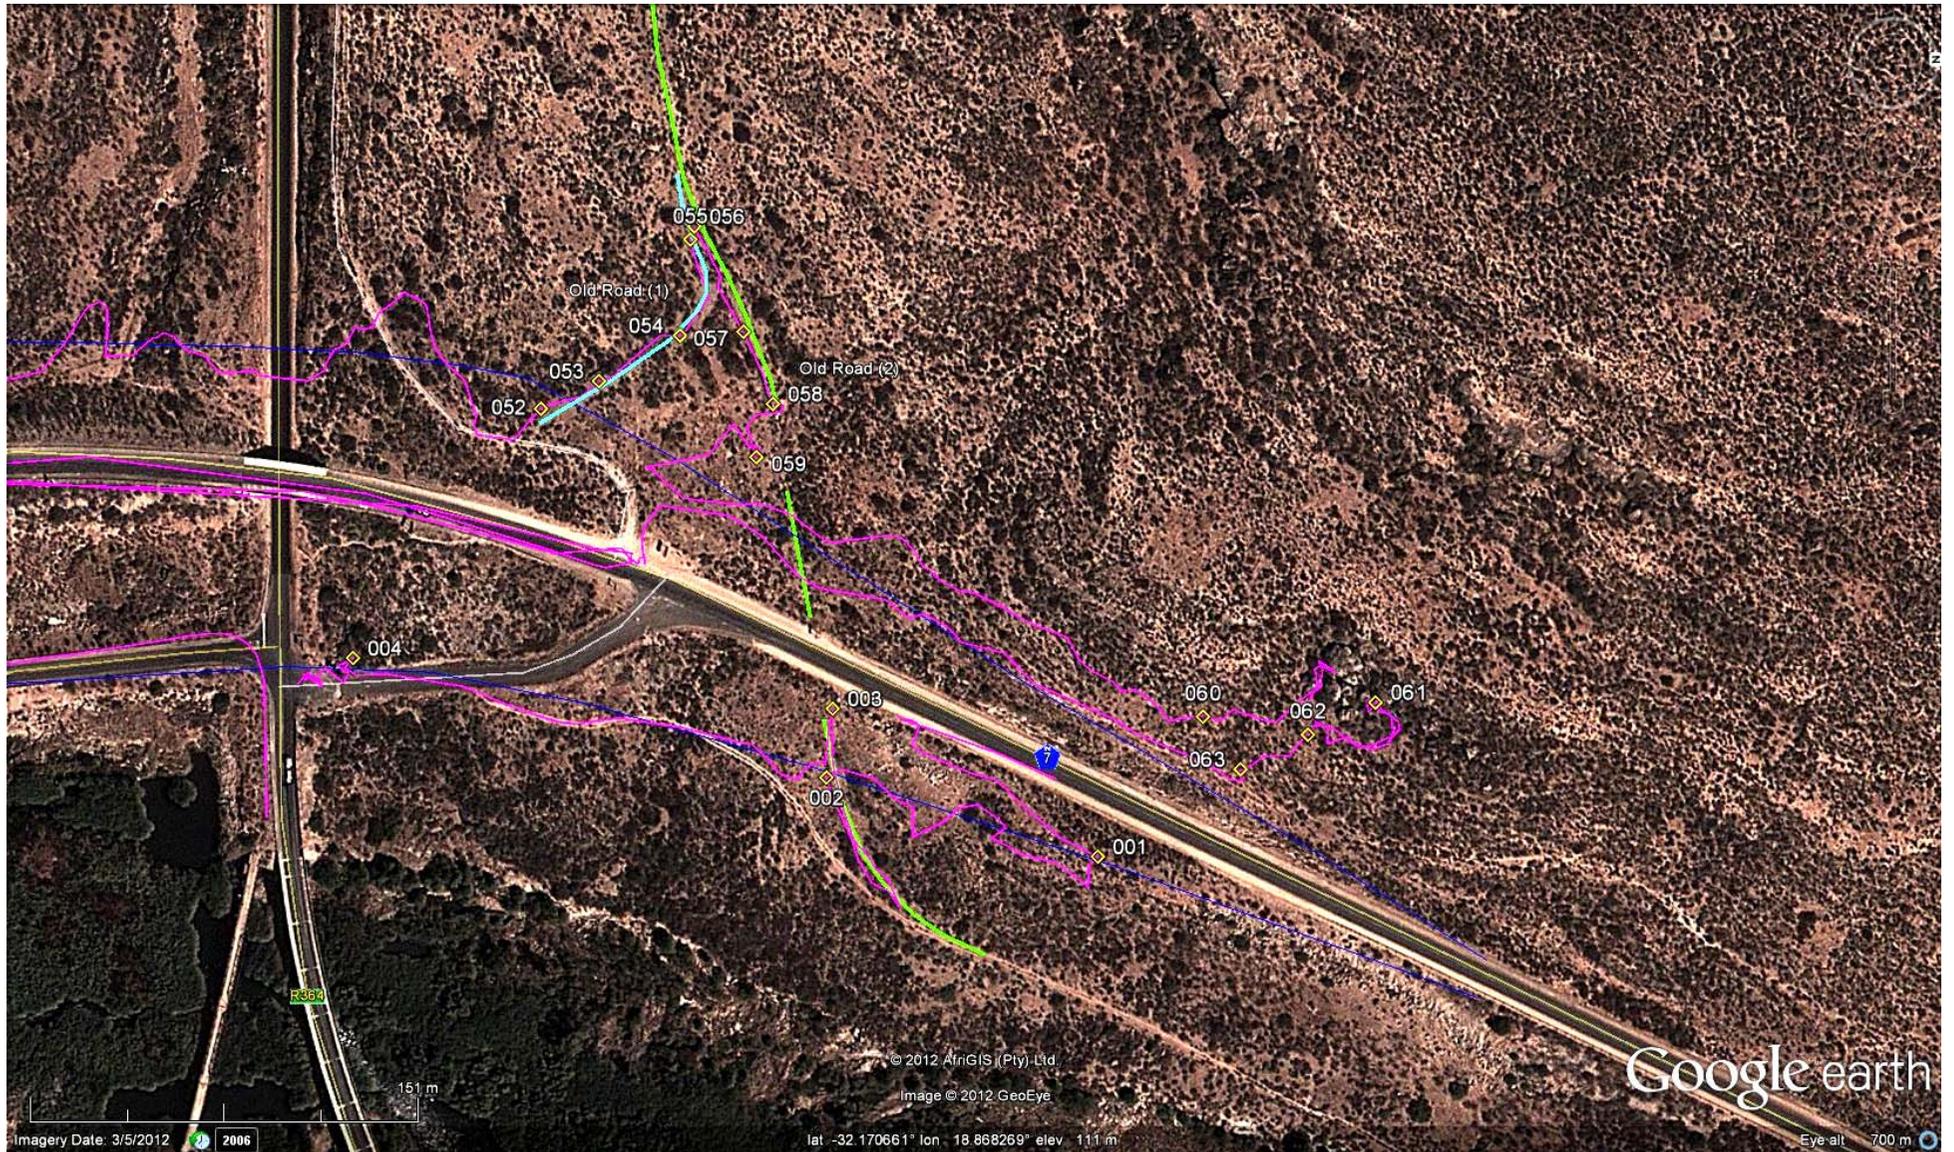
Figure 2: Detailed views of the ramp alignments 2 (west) and 3 (east) (blue), Walk and drive paths (magenta), heritage sites (yellow diamonds), old road (1) (turquoise), old road (2) (green).

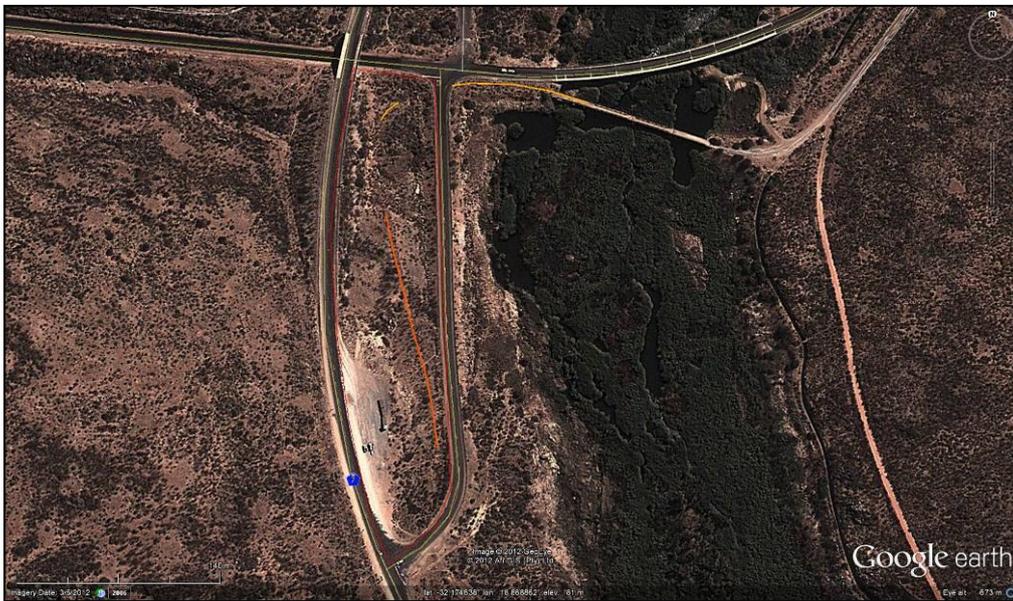
Sections of the old Clanwilliam Road are preserved within the proposed area and are indicated on Figure 2 and Plates 1 - 4. A section of old road (~170 meters) with preserved dirt surface fabric and dry stone embankment walls is noted in the southern half of the area (orange line). In the northern section of the site the road has been considerably disturbed and only sections of road surface were observed there, although in sufficient condition to indicate that the old road obviously linked up with the old iron girder bridge crossing the Olifants River in the direction of Clanwilliam.

Figure 2: Additional sections of old road were located within the area proposed as an alternative alignment for Ramp 4. Section indicated by orange line consists of old road surface fabric and dry stone embankment walls. Areas indicated by yellow lines only have surfacing preserved. The old road obviously linked up with the old iron girder bridge crossing the Olifants River.

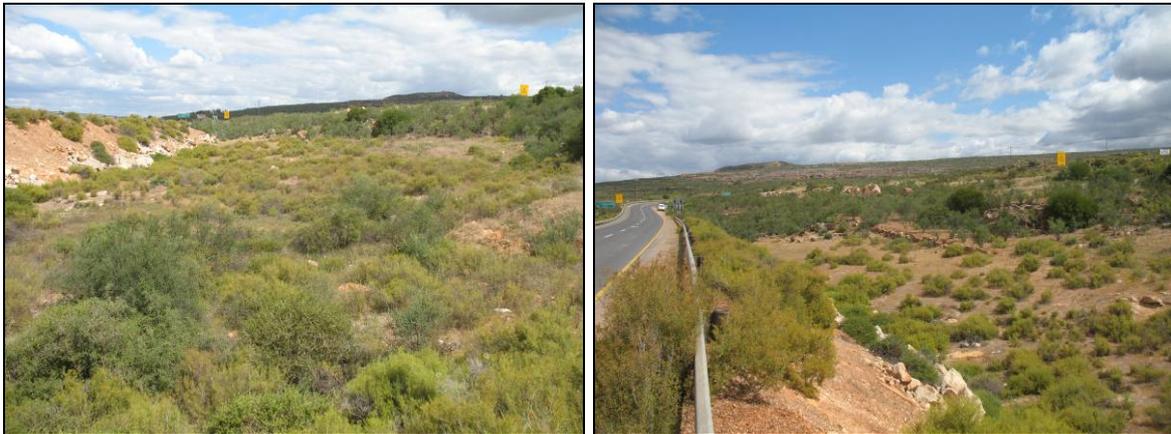
Plate 1: The site context lying between the N7 and existing offramp. Both are elevated on embankments.
Plate 2: The old road is marked by dry stone embankment walls in the southern section of the site.

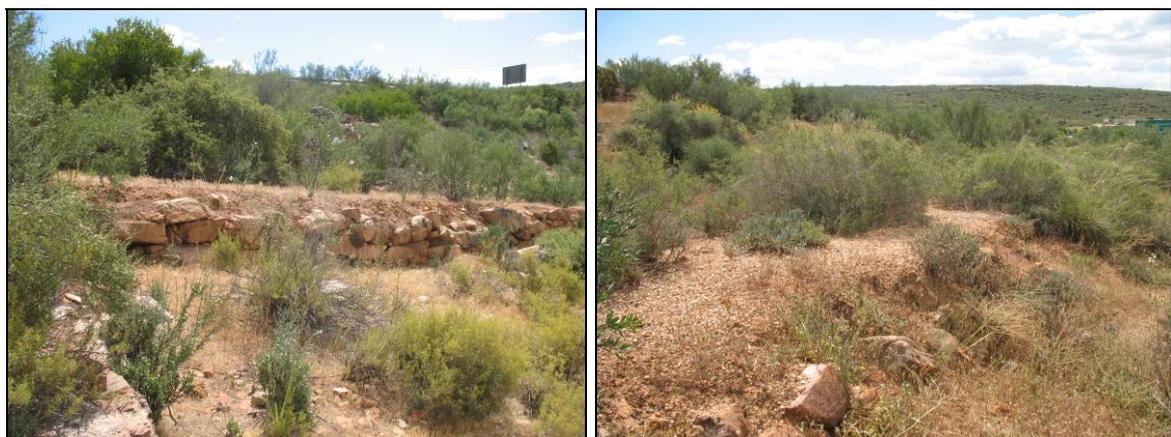
Plate 3: Dry stone embankment walls **Plate 4:** Old surface with traces of embankment stones in the northern section of the site

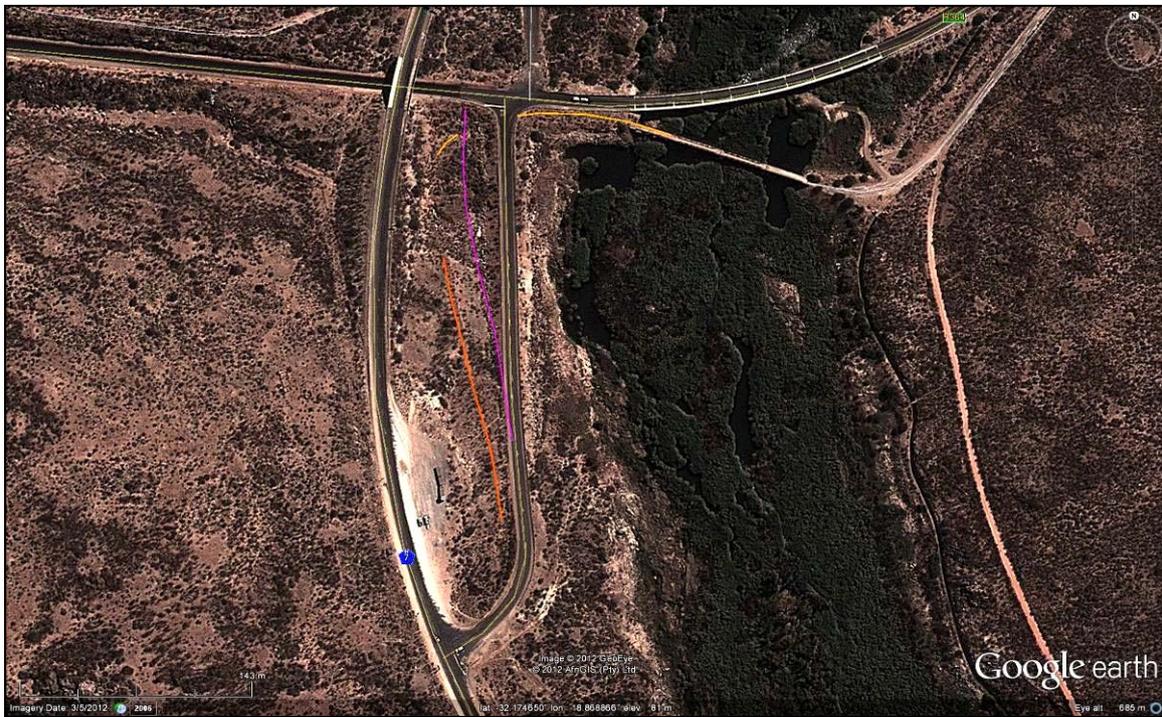
Figure 3: Possible mitigation of the old road would be to have the new off-ramp run parallel to it (purple line) if possible. This would mean that well preserved sections of the old road and dry stone embankment walls in the southern section of the area (orange line) could be retained. In our opinion, sections of the road in the northern section where only traces of the old surface is present could be removed.

Possible mitigation of the old road would be to have the new off-ramp run parallel to it (purple line) if it were possible to accommodate (see Figure 3). This would mean that well preserved sections of the old road and dry stone embankment walls in the southern section of the area (orange line) could be retained and preserved. In our opinion, sections of the road in the northern section where only traces of the old surface is present could be removed. The old road and old iron girder bridge (although not affected by this proposal) are not without some heritage significance and potential tourist value.

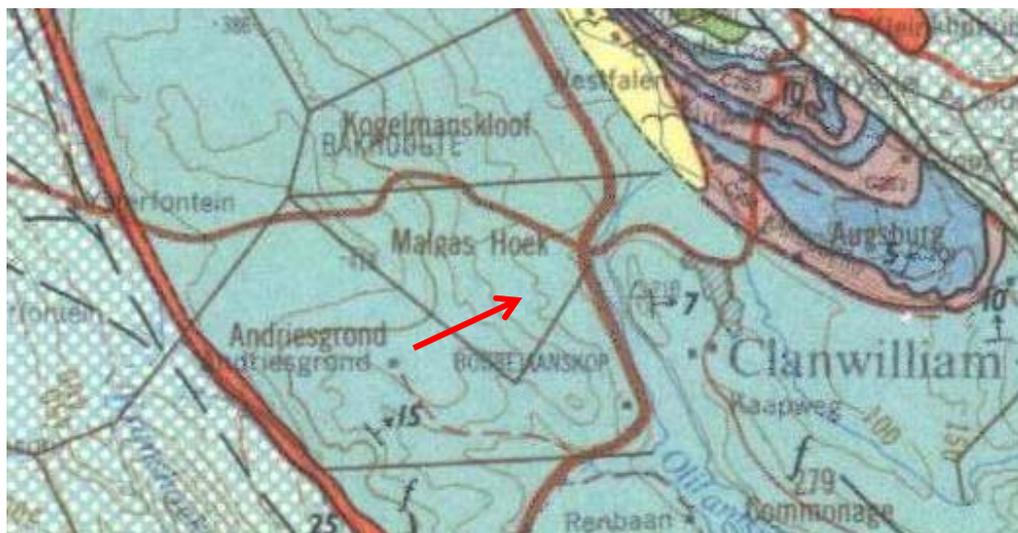
Locality details were provided. A desktop study was conducted, by Dr G. Avery, Archaeozoologist. Details of the underlying sediments are derived from 1:250 000 Geological Series 3218 Clanwilliam (Figure 2).

Figure 2. Section of 1:250 000 Geological Series 3218 Clanwilliam (location of proposed new interchange arrowed).
