**HERITAGE IMPACT ASSESSMENT  
 PROPOSED UPGRADE TO NATIONAL ROUTE 7,  
 SECTION 4 FROM TRAWAL TO VANRHYNSDORP,  
 WESTERN CAPE**

(Assessment conducted under Section 38 (8) of the  
 National Heritage Resources Act as part of an EIA)

October 2012

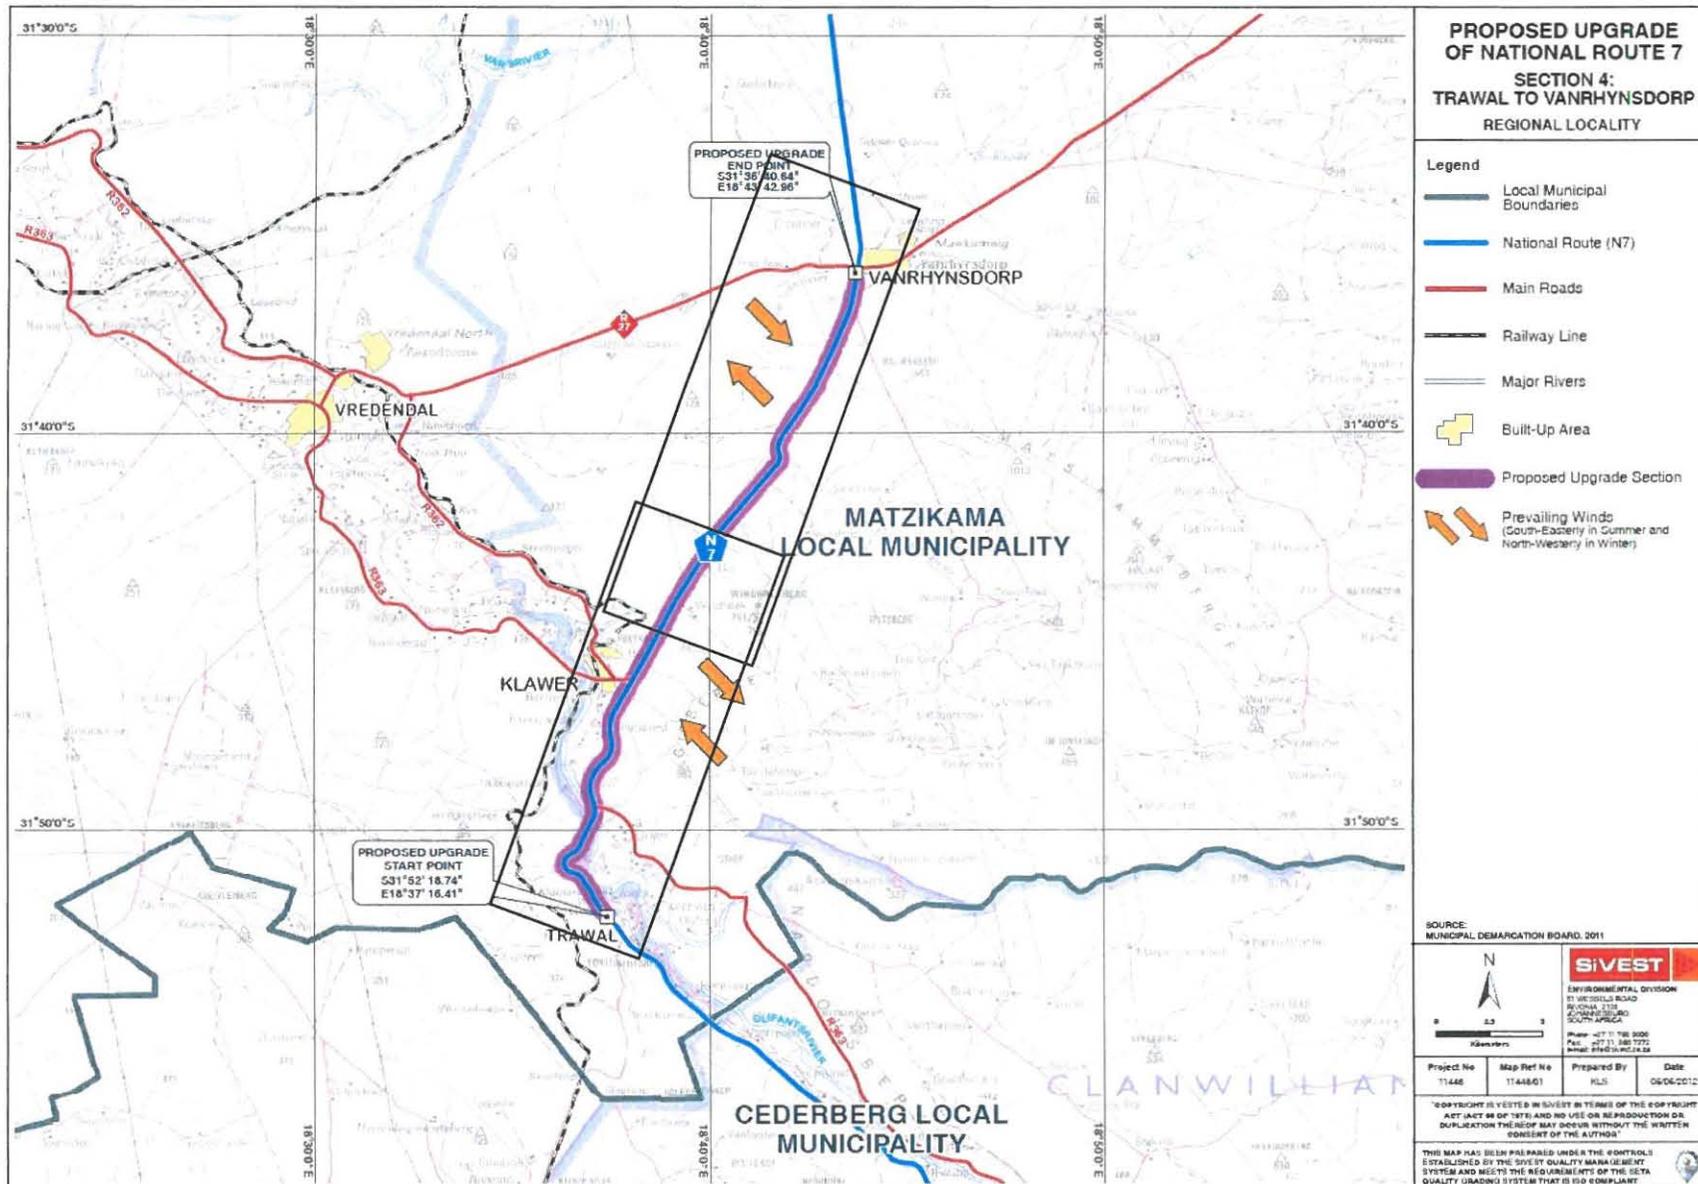
Figure 1: Route layout maps (supplied by client). Rectangles show the locations of the climbing lane diagrams in Figure 2 (author's addition)

Following the comment on the NID for the proposed project compiled by ACO Associates cc (see Appendix 1 - still awaiting comment) we have been appointed by SiVest to undertake a Heritage Impact Assessment, as part of the EIA process, that addresses particularly archaeological, palaeontological and visual issues for the proposed upgrade to National Route 7 Section 4, from Clanwilliam to Trawal (Figures 1 and 2).

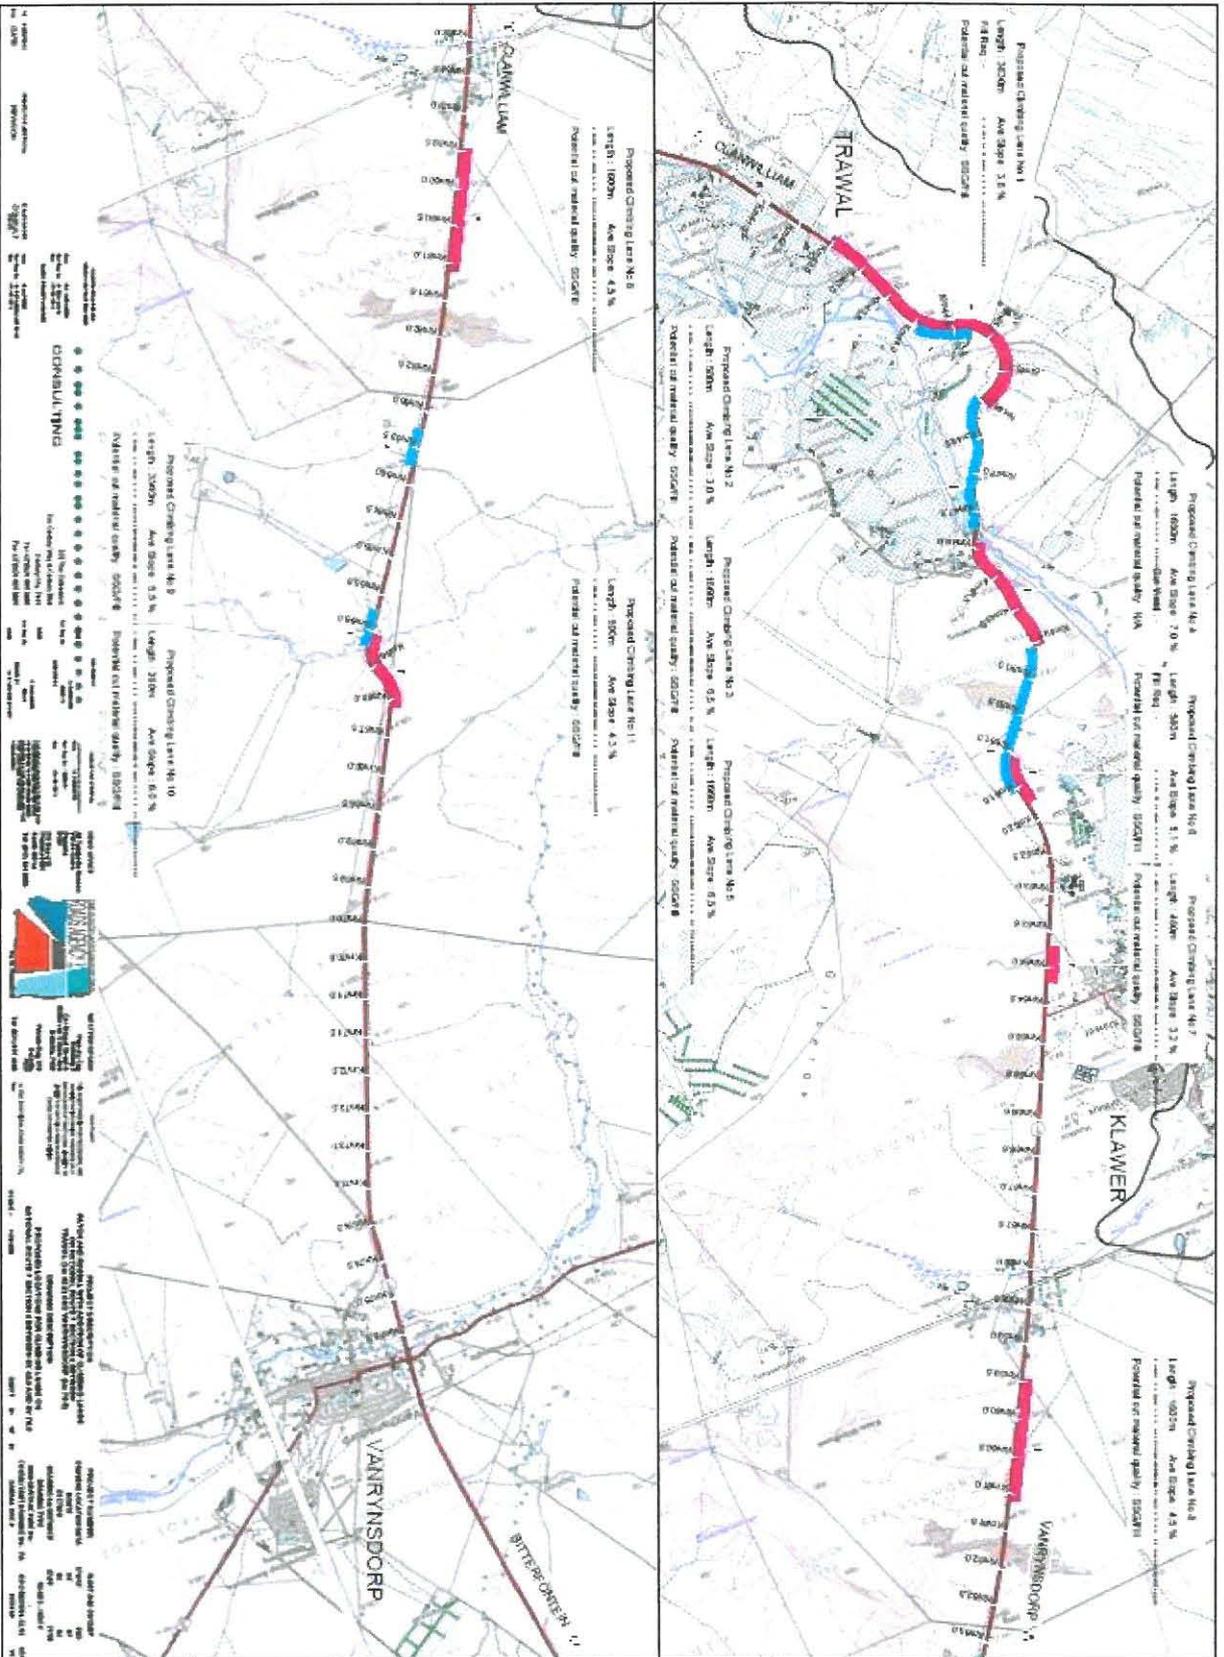
Figure 2: Proposed upgrade with passing lanes shown by red and blue stripes

The proposed project would undertake remedial measures aimed at improving the overall condition and safety of the N7, Section 4 from Trawal to Vanrhynsdorp within the Matzikama Municipality. The following activities are proposed: (see Figure 2 for detailed mapping):

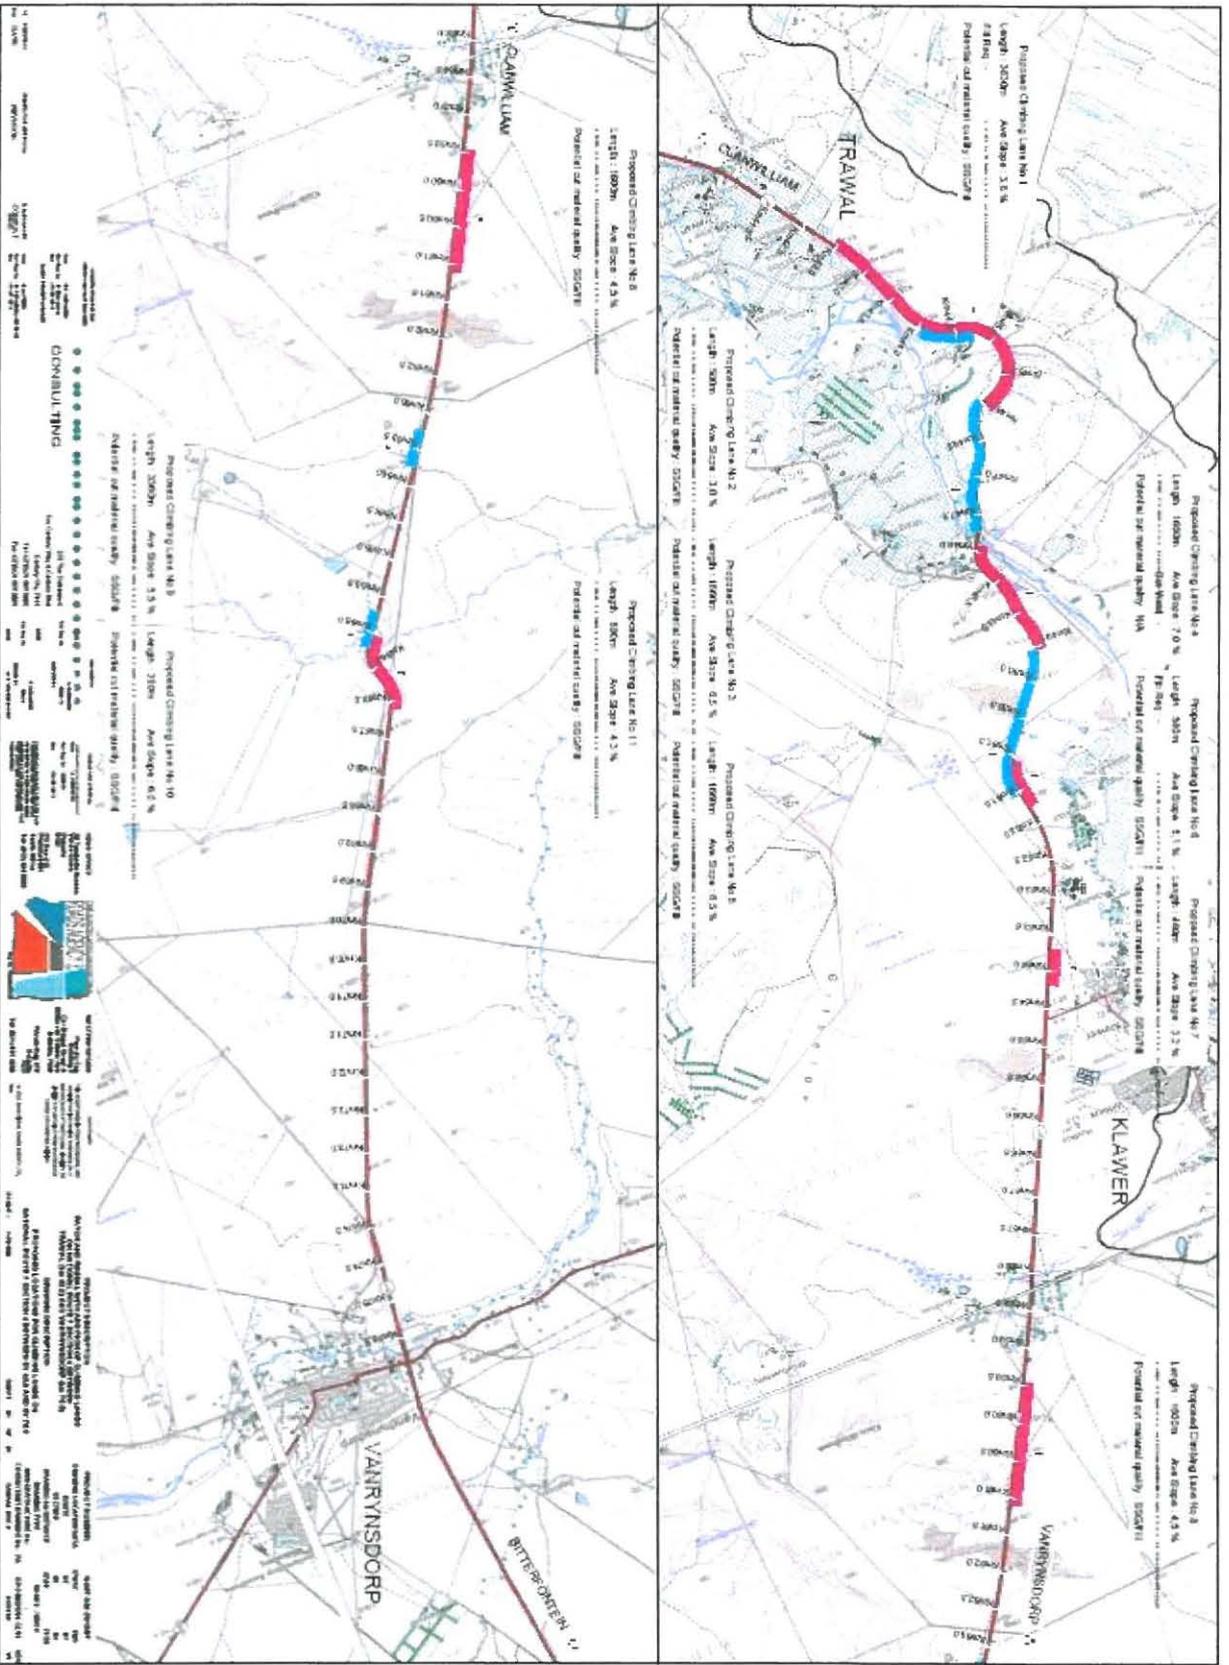
Figure 2: Proposed upgrade with passing lanes shown by red and blue stripes

Maps of the proposed Climbing Lane sections, culverts, bridges and borrow pits were provided by SIVEST (Figure 2). Lane sections were digitised and converted for uploading to handheld GPS receivers (set to the WGS84 datum) to facilitate the identification of the search area during field work. Drive and walk search paths were recorded with the GPS and photographs were captured to characterise the local receiving environment and heritage resources. Most works will occur within the existing road reserve although in some instances where existing conditions are difficult, additional land might have to be acquired to facilitate climbing/passing lanes.

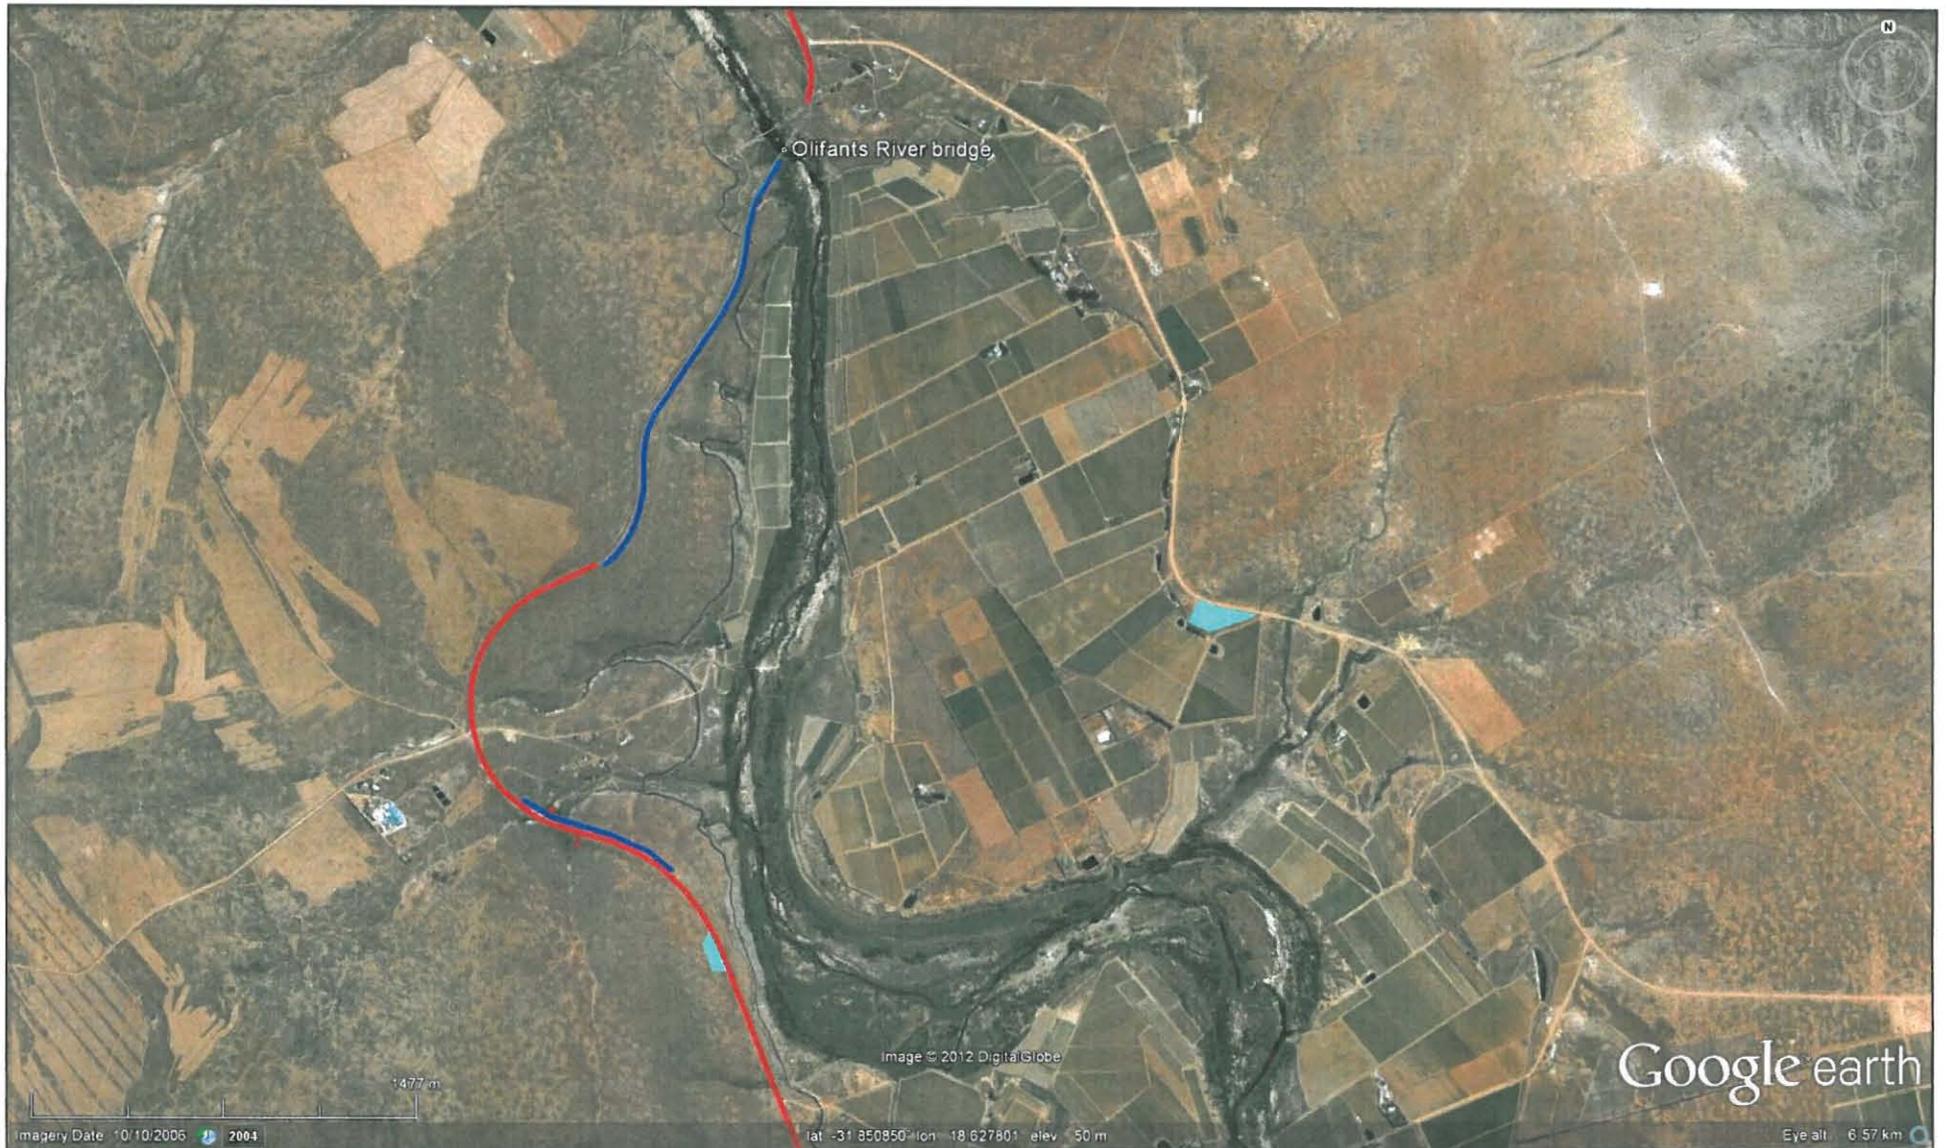
**Figure 3:** Most heritage issues lie within this area. The borrow pits are shown by Turquoise polygons, while the cemeteries by small ochre coloured polygons just to the south on the wide curve. Climbing lanes indicated by blue or red.

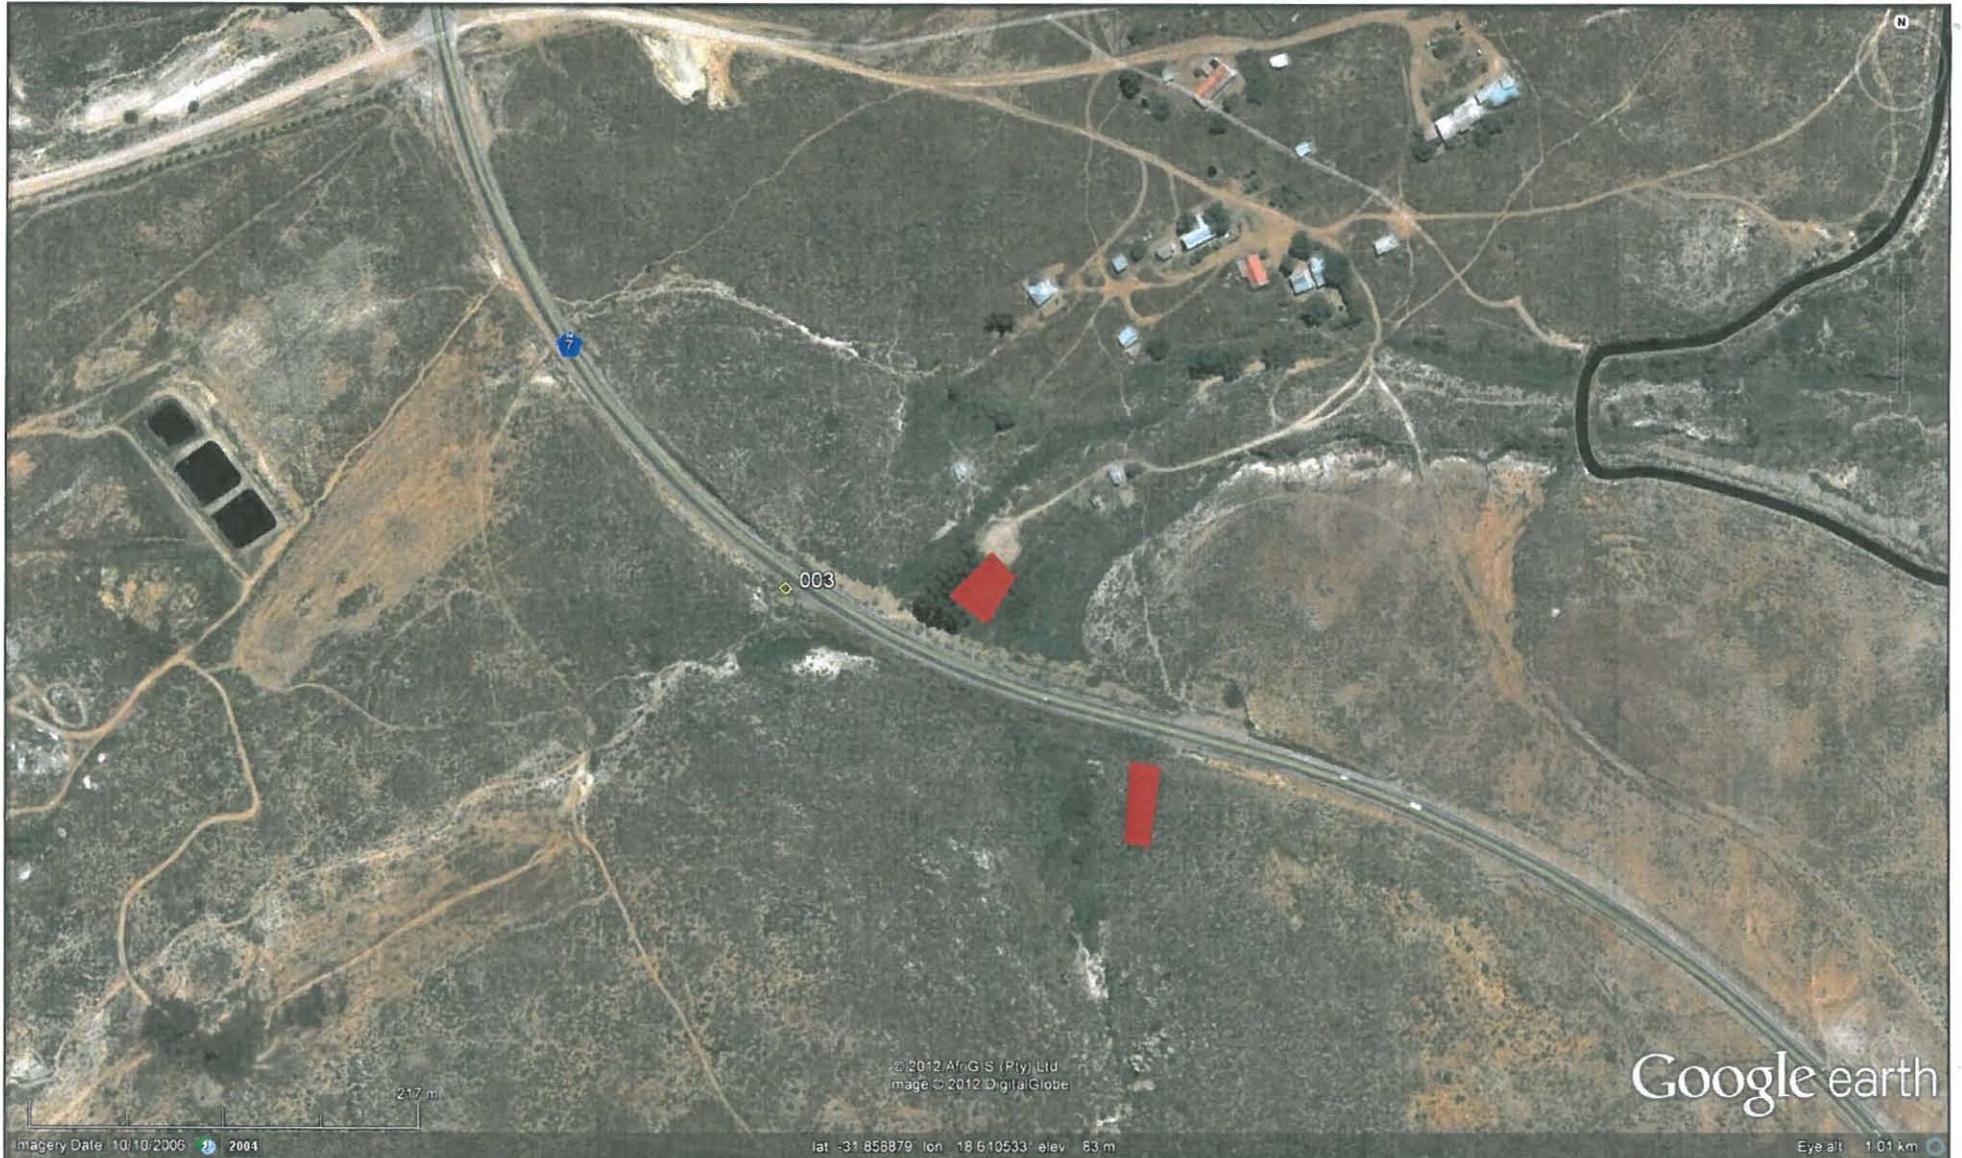
**Figure 4:** A small archaeological site is shown by marker 003. The two farm cemeteries are indicated by the ochre coloured polygons based on GPS co-ordinates. The road reserve appears lighter in colour than the surroundings and is elevated on road fill at this point to even out the gradients. Driefontein farm is situated on the northern side of the road.

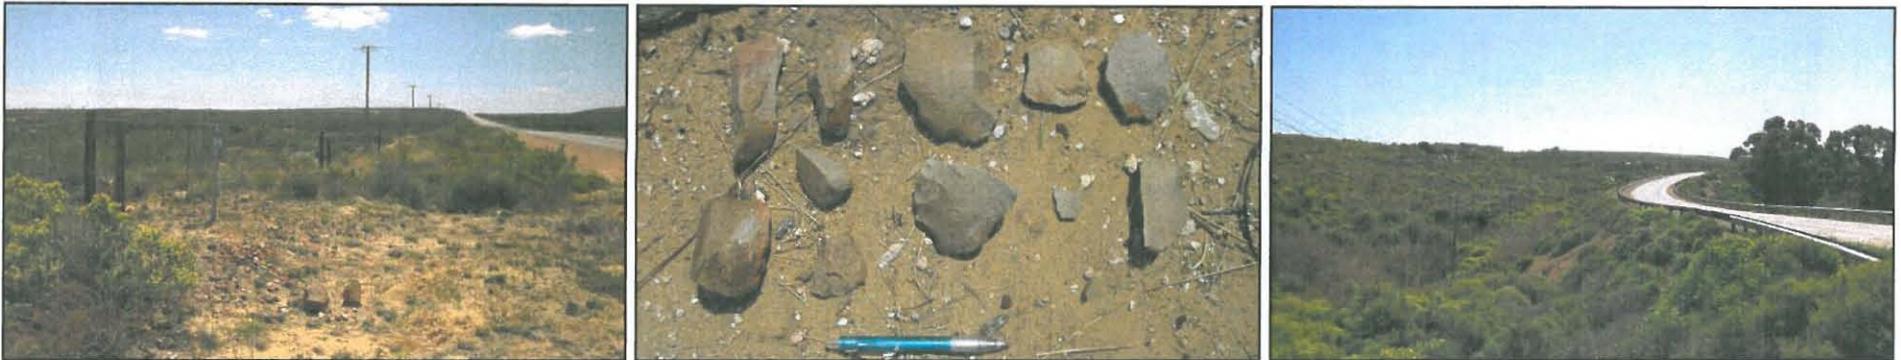
**Plate 1:** The location of the silcrete artefact scatter alongside the road at km 59.8. It is mixed with road gravel inside the road reserve but less so over the boundary fence. **Plate 2:** A selection of large flakes of rather fresh looking appearance. **Plate 3:** A band of TMS, seen in the distance at the bend of the road was previously cut during the building of the N7. The area in front was used by Late Stone Age people who left scattered artefacts there.

road. These had previously been cut through when the original N7 was prepared. A small scatter of Late Stone Age artefacts on silcrete, quartzite and quartz was found in semi-disturbed context just beyond the road reserve on a small "floor" in front of one of the boulders. Some quartz pieces were noted inside the road reserve amongst the rubble of the previous road cutting. No rock paintings were noted on the exposed boulders (Plates 3 - 5).	should be undertaken to collect and document the artefactual material. This can be easily achieved in a short time.
004a	S31.85981	E18.61164	climbing lane 1	Farm graveyard, very overgrown, containing in the order of 20-40 graves. Some of the recent graves close to the N7 are surrounded by the remains of fencing. Many are formal graves with stone or cement surrounds and headstones, while others are simpler with unmarked sandstone slabs used as headstones. Marine shell was noted on some graves. Several graves dated to the 1940's, 50's and 60's and the most recent from 1965. Van Zyl, Van Lill, Niewoudt are some surnames observed (Plates 6 - 10).	Although outside the existing road reserve, road fill to accommodate the widening of the lane, could encroach on the cemetery. The site must be surveyed onto plans and the engineers must determine if the road works can be accommodated without impacting the site. If it will be possible, the cemetery must nevertheless be cordoned off during construction with visible materials.

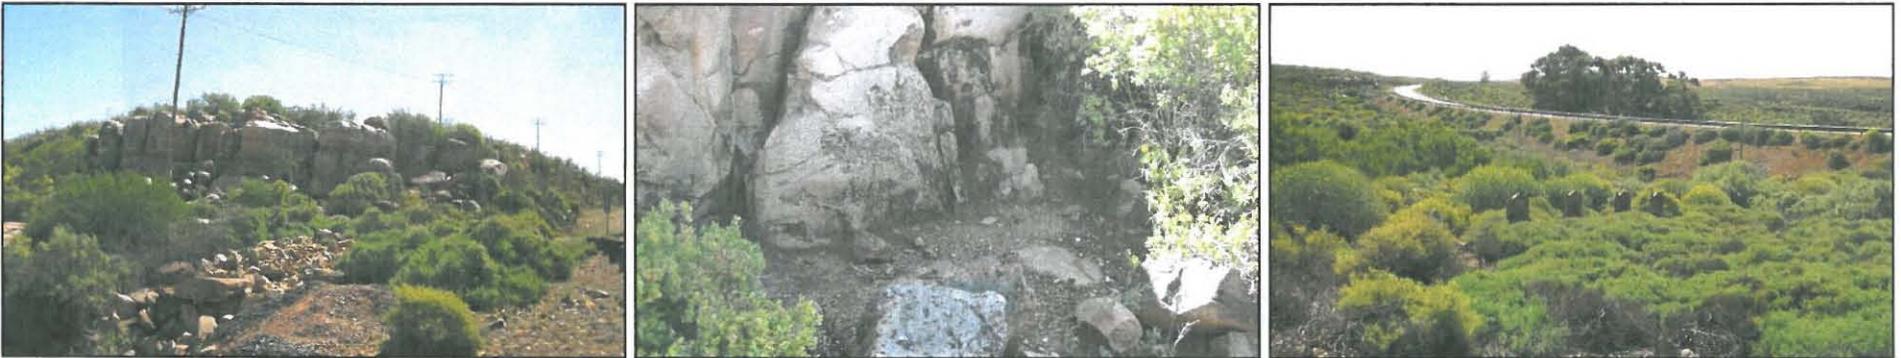
**Plate 4:** Debris from the previous road building can be seen to the side of the road. **Plate 5:** Small sandy “terraces” are too small for occupation but nevertheless contain scattered artefacts. Perhaps a more suitable shelter was removed during the initial road preparation? **Plate 6:** A row of cement gravestones protruding above the vegetation on an old silt terrace mark the one edge of an old farm cemetery (003). In the distance, a stand of bluegum trees identifies the location of another farm cemetery (005).

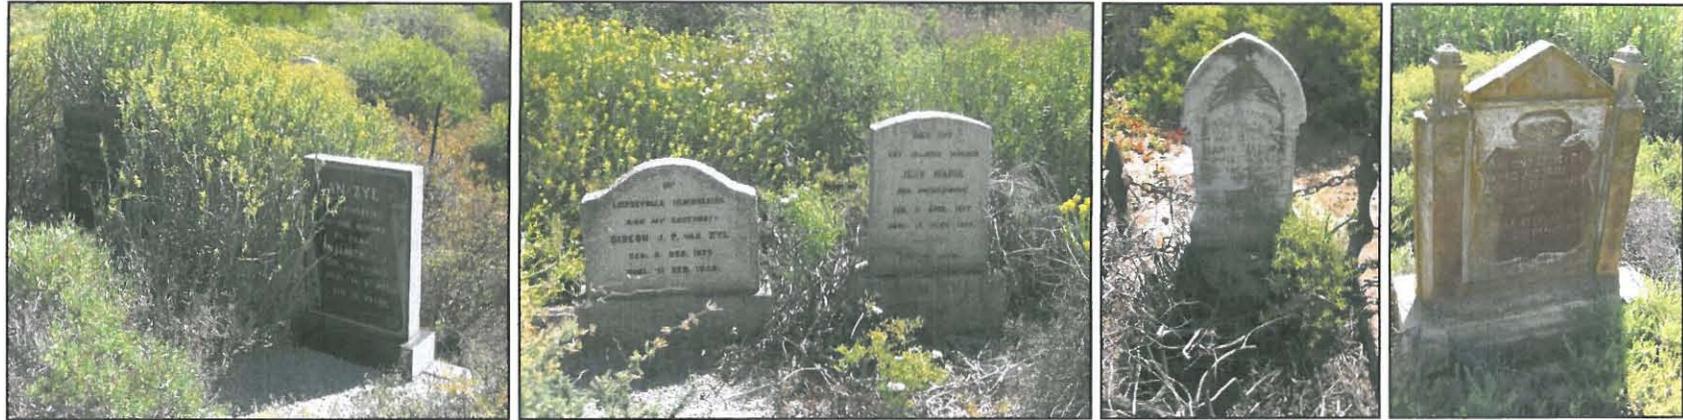
**Plates 7 - 10:** Formal graves date from the 1940's - 1960's. The names Van Zyl and Nieuwoudt are numerous. Some of the graves are marked only by simple stone mounds and sandstone slabs. Marine shell is noted on some graves.

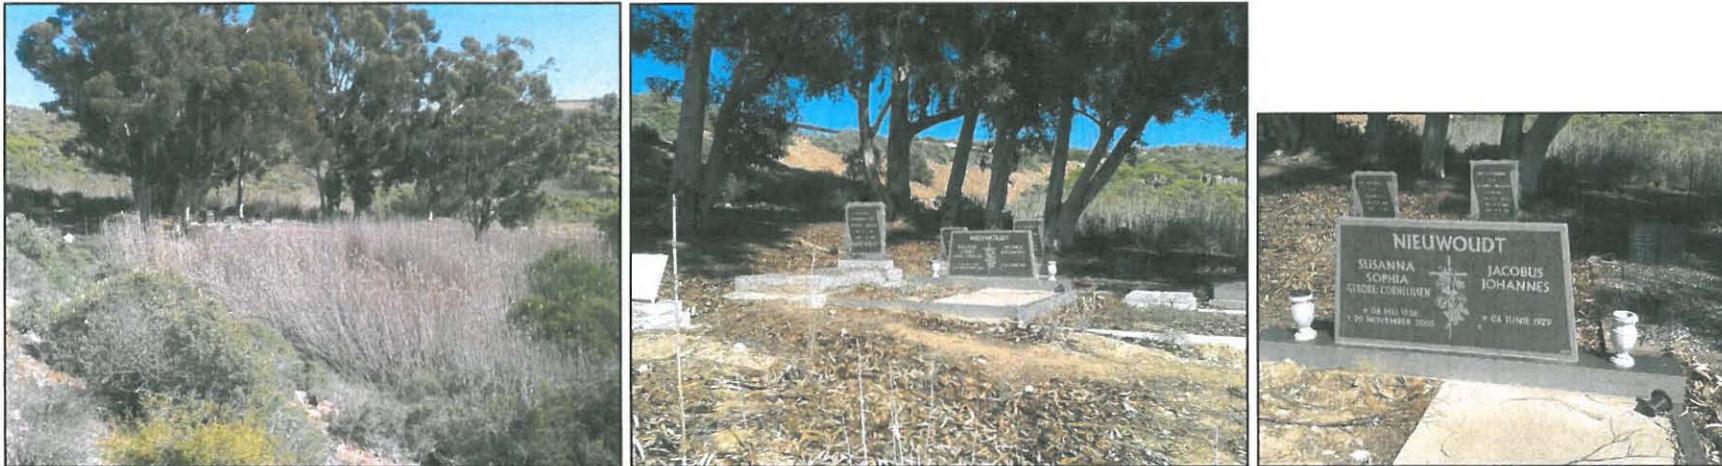
**Plates 11 - 13:** Another farm graveyard, surrounded by bluegum trees can be found immediately north of the N7 where 15 graves are present including graves of the Lochner, Nieuwoudt, Coetzee and Prins families.

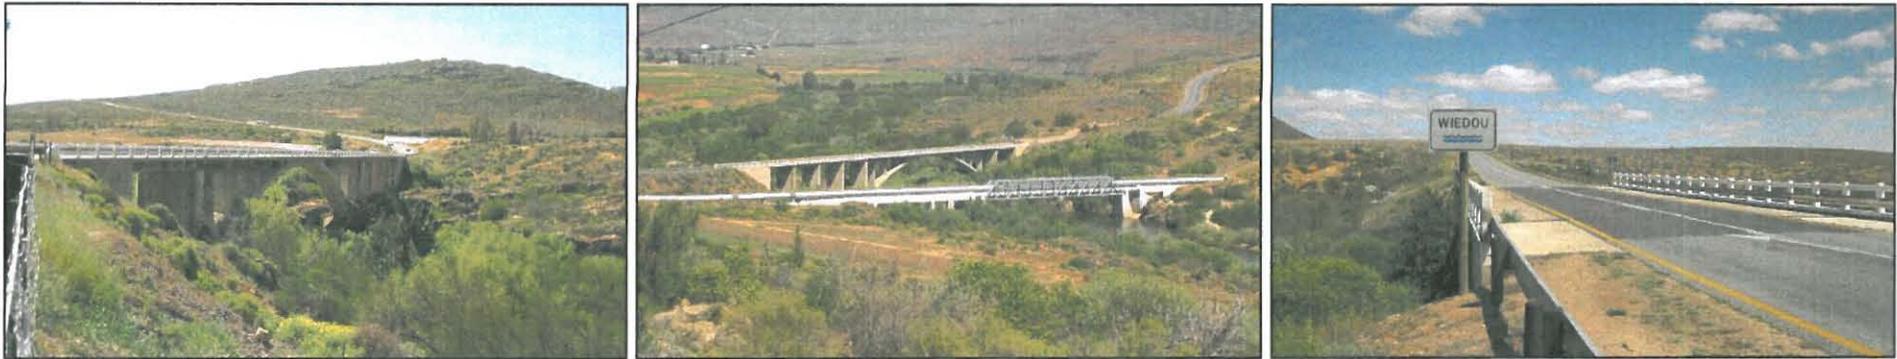
**Plates 14 and 15:** Two views of the Olifants River bridge. **Plate 16:** The Wiedou River bridge

There is no built environment to speak of along the route that will be directly affected by the proposals. The **Olifants River bridge** is perhaps the exception, that could be said has some aesthetic qualities. Postdating 1954, it is an elegant arched structure with some aesthetic qualities (Plates 14 & 15). Only the top of the bridge is being moderately widened to accommodate pedestrian traffic. The proposed work poses no archaeological (or visual) problems. The **Wiedou River bridge** is a standard concrete structure with no particular aesthetic qualities (Plate 16). It will only be resurfaced and so there are no archaeological concerns.

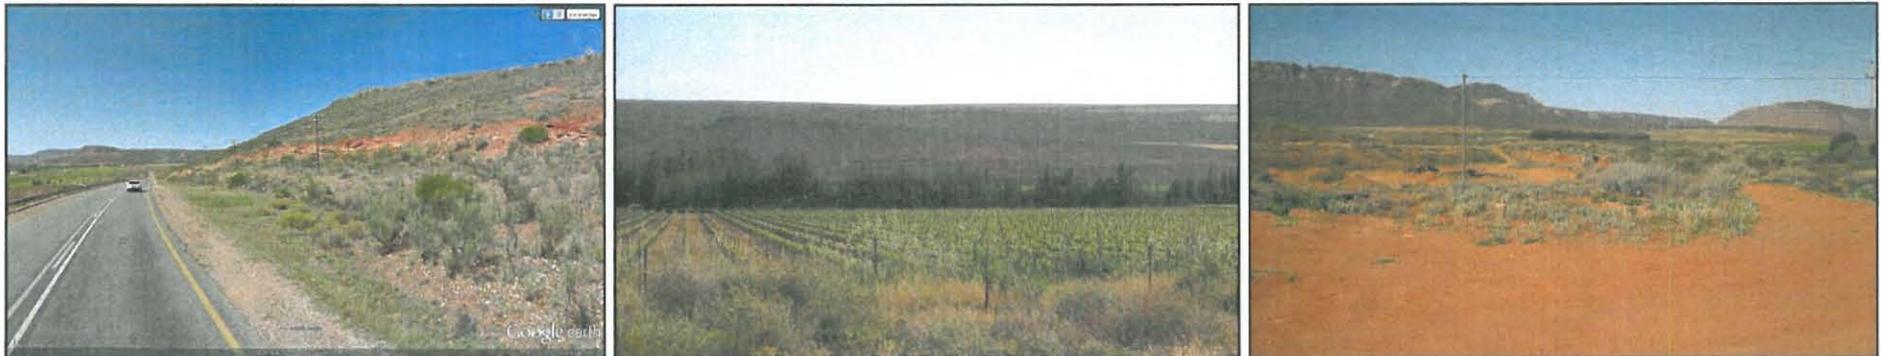
**Plate 17:** An existing borrow pit immediately adjacent to the N7 will be enlarged to supply material for the project. **Plate 18:** The N7 borrow pit can be seen in the distance as a dark line just above the treeline. **Plate 19:** An additional existing borrow pit on the divisional road to Clanwilliam may also be used to supply material for the project.

Two existing **borrow pits** are to be used in addition to material derived from road cuttings (Plates 17 - 19). Borrow pits will be expanded moderately to accommodate the requirements during the N7 upgrade. Minimal isolated ESA archaeological material was identified at BP2.

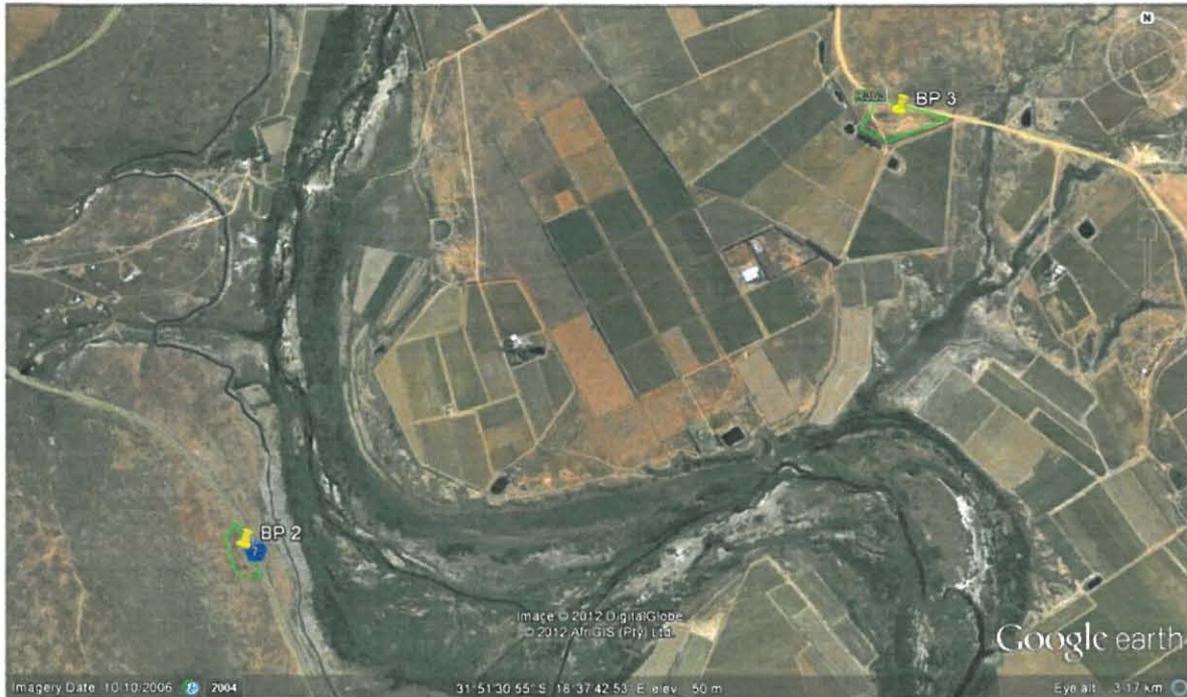
Figure 2. Location of the two proposed borrow pits, **BP 2** (31°51'50.28" S 18°37'01.63" E) and **BP 3** (31°51'07.66" S 18°38'16.60" E)

Figure 3. Google Earth view showing location of proposed borrow pits (ACO Report). Heuweltjies are present in the vicinity of BP2 (and see Figure 5). The surface of BP3 has been disturbed.

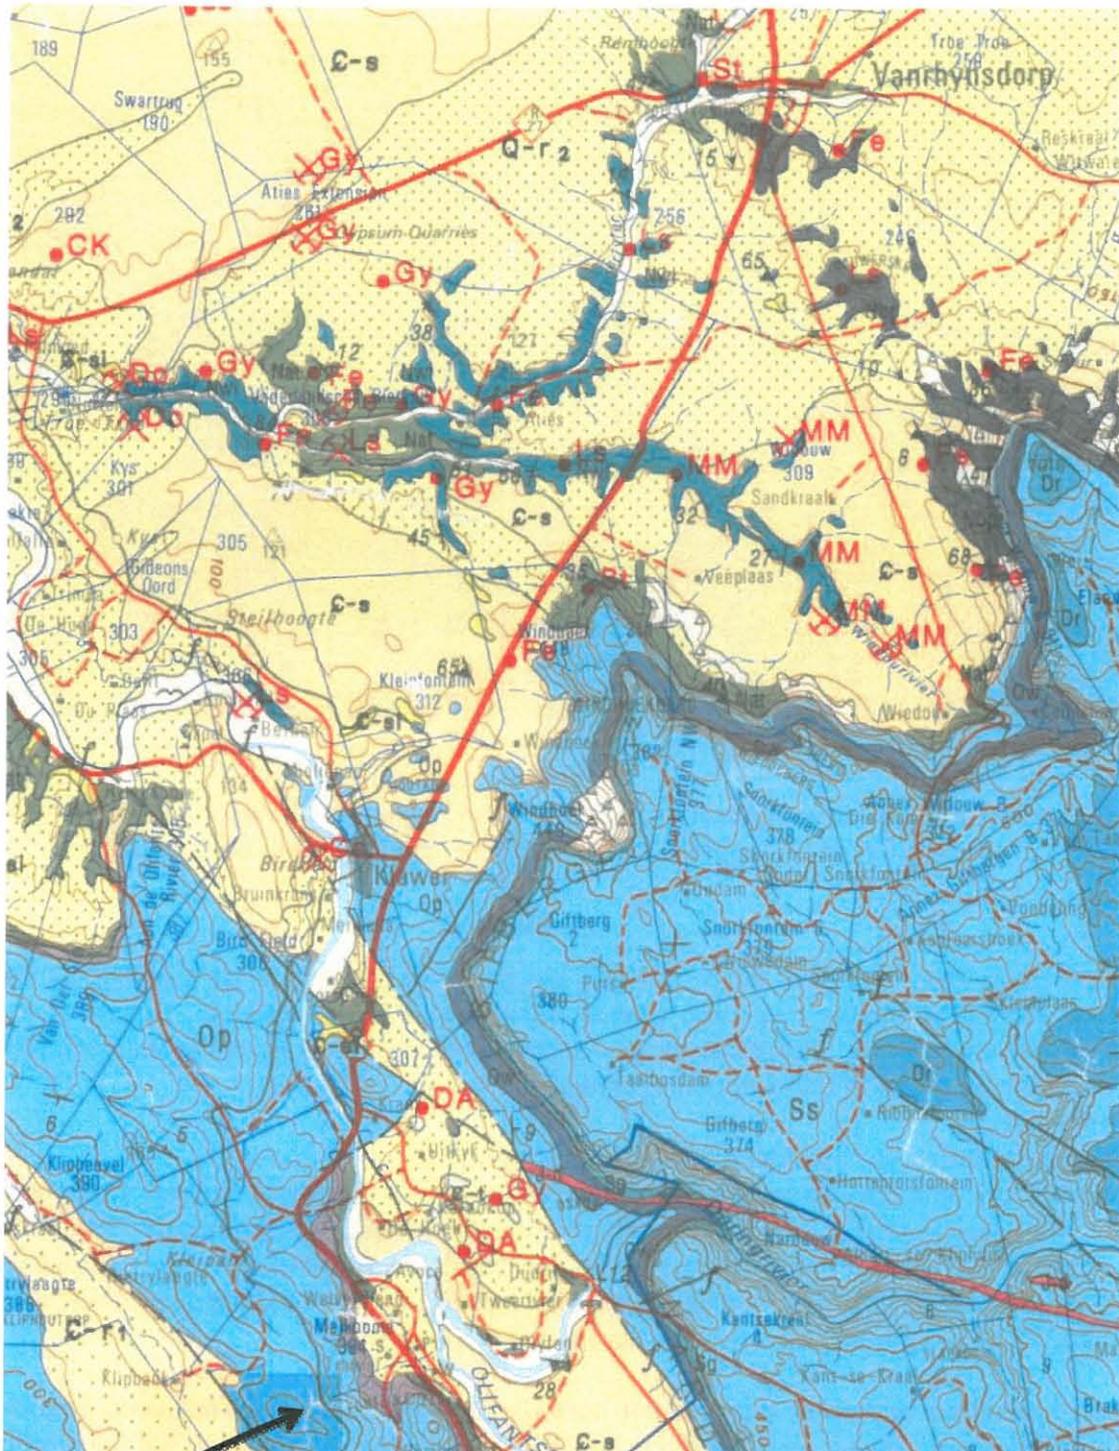
Figure 4. Section of 1:250 000 Geological Series 3118 Calvinia (arrow indicates Trawal).

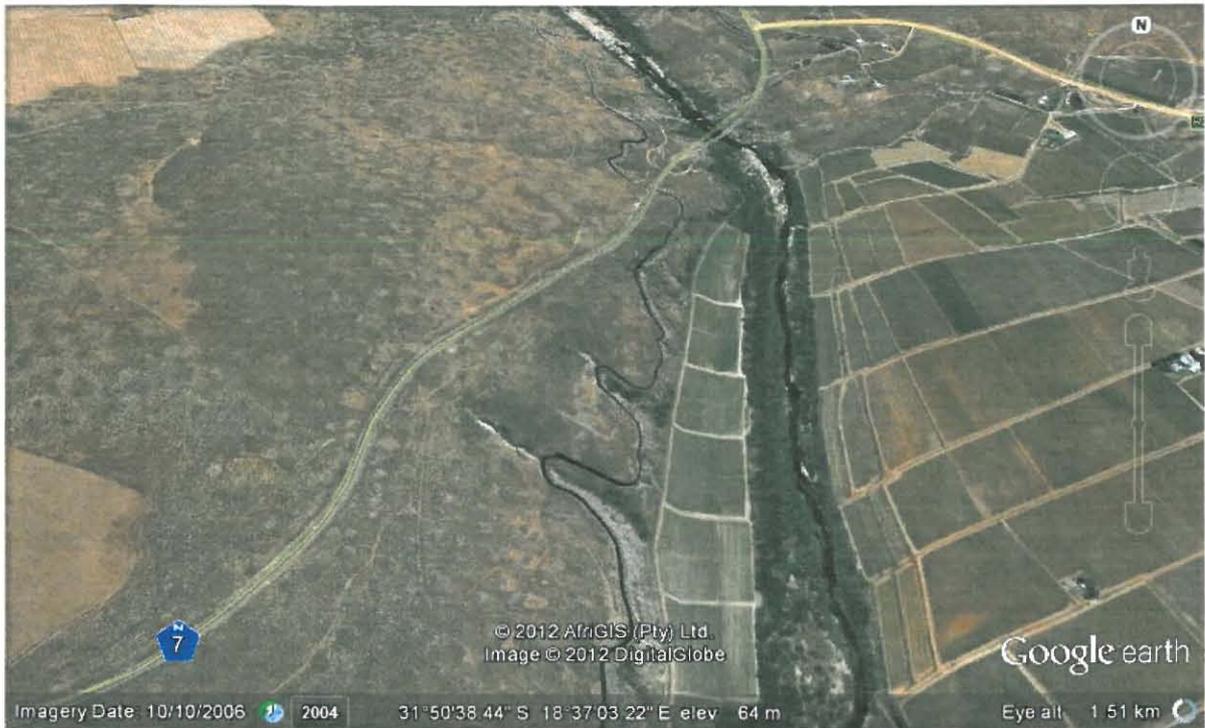
'Round', raised hummocks (known as "heuweltjies") occur on sandy substrates and are evident on the example shown in Figure 5 as scattered patches, often marked by vegetation different to their immediate surroundings. These features are considered to be remnants of fossil termite mounds (Francis et al. 2012). They are of potential interest. Fossils may be revealed if "heuweltjies" are cut through during excavations; under suitable conditions termite nests themselves can be preserved (Moore and Picker, 1991, Lovegrove and Siegfried, 1989). While active ardvarks dig into termitaria and their burrows may subsequently be occupied by bone-accumulating animals, such as hyenas and porcupines; the calcareous content of the mounds may help to preserve bones. "Heuweltjies are present in the vicinity of BP2, but BP3 appears to have already been heavily disturbed. Any excavation along the upgrade that cuts through a "heuweltjie" should be carefully monitored.

Figure 5. Google Earth image showing “heuweltjies” (centre-point 31°50’41.61”S; 18°36’52.80”E).

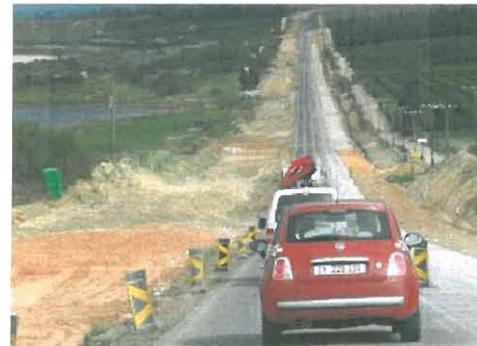
Example of road widening during construction of N7 between Citrusdal and Clanwilliam.

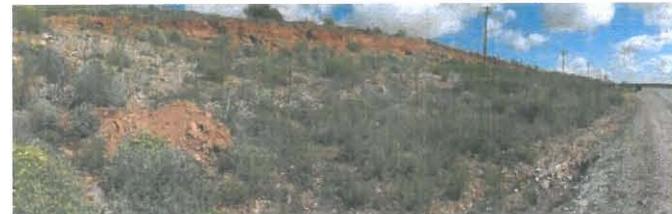
Existing borrow pit 'C' on the N7 identified for proposed expansion.

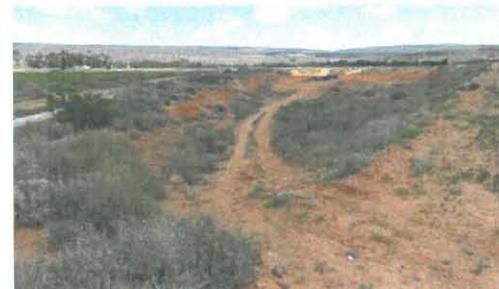
Existing borrow pit 'D' on district road, identified for proposed expansion for road works.
