**HERITAGE IMPACT ASSESSMENT  
 PROPOSED UPGRADE TO NATIONAL ROUTE 7,  
 SECTION 4 FROM TRAWAL TO VANRHYNSDORP,  
 WESTERN CAPE**

(Assessment conducted under Section 38 (8) of the  
 National Heritage Resources Act as part of an EIA)

October 2012

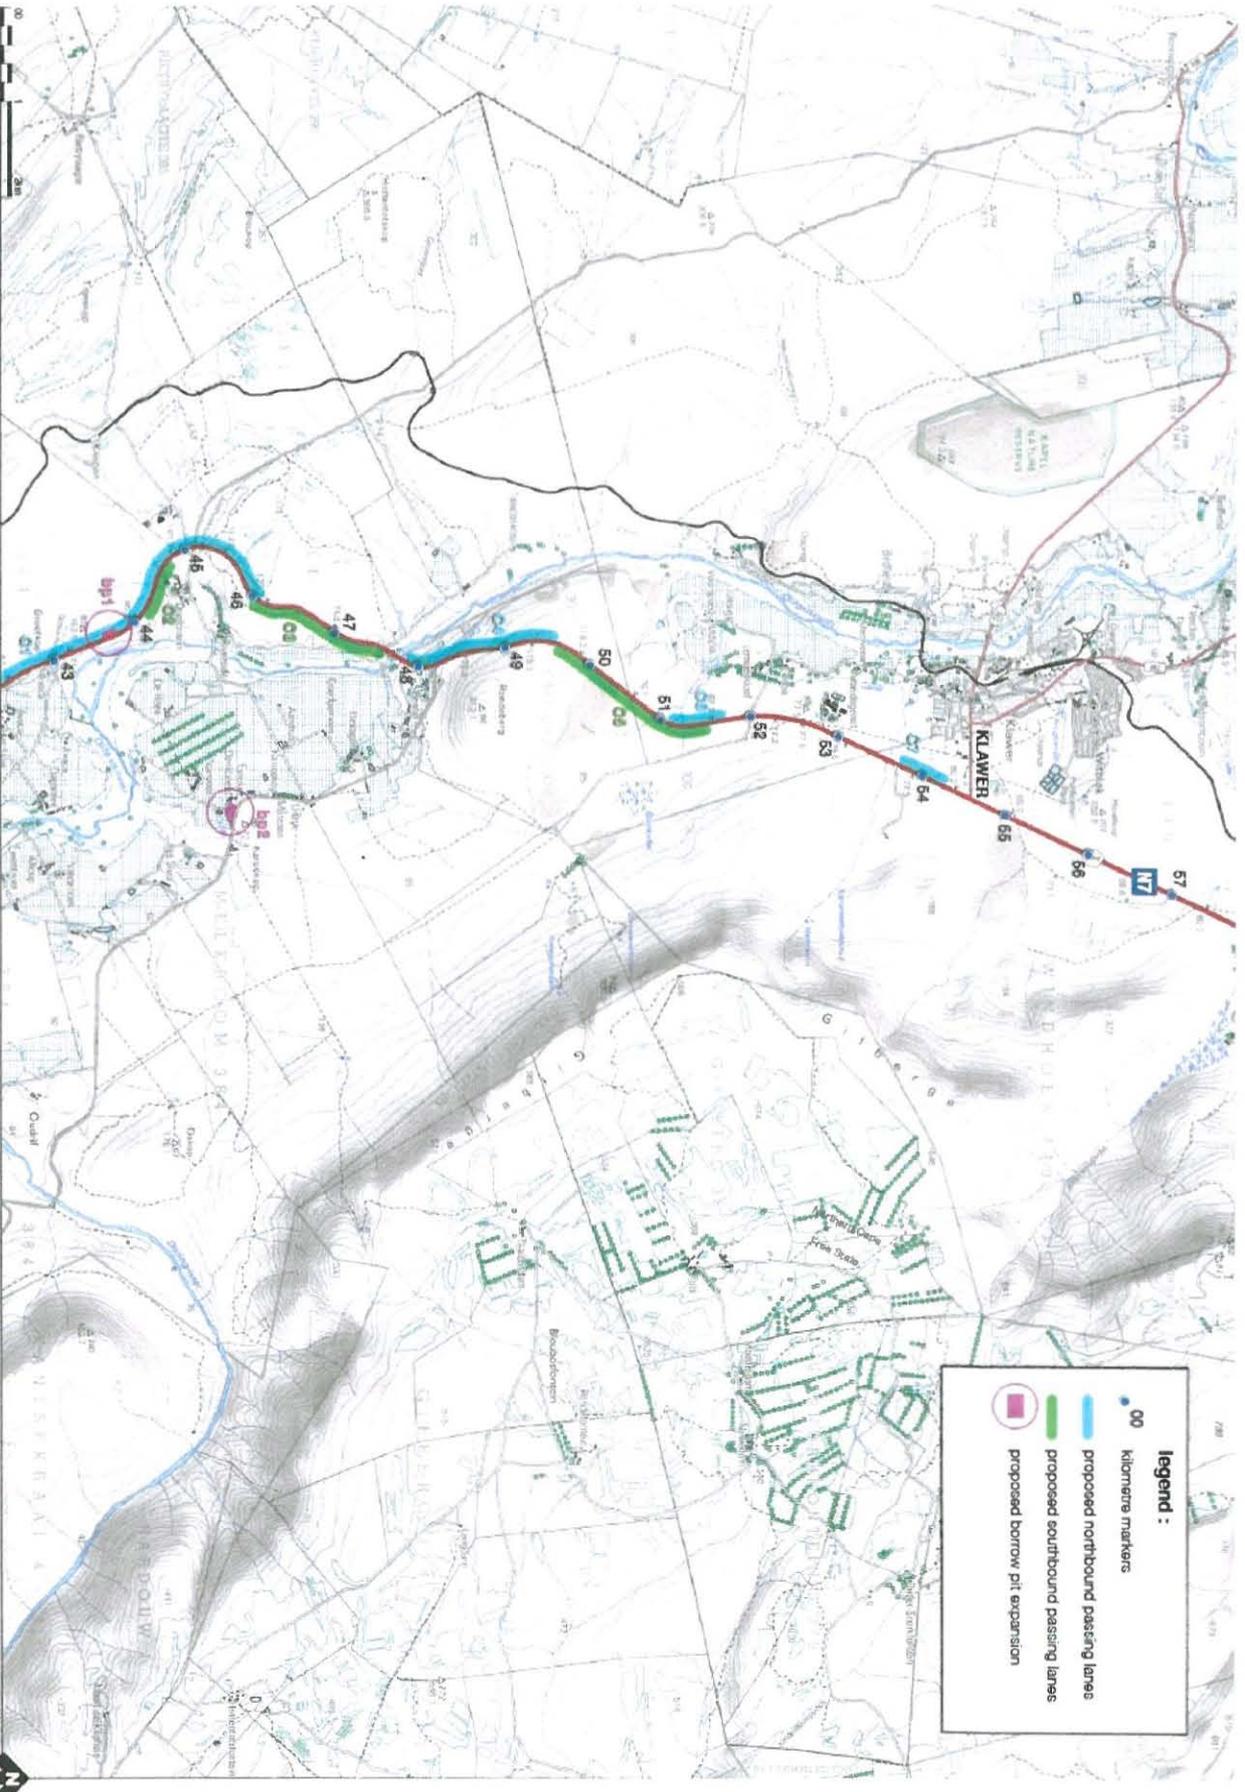
Figure 4 - N7 Section 4 Upgrade - Proposed Passing Lanes (Trawal to Windhoekdooi - 42 to 58km)

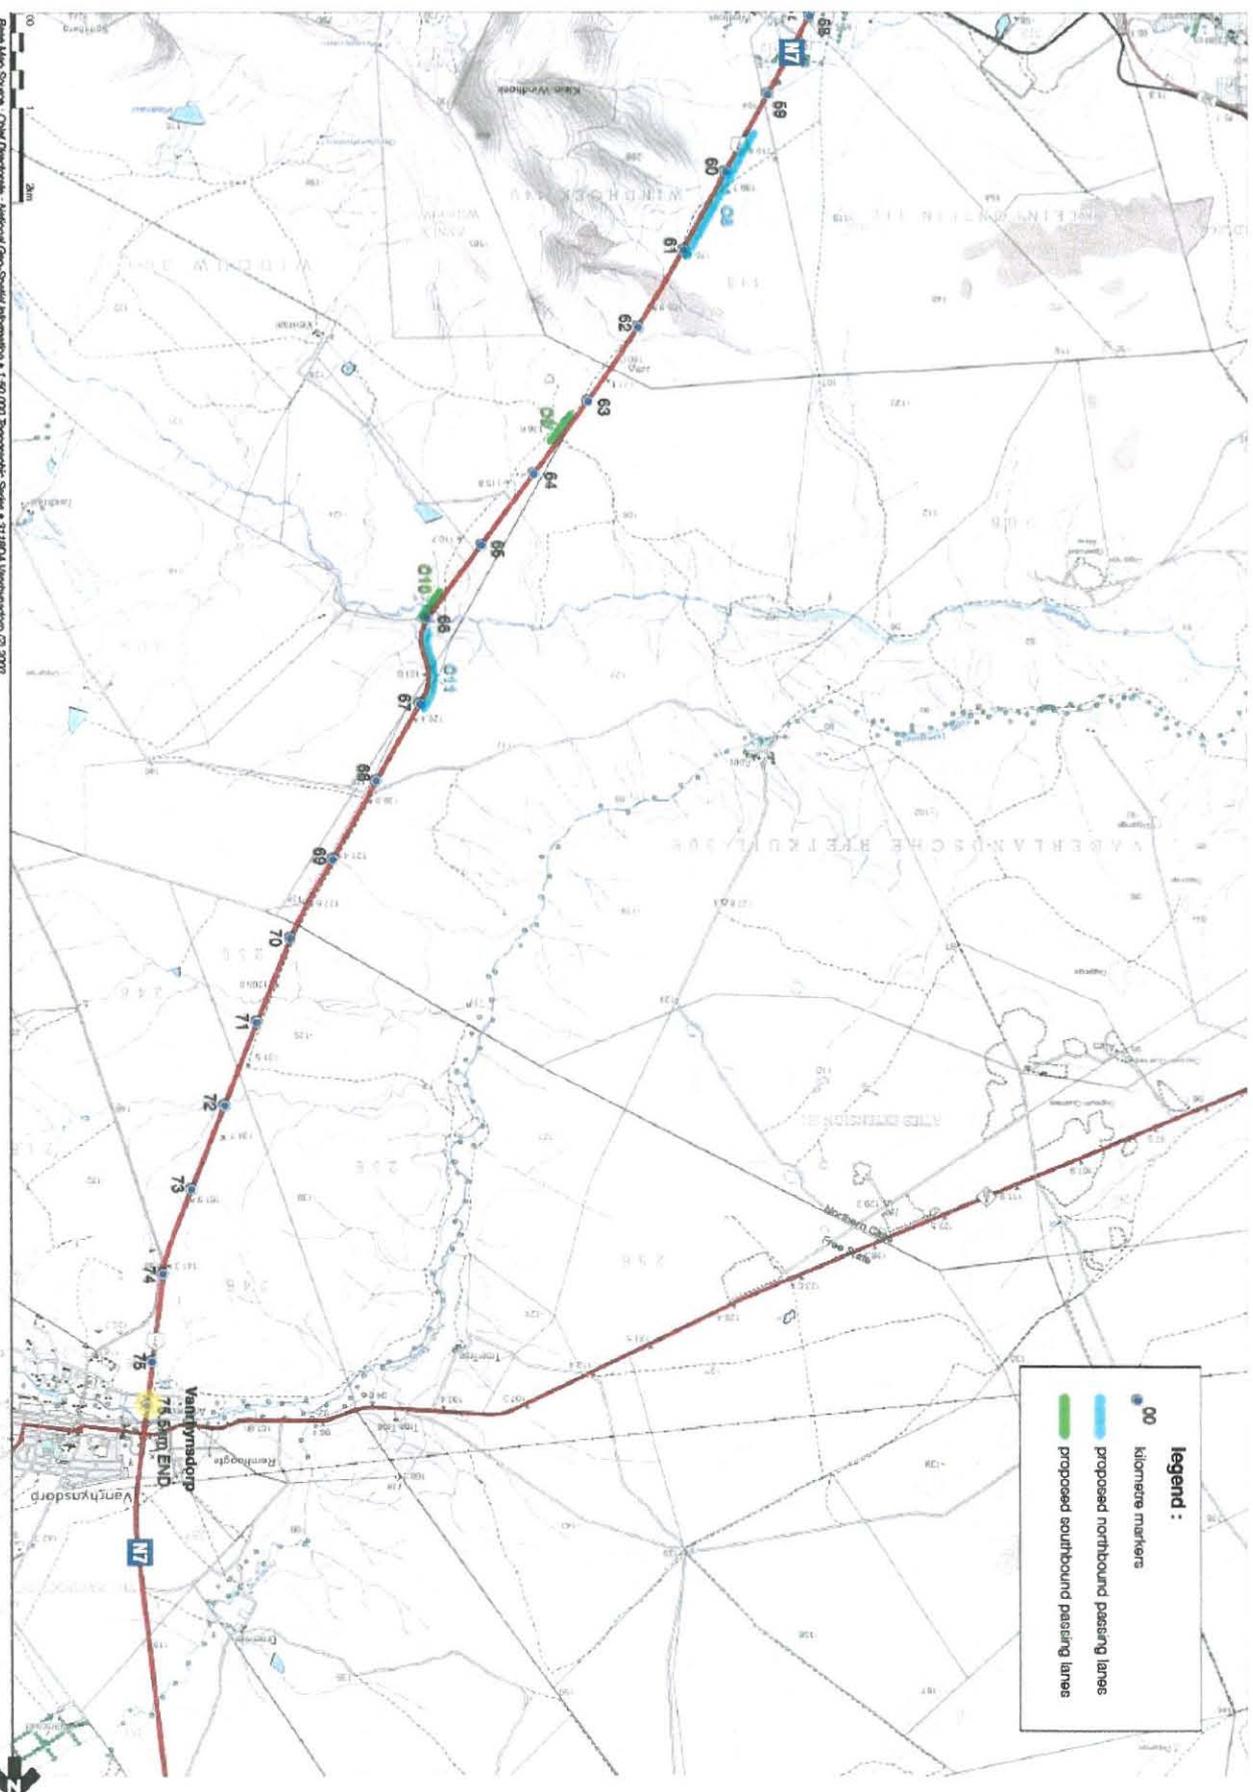
Figure 5 - N7 Section 4 Upgrade - Proposed Passing Lanes (Windhoek Farm to Vantynsdorp - 58 to 75.5km)

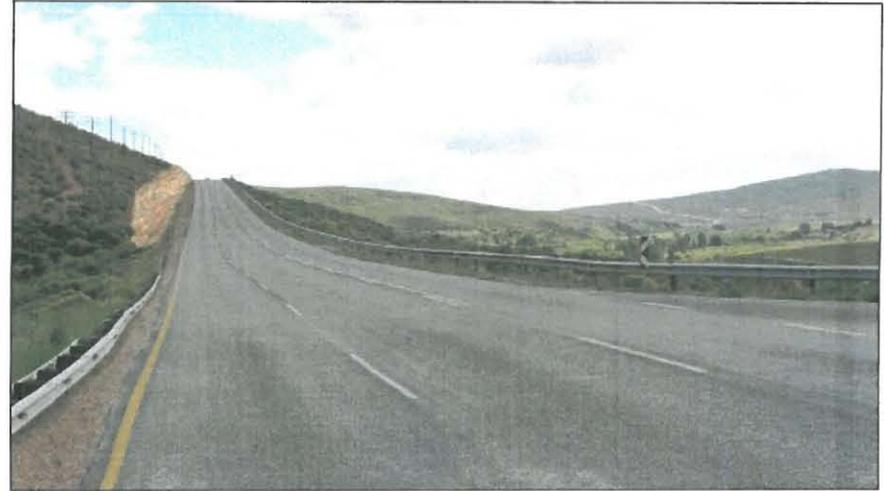
C1 • northbound passing lane starting at 42.43km - 3630m long

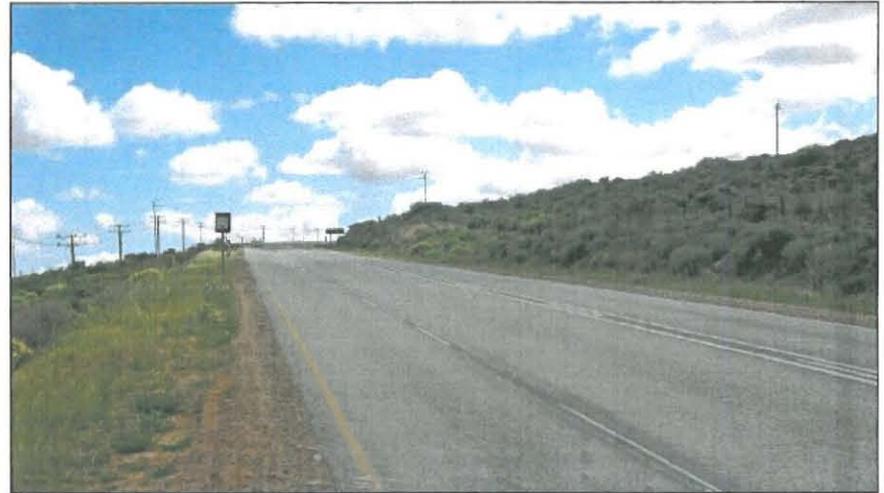
C4 • northbound passing lane starting at 47.86km - 1660m long

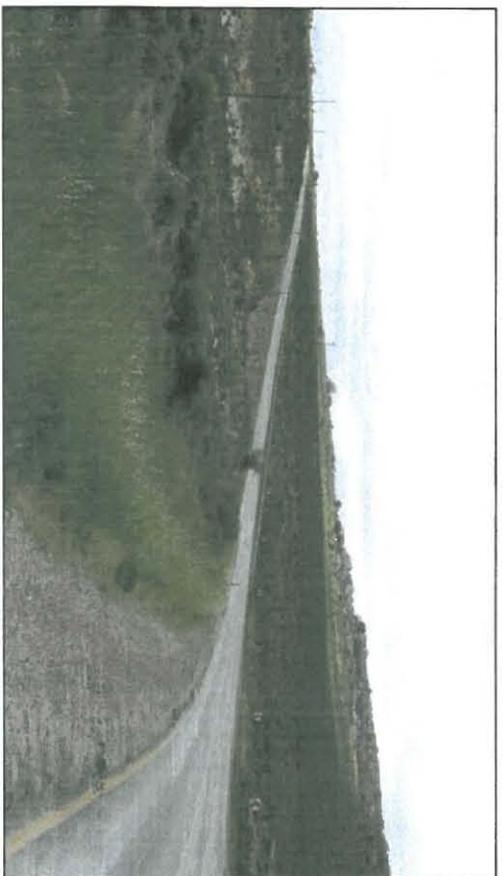
**C9 • northbound passing lane starting at 51.12km - 580m long  
(C8 • southbound passing lane on opposite side)**

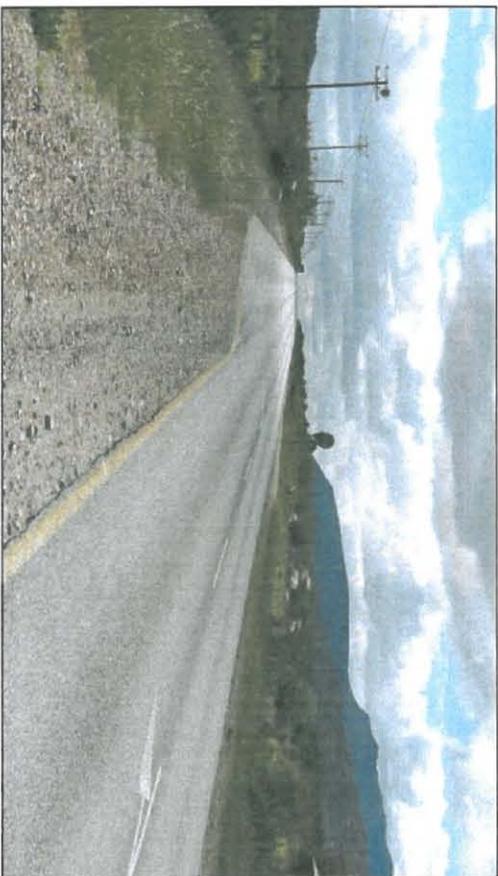
**C7 • northbound passing lane starting at 53.76km - 480m long**

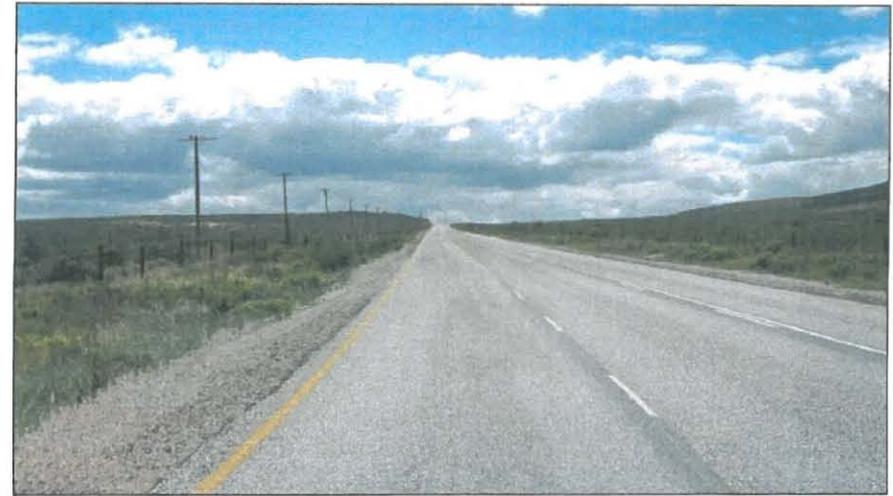
**C8** • northbound passing lane starting at 59.5km - 1600m long

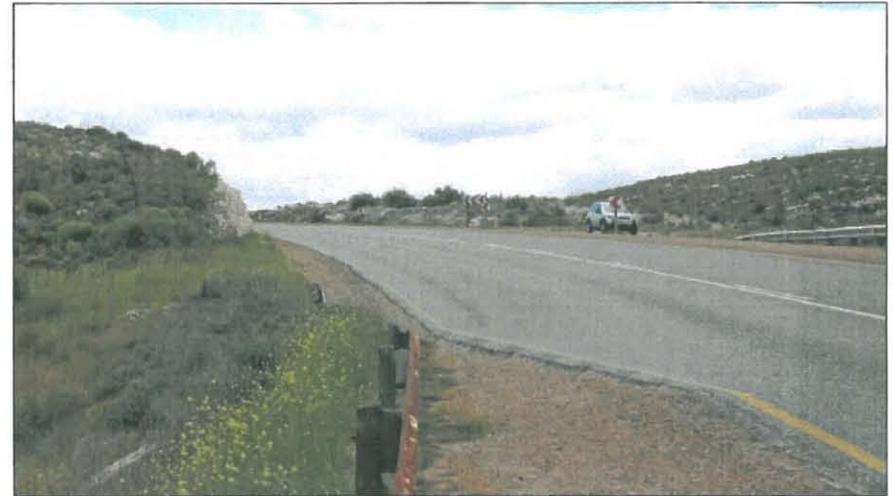
**C11** • northbound passing lane starting at 66.19km - 890m long

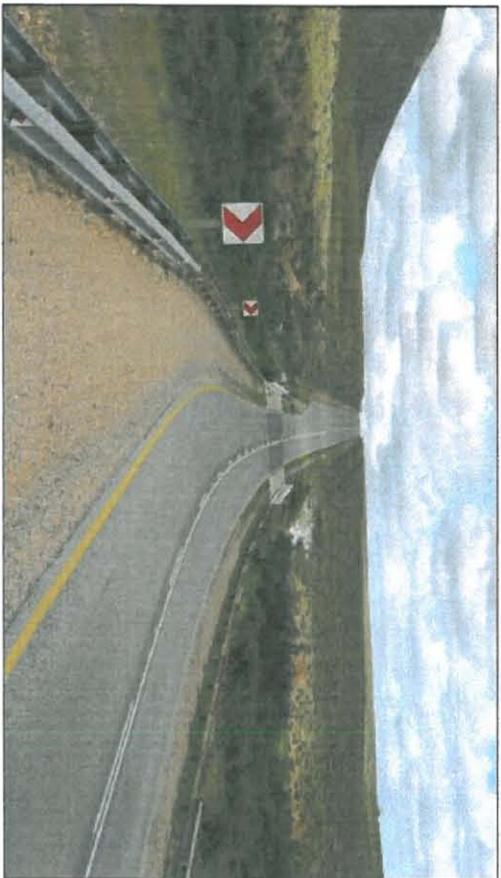
C-10 • southbound passing lane starting at 66.08km - 360m long

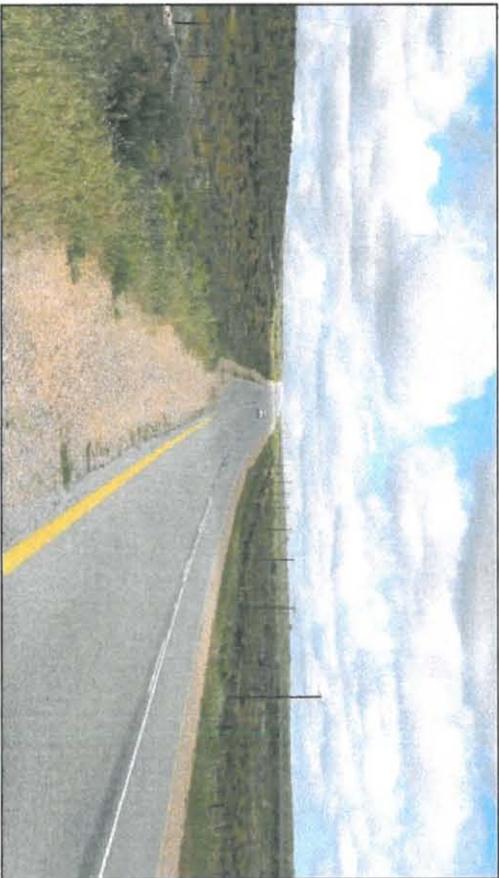
C-9 • southbound passing lane starting at 63.64km - 360m long

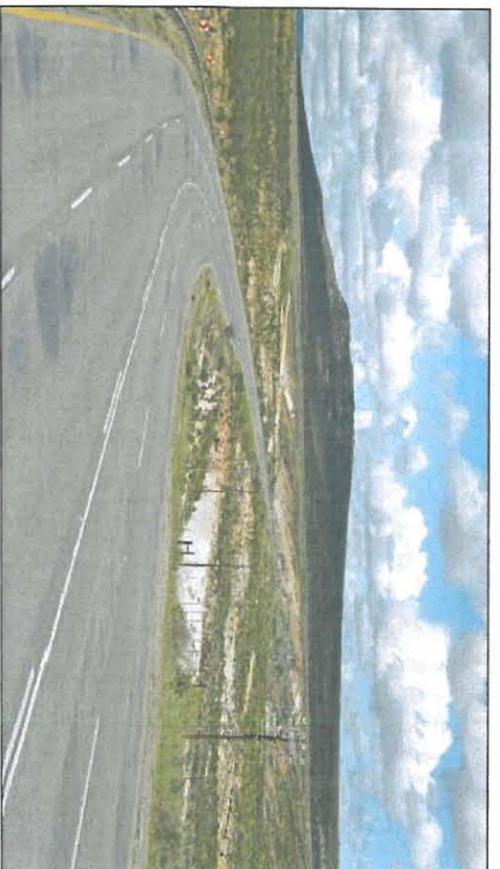
**C5 • southbound passing lane starting at 51.5km - 1880m long**  
(C6 • northbound passing lane on opposite side)

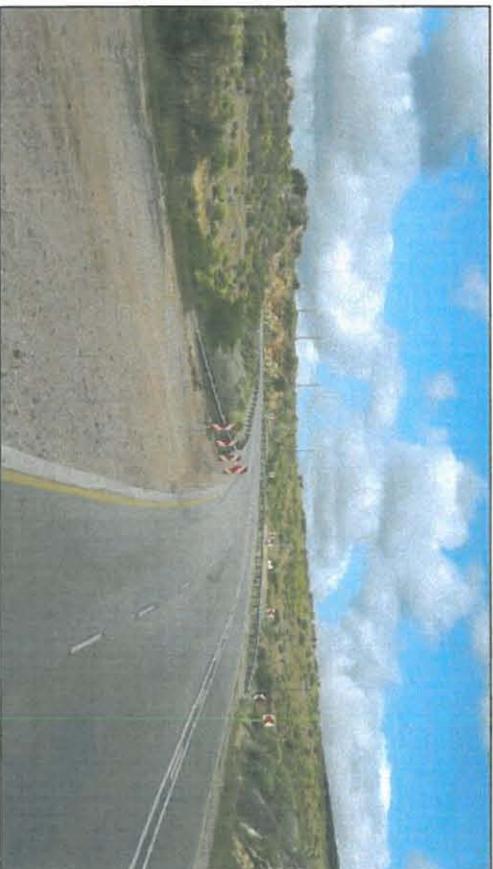
**C3 • southbound passing lane starting at 47.74km - 1660m long**

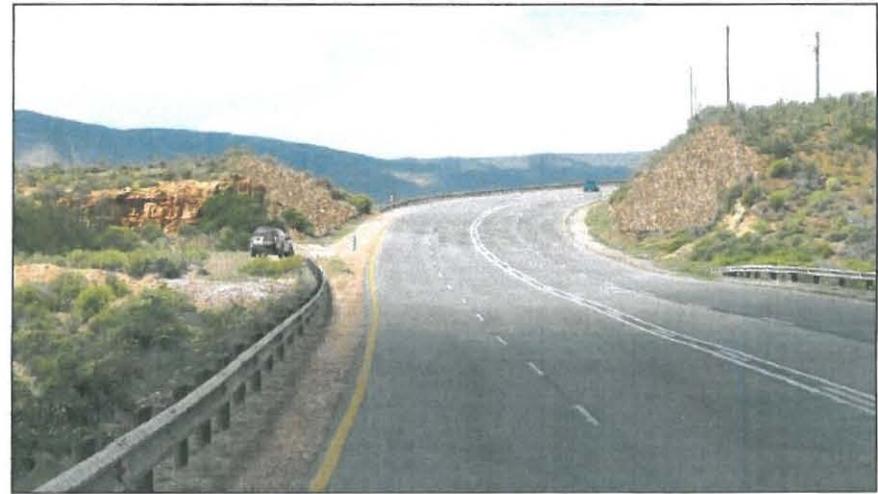
**C2 • southbound passing lane starting at 44.74km - 580m long**  
(C1 • northbound passing lane on opposite side)

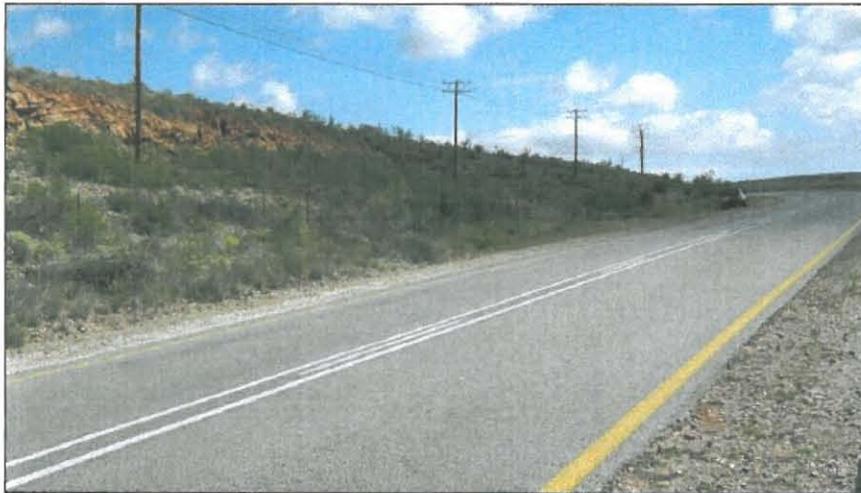
**Borrow Pit 2 • adjacent to N7 at 43.7km - ? ha**

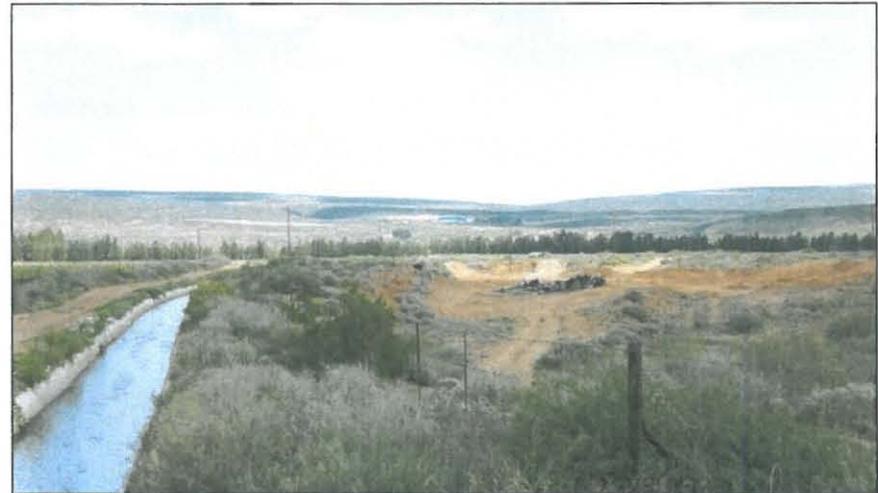
**Borrow Pit 3 • adjacent to regional road R363 - ? ha**

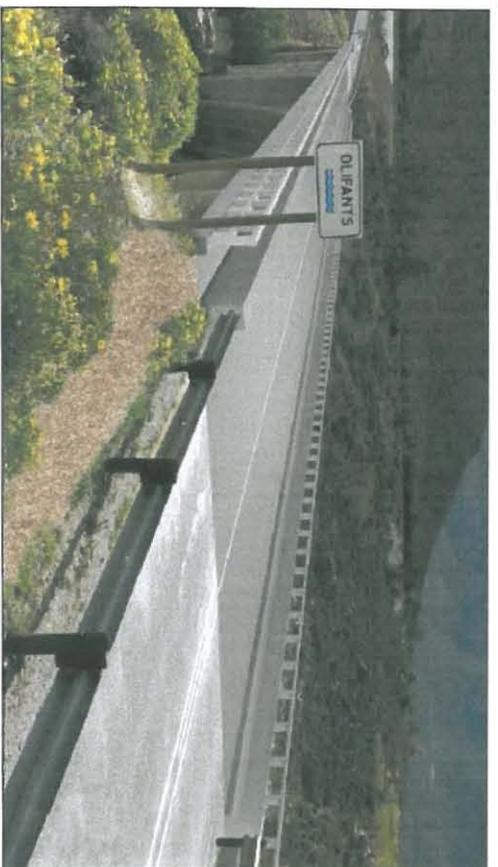
Olfants River Bridge • widened
