PROPOSED HOUSING AND ASSOCIATED  
INFRASTRUCTURE DEVELOPMENT  
ELANDSKLOOF

HERITAGE IMPACT ASSESSMENT REPORT

CASE NO: 130530JW35E

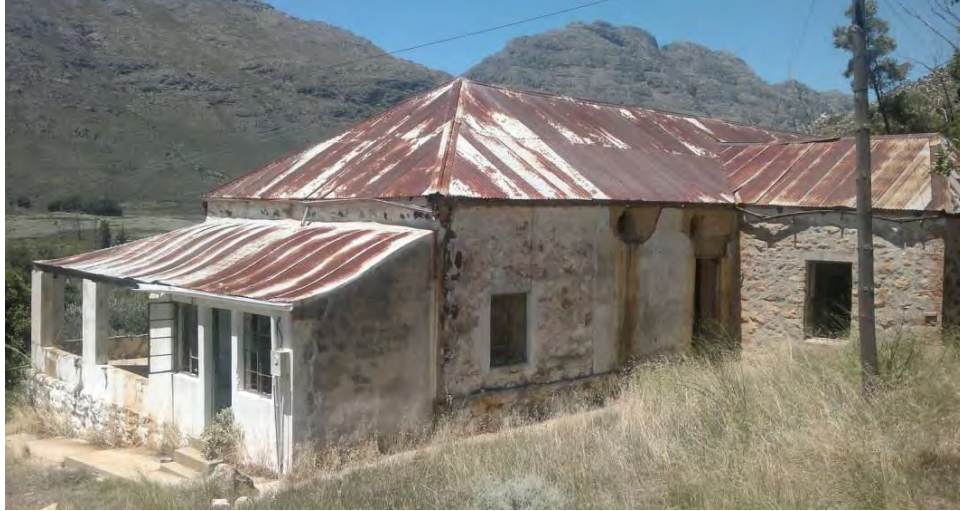
Figure 1: The ruined pastorie

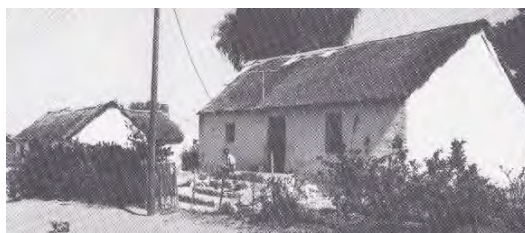
**Figure 3: Wittewater cottage    Walton's Cape Cottages 1994**

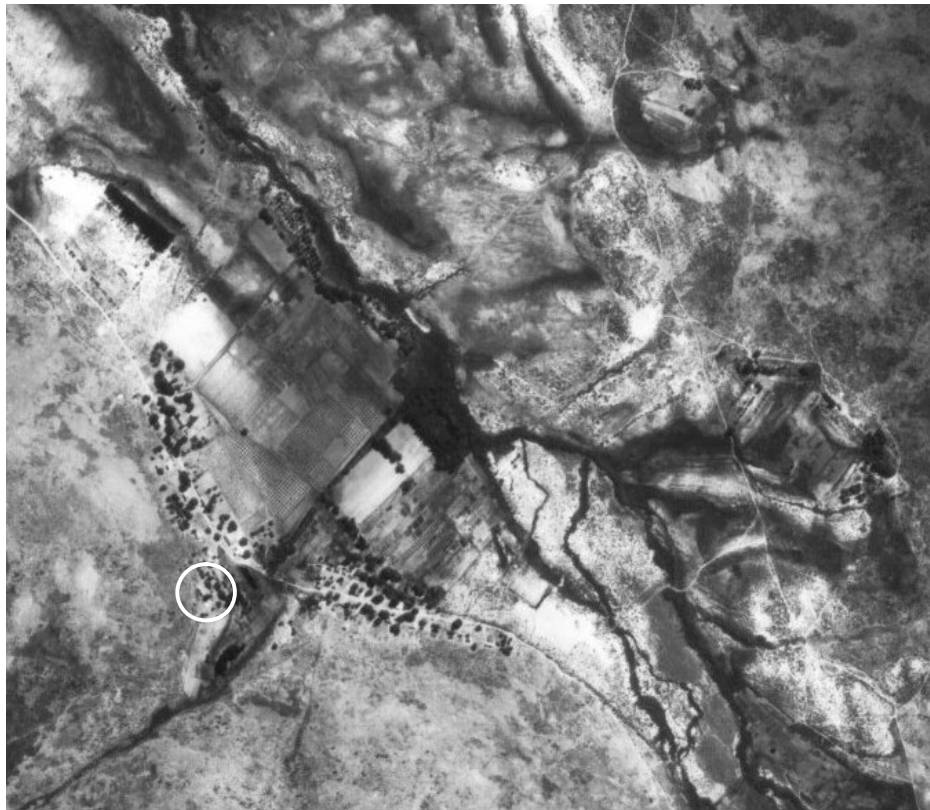
**Figure 4: 1960 aerial photograph showing the valley floor under intensive cultivation. Besides the long narrow strips producing vegetables there were orchards and citrus groves north of the Pastoriekloof furrow. The pastorie is shown circled**

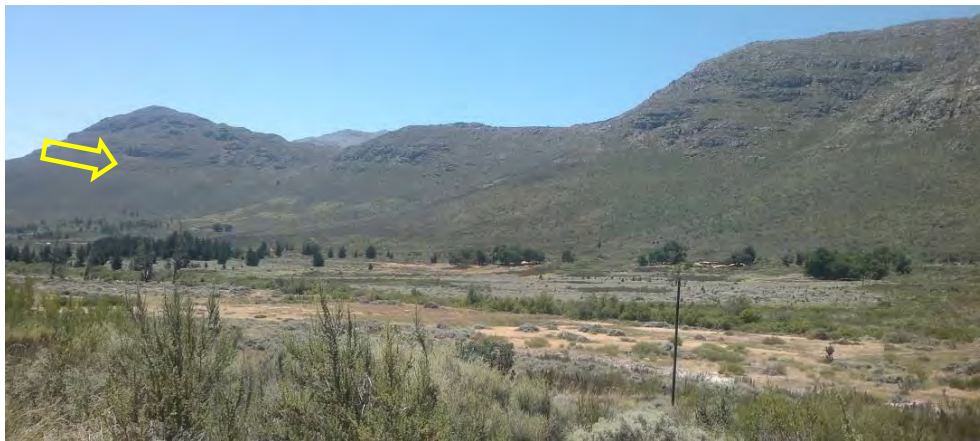
**Figure 5: View towards the northwest. The Middelberg Pass is indicated traversing the 1221m peak overlooking the valley**

There are two narrow tracks that skirt the foot slopes of the valley with that on the western side serving most of the cottage sites, the church, pastorie and school. The winding track on the eastern side provides access to the *buitepost*. As can be seen in Figures 5 and 6, cluster pines *Pinus pinea* has begun to invade parts of the valley.

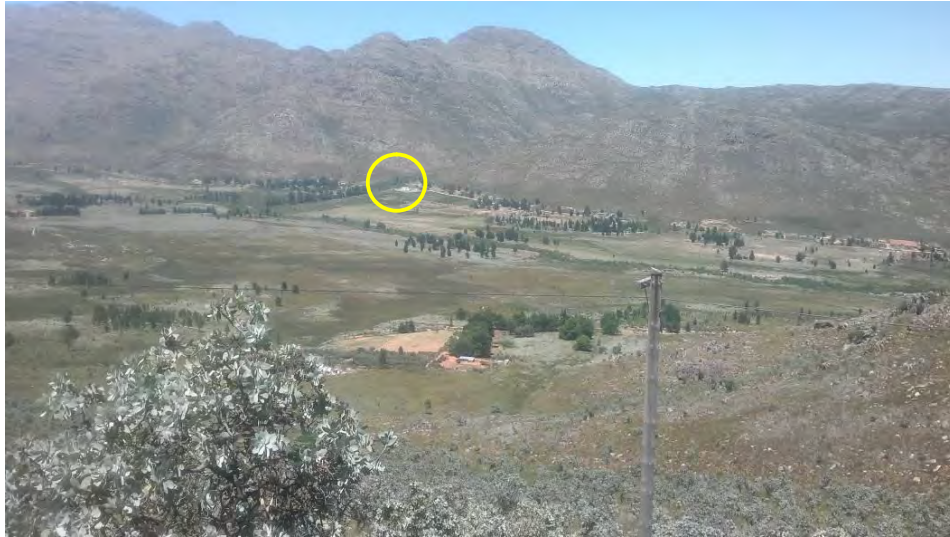
**Figure 6: View over Elandskloof from the Middelberg Pass with kreupelbos and other Olifants Sandstone Fynbos vegetation in the foreground. Below on this eastern side of the valley is one of several buiteposte while across the valley floor is the historic church, pastorie and school towards the southern end**

This however is very unlikely scenario as the process since the farm was transferred to the ECPA has ensured that this can't take place. There is a legal requirement and community expectation that the 308 listed beneficiaries will receive a serviced plot and a house. The proposed new settlement will be about three times the size that it was at its peak and will therefore have a high visual impact particularly when viewed from the Middelberg Pass (see Figures 6 and 7).

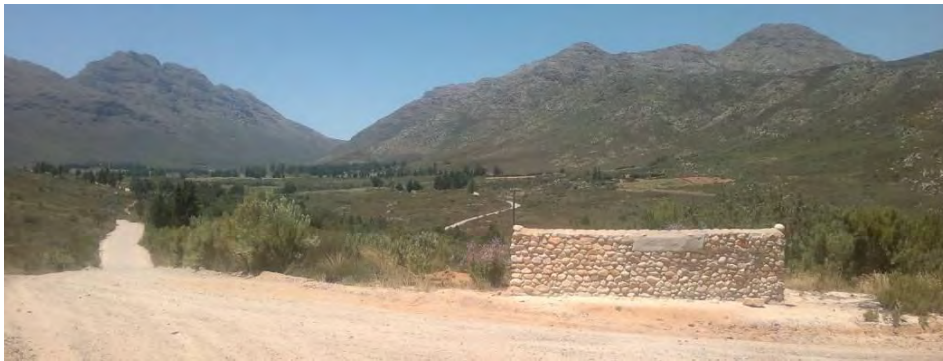
**Figure 7: View up the valley from the Middelberg Pass. Until this was built in 1940 the road through Elandskloof seen in the background was one of the few routes up into the Koue Bokkeveld**

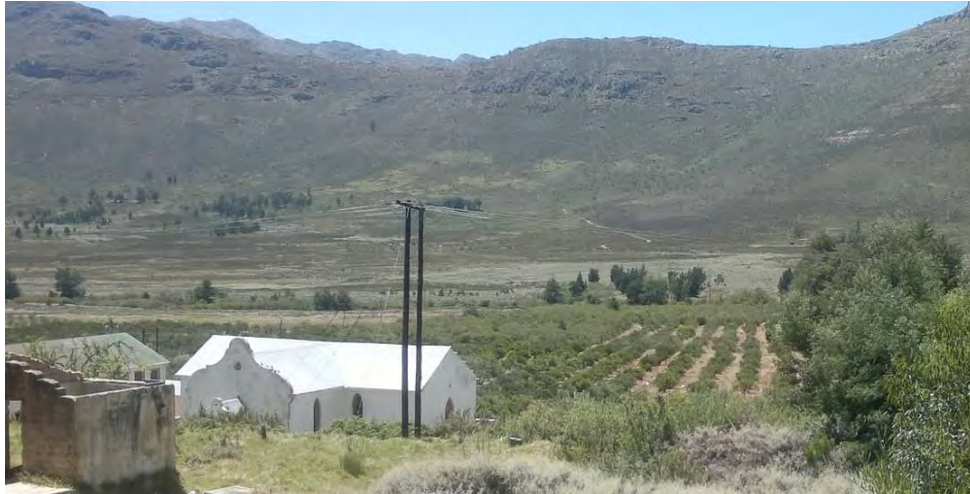
**Figure 9: The orchards are sited below the church**

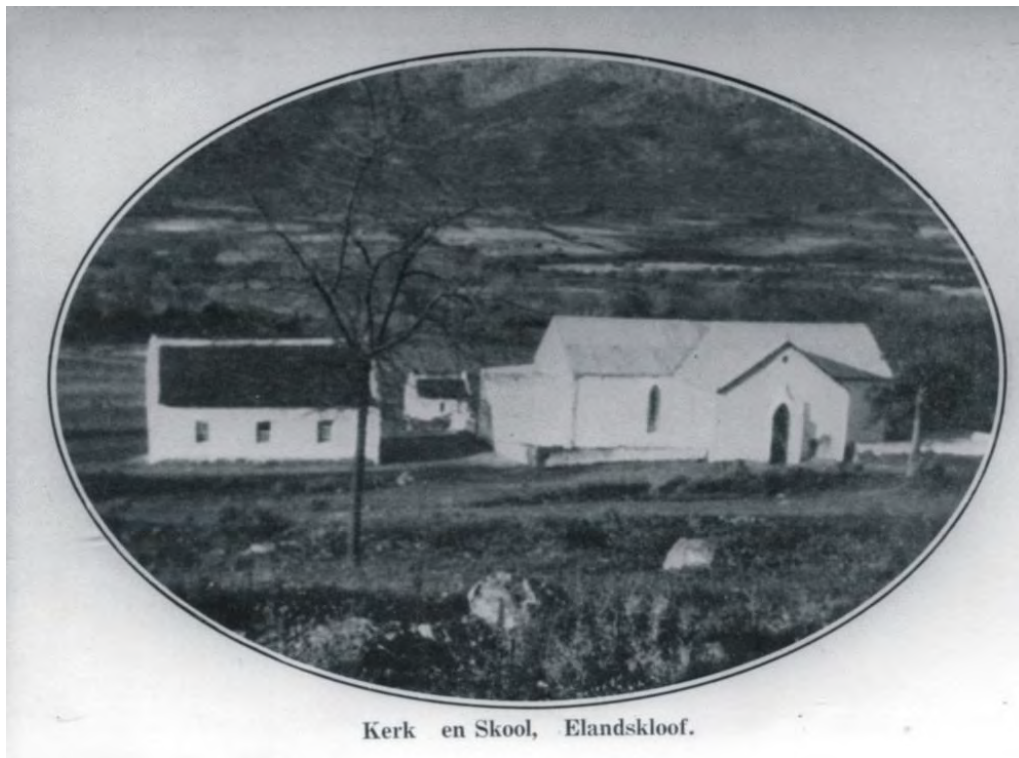
**Figure 12: Church and school in 1932. At that time the school must have been a single classroom and the porch to the church had yet to be built. Note the current holbol gable was also not then in existence and there appears to be a lean-to addition at the north end**

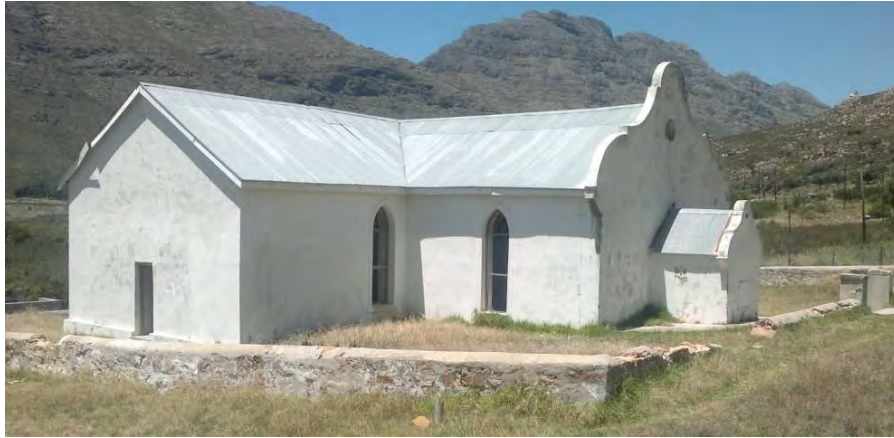
**Figure 13: The simple H-shaped church is sited at a bend in the main track on the western side of the valley enclosed by a low plastered and painted stone wall**

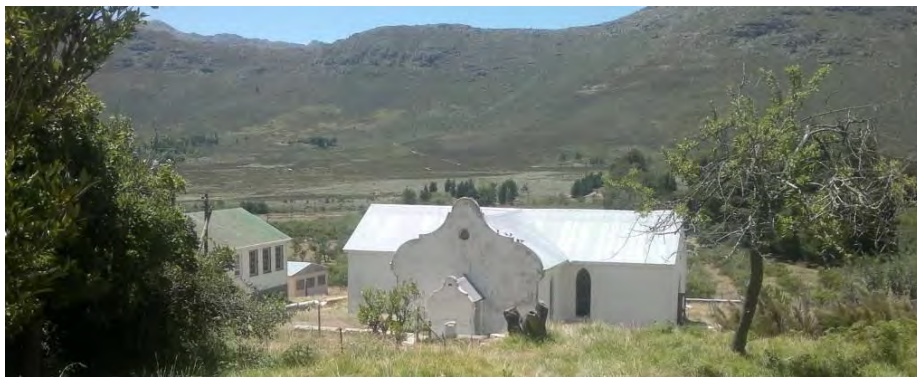
After the Elandsklowers were evicted the church was used as a store by the Smit brothers. When the farm was transferred to the ECPA in 1996 the church was re-plastered, re-roofed and repaired with international donor funding. Services were once again held. Community conflict led to services being discontinued. Sadly the building has been severely vandalised with wooden window frames and ceiling panels torn out. Not a single pane of glass survives. A section of the corrugated iron roof has been torn off at the south gable end.

**Figure 14: The main entrance to the church is from a small porch but there are also doors at each gable end. The school is on the left**

- A landscape plan is to be prepared with a focus on extensive tree planting throughout the valley for visual screening and on hard and soft landscaping particularly of the roads;
- The church-pastorie complex must be renovated immediately or at the very least the roofs are to be repaired as an interim measure to prevent further deterioration. Options for re-use must be investigated;
- No high mast lighting to be installed.

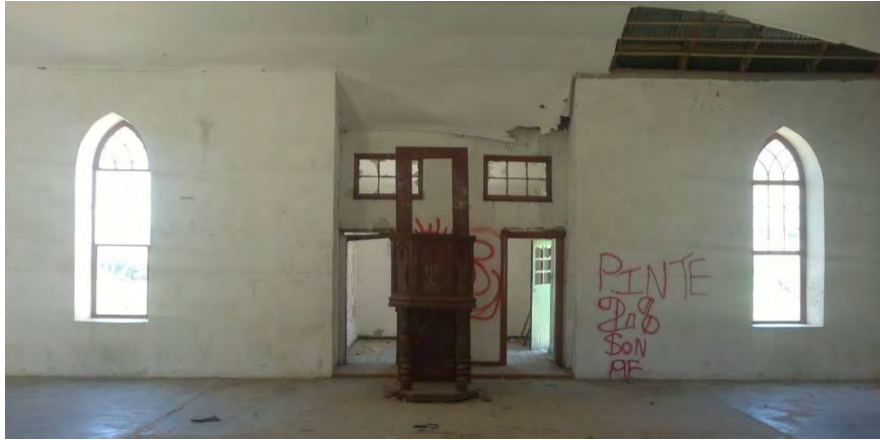
**Figure 15: The pulpit with consistory behind. The remains of the wood tracery can be seen in the window on the right**

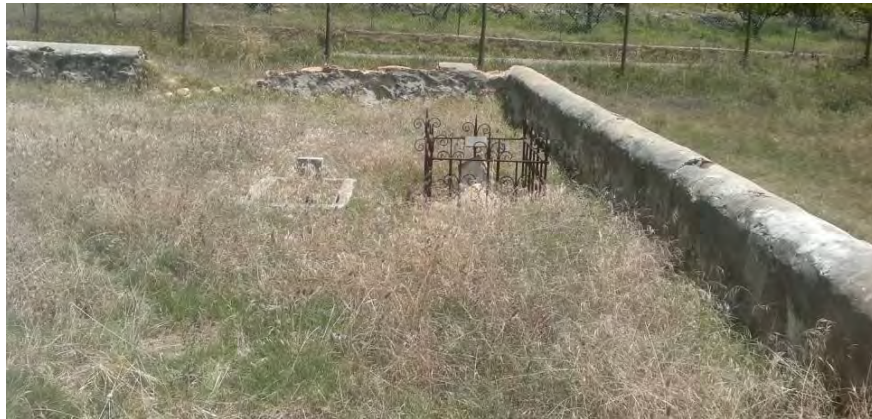
**Figure 16: Two small graves are sited in one corner of the church enclosure**

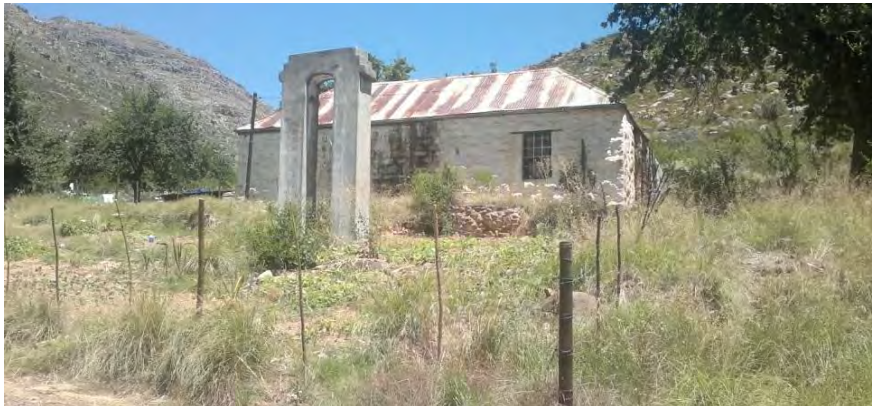
A small un-plastered stone cottage sited to the northwest of the main pastorie building was probably the original pastorie built when the mission station was established. It now has a corrugated iron roof but must have originally had a roof of thatch.

**Figure 17: Original pastorie with the bell tower**

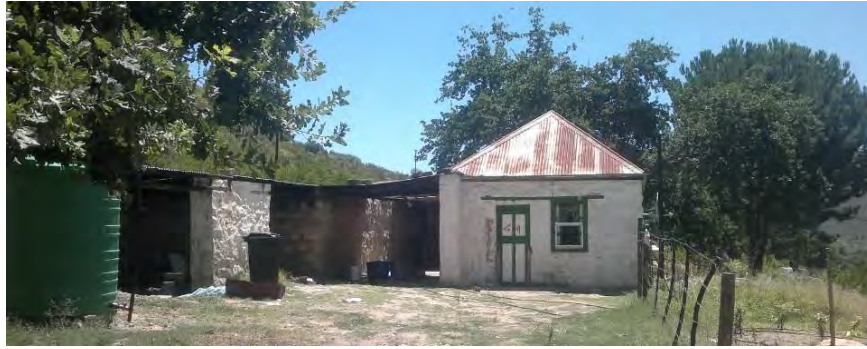
**Figure 18: southeast end of the original pastorie with stables and stores in the yard**

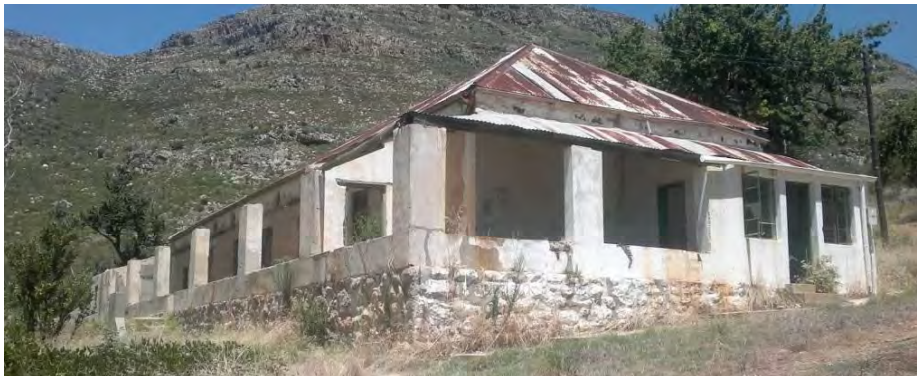
A larger pastorie was subsequently built occupying one of the most prominent positions in the valley: a high terrace at the entrance to Pastoriekloof overlooking the entire valley. It has many late 19<sup>th</sup> Century characteristics with a hipped corrugated iron roof over a double bank of interconnected rooms with a curved corrugated iron veranda along the main façade and across each end. Window openings indicate that there were originally sliding sash windows.

**Figure 19: A veranda once ran along the entire front façade and around each end. The stoepkamer on the right functioned as an office**

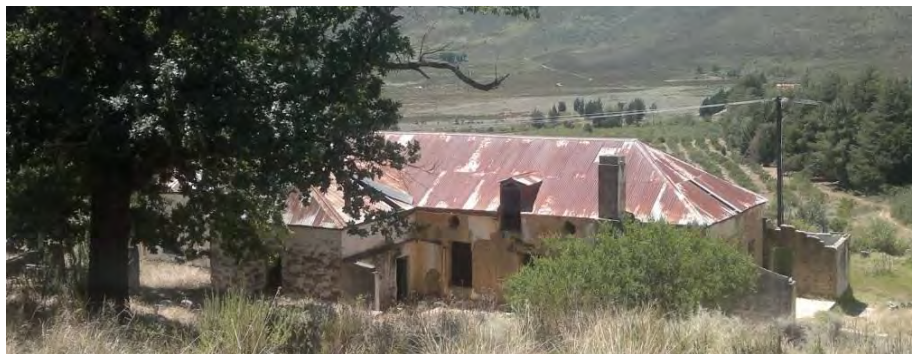
**Figure 20: Back of the building with the tail addition of un-plastered stone. The central core of the building is of sun dried brickwork with clay mortar. As can be seen most of the plaster has been lost and brickwork is in poor condition**

A loft door at the back of the building indicates that the loft was used to store produce like sweet potatoes, potatoes and possibly grain. The walls are of sun dried brick no doubt made on site. It was clearly extended at various stages with stoepkamers at each end of the veranda and a tail at the back of the building built of unplastered stone. The ceilings/floor of the storage loft are of pine boarding on joists with quirk moulded edges. These are largely intact but given that roof sheeting has been removed in places rain has penetrated the building and caused damage. None of the suspended timber floors survive.

All of the external and internal joinery has been removed. This appears to have taken place many years ago as the openings are very weathered. Plaster has been lost on most of the rear wall of the building. The interior walls are covered with graffiti and plaster has also been lost there. The building although in very poor condition can be renovated and conserved. Re-roofing or at the very least roof repair should be undertaken urgently.

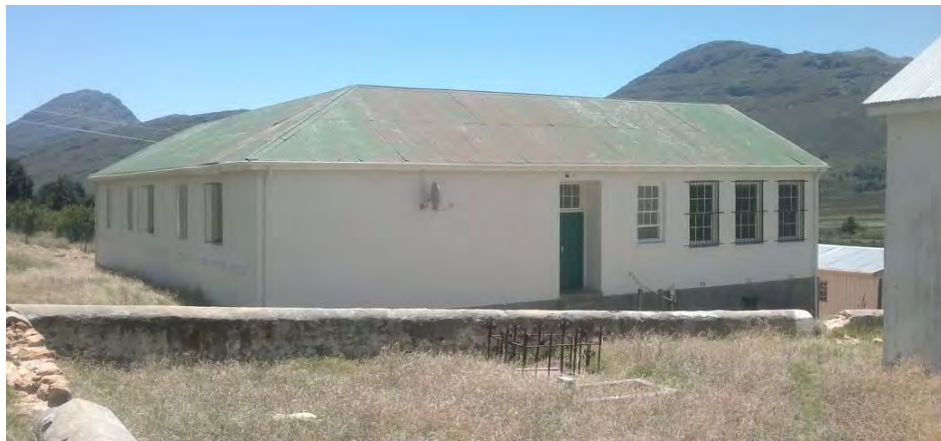
The school dates from the 19<sup>th</sup> Century and was enlarged and upgraded soon after transfer of the farm to the ECPA. It is not currently in use. Local children are transported by bus to Citrusdal to attend school there. The building is in good condition but there are broken window panes and the roof sheeting needs refixing. It is used occasionally by the Cederberg Municipality for public meetings.

**Figure 21: The school is sited close to the northwest of the church enclosure**

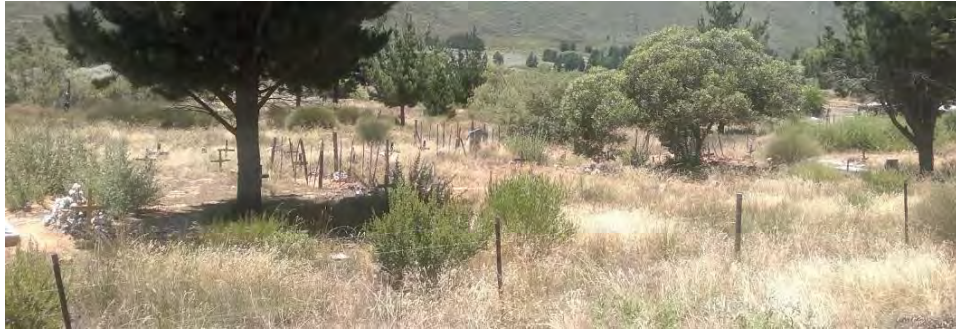
**Figure 22: Many of the gravestones and wooden crosses indicate that a significant number of burials have taken place since the ECPA took ownership in 1996**

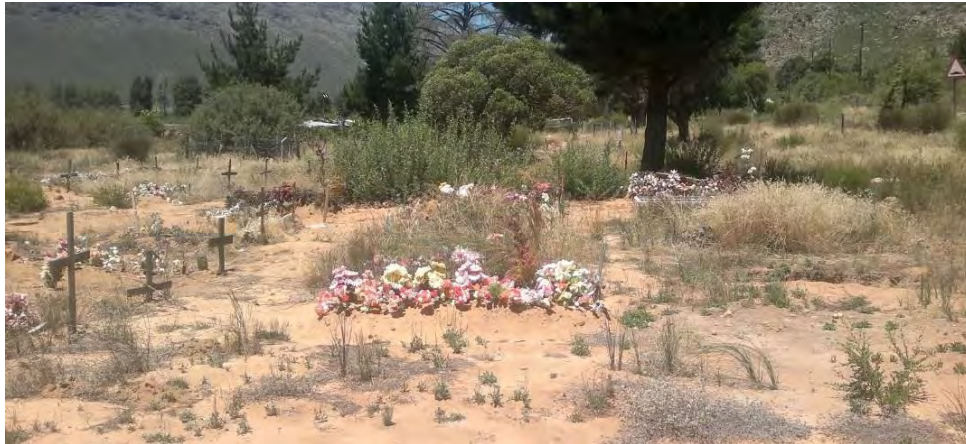
**Figure 23: Recent grave site**

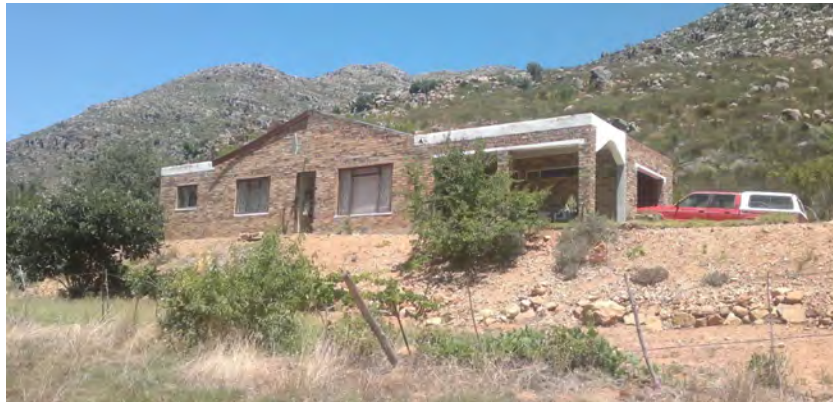
After the farm was transferred to the ECPA some 70 dwellings were erected on the farm. Most were sited on the western side of the main track and a few were erected on the eastern side. Dwellings were also erected at the *buiteposte* sites. This occupation of parts of the farm was uncontrolled and led to many community disputes. The planning consortium eventually managed to obtain community support for a linear residential area of 192 lots which were surveyed and pegged. Some of these dwellings are permanently occupied while others are occupied occasionally at weekends and during holiday periods. There are a few dwellings unoccupied and still under construction. Most are quite small ranging from 40-60m<sup>2</sup>. Many appear to have been erected on the original cottage platforms where an old level terrace could be easily utilised. In some cases old stoep areas could be incorporated into the new structure. Existing trees provide shade and visual screening. One new dwelling however is quite substantial and its construction has involved earth moving for the creation of a broad terrace.

**Figure 24: Substantial house built recently on a terrace site at the south west end of the valley. As can be seen a seen there has been considerable cut and fill creating an unsightly bank of exposed rubble**

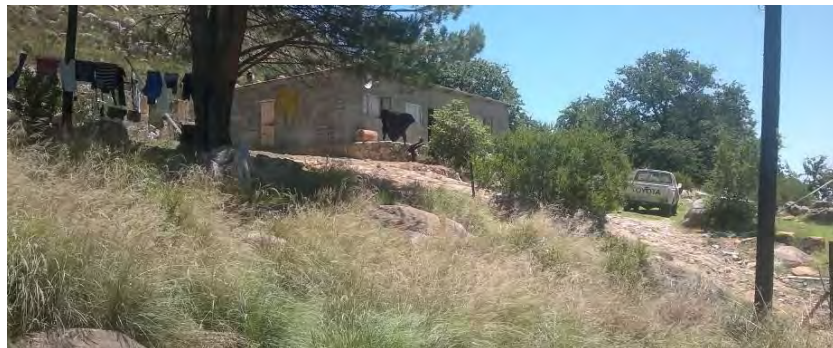
**Figure 25: Masonry structure that appears to have been built on the original cottage platform**

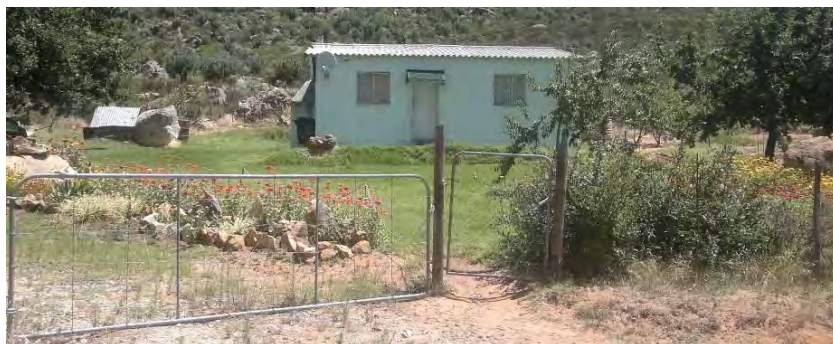
**Figure 26: Small dwelling of masonry construction built on the original cottage platform**

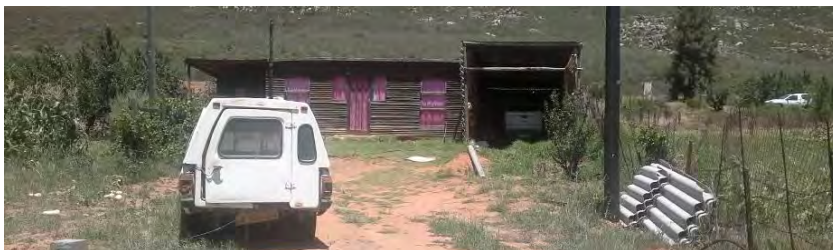
**Figure 27: Small timber frame structure**

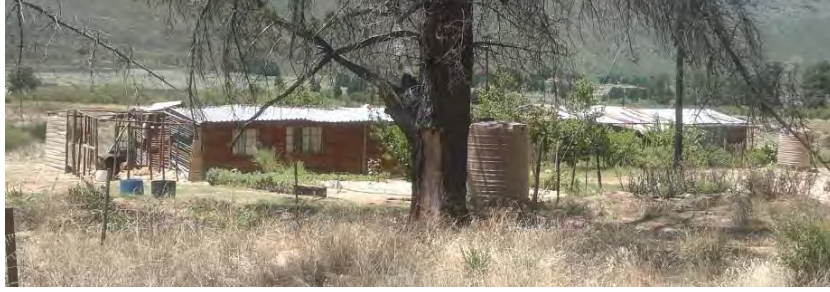
**Figure 28: Two timber frame structures. Each dwelling has been supplied with a water storage tank**

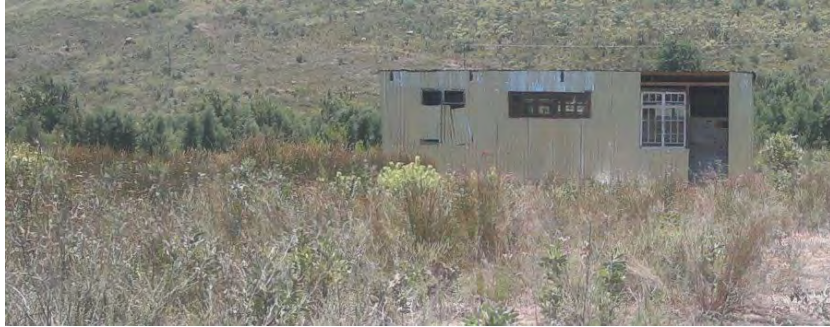
**Figure 29: Some structures are unfinished**

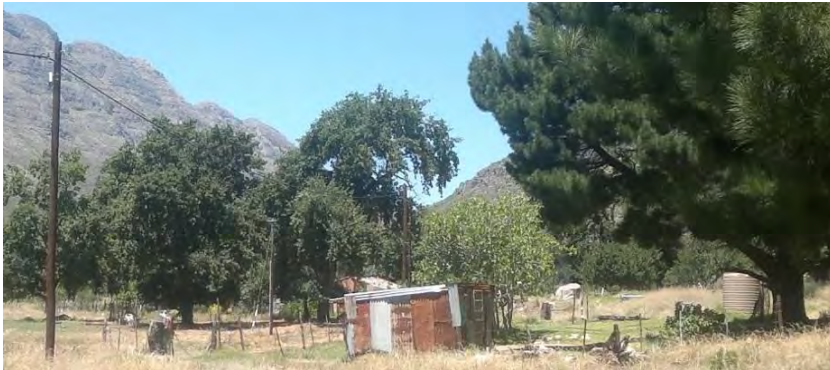
**Figure 30: Wood and iron structure. Note the ESKOM power line**

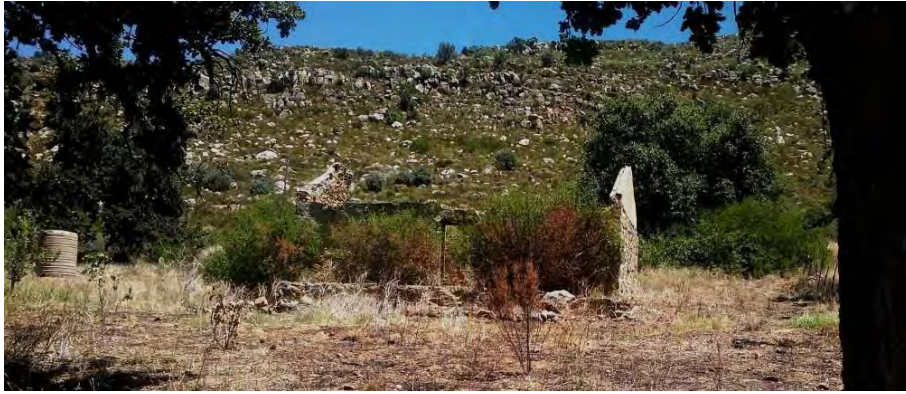
The ruins of dwellings erected by Elandsklowers are found all over the farm. Most are little more than a pile of stones but some as illustrated still have substantial sections of masonry standing. Having been built with clay mortar once roofs had gone walls quickly collapsed. As pointed out above many of the dwellings erected since the ECPA took transfer of the farm, have incorporated the old building platforms and stoeps. Often the site of a dwelling is indicated only by a grove of old oaks.

**Figure 31: Ruin above the road with gable walls still standing**

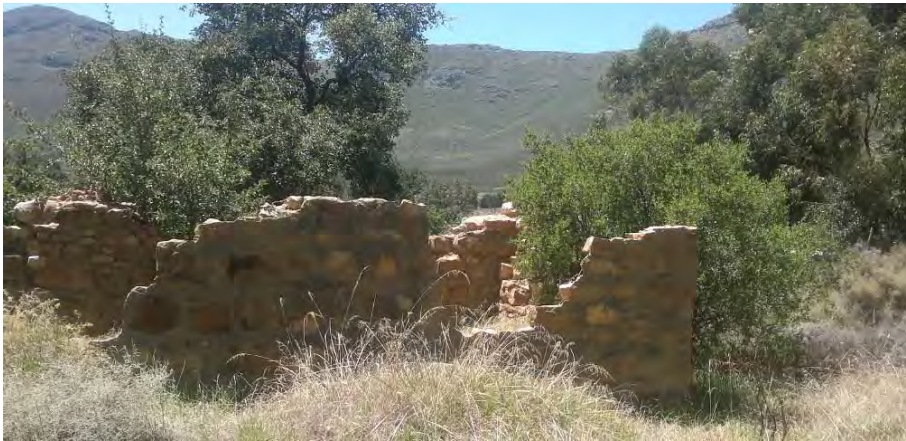
**Figure 32: Most ruined dwellings are now little more than a pile of stones**

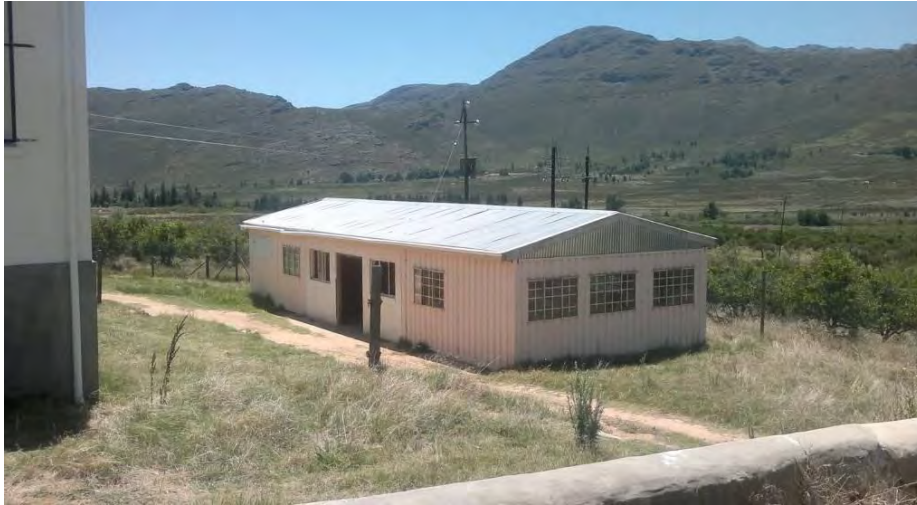
There are a few farm structures: a modern pack shed, a stock yard with shelters and a store and a large circular reservoir fed by the Pastoriekloof stream. Because of its elevated position water can be gravity fed to most dwellings. There are also two boreholes on the valley floor providing water for irrigation and livestock.

**Figure 33: Steel framed pack shed close to the citrus orchards**

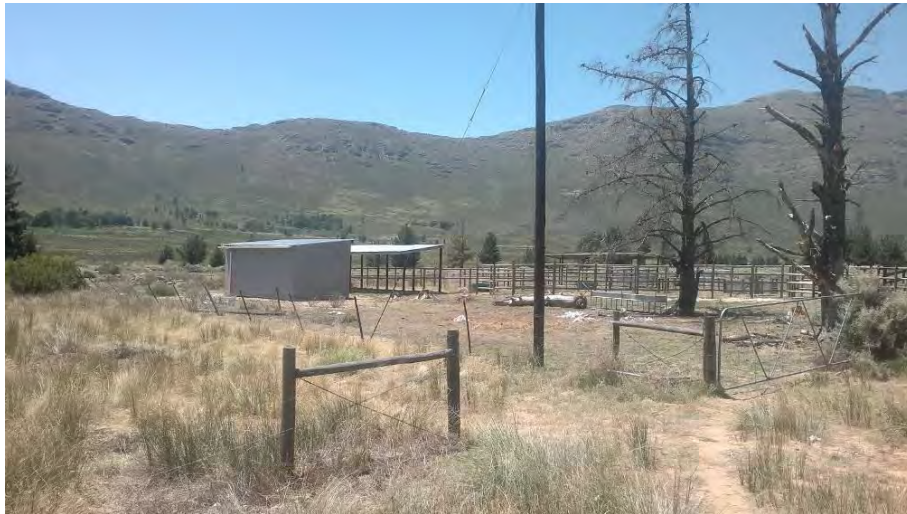
**Figure 34: Stockyard with shelters**

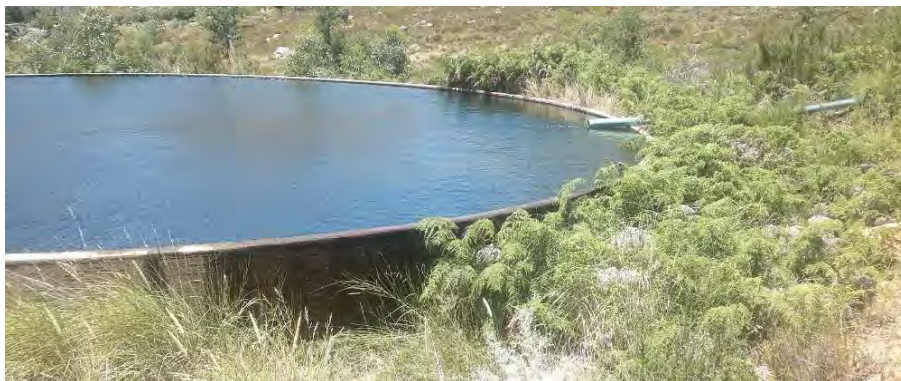
**Figure 35: Pastoriekloof reservoir**
